## Fuller Farmstead: Reuse & Rehabilitation Feasibility Report

# The Fuller Farmstead

Reuse and Rehabilitation  
Feasibility Report

*Community Partner:*  
The Barnstable Land Trust,  
Barnstable, MA

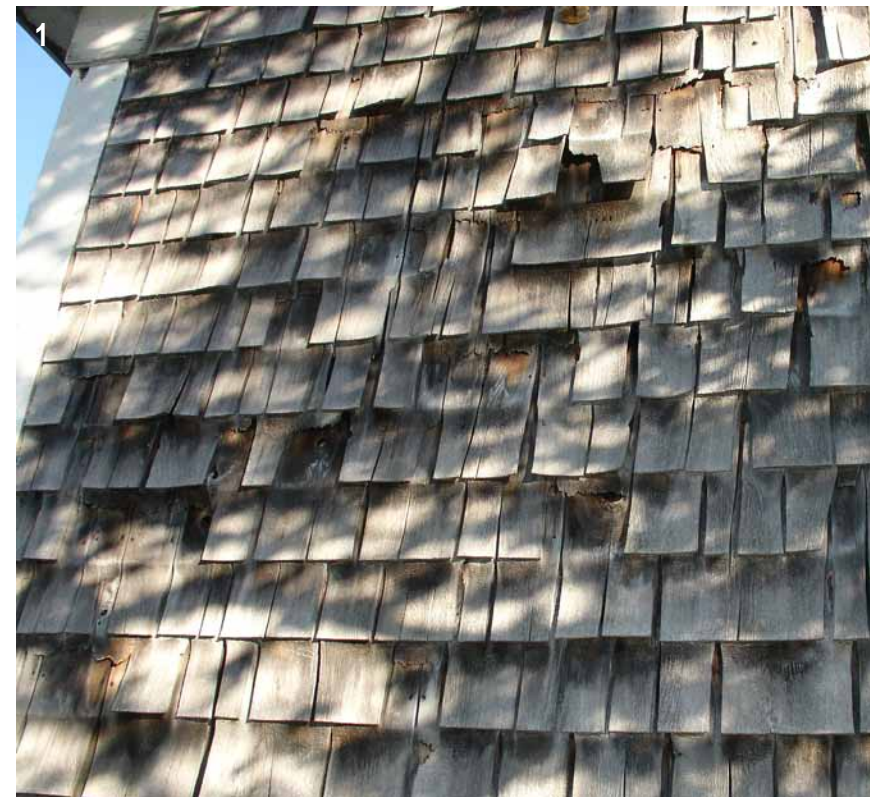
- Shingles are in poor or fair condition.
- Shingles are attached with machine-manufactured cut nails.
- Approximately 75-80% of the shingles are missing or have weather damage.
- Shingles on the second floor are rotting and in poor condition.
- There is no base trim or splash board.
- There is no vapor barrier between the shingles and sheathing.

1. 75-80% of the wooden shingles are damaged or missing.

- Remove existing shingles.
- Replace damaged shingles in original starter course.
- Add layers of rosin paper (Trimaco Red Rosin Paper) to help with sheathing and contracting of shingles.
- Install new cedar shingles
  - **Option 1:** Cedar Shingle Panes: Shakerstown Webster Gray 004-ST semi-transparent cedar shingle panels.

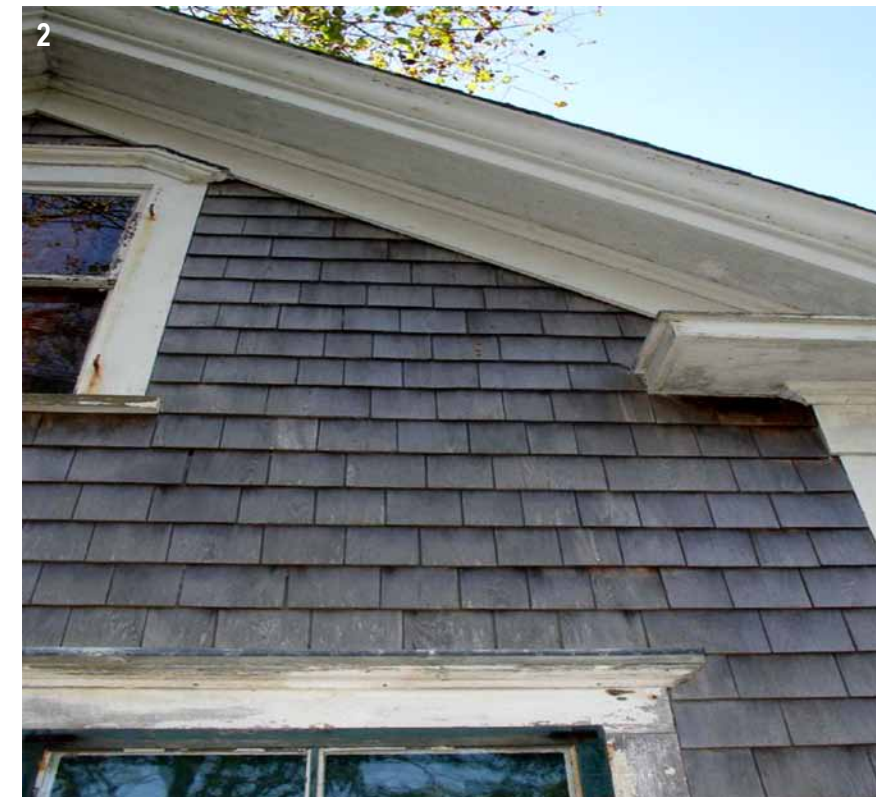
- Exterior trim shows signs of wood rot, extensive moisture damage and splitting.
- Evidence of damage from animal nesting is seen along the fascia on the roof line.
- Trim paint exhibits signs of wear and oxidation.
- First floor trim has little paint, while trim on the second floor has no paint.
- East elevation bead board is sinking and in poor condition.

2. Architectural trim shows wood rot, moisture damage, wear and oxidation.

- Replace sections where there is wood rot, extensive moisture damage and splitting.
- If a section has less than 20% rot, remove the damaged portion, seal with an epoxy-based sealer, fill, sand and finish.

- If section has more than 20% rot, remove the damaged portion, attach new material with replacement wood – either salvaged or new.
- Seal all animal nesting and bird holes with Dutchman Patch.
- Remove loose, flaking or checking paint by removing surface edges. Using two coats of primer, apply a white final coat with latex satin finish paint.

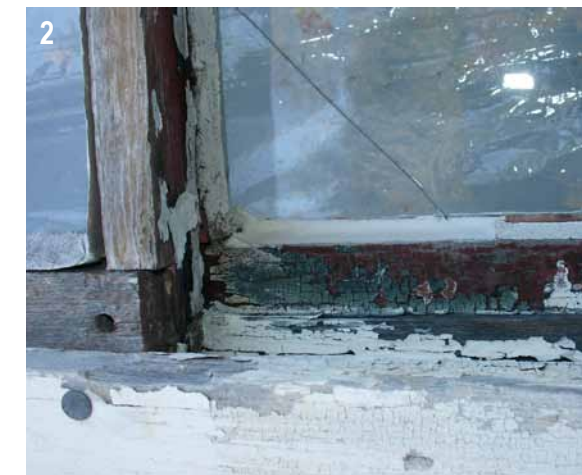
1. East porch sills are supported by concrete piers.
2. Storm windows show decay and failure.
3. Chimney in northern ell shows signs of cracking and moisture damage.

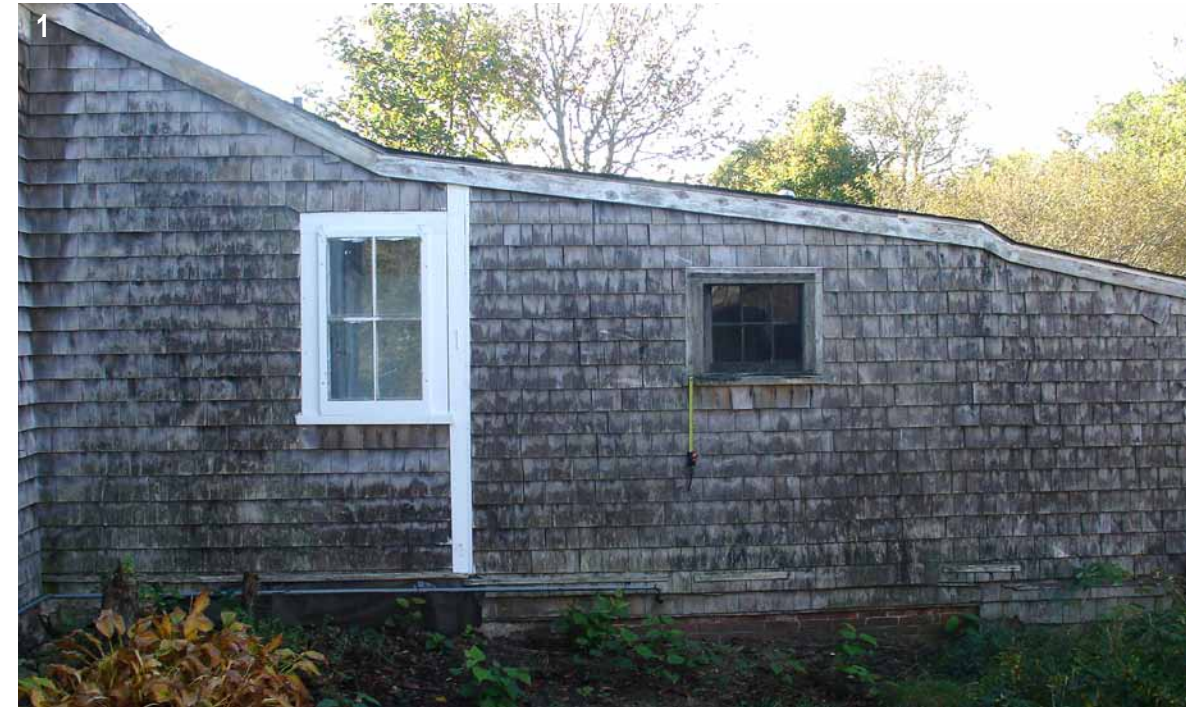
- Southwestern ell constructed at three different times.
- Moisture and weather have damaged the third part of the ell.
- Separation of second section of ell reveals horizontal planning.
- Southwest corner indicates structural failure.
- Window missing and replaced with plywood.
- Foundation consists of fieldstone, brick and cinder blocks.
- Second and third ells are in poor condition.

1. The exterior ell on the western elevation was constructed at three different times.

- Second and third section of ell will be demolished.
- Retain first section of the ell, which has the fieldstone foundation.
- Install windows in remaining ell with matching windows from the rest of the structure.
- First section of the ell should be replanked and reshingled in line with the existing exterior structure.

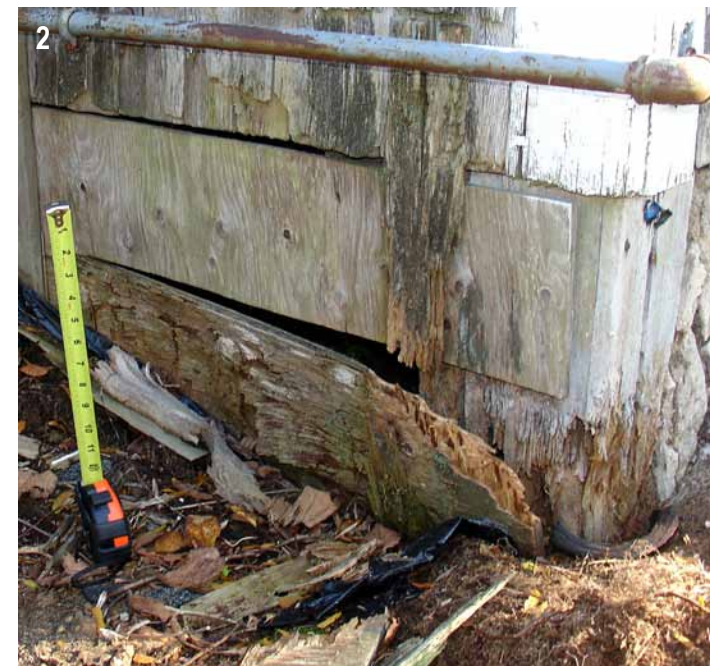
- The foundation includes round poles, roughly 10" tall and 8" in diameter, which are embedded within the walls. It is unknown how deep the poles run.
- Poles are located midway across the foundations walls and at the corners, but it is not apparent if the poles actually help support the structure.
- Currently, the sills rest unattached upon the poles.
- Foundation poles are extremely decayed.
- There is a hole approximately 10" wide from ground level to sill, located immediately below the double-hung windows in the central part of the western wall. This appears to have been made as an access path.
- The foundation has a point of failure in the southwest corner. Signs indicate that part of the foundation was removed to allow access under the new wing of the house. This hole is currently covered with rotting plywood.

2. Portions of the south west corner foundation were removed, and the hole is covered with rotting plywood.

- Program calls for a new foundation to be installed under the main structure to create a basement.
- Rubble façade should be added to replicate the original appearance.
- Replace wooden poles at corners/midpoints with concrete piers.
- Restack and recement stones.
- Fill access holes with stone/concrete that match the exterior of the structure.
- Recement and restack foundation at southeast corner.
- Construct angle iron frame with metal doors on southwest corner.

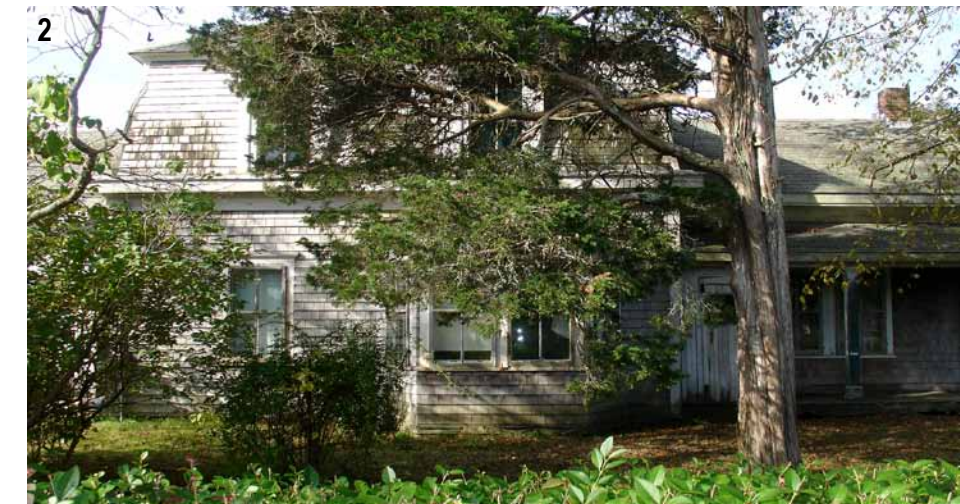
1. Cornice board may conceal gutter system.

2. East elevation has an overgrowth of trees with some hitting the house.

- Check to see if gutters exist behind cornice/trim.
- If gutter systems are hidden, rebuild gutter system to include downspout and splash blocks.
- If there is not an existing gutter system, install profile wood gutters on second story of mansard roof in four corners.
- Install straight gutter runs in four corners of the wings and porches.

- Trim tree branches to eliminate trees rubbing on roof, gutters or wood trim, which will prevent further damage to the structure.
- Examine roots of trees on east elevation and remove those whose roots could potentially cause problems for the property or foundation.
- Remove shed due to structural failure.
- Privy should be moved and repurposed according to the new program requirements.

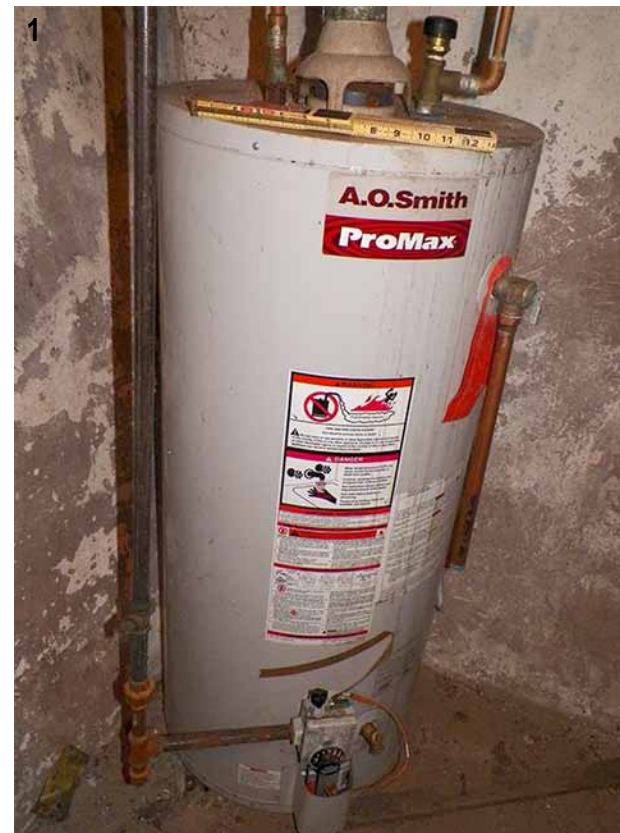
1. Gas hot water heater appears to be new.

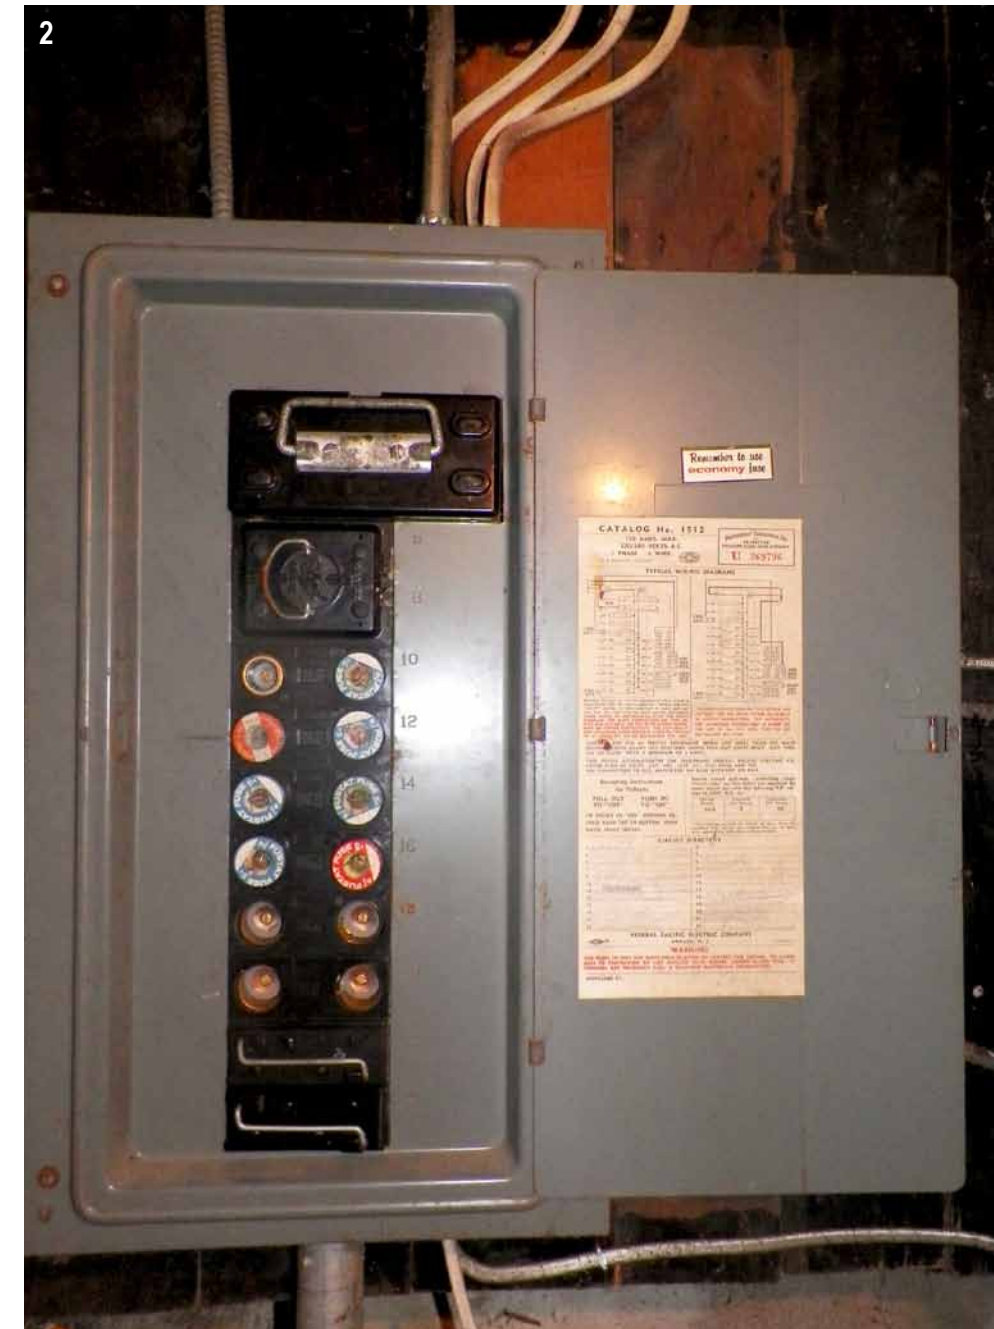
- The electrical system reflects different generations of wiring.
- The panel is a 150 amp maximum panel.
- The circuit panel is of the round glass fuse type, with large block main fuses.
- There are broken fuses in some circuit areas and fuses missing in others.
- The branch wiring is of three different vintages: cloth (possible), metal sheathed and Romex style.
- It's not possible to determine if any of the wire consists of aluminum rather than copper.

2. Electrical panel is 150 amp maximum.

- Existing fuse box should be replaced to code with a 250 amp circuit breaker pane.
- All non-code compliant wiring should be updated to meet current building codes.
- Wires should be snaked along existing channels to locations where power is to feed interior walls.

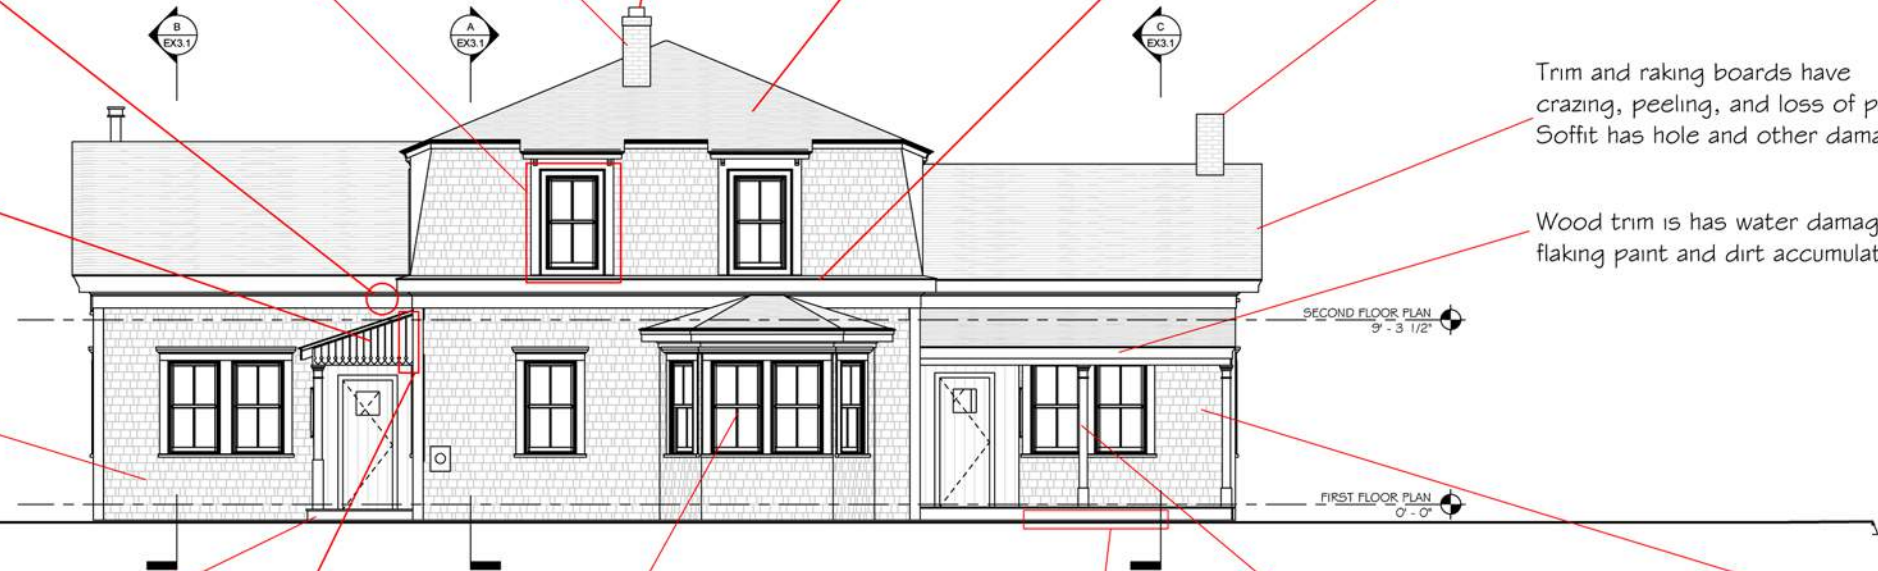
Sheet Title: EXISTING CONDITIONS EAST ELEVATION

Storm Windows have rotting frames. Many also have crack panes of glass. Not weather tight - some barely attached. Typical.

Wood band board and decking has water damage, bio. growth and is significantly decayed. Typical.

Wooden porch posts are weathered, damaged, have failing paint and separating joints. Typical.

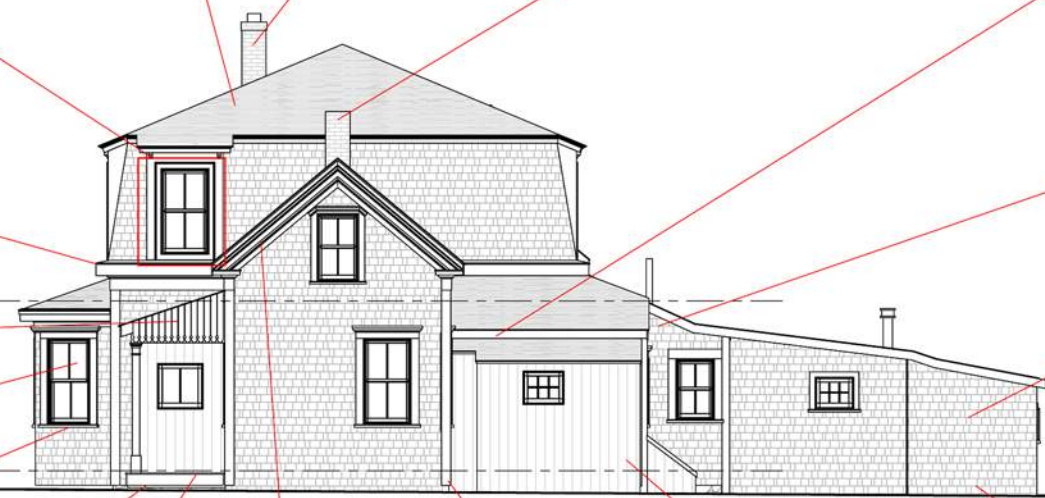
Sheet Title: EXISTING CONDITIONS NORTH ELEVATION

Window has total failure of glazing putty and paint. Cylinder glass panes have cracks. Accumulation of bio. growth, dirt and other natural elements on glass panes and along sill. Not weather tight. Typical.

Brick chimney has failing mortar joints. Accumulation of bio. growth, creosote, and dirt. Typical.

Improper flashing installation

Significant water damage. Cedar shingles damp and decaying.

Corner post bottom severely damaged and decaying

No foundation. Wood supports are decaying and cinderblocks crumbling

Wood framing members are decaying. Currently sagging and has no structural integrity.

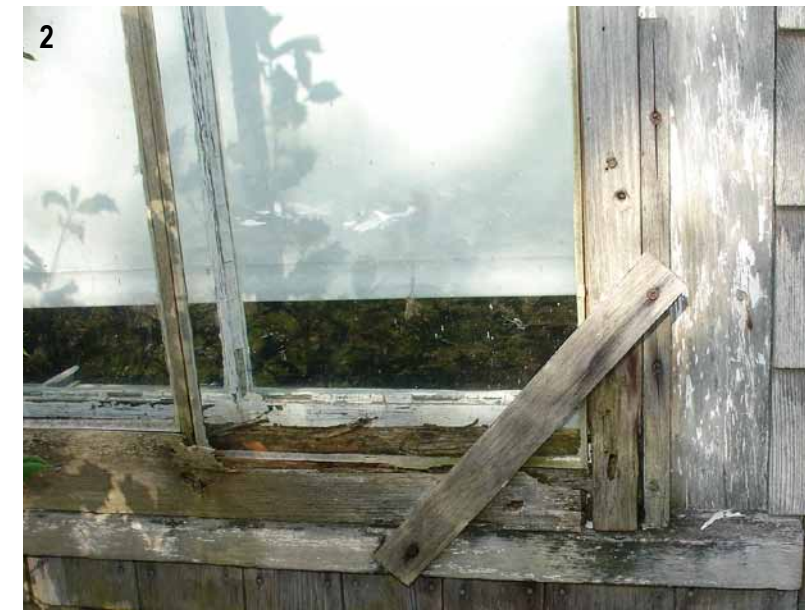
1. South porch roof needs to be reattached to main structure.

2. Wood window sashes need to be repaired.

- Reattach south porch to main structure.
- Replace porch sills with dimension lumber.
- Remove “chicken coop” entrance on east and south porch.
- Rehabilitate porch columns.
- Reattach/fabricate original porch ornamentation.
- Replace floors with similar wood planks.
- Stain/paint trim same as exterior.

- Remove and repair sashes from windows.
- Repair sashes by repining loose cross rails, meeting rails, muntins and top rails.
- Scrape and repair wood deterioration on casings.

- Reconstruct missing wood portions with epoxy filler.
- Re-glaze panes and replace glass with period glass.
- Conform to correct putty bevel.
- Reassemble sashes in jams.
- Use unobstructed wood lugs at corners of sash and jam.
- Prime and paint window sashes to match exterior trim

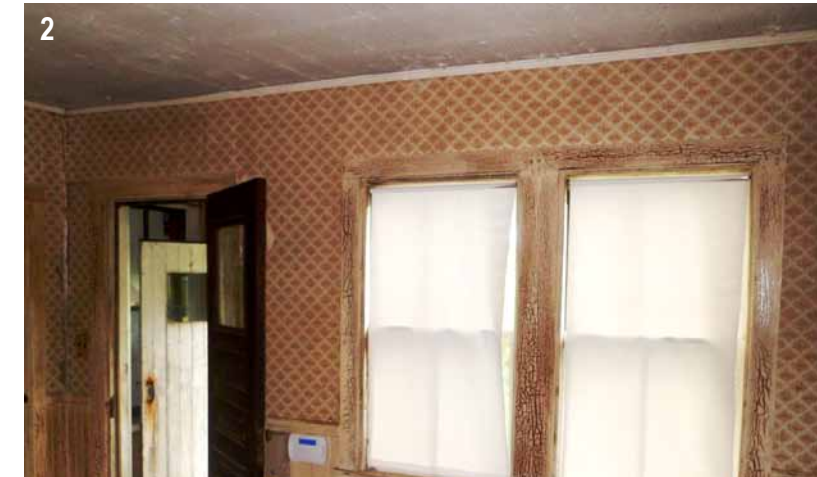
1. The shed on the property needs to be removed due to structural failure.

2. Damaged wallpaper to be removed and replaced. Ceiling cracks to be repaired.

- Damaged walls should be stripped, removing loose or broken plaster.
- Gypsum plaster should be used according to Brief 21, Repairing Historic Flat Plaster.
- Structural cracks at stairs should have interior studs braced and plastered.

- Existing shed should be removed due to structural safety concerns.
- Removal of the shed will improve the view shed of the property.
