St. Mary's Parish House: Reuse and Rehabilitation Feasibility Report

St. Mary's Parish House

Reuse and Rehabilitation
Feasibility Report

Academic Partner:
School of Architecture, Art
and Historic Preservation

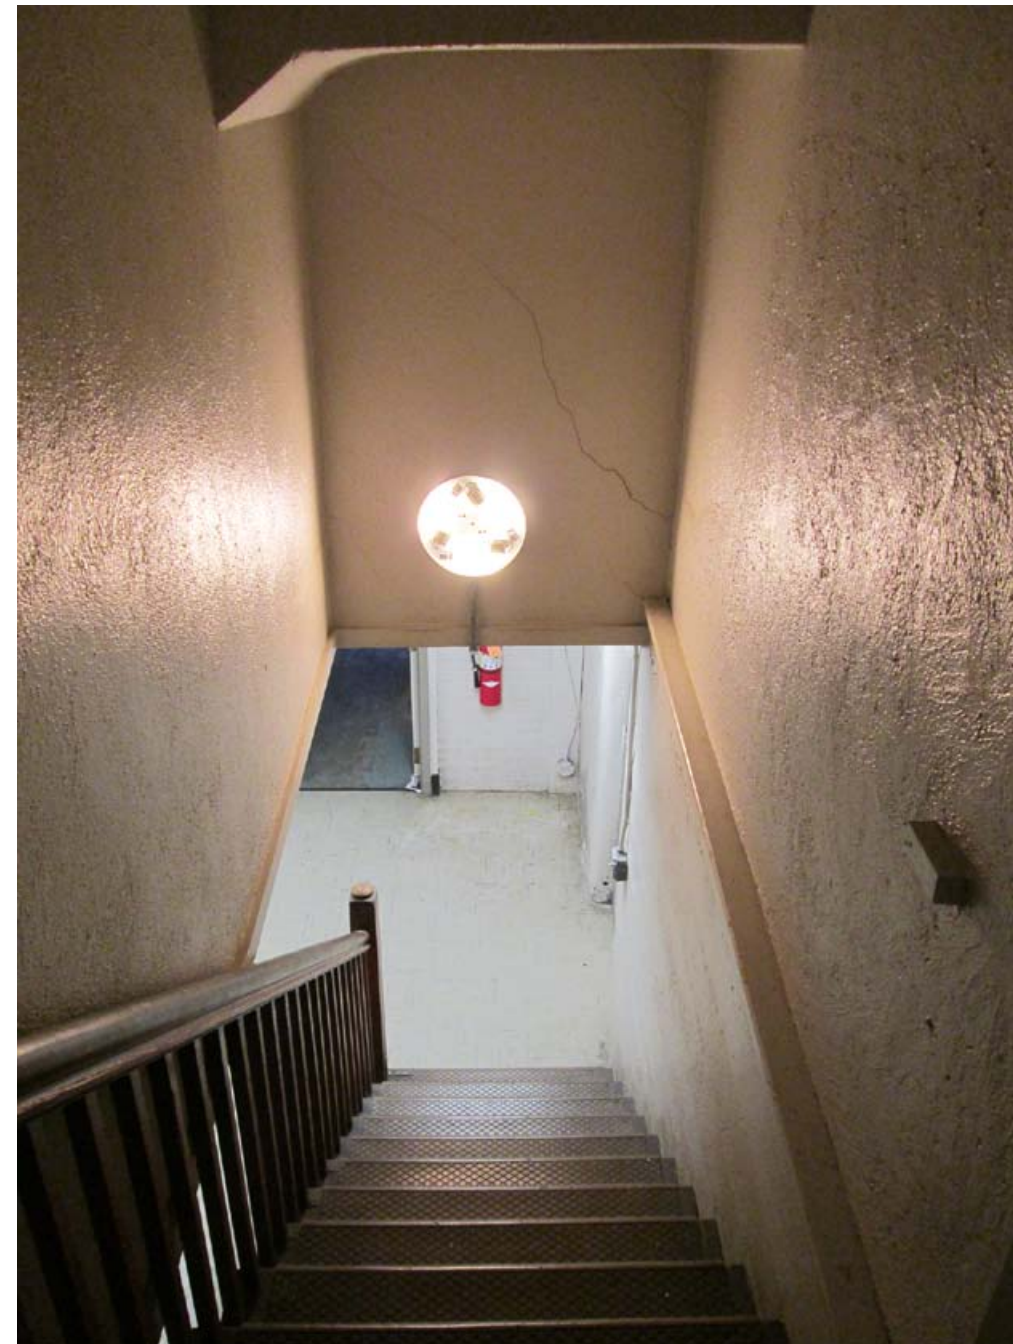
Stairs leading to the basement. Plaster walls exhibit cracking. Light fixtures will be replaced with ones that respect the building's historic character.

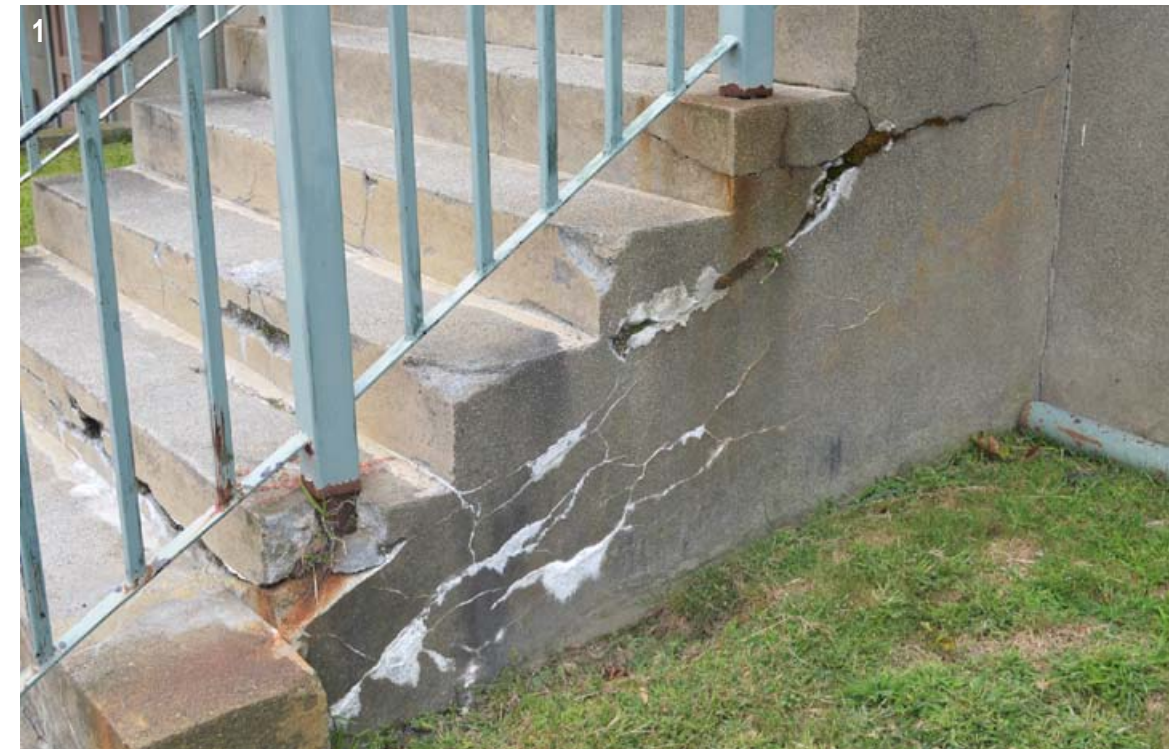
The concrete front porch stairs are in poor condition with significant cracking throughout, rust and loss of large chunks of concrete.

The painted cast iron railings on the steps to the front porch are in poor condition with a significant amount of rust and paint loss. They appear to have been added c. 1980.

1. The front stairs exhibit significant cracking and loss of concrete. The railings show rust and paint loss.

2. The south fire escape shows wood rot, paint loss and detached risers.

The south fire escape is in fair to poor condition. There is significant weathering of the wood, including some rot. Risers are detached from stringers, and treads are detached from risers. There is also significant paint loss.

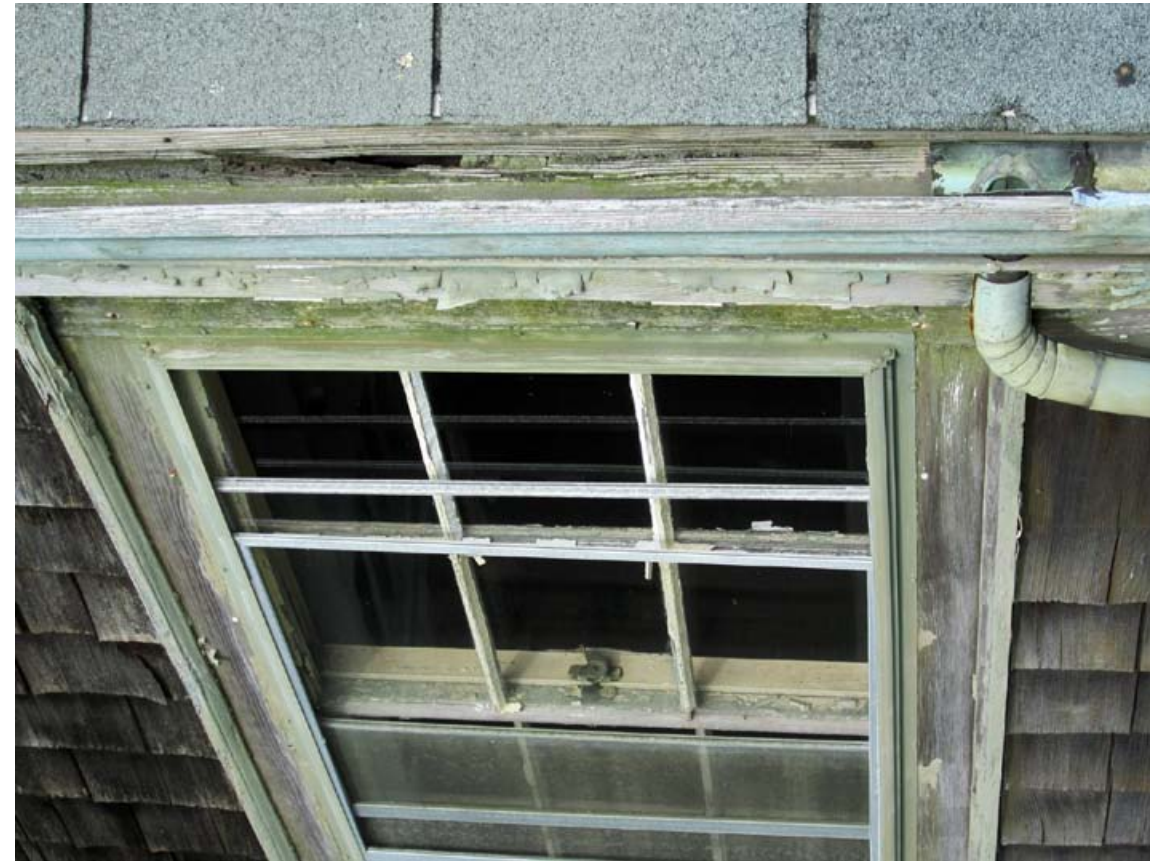
Window frame conditions vary based on location. The window frames protected by the porch are in excellent condition while other frames range from good to fair condition. Most experience minor deterioration due to weathering. Some window frames have rotted and missing wood.

Gutters appear to be wooden with galvanized steel downspouts. The downspouts flanking the front entry porch have been replaced with a material that appears to be PVC piping. There are missing and disconnected downspouts on each elevation. The gutters exhibit some signs of rot and have no flashing to protect the wood from the weather. Further, a missing downspout on the north elevation is channelling water directly onto the pipe where the electrical wires for the structure are gathered. Overall, these gutters are in poor condition and are near the end of their useful life. Gutters on the school addition are aluminum with aluminum downspouts and are in good condition, with some dents and debris.

This window on the south elevation shows a deteriorating wood frame. The wooden gutters show signs of rot and many are disconnected from the downspouts.

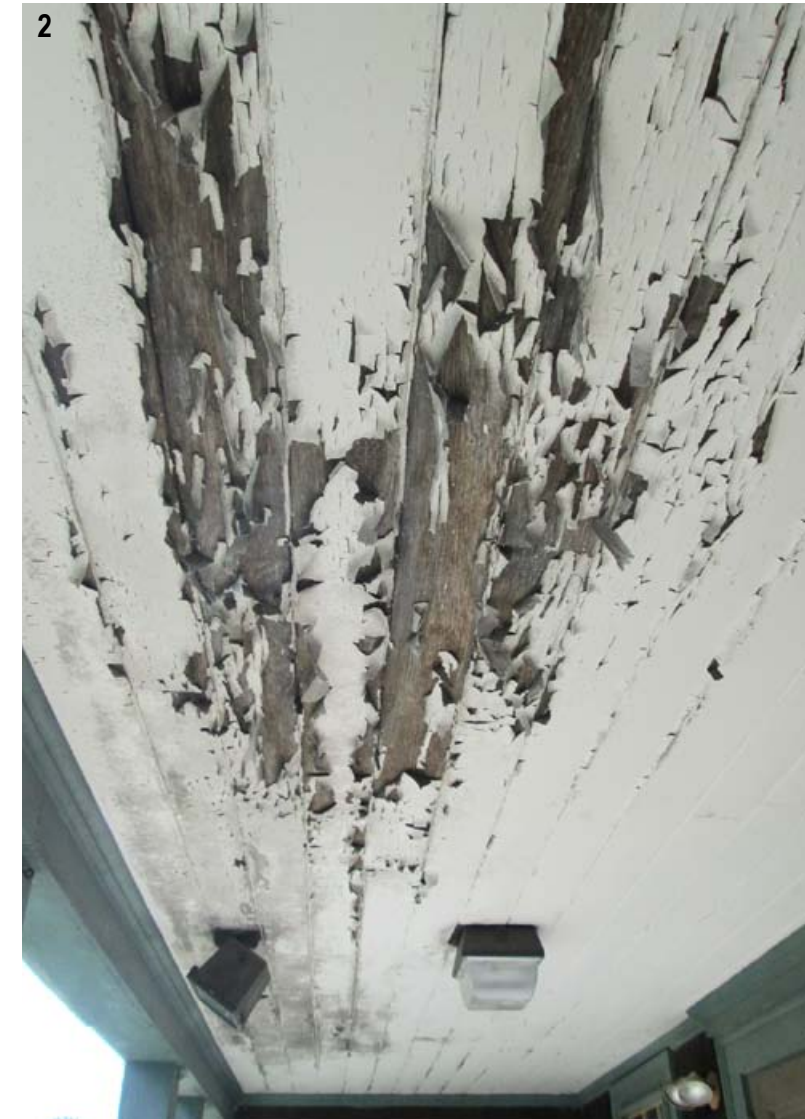
Paint throughout the exterior of the structure is in poor condition. Paint on the front entry door is cracked. Paint on the porch ceiling is peeling off in large flakes that hang from the ceiling. There is significant paint loss on the cornice and most window surrounds.

1. All exterior doors are in good condition including this metal one.
2. The porch ceiling exhibits significant paint peeling.

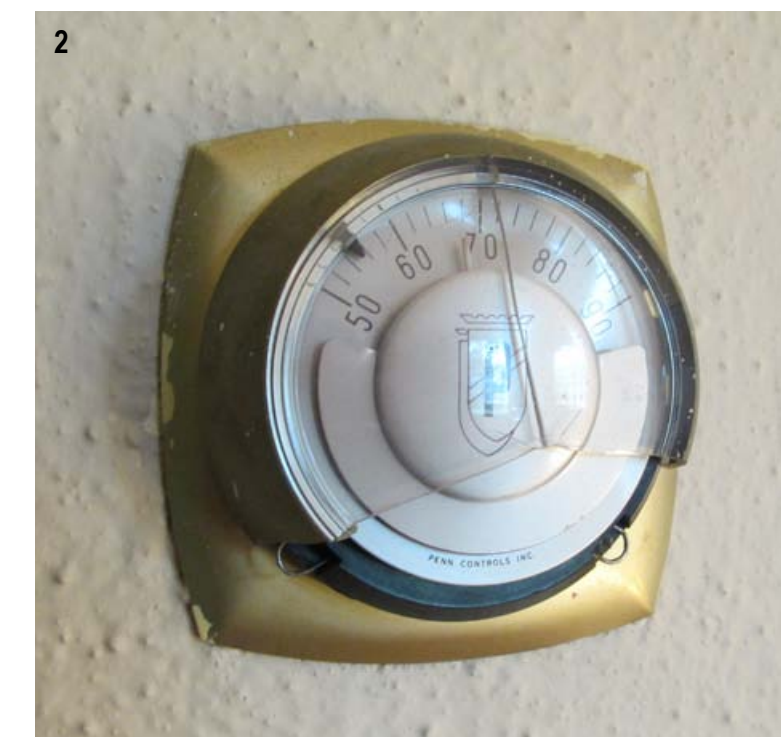
2. Broken thermostat in the upstairs northern classroom.

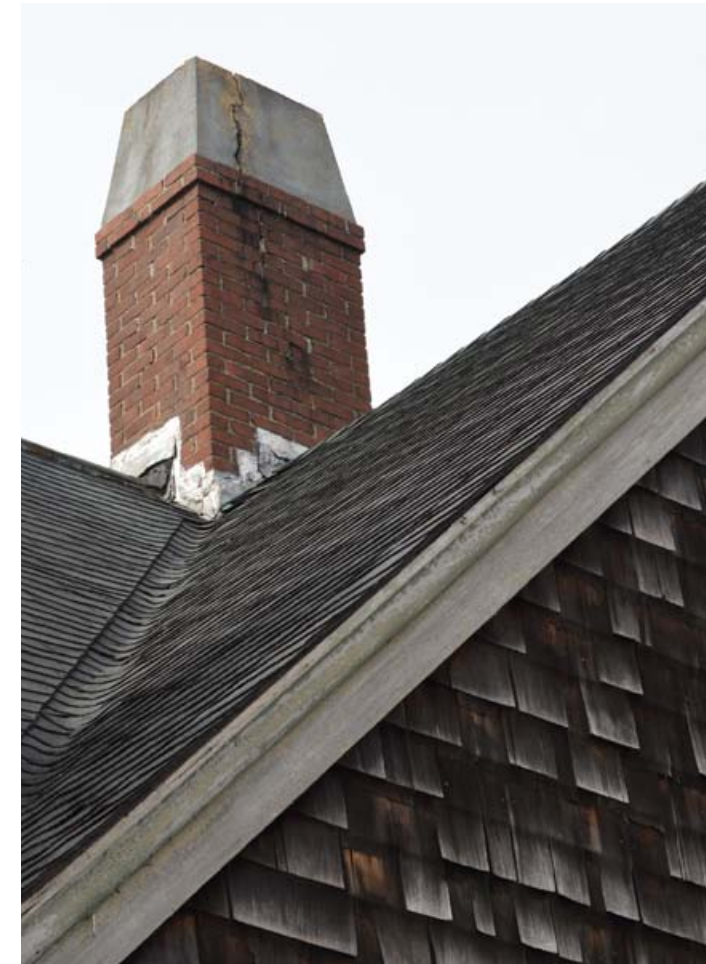
- **Problem:** The chimneys are in fair condition, showing signs of deterioration. There are loose mortar joints in both chimneys and visible cracks running down the exterior of the north chimney up into the concrete chimney cap.
- **Solution:** On the south chimney, all exterior masonry joints will be tapped with a masonry hammer to determine failing joints. Where loose, mortar will be removed down to a sound layer and repointed in kind with matching mortar and joint profiles. This should be done in accordance with NPS

To repair cracks and loose mortar joints, the north chimney will be removed and rebuilt with salvaged bricks.

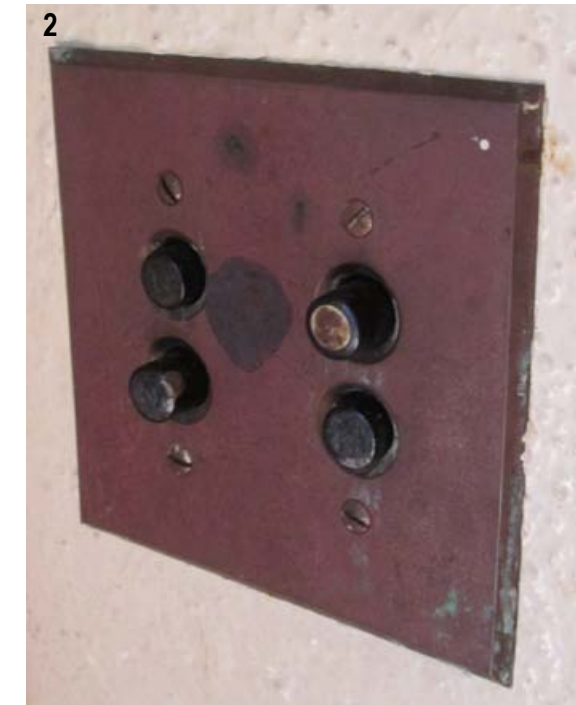
- **Problem:** The cast iron radiators throughout building are in good condition. The only observable issue is some minor paint chipping on several radiators, though some have more chipped paint than others.

1. The cast iron radiators are in good condition, though some require minor scraping and repainting.

2. An historic light switch plate in one of the classrooms. Electrical wiring behind it needs to be examined.

- **Solution:** Loose paint may be scraped and removed. In the case of lead paint, this must be carried out by a professional. The surfaces shall be repainted.
