The Baptist Church in Warren: Rehabilitation and Preservation Report

The Baptist Church in Warren

Rehabilitation and Preservation Report

Fall 2013

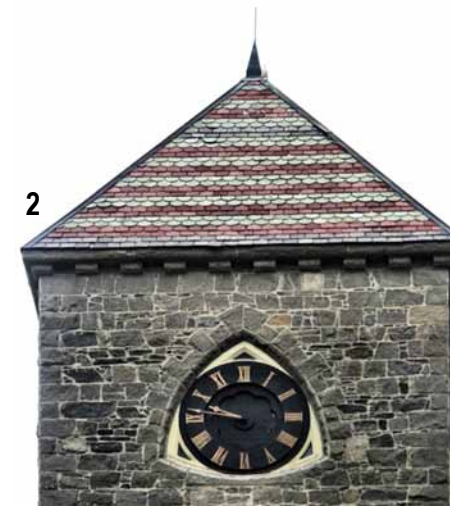
The roof covering the church's tower is bi-colored with grey and red slate forming a striped pattern. Overall, the roof is in fair condition, however, the slate shingled areas are in need of repair. Many slates are missing or hanging by one hanger. This is a failure of the hangers, which only last about a hundred years. These hangers are probably made of brass or copper, since they were the leading hangers of the 1840's. The copper ridge cap looks to be in fair condition, however, after 100 years of service, the roof is showing inevitable signs of age. The framing for the tower roof is in good condition and shows no visible signs of water damage or rot associated with insects or environmental effects.

The gable roof of the main structure is covered in green slate. Overall, the main roof is in poor condition. The existing slate roof was installed over a wooden shingled roof. The condition of the wooden shingles is unknown and could be a cause of the roof's poor condition. As with the tower roof, slates are sliding out of position, which could be caused by failing ferrous fasteners. Certain slates are exhibiting breakage, which could be the result of impurities in the slate. Numerous dark-colored slates show prior maintenance; yet there are missing slates throughout. The copper ridge cap is in good condition. Recently, Renaissance Roofing of Woonsocket, Rhode Island replaced over 400 slate tiles on the main roof.

1. A view of the roof from the tower window. The dark patches are missing slate shingles.
2. The tower roof, showing the red and grey slate striped pattern of the tiles.

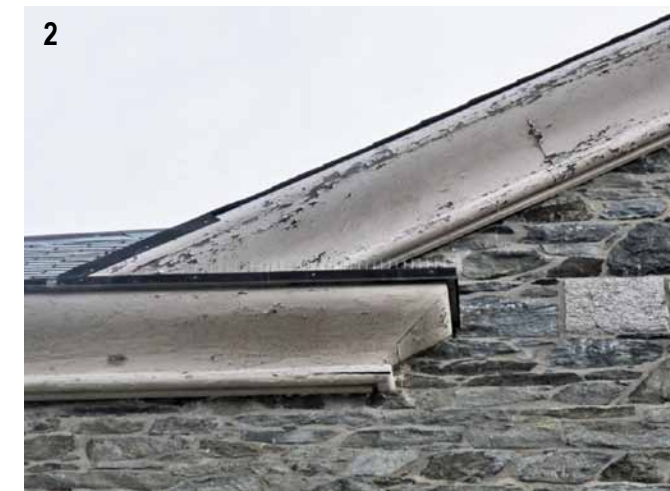
The cornice is composed of a single solid wooden Grecian ovolo profile that is terminated by a large bead at the base. The cornice wood is in good condition with the exception of the paint finish, which is flaking throughout the perimeter of the cornice.

The church is composed of a monolithic, load-bearing, granite-ashlar block. There is no differentiation between the exterior wall and foundation. There is green organic growth along the lower portion of the south and north elevations. Under the windows on the western façade, there is a crack forming in the mortar. Overall the exterior granite and mortar pointing are in good condition. The granite exterior recently underwent restoration.

1. Drainage holes along the base of the north facade show mildew growth from water damage.

2. Paint failure on cornice.

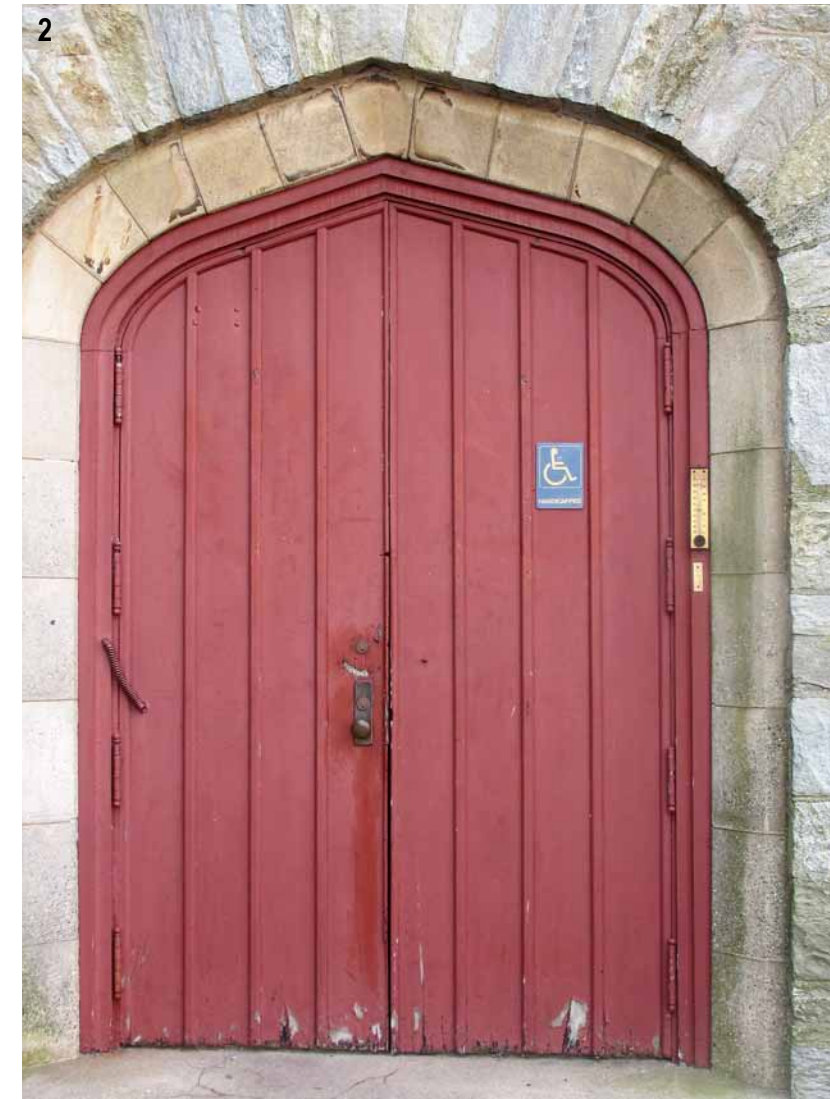
The window glazing is failing. This process has become exacerbated due to the storm windows. The storm windows are not properly ventilated, causing a micro climate within the space between the storm window and the wooden window. This micro climate is causing the paint and glazing to peel away.

1. The northeast window, located on the east façade, has an opening that traps moisture in the cavity between the window and storm window.

2. The doors on the northern entrance exhibit paint peeling and rot at the bottom.

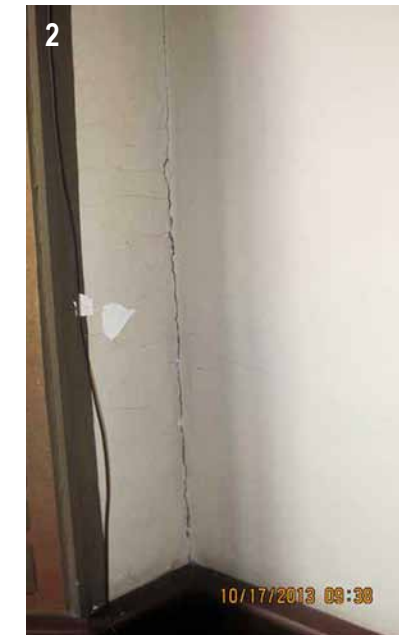
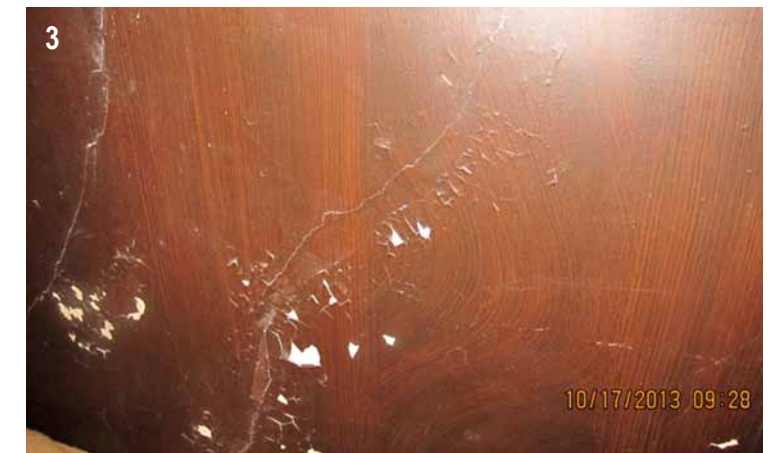
Overall the plaster in the sanctuary is in good condition, however there are a few sections throughout that are deteriorating or cracking, especially in the northwest and northeast corner of the building. The chancel also has plaster issues due to the roof leak. Overall, there are no sections where the plaster is completely detaching from the substrate.

Faux wood graining can be found throughout the sanctuary on doors, door casings, pews and wood paneling. On the mezzanine, overlooking the sanctuary, the wood graining is applied on plaster to mimic wainscoting. Sections of the wood graining show failure, especially in areas applied to the plaster.

1. Narrow stairway to the bell tower, accessed through a door in the sanctuary's balcony.
2. Cracked plaster walls in the sanctuary.
3. Faux wood graining shows failure throughout the church.

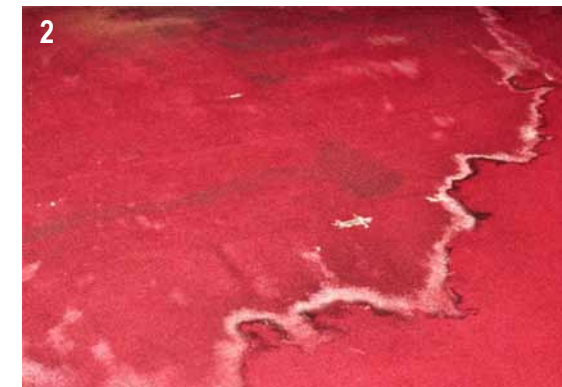
There is leaded glass throughout the sanctuary. It is found on the doors leading into the sanctuary from the front entrance. It is also found in a wooden partition separating the front entry into the sanctuary. The sagging of the lead and glass is an indication that the structural integrity of the lead support is beginning to fail, but the lead came has not failed to the point of breakage or dislodging the glass. On the western and eastern elevation, the stained glass windows are in need of re-caming.

The carpeting in the main sanctuary is heavily stained by water damage with sections worn through to the backing. The finishes throughout the rest of the building are all stable and do not require any necessary replacement at this time.

1. A pronounced view of the stained glass bowing of the doors leading into the sanctuary.
2. The carpet shows signs of water damage.

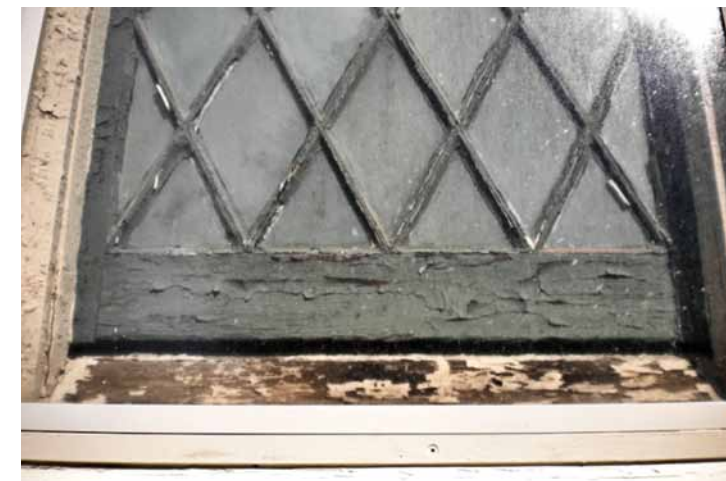
Paint failure around the windows due to moisture exposure.

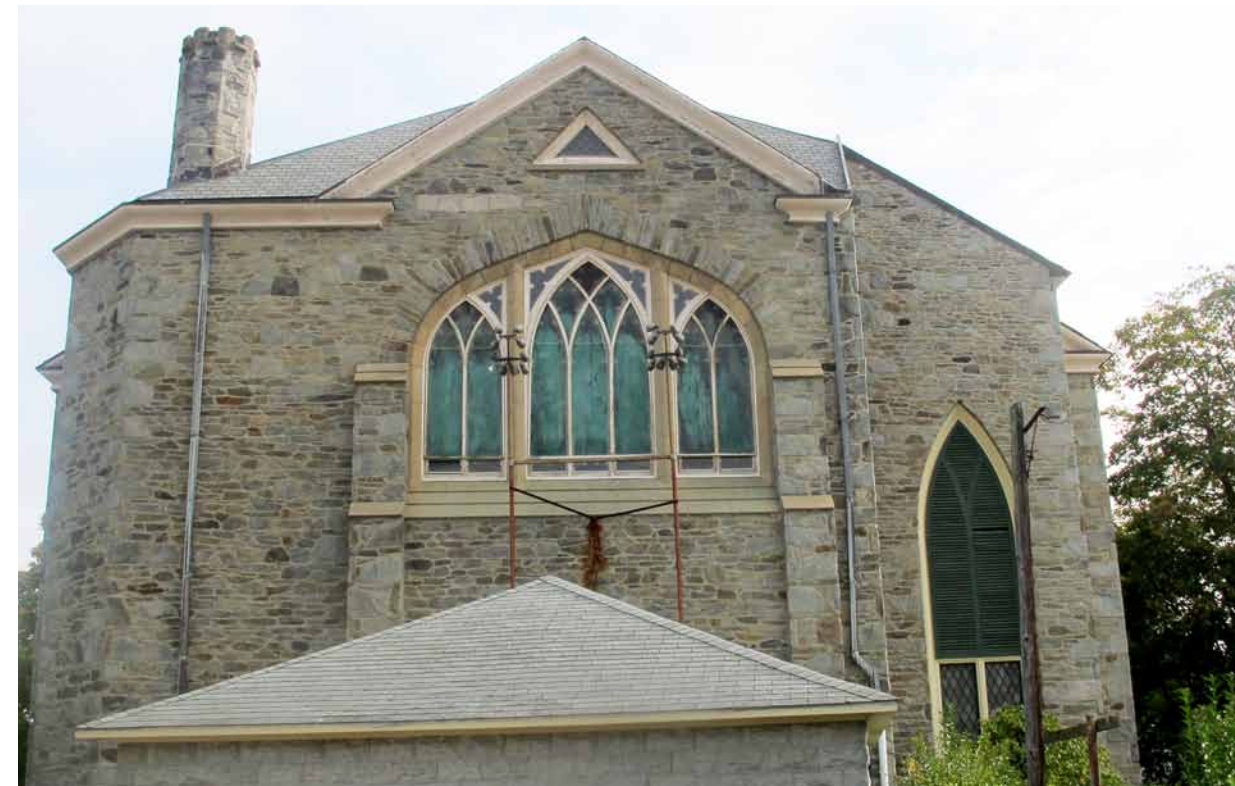
West elevation shows some stone wall rust staining, which needs to be cleaned.

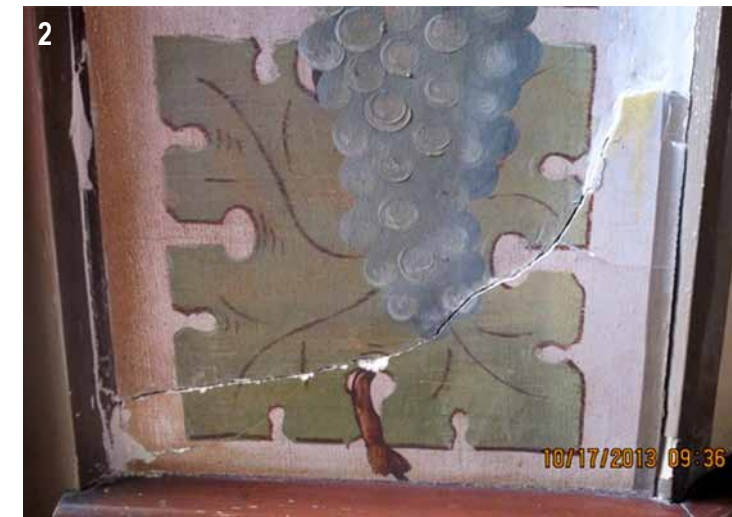
The decorative paint which accents the lancet arches throughout is in good condition. However, the paint on the lower portion of the lancet arch of the windows is deteriorating. The decorative paint in the chancel is in fair condition. The paint in the chancel has suffered moisture damage from a roof leak that has since been repaired. The damaged paint and plaster areas have not been repaired.

1. Areas of paint failure need to be scraped, sanded, cracks filled and surface painted to match existing paint.
2. Cracking and peeling of decorative paint, which needs to be filled and painted to match existing paint.

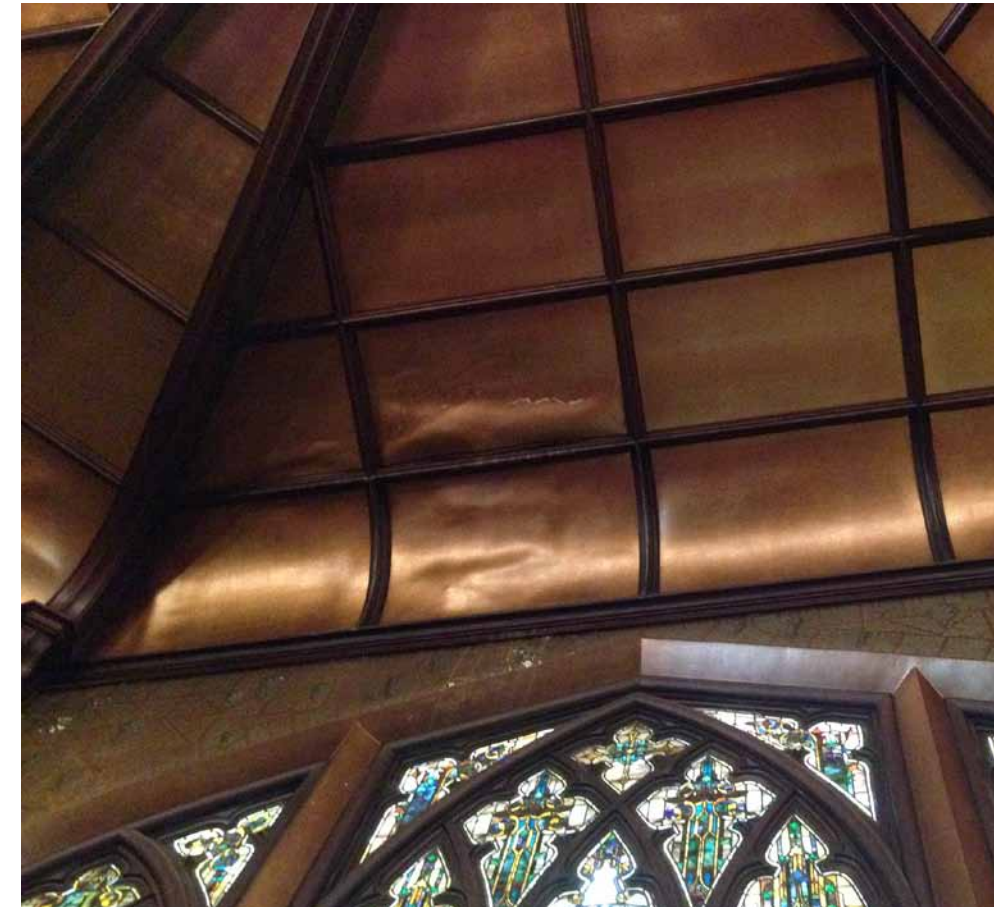
The puckering of the gold leafed, canvas ceiling in the vestry can be seen in the lower left corner.
