Beriah Brown House: Anne Baker's Journal

Beriah Brown house dismantling

By Anne W. Baker

Survey up to May 24th, 1972

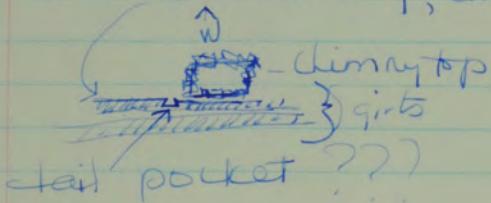
exposed at the end boards
 the west which at this
 point appears to be the
 end that would have been
 away from the "great Room"
 If this house was in fact an
 end chimney house (either exposed
 or not.) Also would be seen
 in the attic, ~~sits~~^{not to} the chimney
 at the floor level, the east
 end chimney girt (double at
 this point ~~with~~^{cutting to} the ^{other} girt closest
 to the chimney, an empty sleeve
