A Return to Manning the Post: the Adaptive Reuse of Publically Owned Fire Control Stations from the Second World War

A Return to Manning the Post

The Adaptive Reuse of Publically Owned Fire Control Stations from the Second World War

May 2012

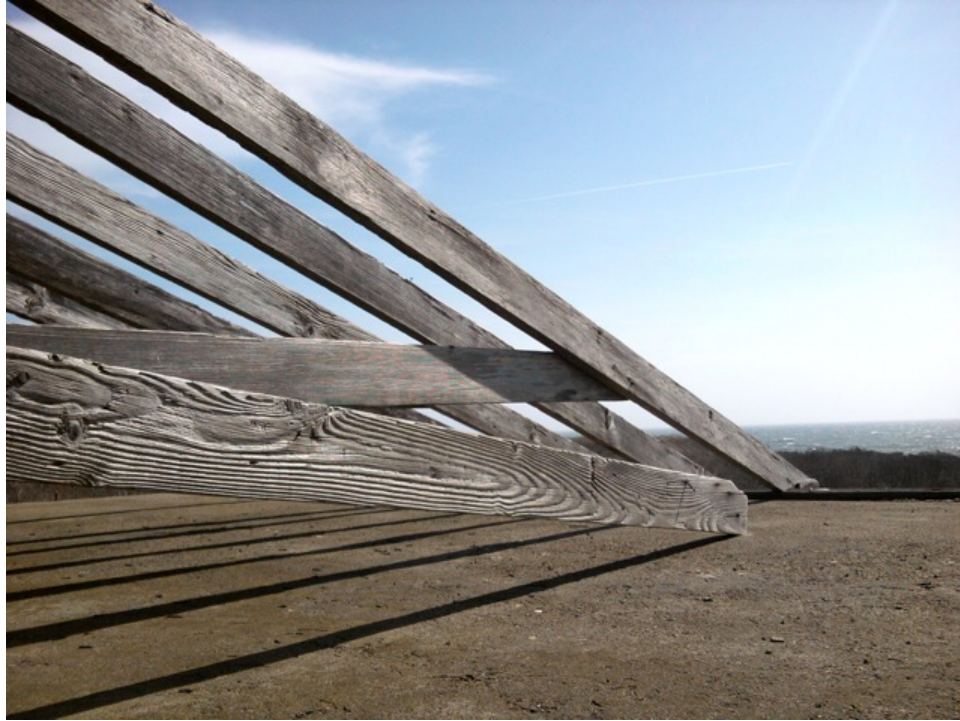
[Fig. 13] Detail of roof structure, facing southeast. Although weathered from exposure, the rafters have remained in good condition.

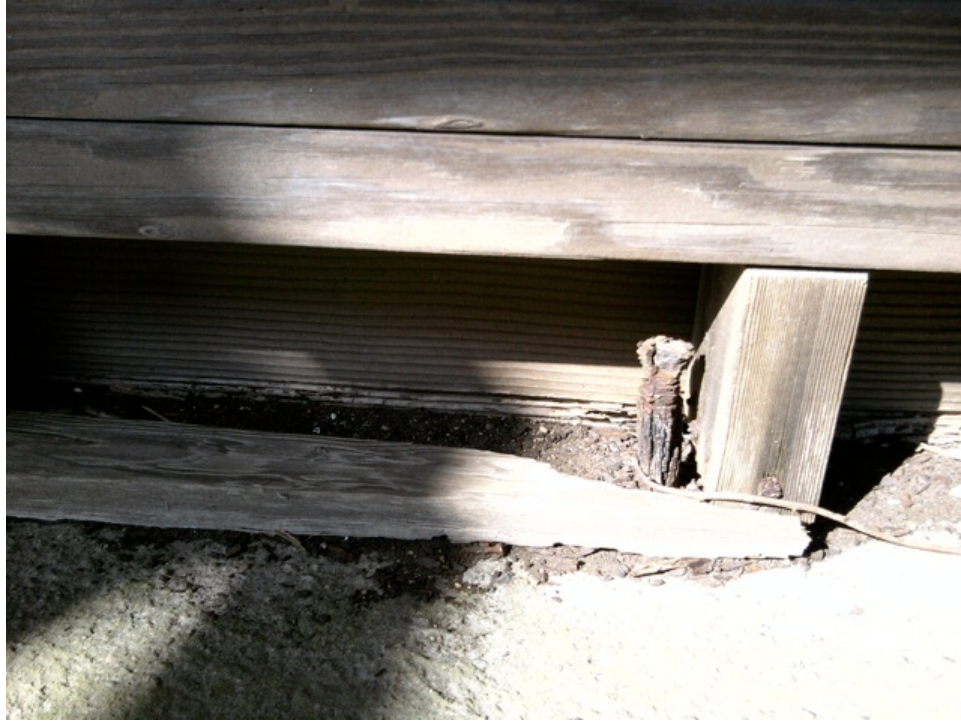
[Fig. 15] Detail of sill plate and roofing system, looking north. Note increased deterioration of wood and steel members.

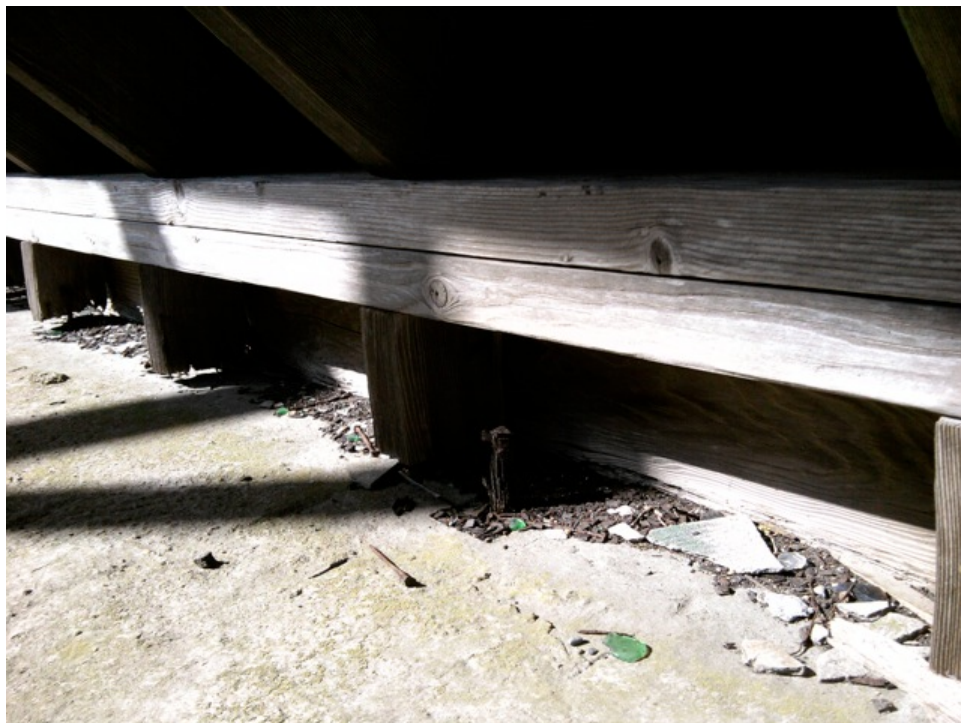
[Fig. 16] Detail of sill plate and roofing system, looking northwest. Note the missing sill plate.

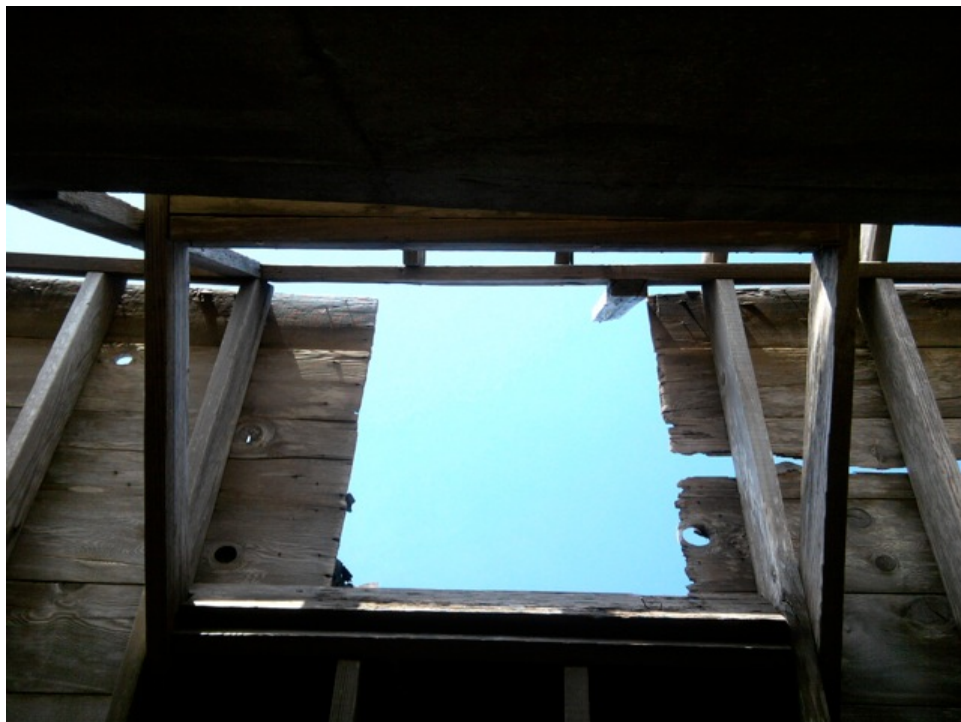
[Fig. 18] Detail of false chimney opening. Note the single remaining 2x4 on the upper right corner. This remnant can be used to attain an accurate height for the reconstructed false chimney.

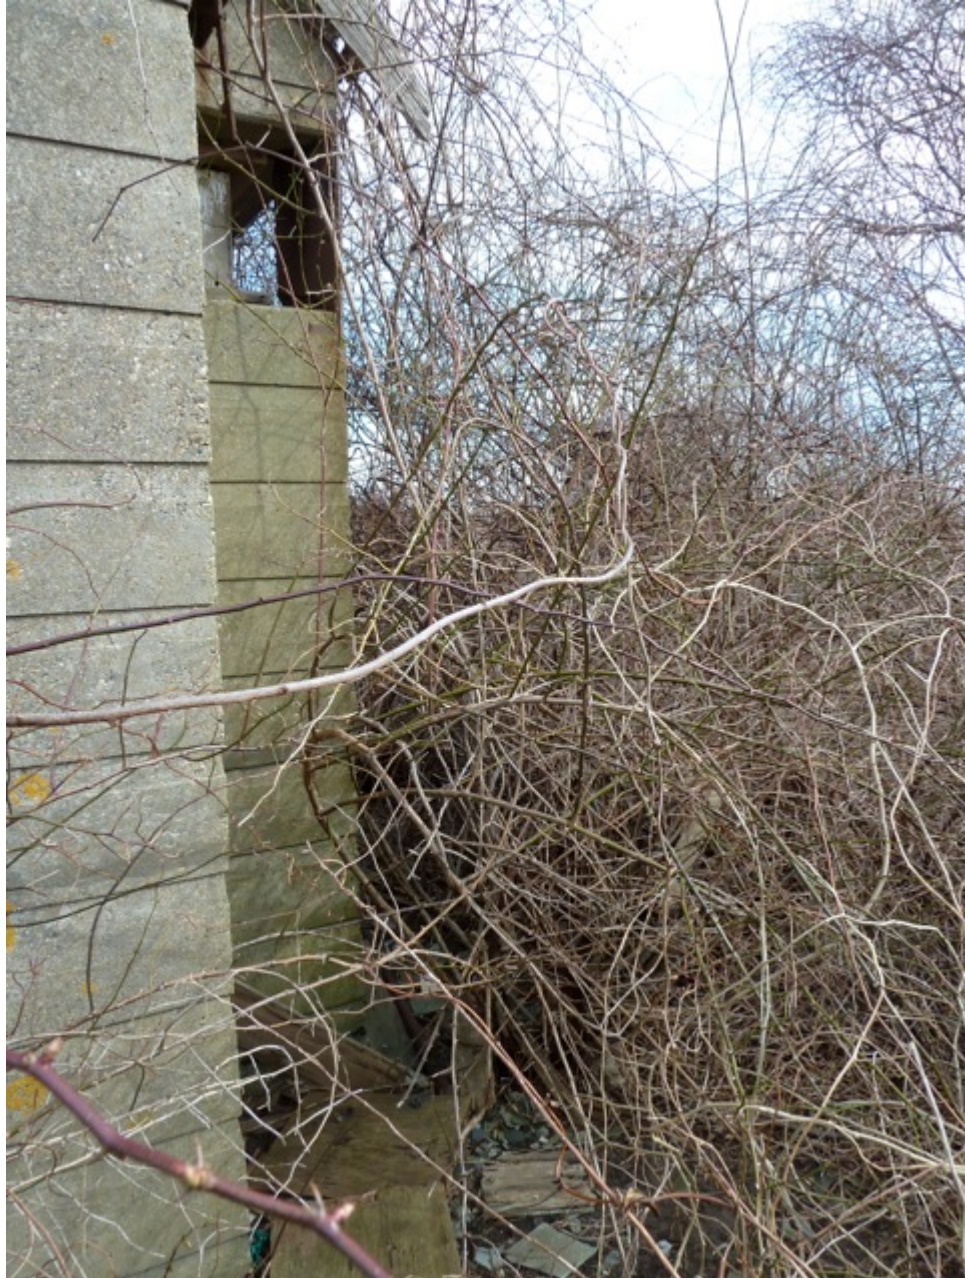
[Fig. 26] View of southwest recessed corner, looking southeast. Note the dense overgrowth.

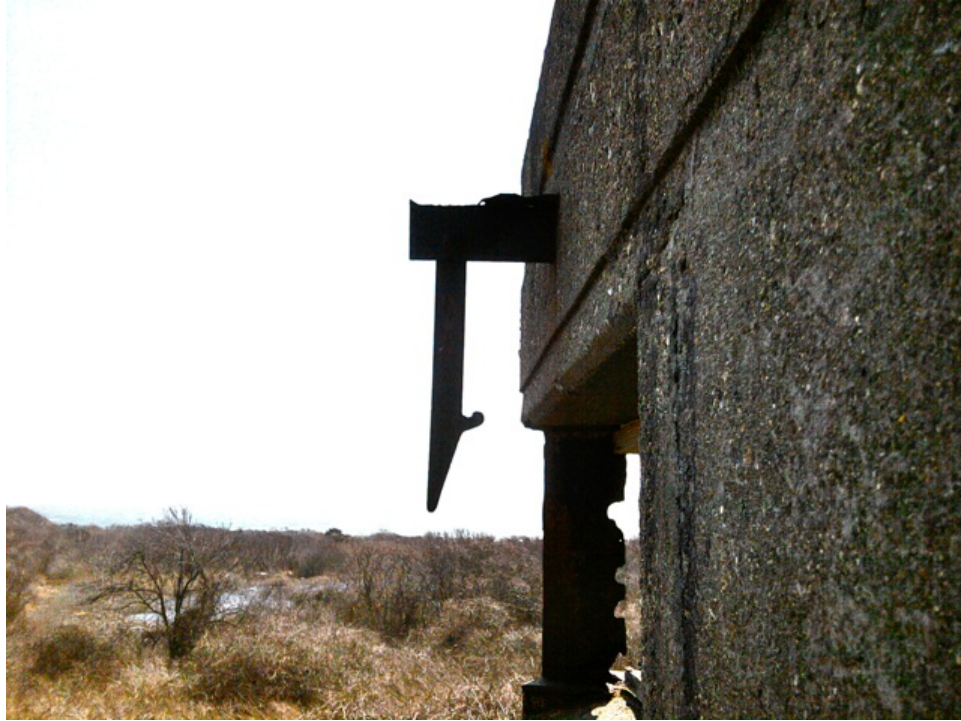
[Fig. 27] View of second story window hook and mount on west elevation, looking south. Note corroded steel corner support.

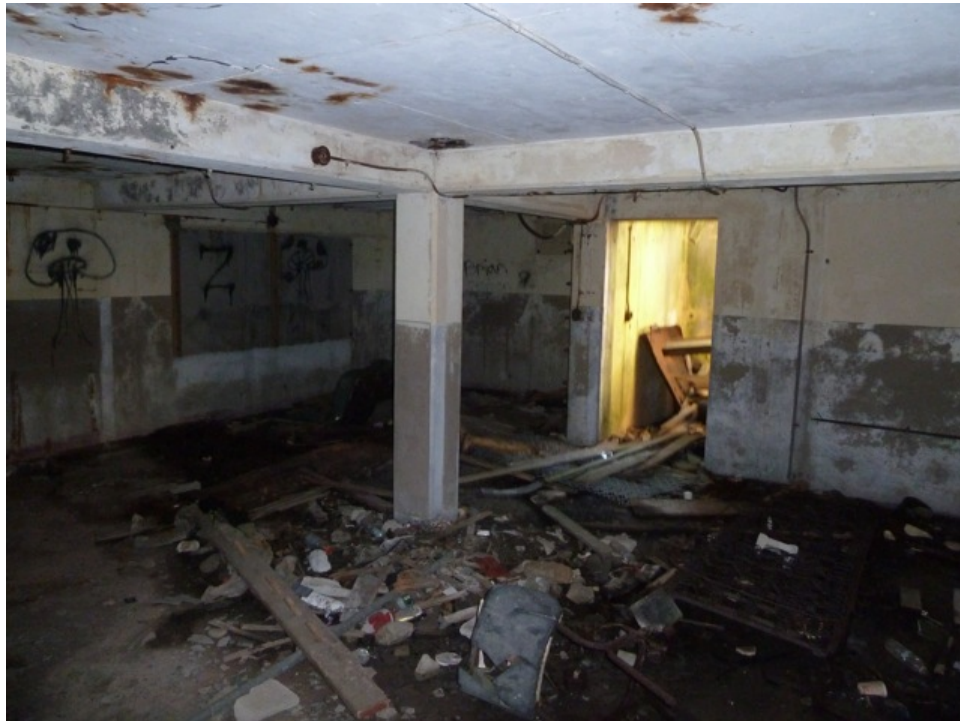
[Fig. 2] View of Room B-1, looking southwest. Note rust stains on the ceiling, debris, intact electrical conduits, and original paint treatment.

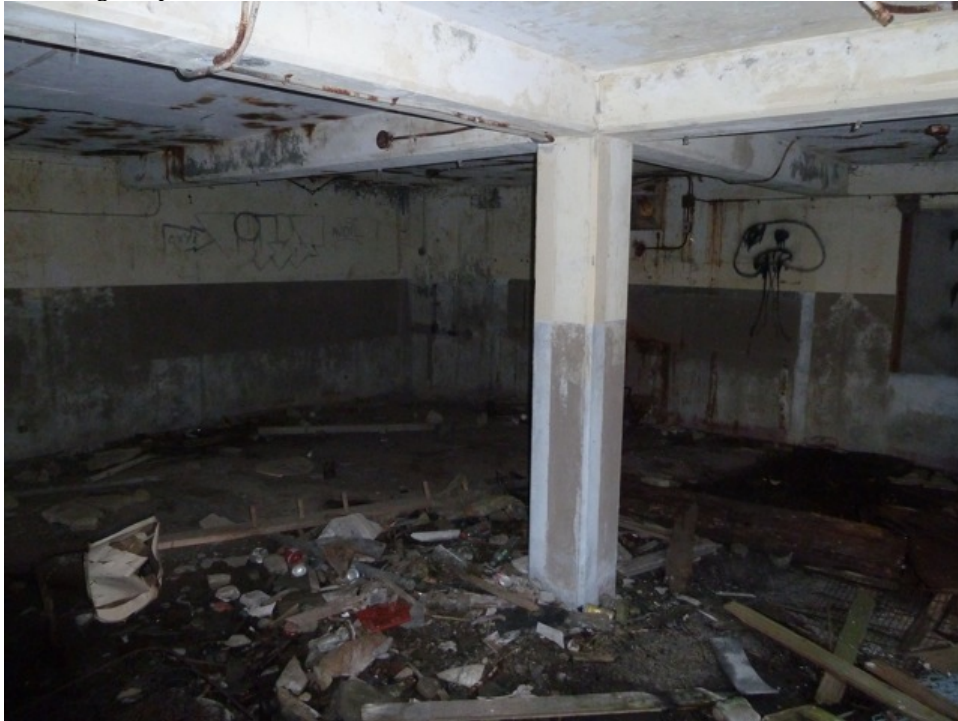
[Fig. 3] View of Room B-1, looking southeast. Note rust stains on the ceiling, debris, intact electrical conduits, and original paint treatment.

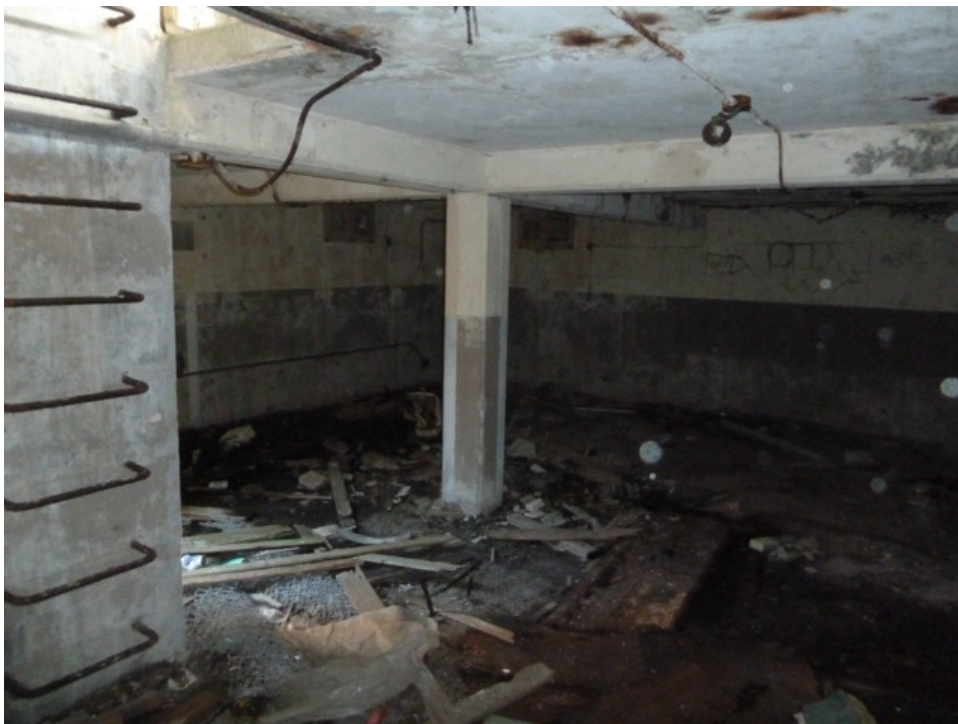
[Fig. 4] View of Room B-1, looking northeast. Note rust stains on the ceiling, debris, intact electrical conduits, ladder rungs, and original paint treatment.

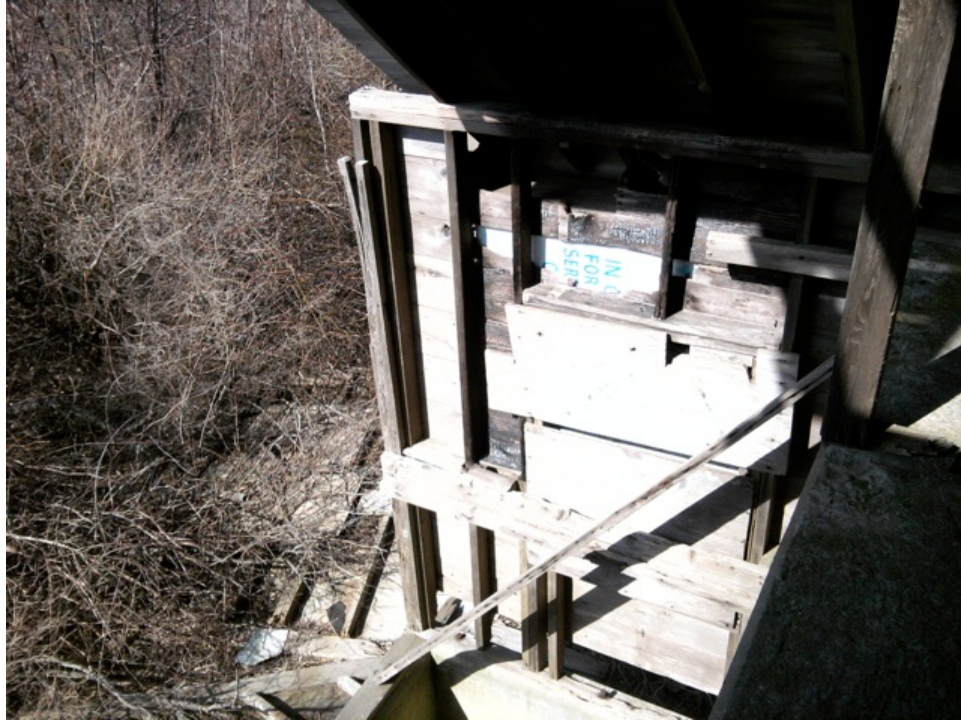
[Fig. 7] View of wooden portion of north elevation. Note the traces of a small fire to the left of the window.

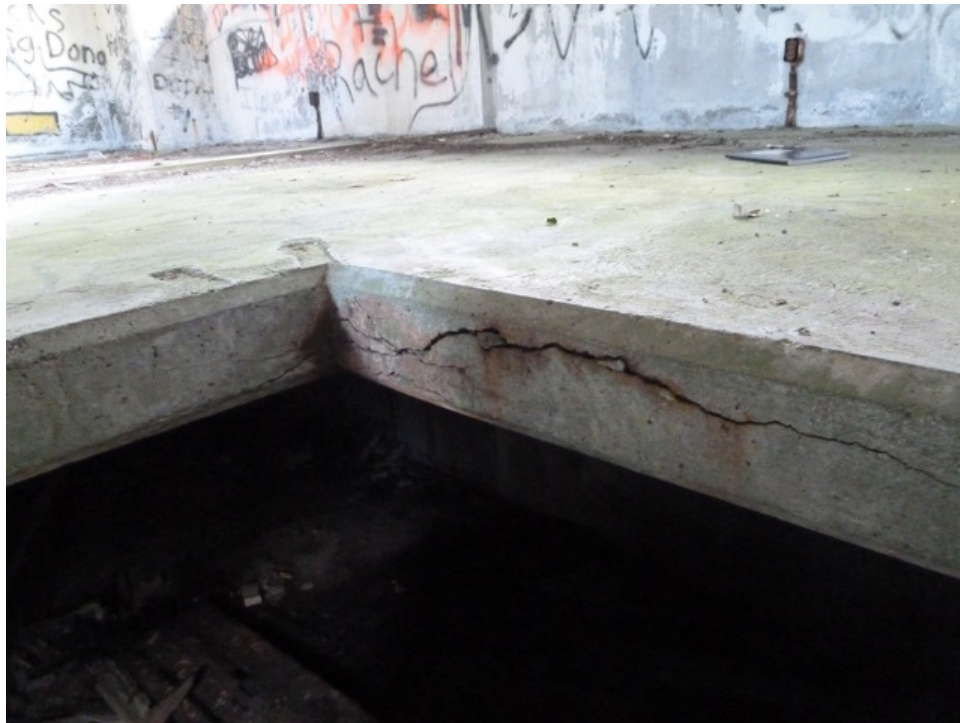
[Fig. 15] The cracking suggests delamination has occurred due to moisture infiltration. Note electrical outlet boxes on the south wall.

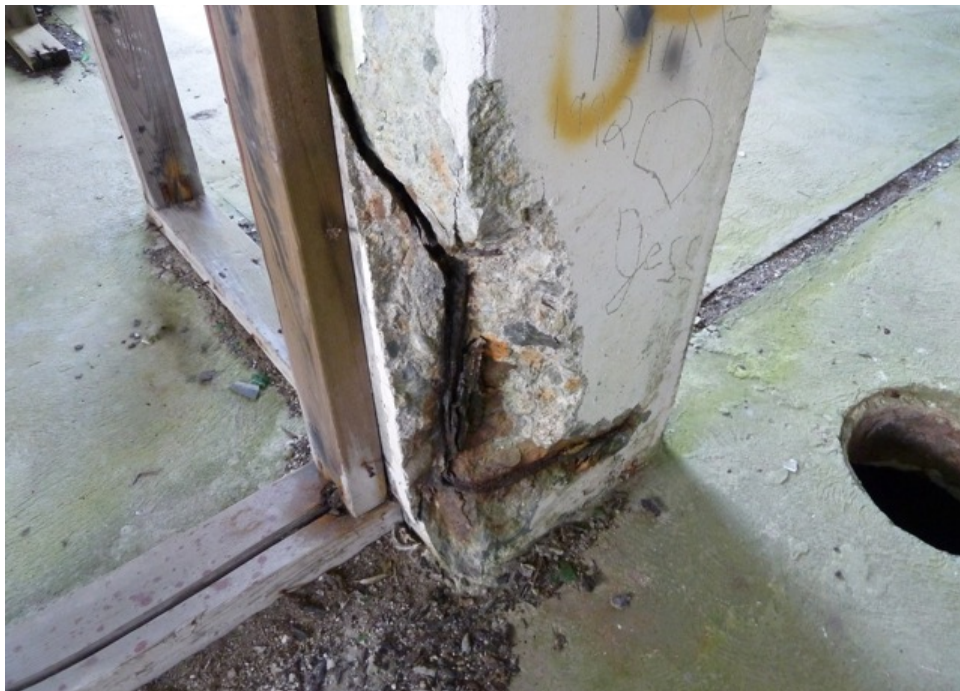
[Fig. 16] Detail of deterioration of central column in Room 1-1, looking northwest. Moisture exposure has led to reinforcement bar corrosion.

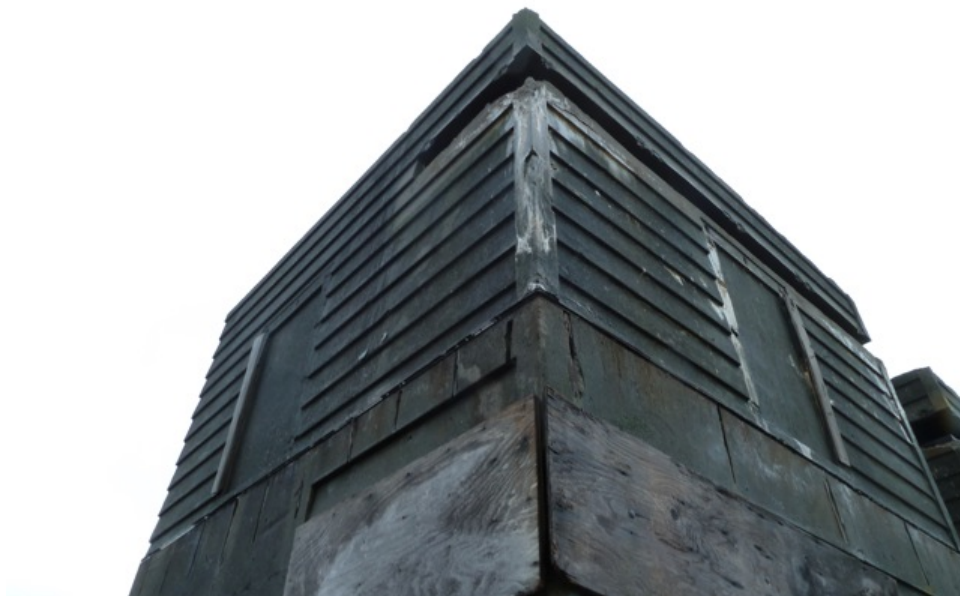
[Fig. 10] Detail of the southwest corner. Note the excessive efflorescence and locations of remaining window jambs bordering each of the two blind windows.

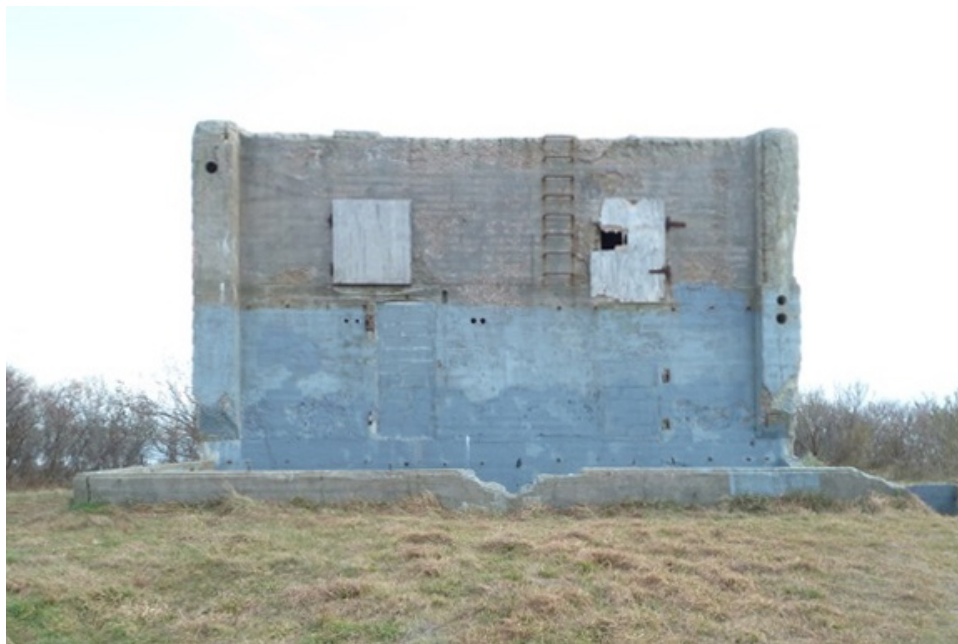
[Fig. 4] View of northwest elevation, looking southeast. Note the exposed ladder rungs and excessive erosion.

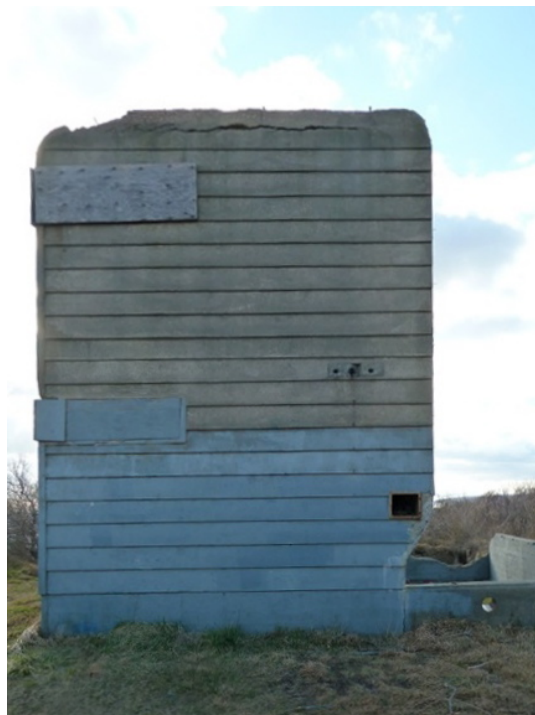
[Fig. 6] View of the northeast elevation, looking northwest. Note the excessive erosion and cracking at the roofline.

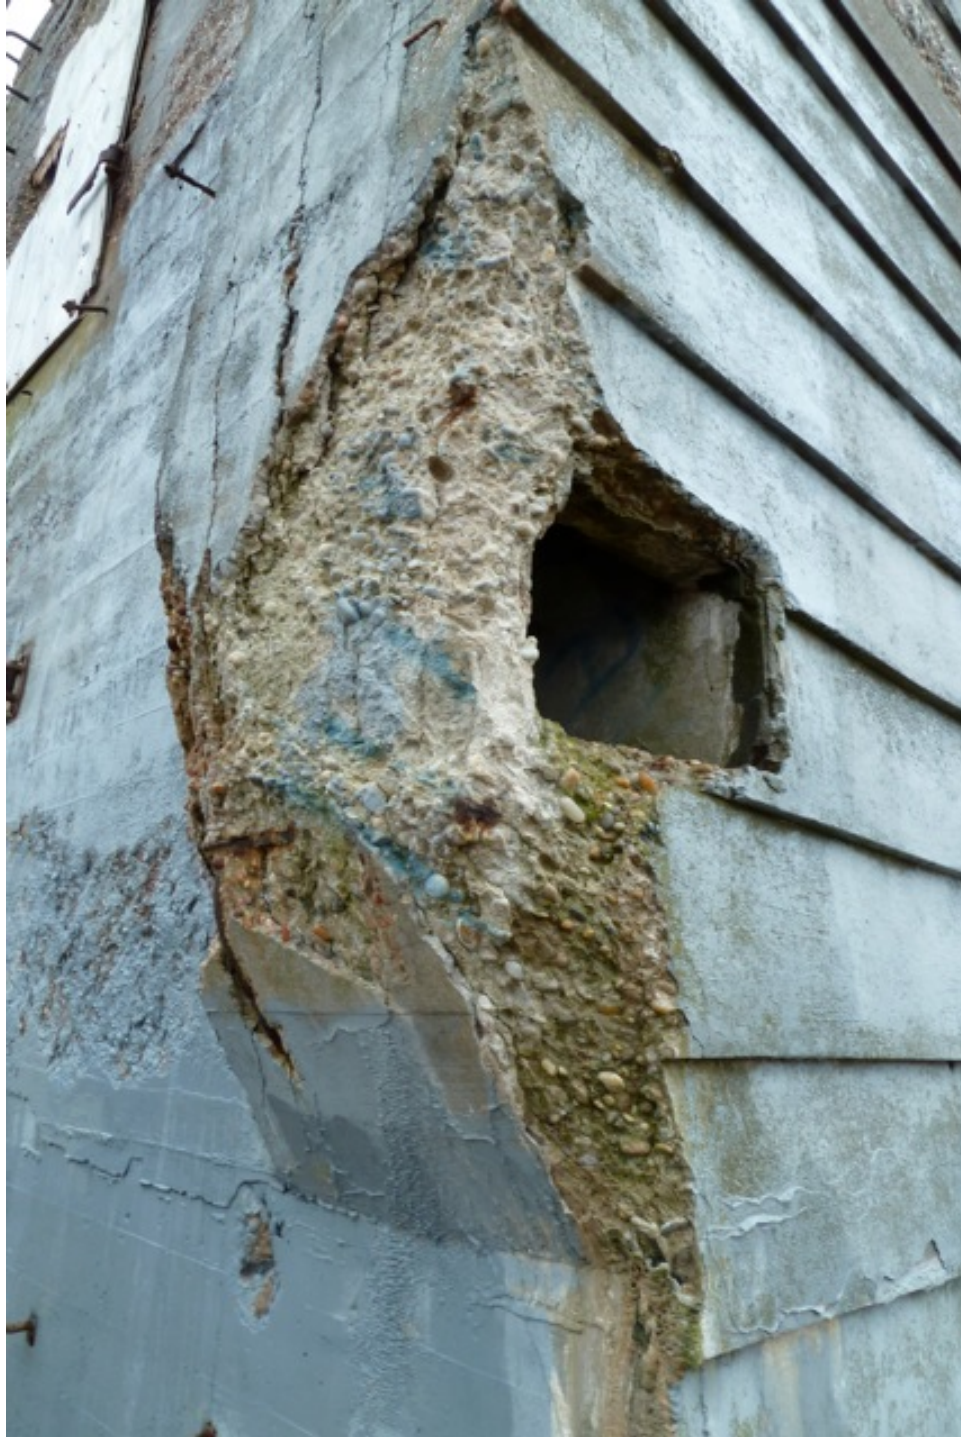
[Fig. 13] Detail of the southwest chimney base, looking east. Note the excessive erosion led to exposed reinforcement bars.

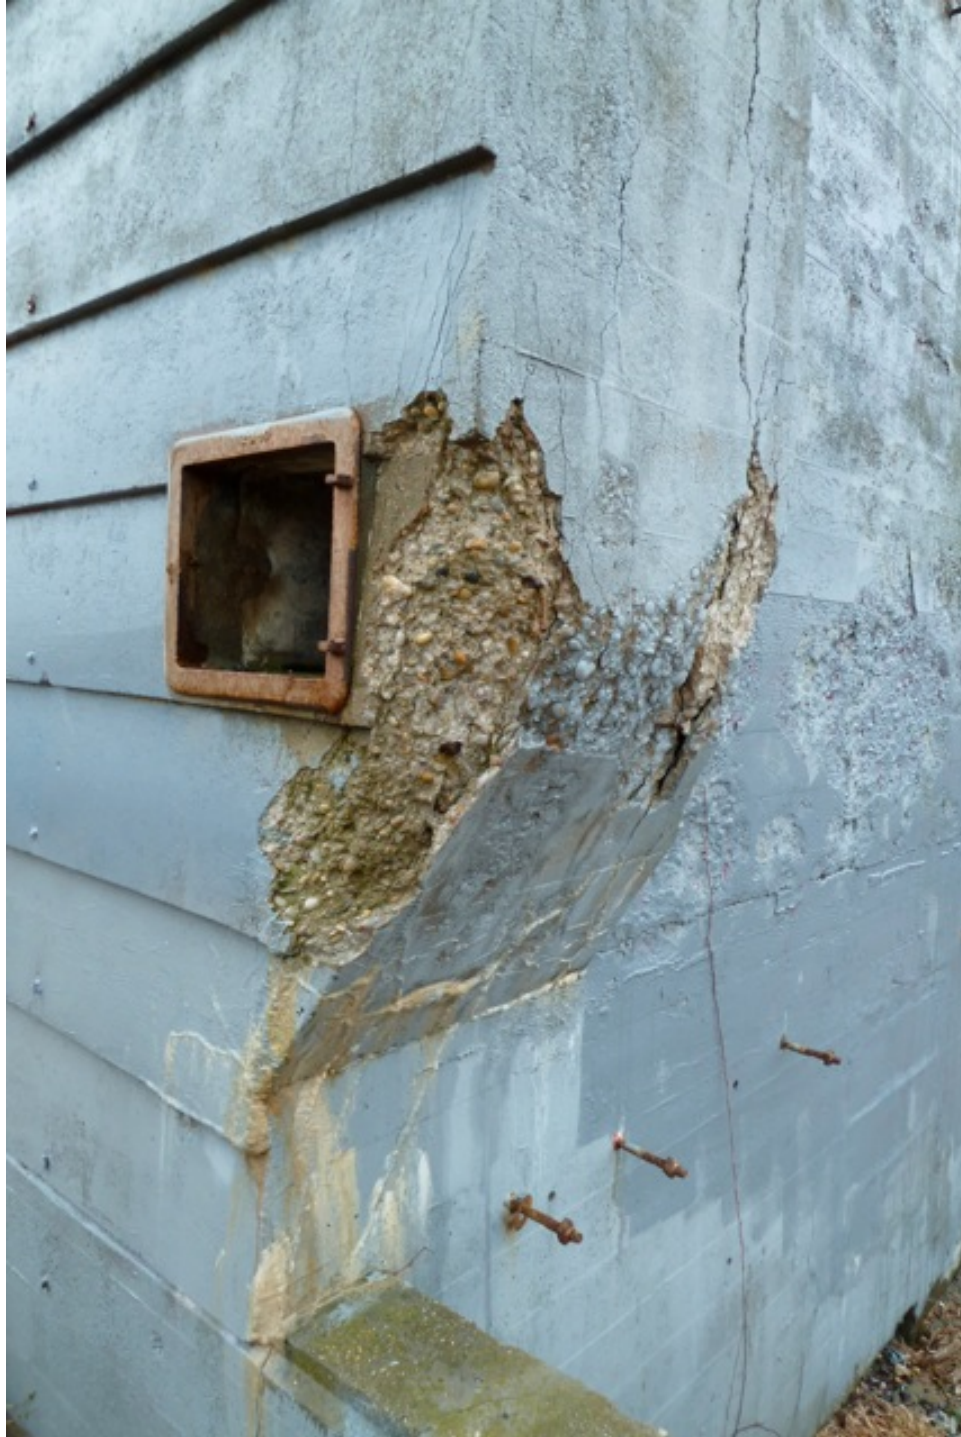
[Fig. 14] Detail of northeast chimney base, looking south. Note excessive erosion and efflorescence, as well as metal doorframe around the chimney access hatch.
