Cultural Resource Survey of College Heights in Fredericksburg, Virginia

Master of Science

Historic Preservation

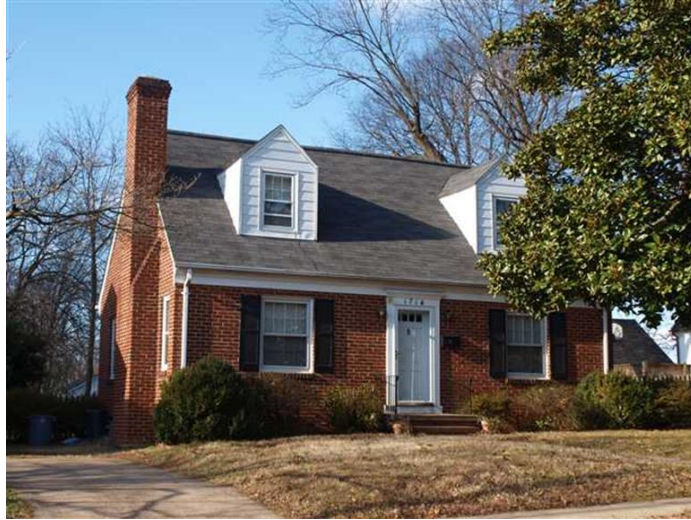
Figure 4.4: 1714 College Avenue, built in 1953.

Figure 4.4 shows 1714 College Avenue. This structure is in good condition and considered contributing because it represents a Cape Cod structure built during the highest period of construction of Cape Cod structures.

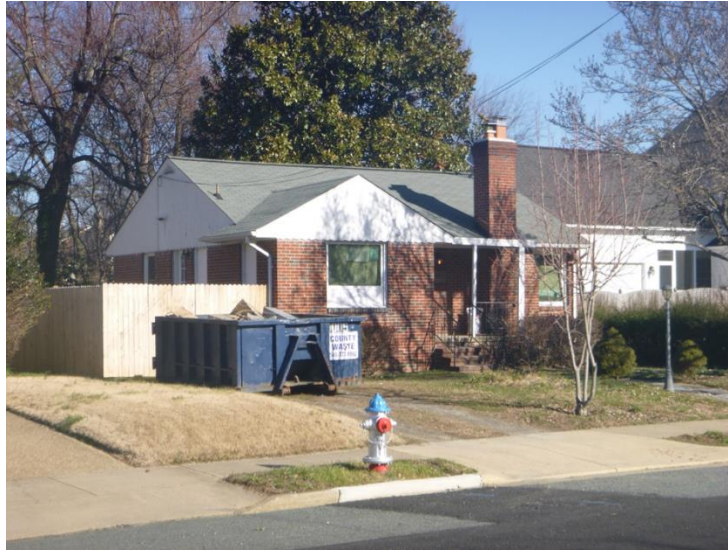
Figure 4.5: 1311 Dandridge Street, built in 1951.

Figure 4.5 shows 1311 Dandridge Street, an example of a typical Minimal Traditional home. This building is in good condition and was deemed contributing.

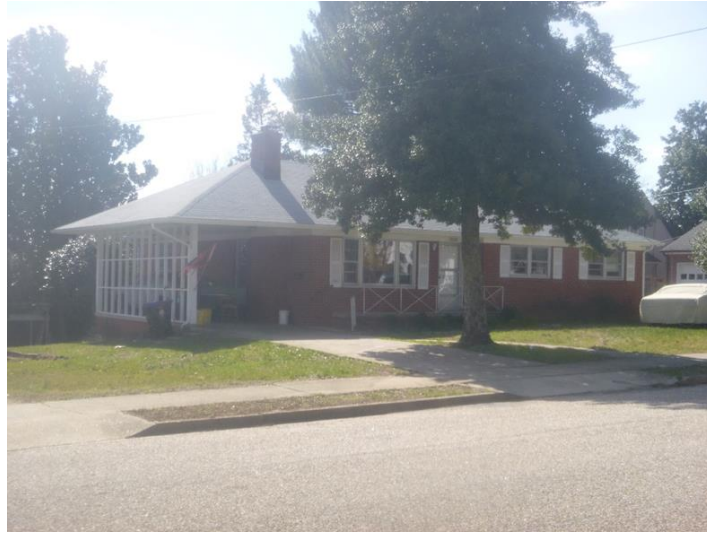
Figure 4.6: 1320 Parcell Street,

Above is 1320 Parcell Street, built in 1949. An example of a Ranch style home with a modern feel. This structure was determined to be in good condition and contributing due to the popularity of this style during its construction.

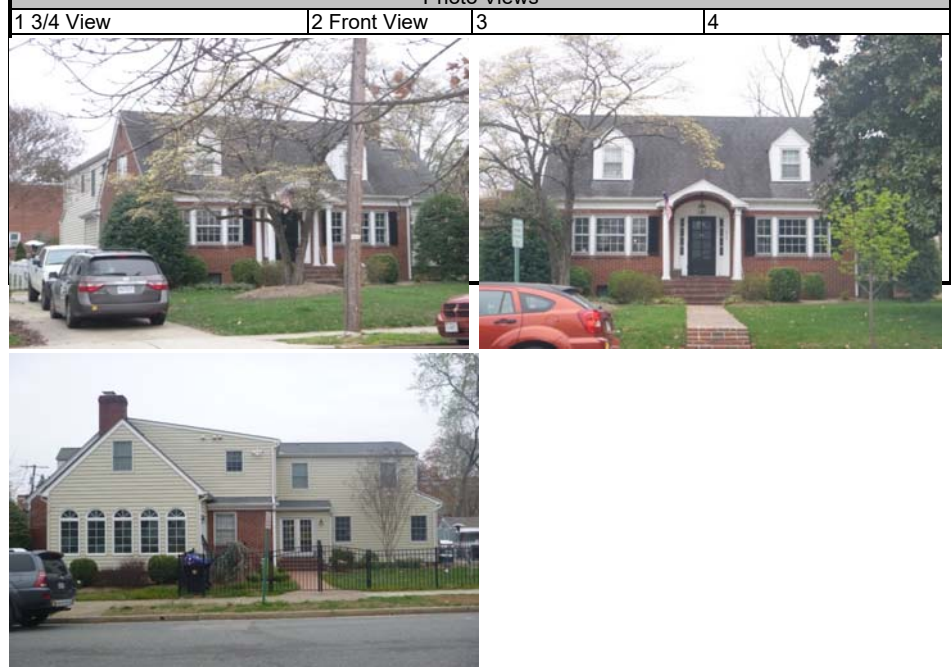
Name of Surveyors	Kimberly Packett		Survey Date	3/26/2016
ADDRESS	Street		Number	
	Brent	Street	1218	
TYPE & NUMBER OF BLGS & STRUCTURES	Type		Number	
	Single Family House		1	
Current Use of Primary Building	Single Family	Historic Use of Primary Building	Single Family	
Style of Primary Bldg	Cape Cod			
Number of Stories	2	Width (bays)	3	
Foundation Material	Cinderblock	Depth (rooms)	3	
Year Built	1948	Wall Cladding Material	Brick	
Roof Shape	Side Gable	Roof Material	Composition Shingle	
Decorative Details/Unique Features	Two front gable dormers on front of house. White front gable portico with white columns above front porch. Black shutters on front bottom windows. White semi-circle pediment above door, transoms on either side of front door. White dentils along front of house.			
Evidence of Integrity Location/Materials	Original brick siding, front windows may be original.			
Additions/Alterations to Primary Building	Additions on right and back side of the house. Additions have vinyl siding. New roof.

Condition of Primary Building	Excellent			code E
Observable Threats	None			
Compatibility with Adjacent Land Uses	Good			
Potential NR Eligibility	Contributing			code C
Other Comments / Salient Details	Black iron fence around backyard. Brick stairs and path leading to brick front porch. Bushes along front of house. Brick stairs and path leading to back door. Chimney on right end of the original house.

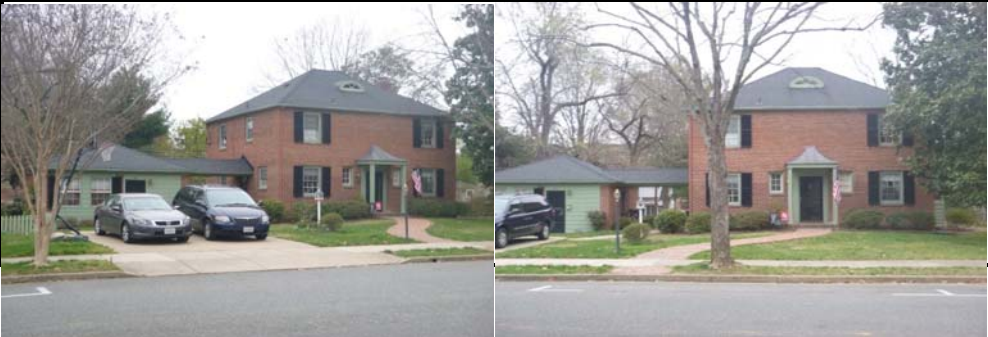
Name of Surveyors	Kimberly Packett		Survey Date	3/26/2016
ADDRESS	Street		Number	
	Colony	Street	1111a and 1111	
TYPE & NUMBER OF BLGS & STRUCTURES	Type		Number	
	Single Family House		1	
Current Use of Primary Building	Multi-Family	Historic Use of Primary Building	Single Family	
Style of Primary Bldg	Colonial Revival			
Number of Stories	2	Width (bays)	3	
Foundation Material	Concrete	Depth (rooms)	3	
Year Built	1950	Wall Cladding Material	Brick	
Roof Shape	Hip	Roof Material	Composition shingle	
Decorative Details/Unique Features	Semi circular transom on front of roof. Black shutters on front windows. Two small windows on either side of front door. Portico with a metal curved hip roof over front door with green columns. Green surround around front door and green windows.			
Evidence of Integrity Location/Materials	Original brick siding and windows.			
Additions/Alterations to Primary Building	Attached garage renovated into a separate apartment. New roof.

Condition of Primary Building	Good		code	G
Observable Threats	None			
Compatibility with Adjacent Land Uses	Good			
Potential NR Eligibility	Contributing		code	C
Other Comments / Salient Details	Brick path and step leading to front door. Bushes along front of house. Covered pathway leads to 1111a a separate apartment. Interior chimney on right side of house. Short green wood fence around backyard. Double driveway in front of 1111a. Black and gold lamppost on front lawn. Green wooden stairs on right side of house lead to side door.			
Photo Views				
1 3/4 View	2 Front View	3	4

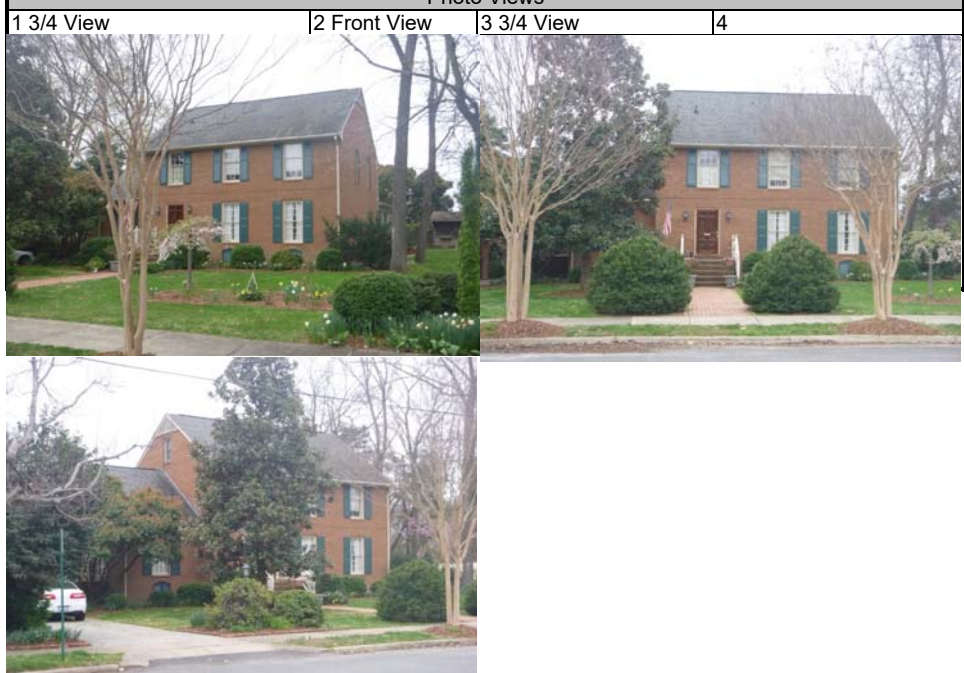
Name of Surveyors	Kimberly Packett	Survey Date	3/26/2016
ADDRESS	Street	Number	
	Buckner Street	1204	
TYPE & NUMBER OF BLGS & STRUCTURES	Type	Number	
	Single Family House	1	
Current Use of Primary Building	Single Family	Historic Use of Primary Building	Single Family
Style of Primary Bldg	Colonial Revival		
Number of Stories	2	Width (bays)	3
Foundation Material	Cinderblock	Depth (rooms)	2
Year Built	1985	Wall Cladding Material	Brick
Roof Shape	Side gable	Roof Material	Composition shingle
Decorative Details/Unique Features	Brick lintel above front door and bottom windows. Green shutters on front windows.		
Evidence of Integrity Location/Materials	Original brick siding, windows, and roof.		
Additions/Alterations to Primary Building	None.		
Condition of Primary Building	Good	code G	
Observable Threats	None		
Compatibility with Adjacent Land Uses	Good		
Potential NR Eligibility	Non-contributing	code N	
Other Comments / Salient Details	Driveway on left side of the house. Brick path and stairs with white iron railing leading to front door. Bushes along brick path and base of the house.
