## Fuller Farmstead: Reuse & Rehabilitation Feasibility Report

# The Fuller Farmstead

Reuse and Rehabilitation  
Feasibility Report

*Community Partner:*  
The Barnstable Land Trust,  
Barnstable, MA

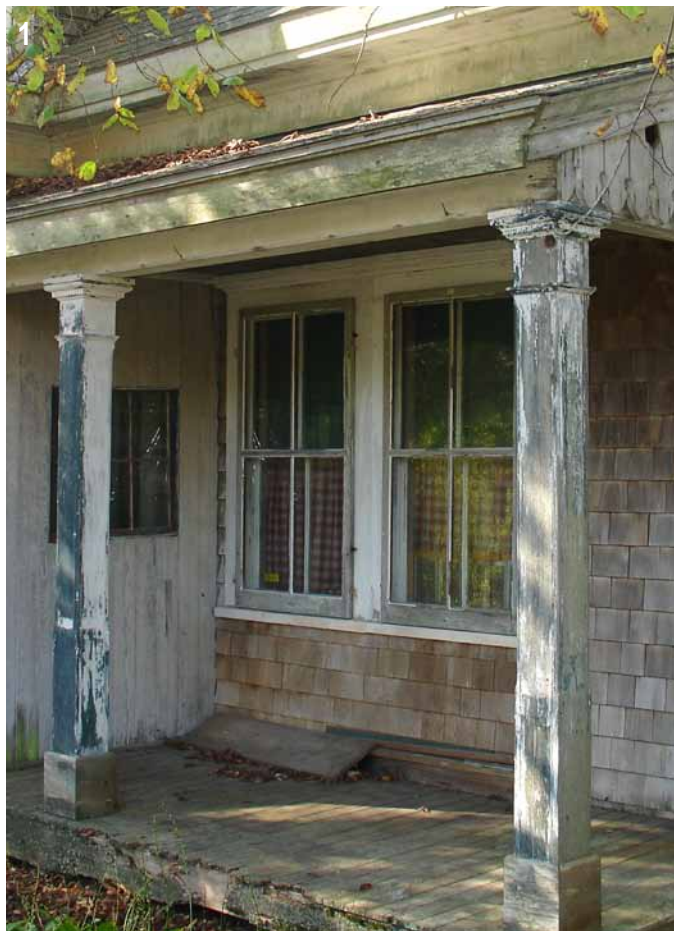
- East porch is missing trim boards.
- Porch indicates moisture and insect damage.
- Porch sills supported on concrete piers.
- Porch posts are missing ornamentation trim.

- Northeast pillar has holes approximately 1.5 inches in diameter.
- South porch failure to solitary porch post, sill and floor.
- South porch roof sags and pulls away approximately five inches from the structure.
- Porches have missing floorboards.
- Porches have enclosed entrances.

- Reattach south porch to main structure.
- Replace porch sills with dimension lumber.
- Remove “chicken coop” entrance on east and south porch.
- Rehabilitate porch columns.
- Reattach/fabricate original porch ornamentation.
- Replace floors with similar wood planks.
- Stain/paint trim same as exterior.

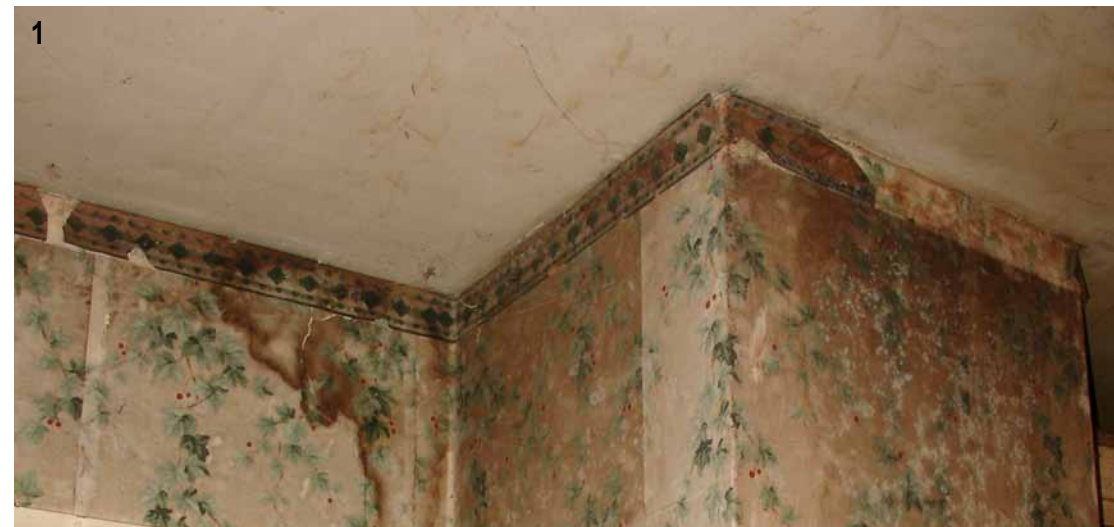
- The ceiling and walls, with the exception of the north kitchen, show extensive cracking and multiple repairs to the plaster.
- Ceilings exhibit calcification and peeling of the paint over an estimated 80% of their surface.
- Walls have multiple layers of wallpaper, which has separated from the plaster in many areas.
- Ceiling in almost all rooms shows past history of water staining and cracking of the plaster.
- Northeast corner of the kitchen shows serious water damage. There is evidence of current interior water damage that has detectable moisture.

1. Walls have multiple layers of wallpaper; some areas exhibit water stains.

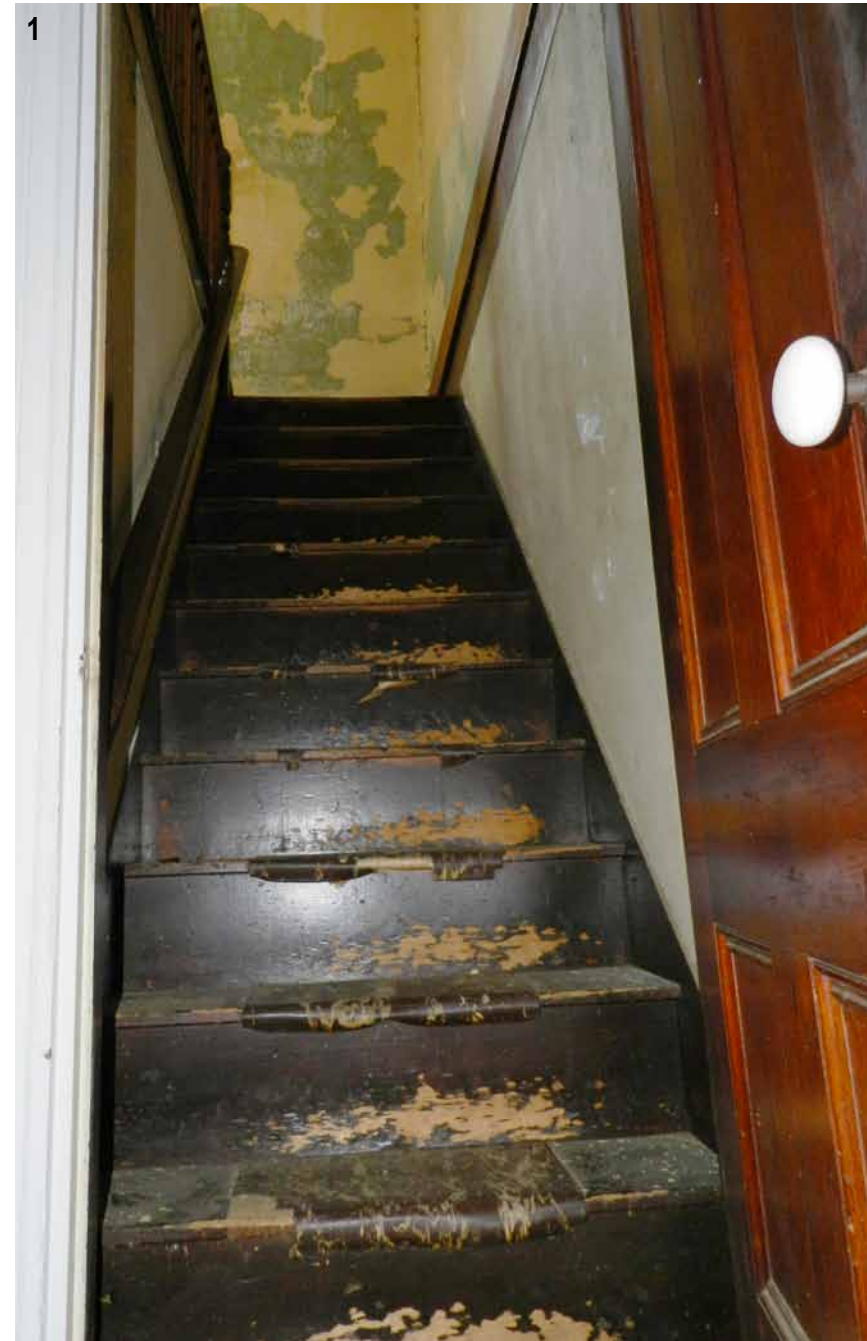
- There are 12 steps from the first floor to the second floor.
- Discoloration of the floor varnish indicates there were once treads on the steps.
- The staircase has a wraparound banister with two different style railings that create a pattern.
- The banister is in excellent condition.

- The staircase has one newel post and a hand-rail; both appear to be in good structural condition.
- Stairs are constructed of wood planking.

1. Main staircase on first floor shows discoloration.

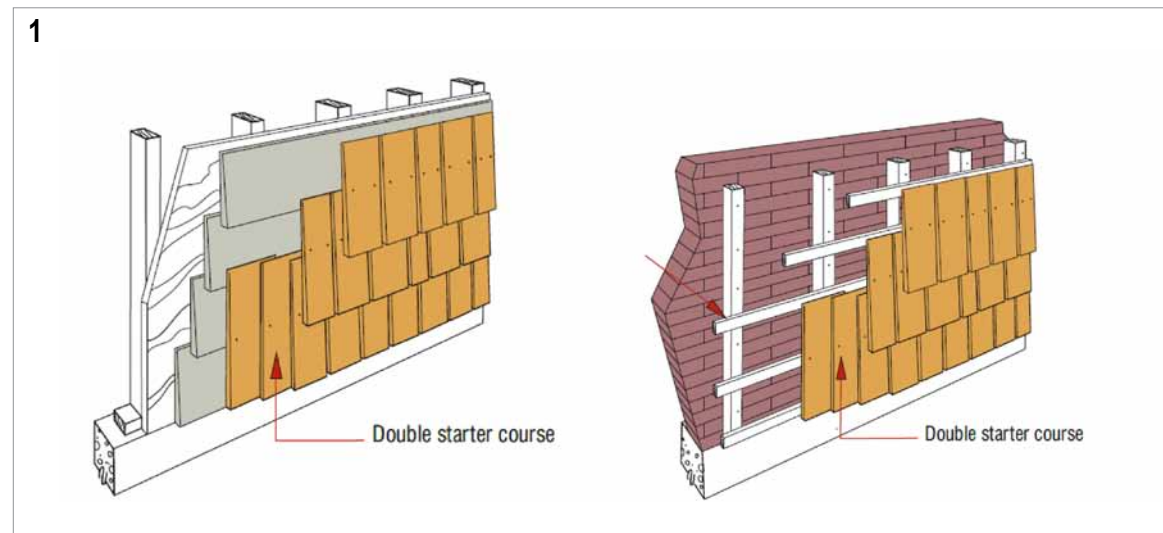
1. Diagram of cedar shingle application.

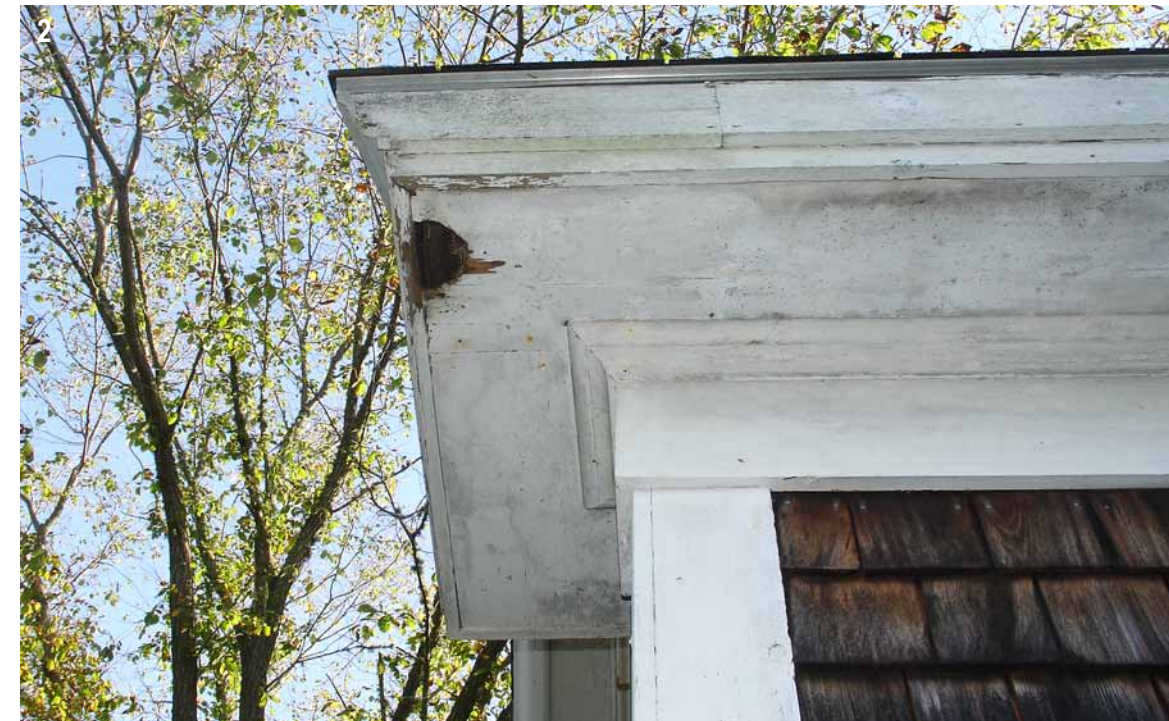
2. Animal nesting holes to be sealed.

- If section has more than 20% rot, remove the damaged portion, attach new material with replacement wood – either salvaged or new.
- Seal all animal nesting and bird holes with Dutchman Patch.
- Remove loose, flaking or checking paint by removing surface edges. Using two coats of primer, apply a white final coat with latex satin finish paint.

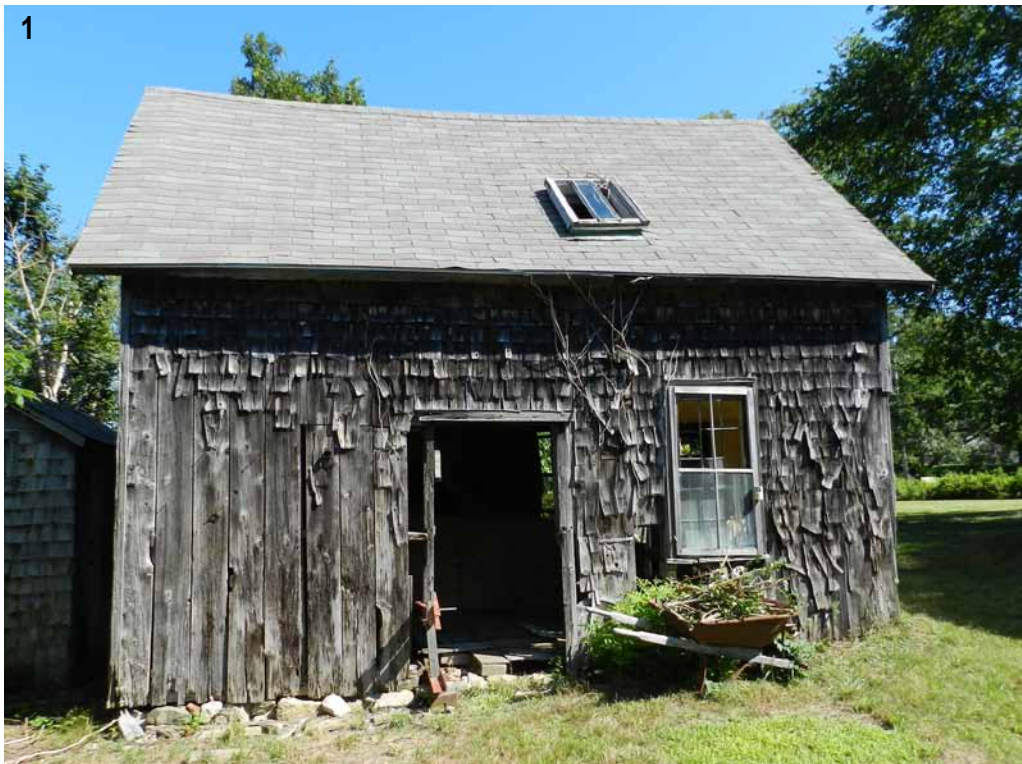
2. Restack and recement foundation stones.

- Program calls for a new foundation to be installed under the main structure to create a basement.
- Rubble façade should be added to replicate the original appearance.
- Replace wooden poles at corners/midpoints with concrete piers.
- Restack and recement stones.
- Fill access holes with stone/concrete that match the exterior of the structure.
- Recement and restack foundation at southeast corner.
- Construct angle iron frame with metal doors on southwest corner.
