St. Mary's Parish House: Reuse and Rehabilitation Feasibility Report

St. Mary's Parish House

Reuse and Rehabilitation
Feasibility Report

Academic Partner:
School of Architecture, Art
and Historic Preservation

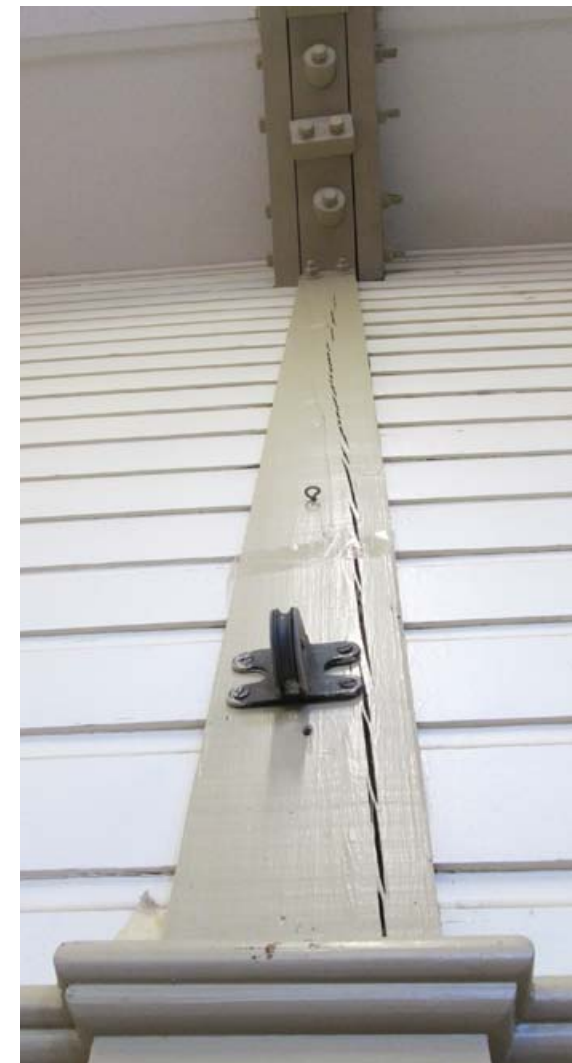
The structural piers in the gym are splitting vertically, which happens over the lifetime of many species of wood. This seems to be allowing weight to still be transferred downward because this member is in compression. These cracks do not appear to be new and there is no apparent rot or structural instability upon visual inspection from the floor.

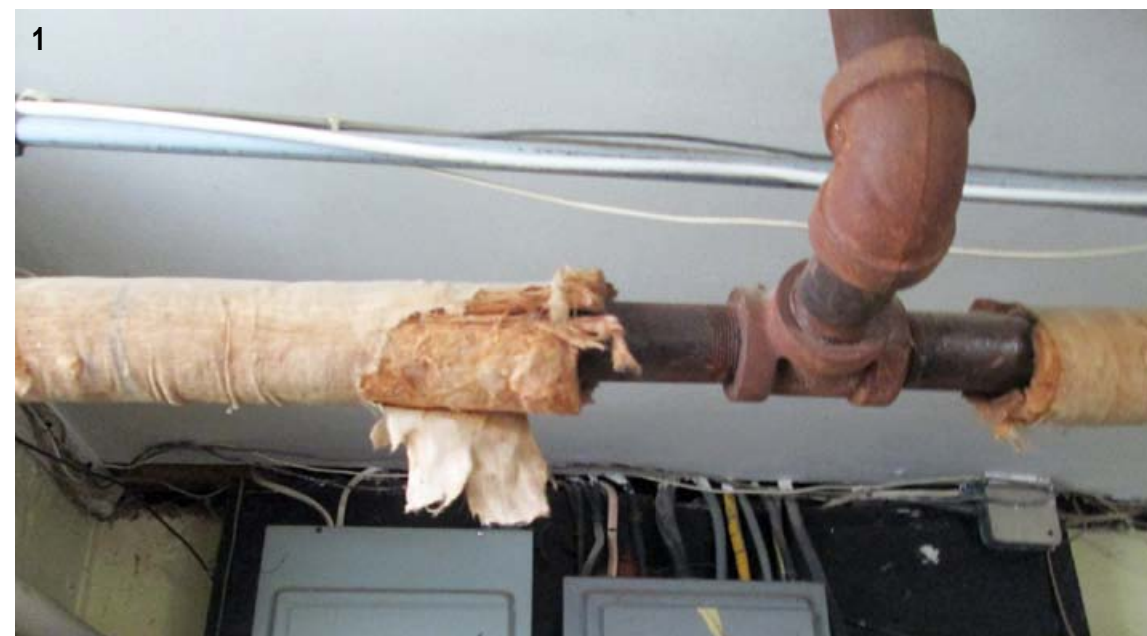
There are no visible issues with the pipes themselves, however, the pipes in the basement need rewinding as the insulation is significantly deteriorated in most places.

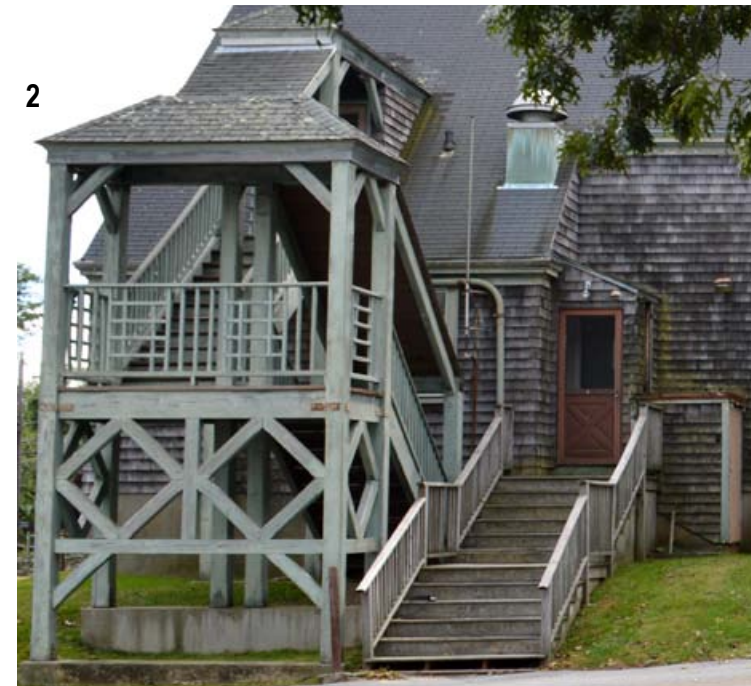
2

- **Problem:** The north and south fire escape are in fair to poor condition. There is significant weathering of the wood, including some rot. Risers are detached from stringers, and treads are detached from risers. The wood posts that make up the majority of the stair structure show significant signs of weathering and deterioration. There is also a large amount of paint cracking on the entire structure.
- **Solution:** The fire escapes will be retained and repaired. The structural integrity of the fire stairs will be examined and any loose or warped wood will be replaced with wood of matching dimensions. After repair, the fire stairs should be painted with an exterior-grade paint to ensure the longevity of the wood. During Phase II of the rehabilitation, the fire escapes will be removed once alternate egress is constructed in the addition.

2. Loose and warped wood from the north fire escape will be replaced, repaired and painted.

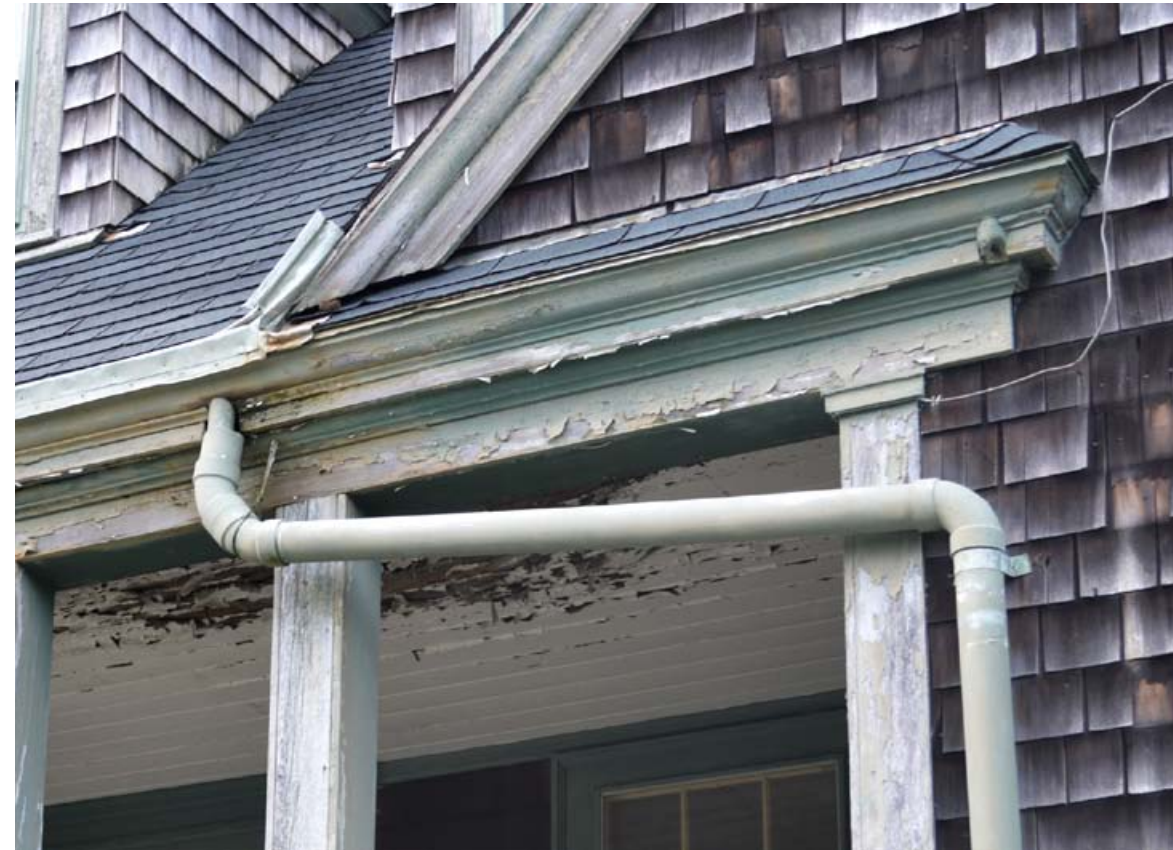
Cornice

- **Problem:** The exterior of the cornice is slightly deteriorated, showing signs of weathering

and cracking. There is paint loss and chipped paint throughout. Additionally, the cornice contains internal wooden gutters lined with copper. These gutters are in poor condition, with the copper lining deteriorating and the wood beneath rotting. They are undersized for the large roof of the parish house.

- **Solution:** Replace the original wood gutters with wider aluminum gutters with a historic molding profile that approximates the existing profile. Retain the existing molding beneath the gutter where possible. Areas of rot must be

replaced with new wood of the same dimensions and profile. Areas of cornice molding to be retained should be scraped and repainted with an exterior grade paint to protect the wood.

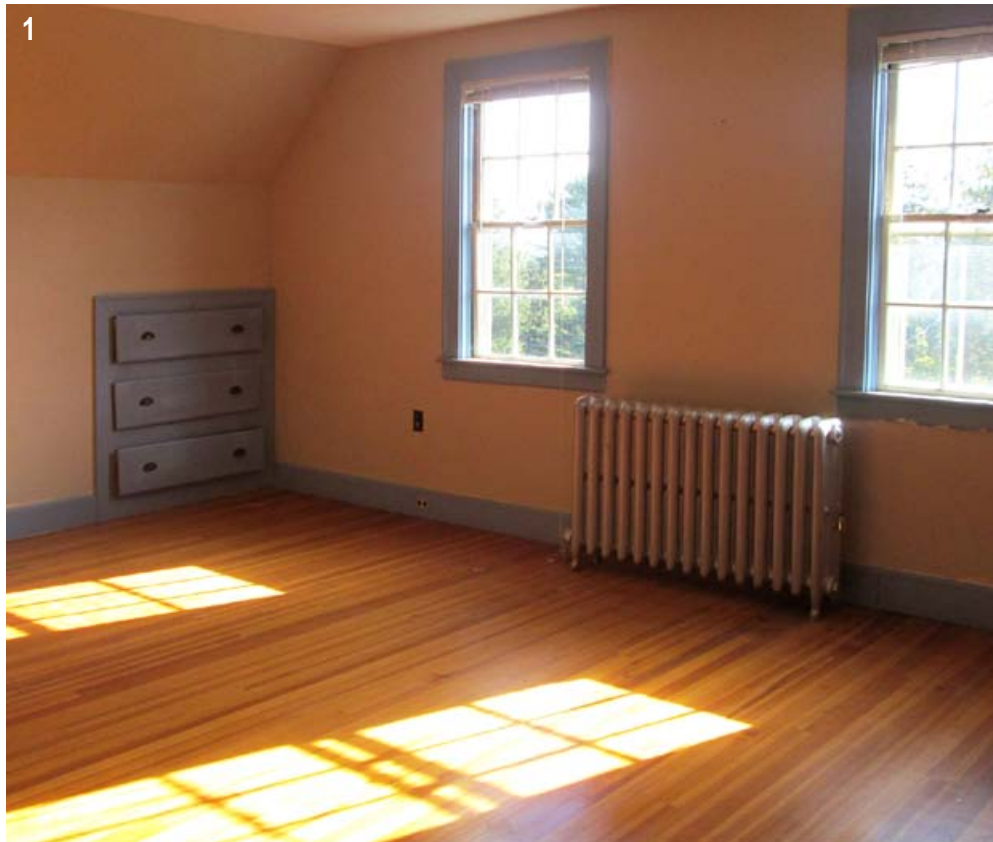
Plaster Finishes

- **Problem:** Plaster condition varies throughout the structure. The plaster is in generally fair condition throughout the first floor, with some holes, missing plaster and hairline cracks. The plaster textured finish on the walls in the upstairs classrooms and particularly in the stair hall is in poor condition, including cracking, bulging and separation from the walls in some areas.
- **Solution:** The plaster shall be retained and repaired. Holes shall be patched with new plaster that matches the historic material in color and texture. Areas of plaster that are bulging shall be reattached to the lathe using mechanical fasteners or chemical adherents.

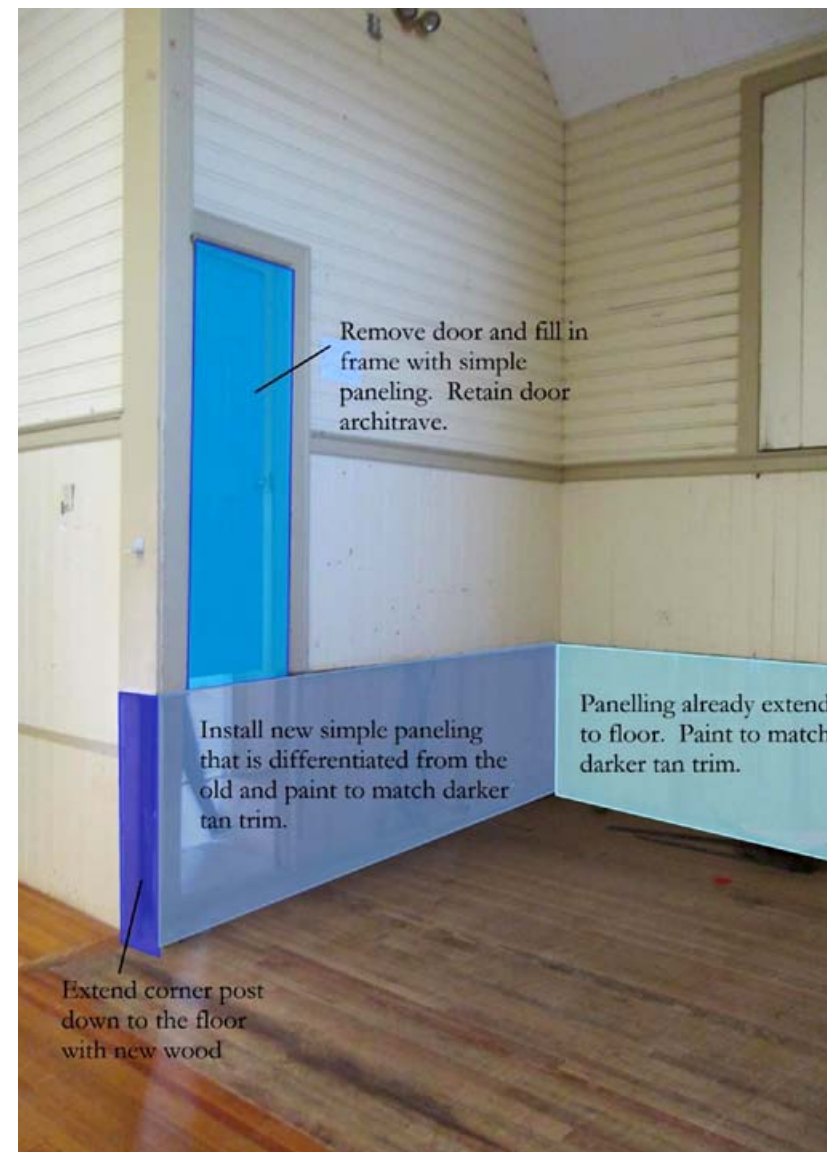
Stage Area

- **Problem:** The wood panelling on the walls of the gymnasium is in good condition, despite some loss of paint in a few places.

Some areas exhibit bulging, scratches or deterioration. However, the stage was recently removed, leaving the wood panelling under the former stage unfinished (back wall) and non-existent (side walls).

- **Solution:** See above solution for repainting surfaces. The stage area will be refinished in a way that recognizes the space that the stage formerly occupied. The door architraves will be retained and non-historic doors will be replaced with simple panels to indicate the former location of the doors. Additionally, the unfinished side walls will have panelling that matches the existing vertical panelling installed, but hung horizontally to differentiate it from the original panelling. The new panelling and the existing unpainted panelling on the back wall will be painted the same colour as the door architrave and trim to further preserve the memory of the stage area.

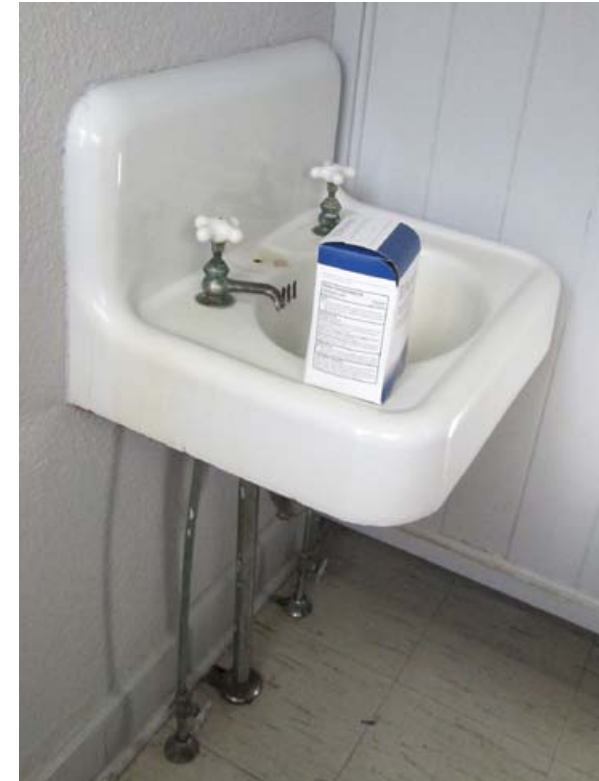
Bathroom Fixtures

- **Problem:** Bathroom conditions on the first and second floors are functional but are showing signs of age and deterioration. They will not be of sufficient size for the desired new program of the building.

Bathroom fixtures need to be updated and additional bathrooms built to accommodate increased occupancy.

- **Solution:** Bathroom fixtures on the first and second floor of the original structure will be replaced with updated fixtures. Bathroom fixtures in the school addition will remain as-is until demolition. Additional bathrooms will be incorporated in the design of the new addition to accommodate the desired occupancy of the building.

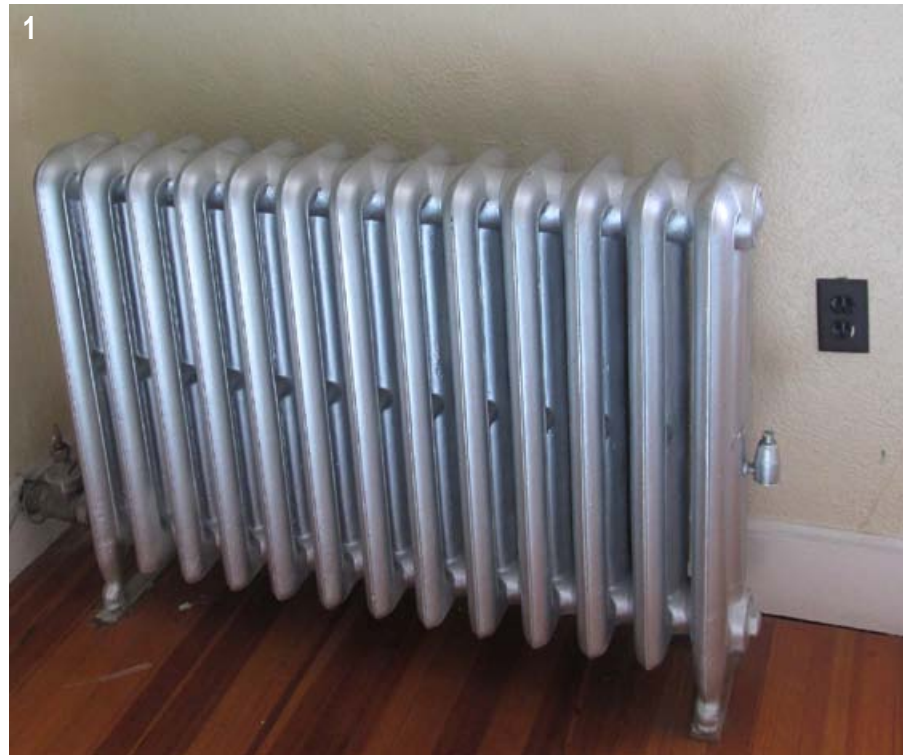
Radiators

- **Problem:** The cast iron radiators throughout building are in good condition. The only observable issue is some minor paint chipping on several radiators, though some have more chipped paint than others.

1. The cast iron radiators are in good condition, though some require minor scraping and repainting.

- **Solution:** Loose paint may be scraped and removed. In the case of lead paint, this must be carried out by a professional. The surfaces shall be repainted.
