The Baptist Church in Warren: Rehabilitation and Preservation Report

The Baptist Church in Warren

Rehabilitation and Preservation Report

Fall 2013

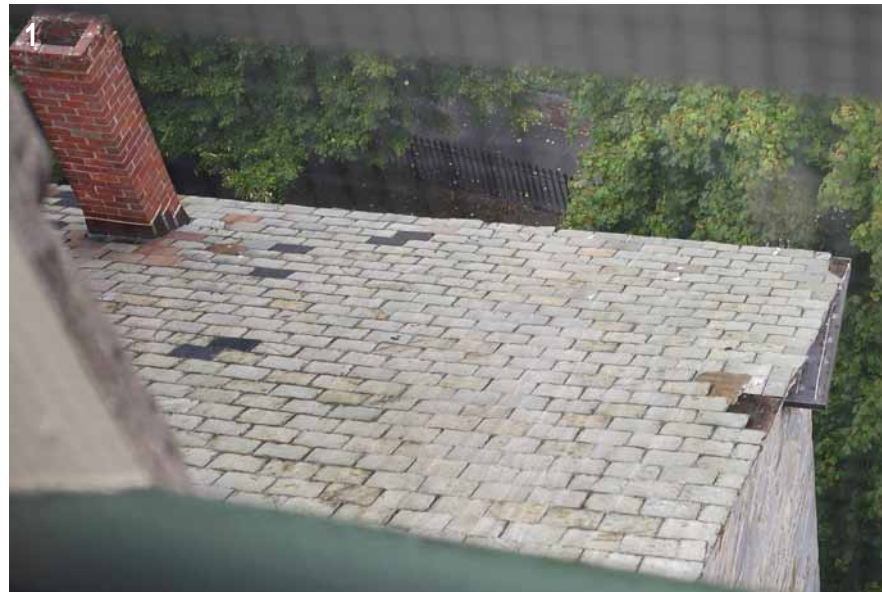
The roof covering the church's tower is bi-colored with grey and red slate forming a striped pattern. Overall, the roof is in fair condition, however, the slate shingled areas are in need of repair. Many slates are missing or hanging by one hanger. This is a failure of the hangers, which only last about a hundred years. These hangers are probably made of brass or copper, since they were the leading hangers of the 1840's. The copper ridge cap looks to be in fair condition, however, after 100 years of service, the roof is showing inevitable signs of age. The framing for the tower roof is in good condition and shows no visible signs of water damage or rot associated with insects or environmental effects.

The gable roof of the main structure is covered in green slate. Overall, the main roof is in poor condition. The existing slate roof was installed over a wooden shingled roof. The condition of the wooden shingles is unknown and could be a cause of the roof's poor condition. As with the tower roof, slates are sliding out of position, which could be caused by failing ferrous fasteners. Certain slates are exhibiting breakage, which could be the result of impurities in the slate. Numerous dark-colored slates show prior maintenance; yet there are missing slates throughout. The copper ridge cap is in good condition. Recently, Renaissance Roofing of Woonsocket, Rhode Island replaced over 400 slate tiles on the main roof.

1. A view of the roof from the tower window. The dark patches are missing slate shingles.
2. The tower roof, showing the red and grey slate striped pattern of the tiles.

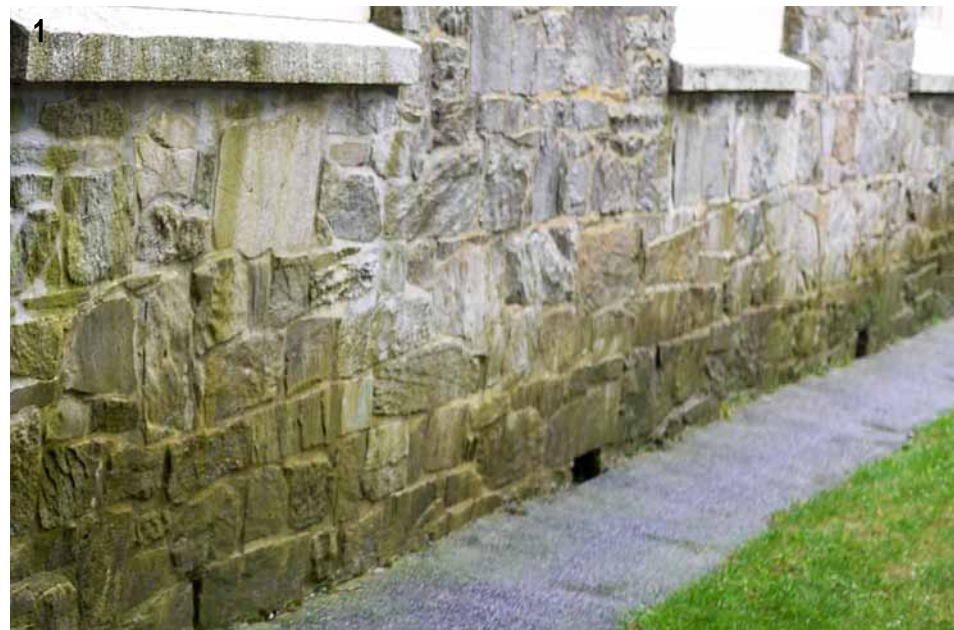
The masonry along the west elevation appears to be in good condition, displaying no structural concerns or material pathologies. There is some staining of the stone due to the bleeding of the rusted iron fittings designed to support lighting along the church's rear, but there appears to be no other damage other than aesthetic from this.

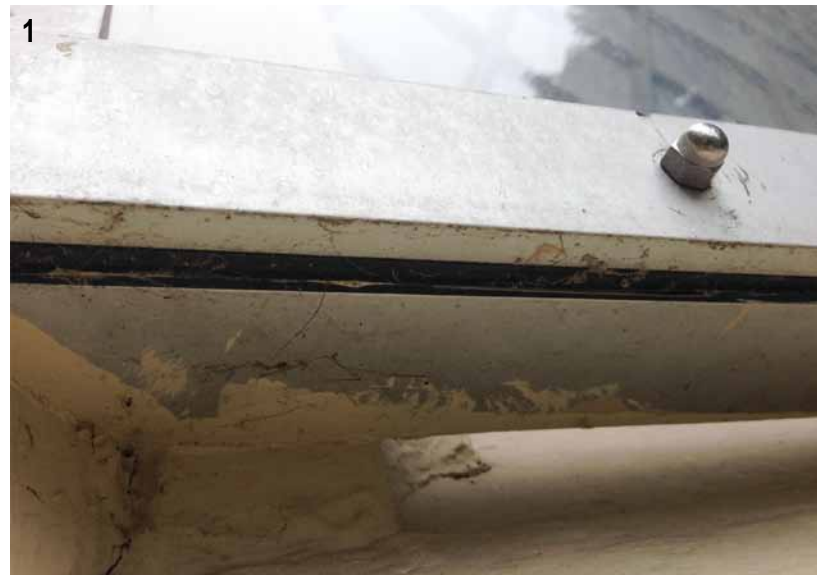
alligating. The bond between layers has broken due to inter-coat paint failure. This allows exterior moisture to penetrate the surface cracks, causing the wood to swell and deeper cracking to take place.

The window glazing is failing. This process has become exacerbated due to the storm windows. The storm windows are not properly ventilated, causing a micro climate within the space between the storm window and the wooden window. This micro climate is causing the paint and glazing to peel away.

1. The northeast window, located on the east façade, has an opening that traps moisture in the cavity between the window and storm window.

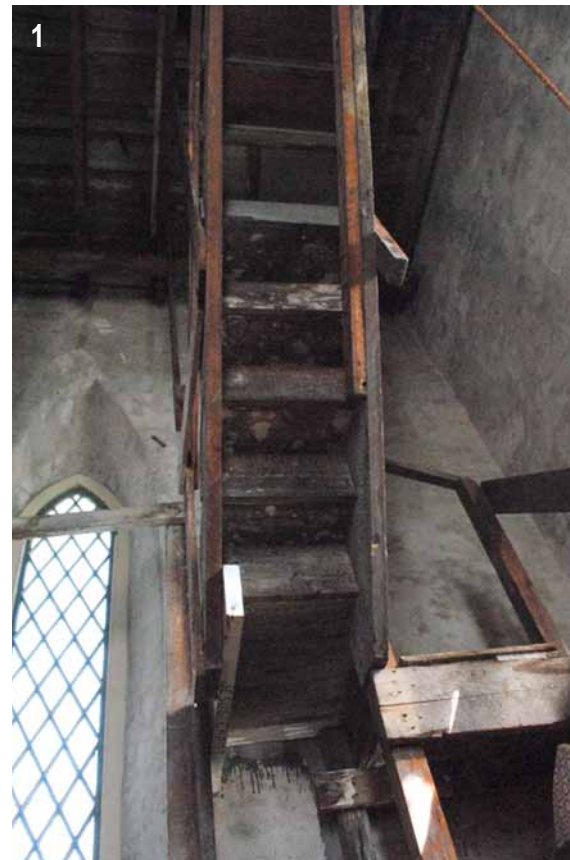
Access to the tower is through a door in the sanctuary's balcony. The tower is comprised of exposed masonry walls and staircases that lead to the bell room and clock gears. The first staircase is 2'6" wide. The second staircase, which leads to the second level, is only 1'1" wide. The staircase

and ladders, although appearing serviceable, are narrow, cramped and unpleasant for the workers at the church. The exposed masonry allows for patching to be done to fix cracks in the mortar. There is a prominent patch under the east window.

1. Narrow stairway to the bell tower, accessed through a door in the sanctuary's balcony.
2. Cracked plaster walls in the sanctuary.
3. Faux wood graining shows failure throughout the church.

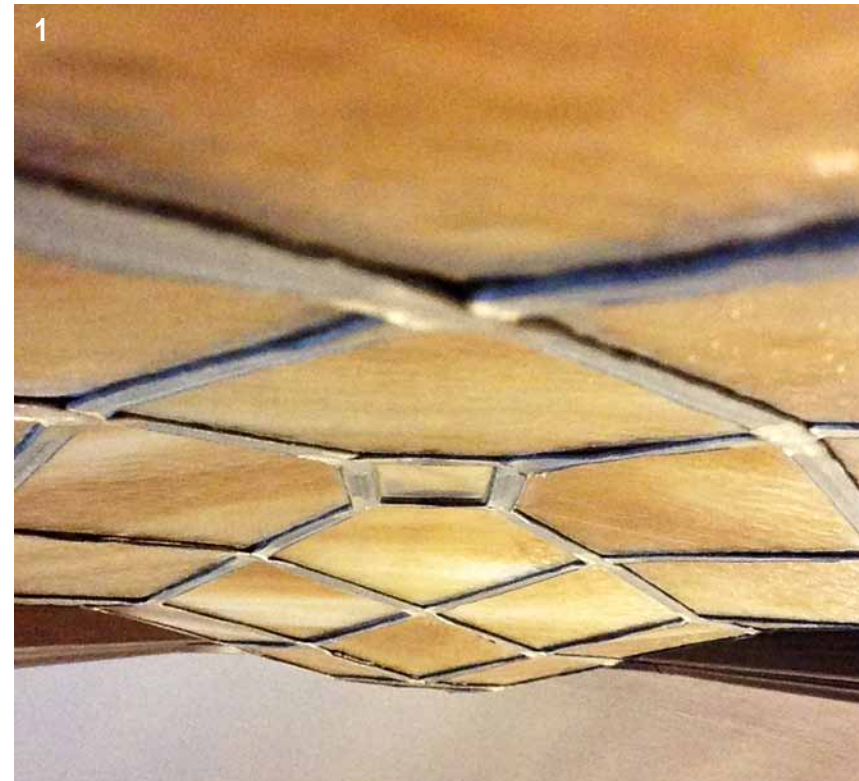
There is leaded glass throughout the sanctuary. It is found on the doors leading into the sanctuary from the front entrance. It is also found in a wooden partition separating the front entry into the sanctuary. The sagging of the lead and glass is an indication that the structural integrity of the lead support is beginning to fail, but the lead came has not failed to the point of breakage or dislodging the glass. On the western and eastern elevation, the stained glass windows are in need of re-caming.

1. A pronounced view of the stained glass bowing of the doors leading into the sanctuary.
2. The carpet shows signs of water damage.

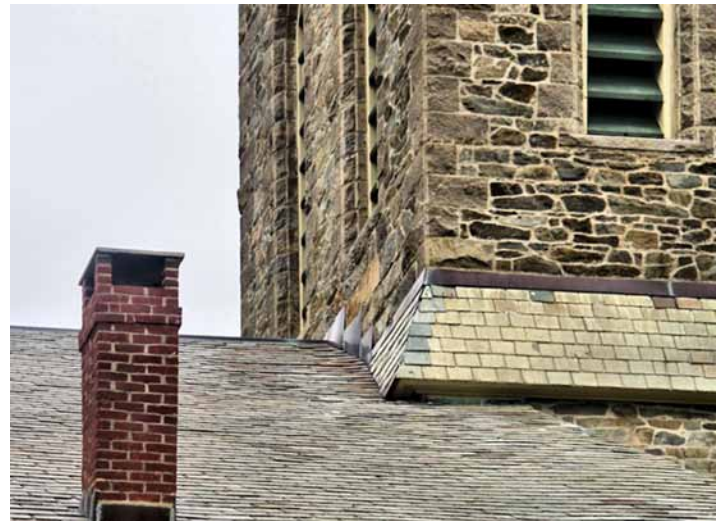
The gable roof of the main structure is covered in “sea green” slate. The main roof is in poor condition; the existing slate roof was installed over a wooden shingled roof. The condition of the wooden shingles is unknown and could be the cause of the roof’s poor condition. Slates are sliding out of position, which could be caused by failing ferrous fasteners. Certain slates exhibit breakage and could be the result of impurities in the slate. Currently the roof is being repaired. Around 1400 slate tiles have been replaced. The tower roof is in fair condition and is covered with alternating courses of scalloped “sea green” and rectangular “unfading red” slate. Some slates are sliding out of position.

- **1.2.1** Replace broken, cracked and missing slates with new slate material. New slate should match the size, shape, texture and weathered color of old slate. Assess the condition of slates sliding out of position; salvage sound undamaged slate and re-hang with copper fasteners.
- **1.2.2** Slide new slate into place and hold in position with one nail inserted through the vertical joint between the slates in the course above and approximately one inch below the tail of the slate two courses above. To prevent water penetration through the newly created nail hole, a piece of copper with a friction

- **1.2.3** Alternate methods for securing the replacement slate include the use of metal hooks, clips and straps that are bent over the tail end of the slate.

- **1.2.4** The application of roofing mastic or sealants to damaged slates should not be considered a viable repair alternative because these materials, though effective at first, will eventually harden and crack, thereby allowing water to enter.

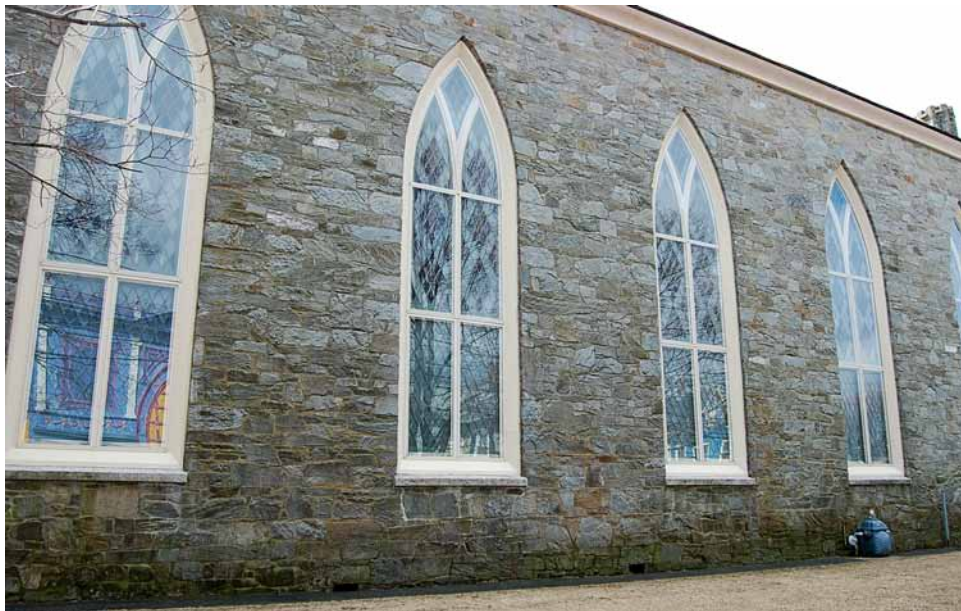
Window repair requires removing hardware, scraping paint by hand and re-glazing the glass.

- **1.2.31** Install new brass weather stripping on jamb sides of upper and lower sashes. Also install brass weather stripping at meeting rail.
- **1.2.32** Provide spring bronze or copper weather stripping for window reinstallation. 204 inches by 1.125. 008” hemmed spring bronze (brass) packed with nails of similar material. Nails should be approximately 1-1/2” on center. Fills up to a 1/8” space in a closed position.

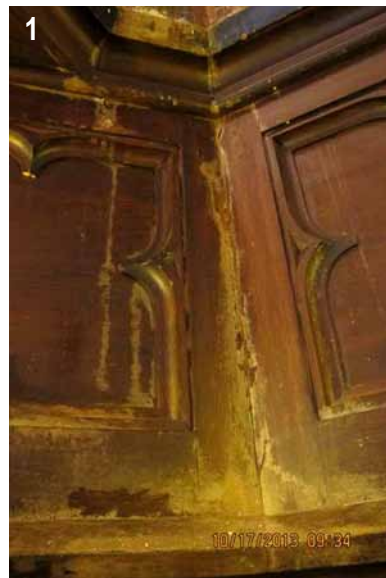
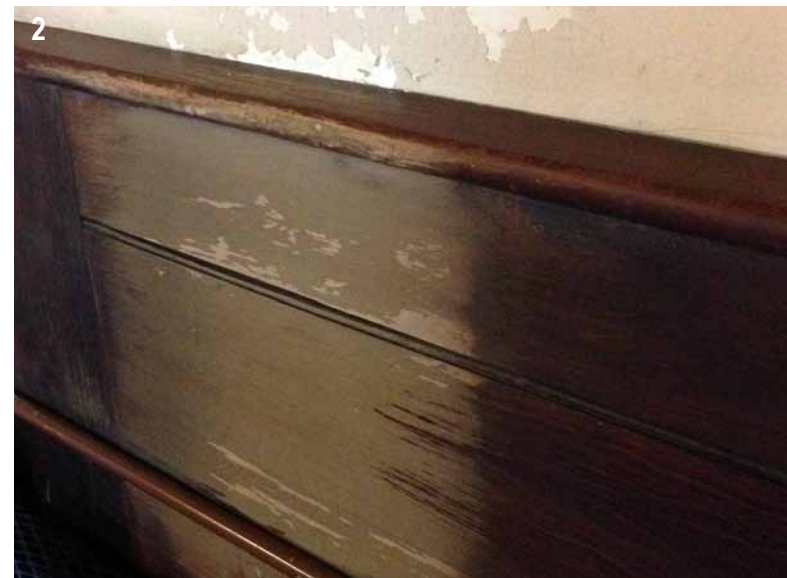
The finish to the wood paneling in the chancel has suffered damage due to the water leak; however, there is no noticeable damage to the structure of the wood. Overall, the wood in the chancel is in good condition.

1. Water damage to chancel woodwork requires repair.
2. Faux finished wood graining has worn away in some areas.

- **1.2.1** Onsite collection of finish samples and laboratory analysis of surface treatments must be undertaken to assess appropriate finish, glazing material and stain color.
- **1.2.2** Sand areas where water damage has occurred to remove finish and expose bare wood. When the finish has been removed, bleach the entire stained surface with a solution of oxalic acid if wood is stained dark.⁹

- **1.2.3** Stain bare wood to match existing stain.
- **1.2.4** Prepare existing finish surrounding treated area with sandpaper grit-220.
- **1.2.5** Re-finish the wood paneling to match existing finish throughout.
- **1.2.6** All materials and shop drawings required for work in this section shall be subject to approval by preservation consultant and the architect based on submittal of product information, samples and supporting material.

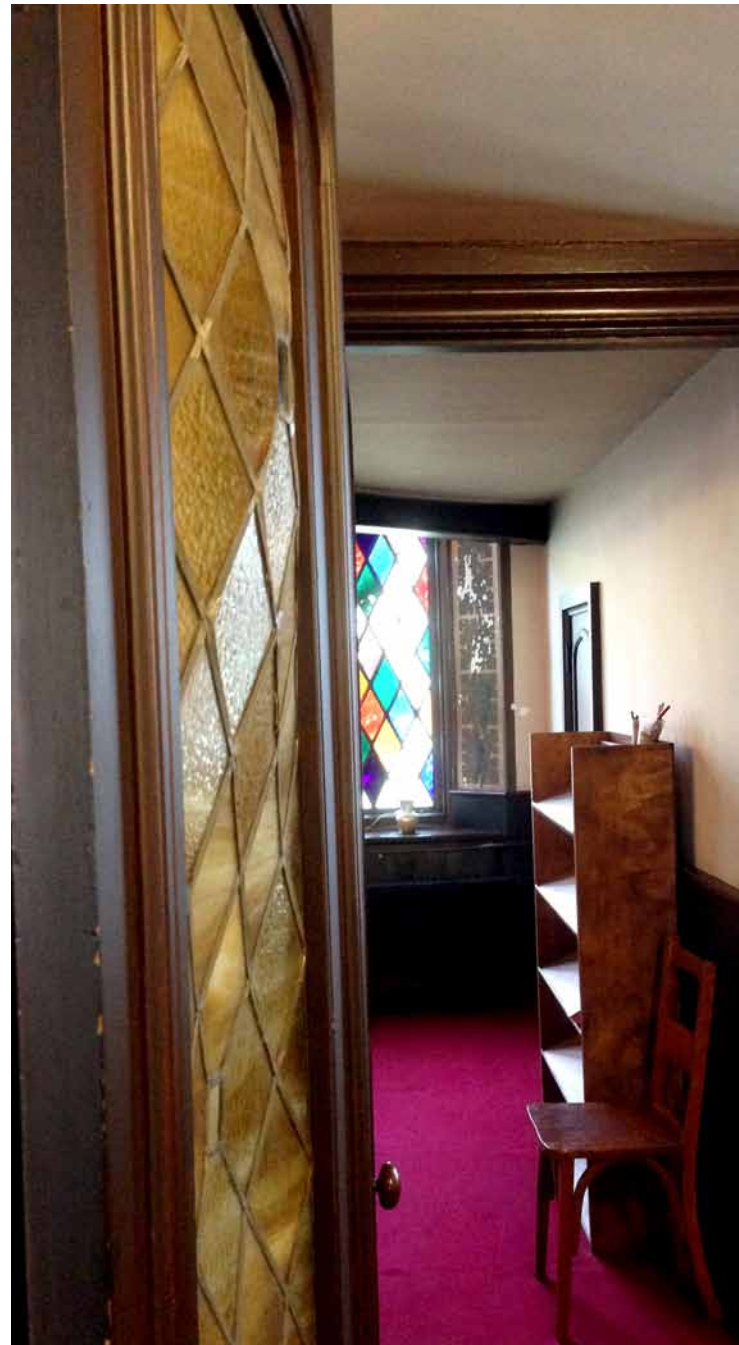
There is leaded glass throughout the sanctuary. The sagging of the lead came and glass is an indication that the structural integrity of the lead support is beginning to fail. The lead has not failed to the point of breaking or dislodging the glass.

The stained glass window in the door is bowing due to failure of the lead comes.

- **1.2.1** If window is sagging or bulging more than 1½” out of plane, it has reached the point where it should be removed from the opening to be flattened out.
- **1.2.2** Record location of each section prior to removal to ensure section is reinstalled in original location.

- **1.2.3** The window must be allowed to flatten over a few weeks in a horizontal position. This will minimize stress on the solder joints and glass. A moderate weight and controlled heat will help coax the window back into its original plane.
- **1.2.4** Once the window has flattened, additional support should be added as necessary. It is crucial to consider the original design so the new support bars do not intrude on important window features.
- **1.2.5** Reinstall windows.
- **1.2.6** All materials and shop drawings required for work in this section shall be subject to approval by preservation consultant and the architect based on submittal of product information, samples and supporting material.¹¹

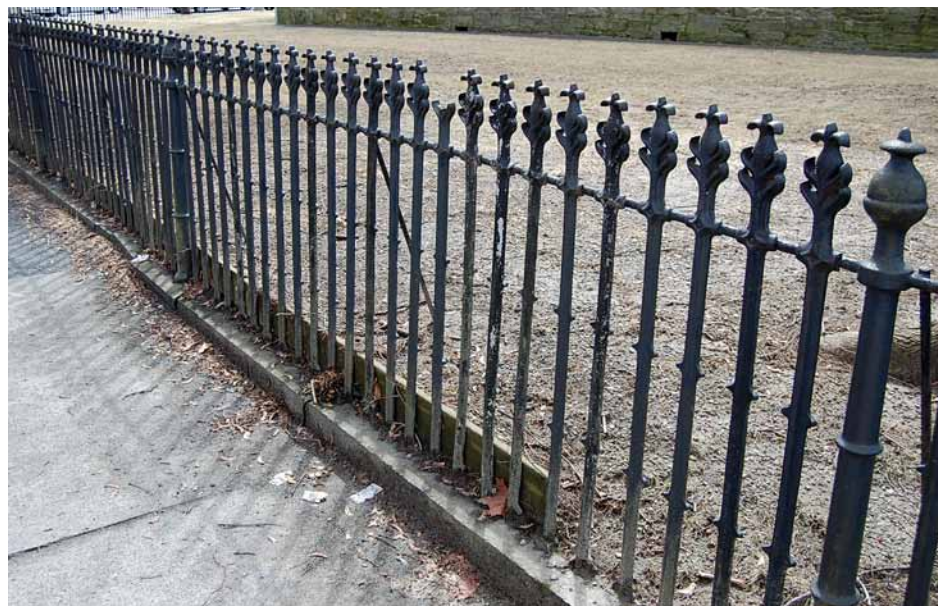
Skirting the perimeter of the church property on Main Street and Miller Street is a decorative cast iron fence and looks to be original based on historic photos, with about 75% of the original material still existing. Some missing pieces of the

original fence have been replaced with similar pieces that do not detract from the overall aesthetic of the fence, except for some issues with the protective finish. There are still some missing and broken pickets, and many of the footings are heaved. Overall the fence is in fair condition.

The cast iron fence is original to the church with about 75% of the original material still existing.

- **1.2.1** When there is extensive failure of the protective coating and/or when heavy corrosion exists, the rust and most or all of the paint must be removed to prepare the surfaces for new protective coatings
- **1.2.3** Local environmental regulations may restrict the options for cleaning and paint removal methods, as well as the disposal of materials.
- **1.2.4** Hand scraping, chipping and wire brushing are the most common and least expensive methods of removing paint and light rust from cast iron.
- **1.2.5** Before removing paint from historic architectural cast iron, a microscopic analysis of samples of the historic paint sequencing is recommended.
- **1.2.6** Thorough surface preparation is necessary for the adhesion of new protective coatings. All loose, flaking and deteriorated paint must be removed from the iron, as

- **1.2.7** Joints between pieces must be caulked to prevent water from seeping in and causing rusting from the inside out. For good adhesion and performance, an architectural-grade polyurethane sealant or traditional white lead paste is preferred.¹⁹
- **1.2.8** Although the footings are heaved, removal from the granite foundation would potentially damage the existing fence. The missing pickets should be replaced with replicas as has been done in prior incidents of replacements
- **1.2.9** All materials and shop drawings required for work in this section shall be subject to approval by preservation consultant and the architect based on submittal of product information, samples and supporting material.

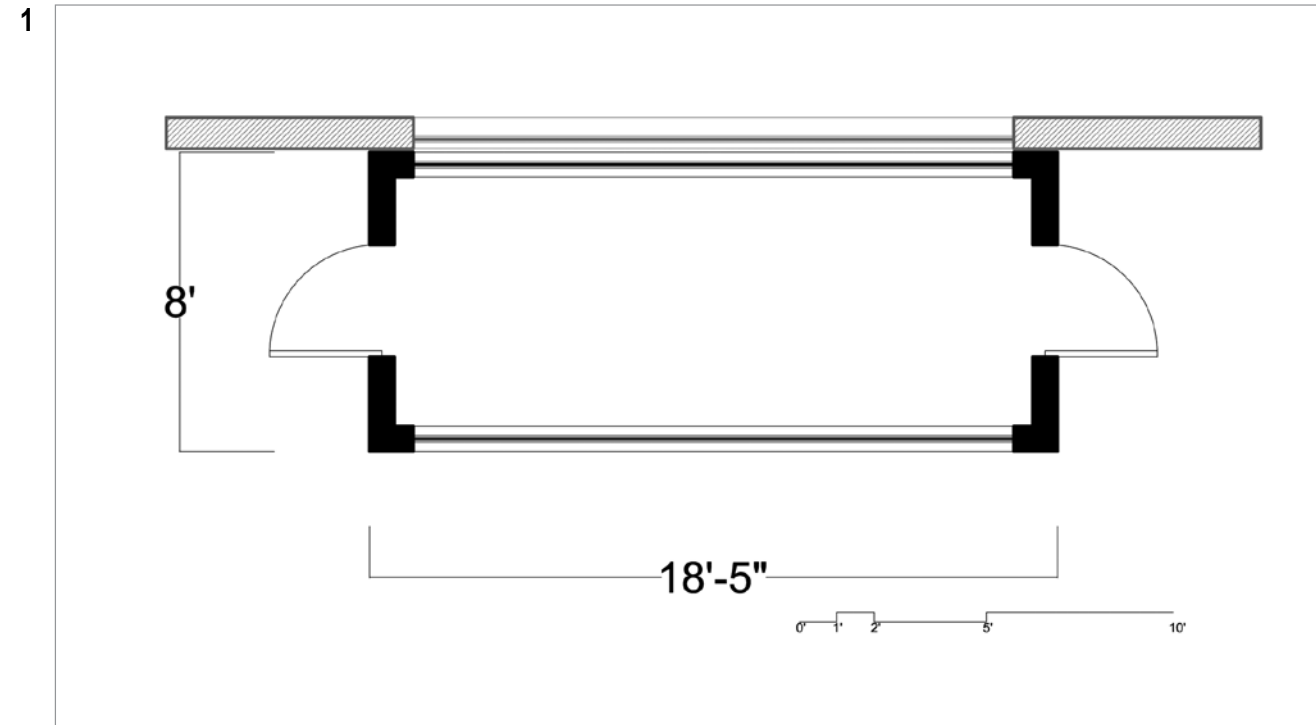
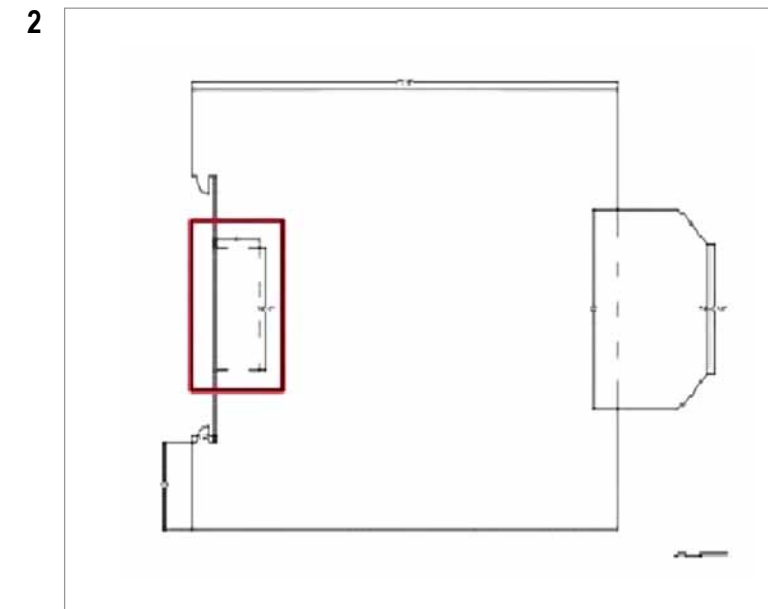
1,2. Design and location of a new addition for a cry room. The modular or prefabricated room could easily be broken down if necessary.

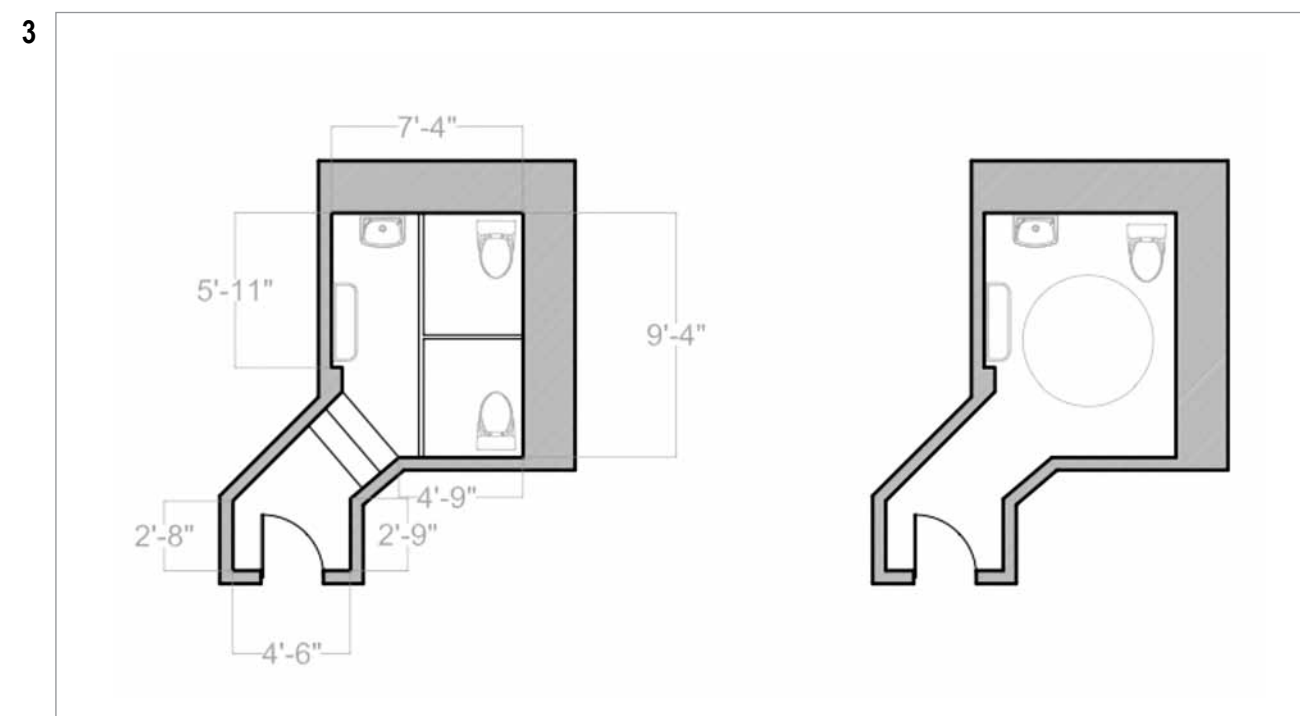
3. Existing and revised ADA-compliant bathroom design.

Once demolished, the bathroom will be an empty space. The floor will be raised to create a flat entry into the room. All plumbing and systems can be located beneath this platform. The room itself will be a single stall with the toilet installed at the southwest corner of the room, grab-rails at the south and west walls. The sink will be installed along the north wall in order not to block the entry or impede the necessary area around the toilet (60 x 59"). All changes must abide by State of Rhode Island and Providence Plantations Rehabilitation Code for existing buildings and structures – Chapter 10 Accessibility – and the Town of Warren Department of Building and Zoning. Accessibility must meet the 2010 ADA Standards for Accessible Design.
