A Return to Manning the Post: the Adaptive Reuse of Publically Owned Fire Control Stations from the Second World War

A Return to Manning the Post

The Adaptive Reuse of Publically Owned Fire Control Stations from the Second World War

May 2012

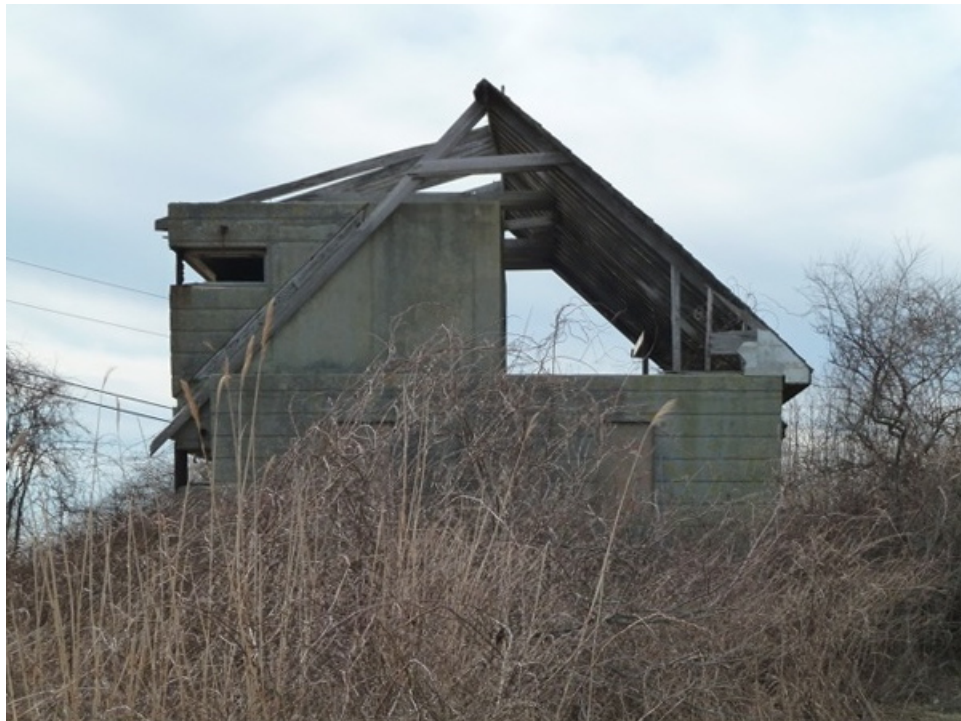
[Fig. 6] East elevation of Station 1-B, looking west. Note remains of the original wooden wall at the northeast corner.

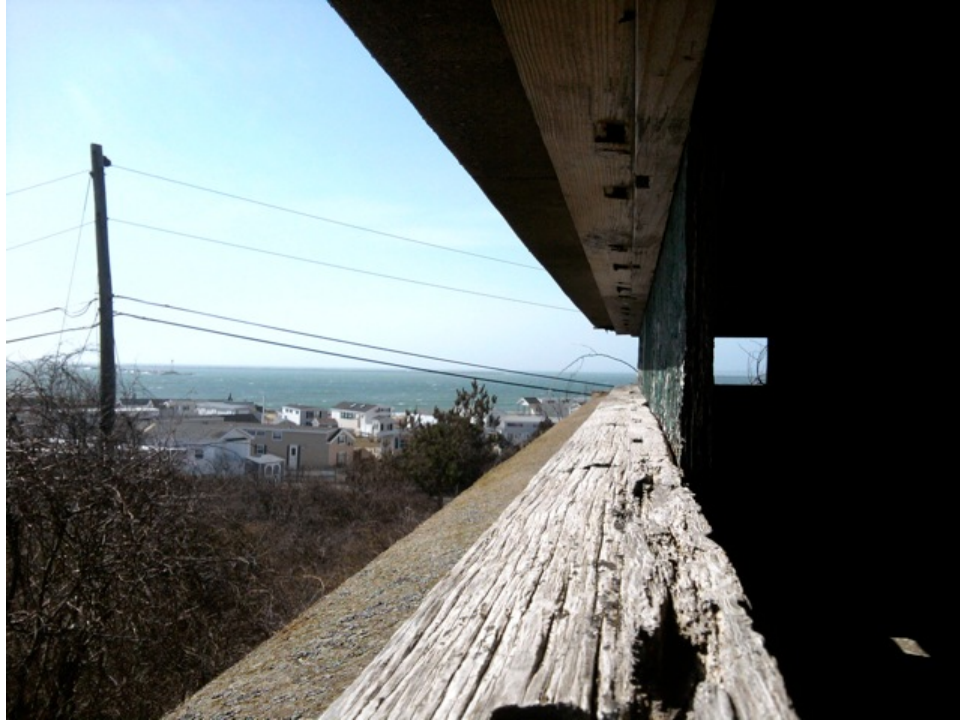
Like the first floor, window frames were present and in fair condition; however no trace of attached window sash remained [Appendix 6.1.1.1 - Fig. 21].

[Fig. 21] Detail of ribbon window frames in Room 2-1. Marks on the upper frame were for the hinges of each awning window.

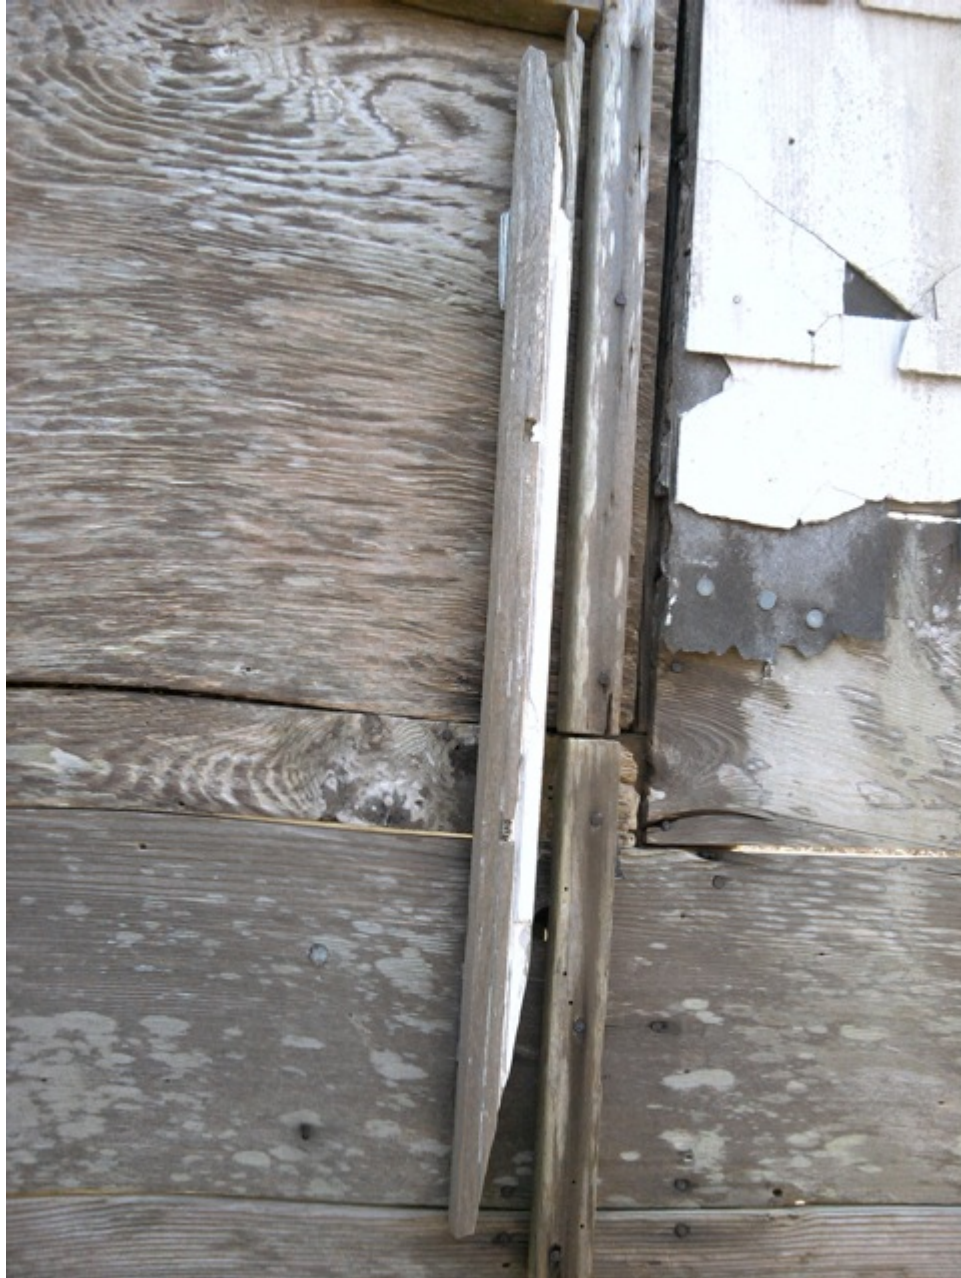
The top rail of an awning window possibly from the station was screwed to hold a piece of plywood to cover the window opening's exterior [Appendix 6.1.1.1 - Figs. 22, 23].

[Fig. 22] View of ribbon window sash remnant on the north elevation, looking south. The remnant is painted white and reused for bracing plywood covering the stair hall window opening.

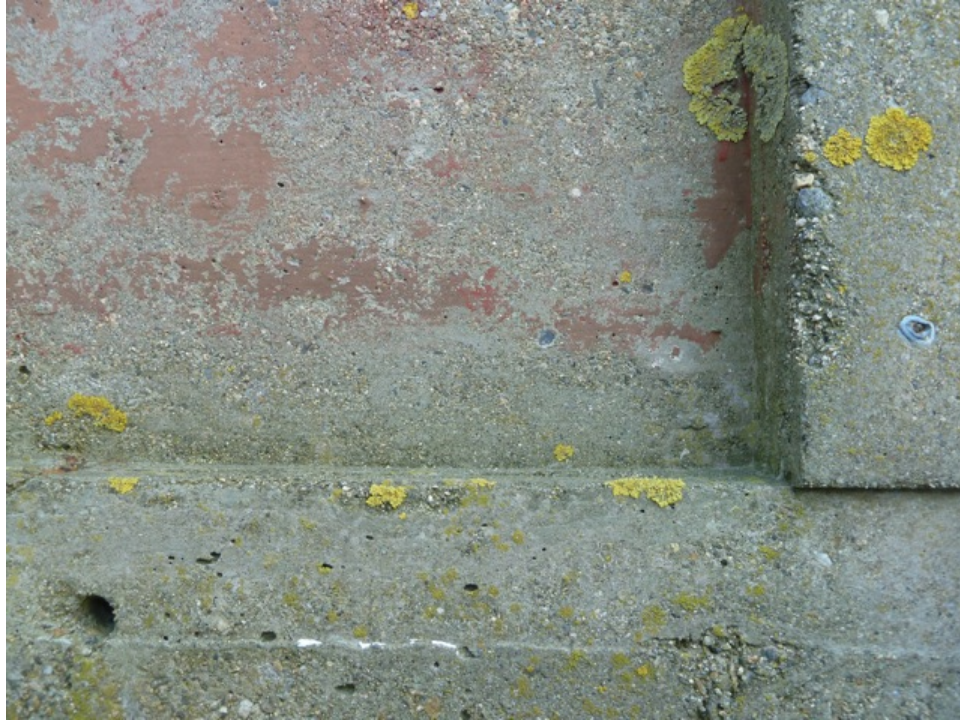
Any remaining finishes were sparse, but did exist. The two blind windows on the north elevation retained their reddish-brown paint color and wooden lintels. Areas of concrete around the blind windows still contained traces of white paint [Appendix 6.1.1.1 - Fig. 24]. The reused top rail of the awning window on the north elevation was also covered in what appeared to be a coat of whitewash.

[Fig. 24] Detail of blind window on the north elevation. Note the plastic screw anchor for a wooden jamb, reddish-brown paint in blind window, and trace of white paint on the concrete area formed to mimic simple drop wooden board.

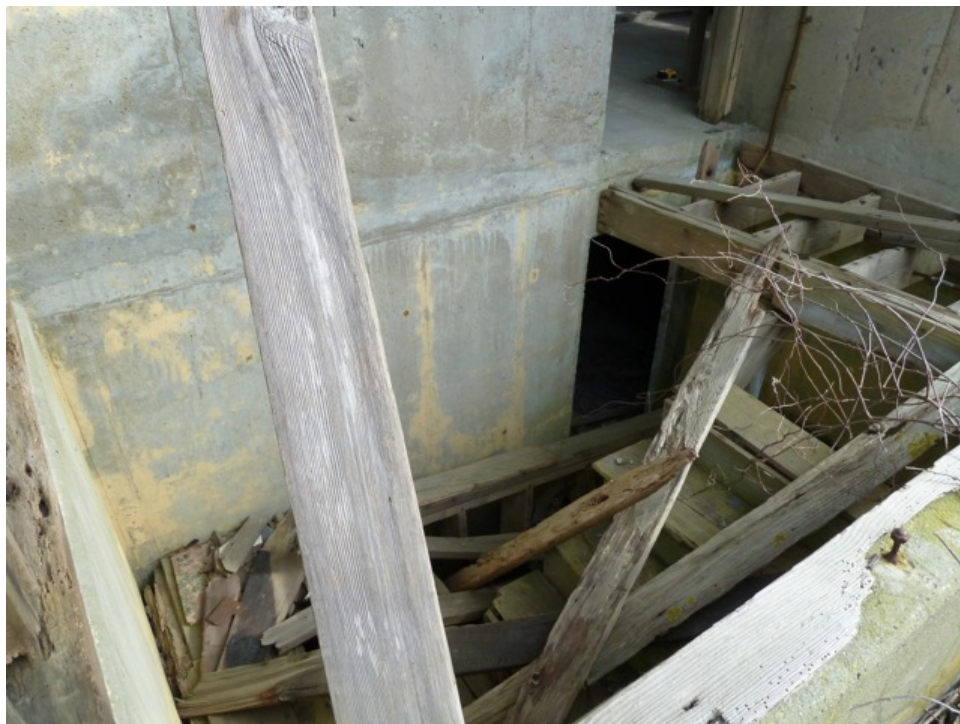
[Fig. 25] Detail of stair hall, looking southeast. Note the original paint treatment on the basement level exposed to the elements.

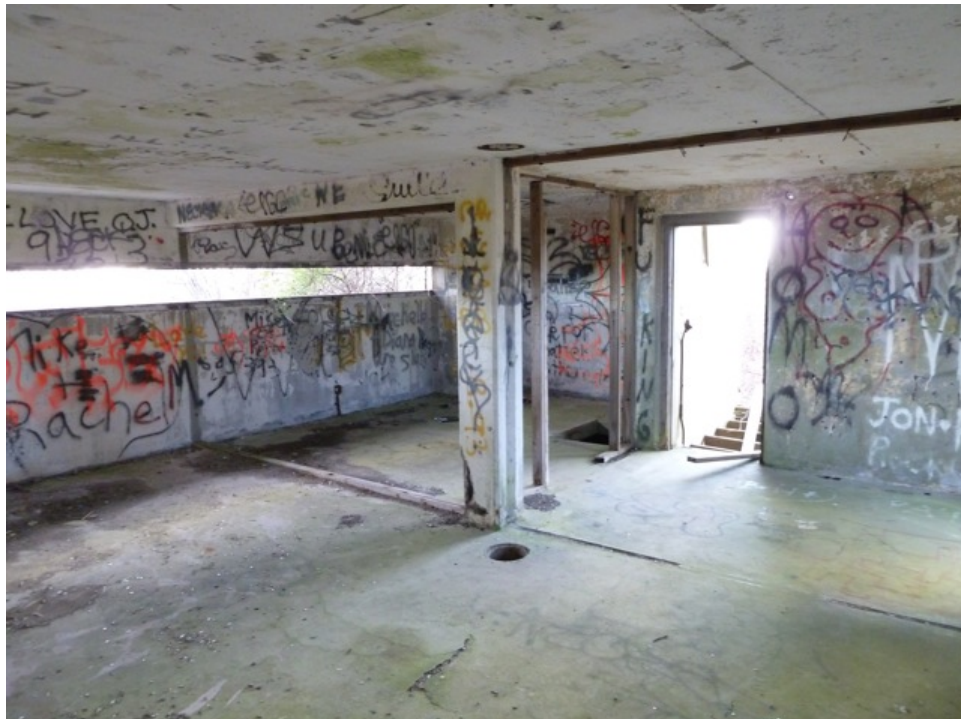
[Fig. 10] View of Room 1-1, looking southwest. Note the hole for a stove ductwork and original paint treatment under graffiti.

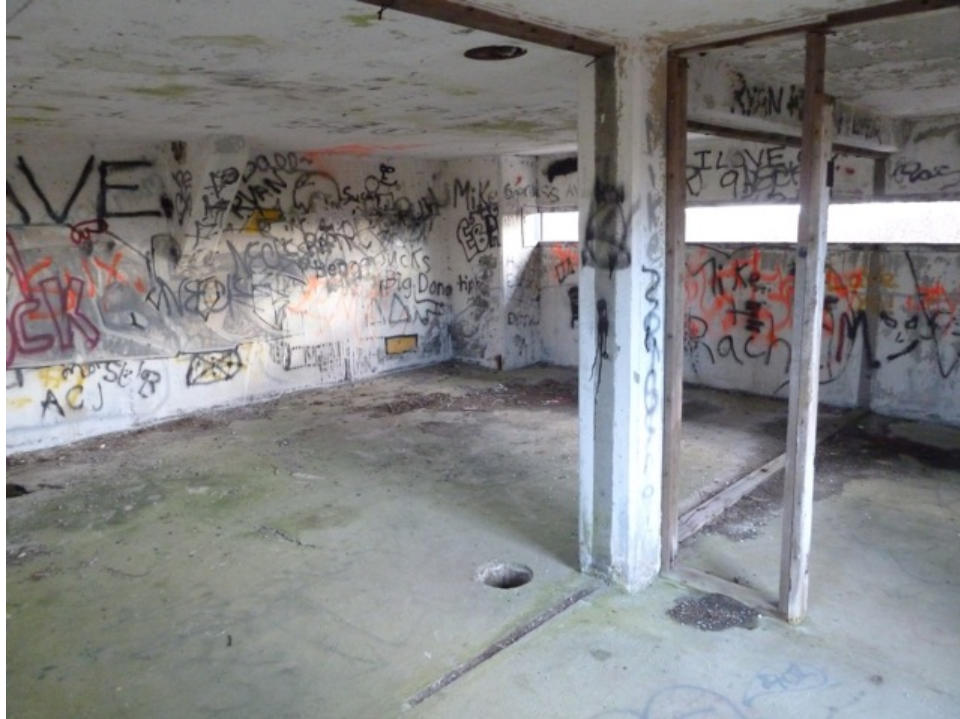
[Fig. 11] View of Room 1-1, looking southeast. Note the hole for a stove ductwork and original paint treatment under graffiti.

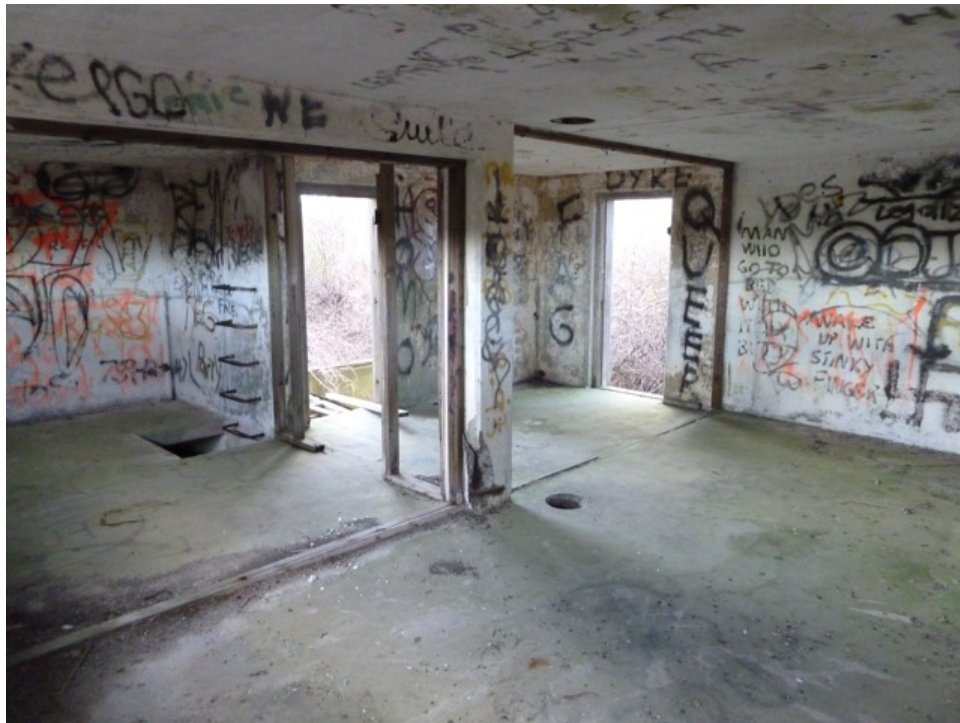
[Fig. 13] View of Room 1-1, looking northwest. Note the wooden framework for partition walls, ladder rungs, and original paint treatment under graffiti.

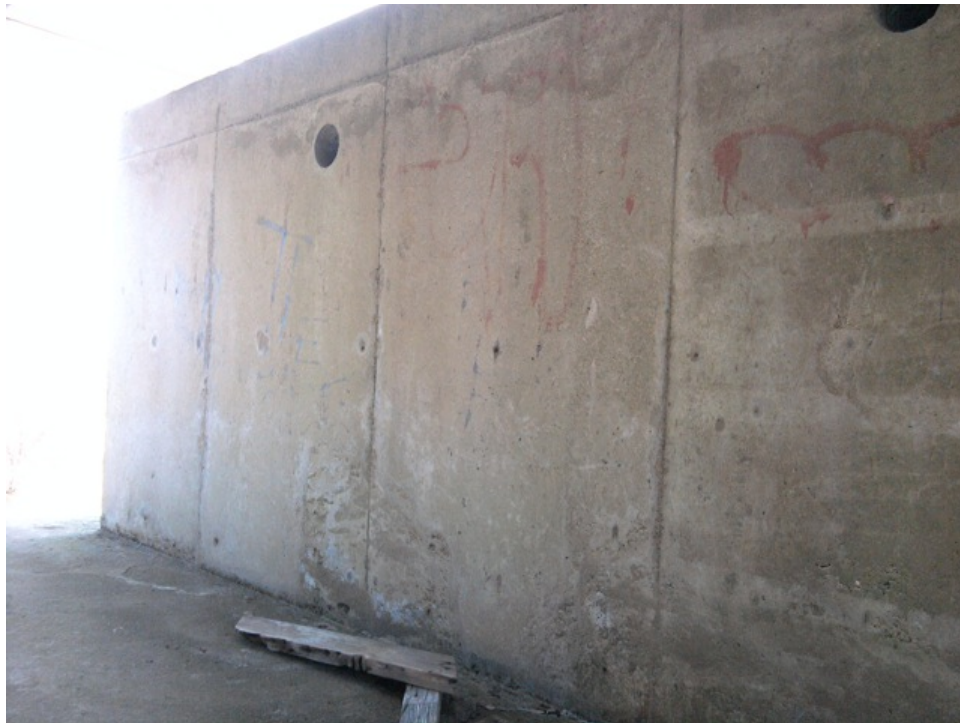
[Fig. 25] The south wall of Room 2-2, looking southeast. Note the false chimney remnant at the base of the wall.

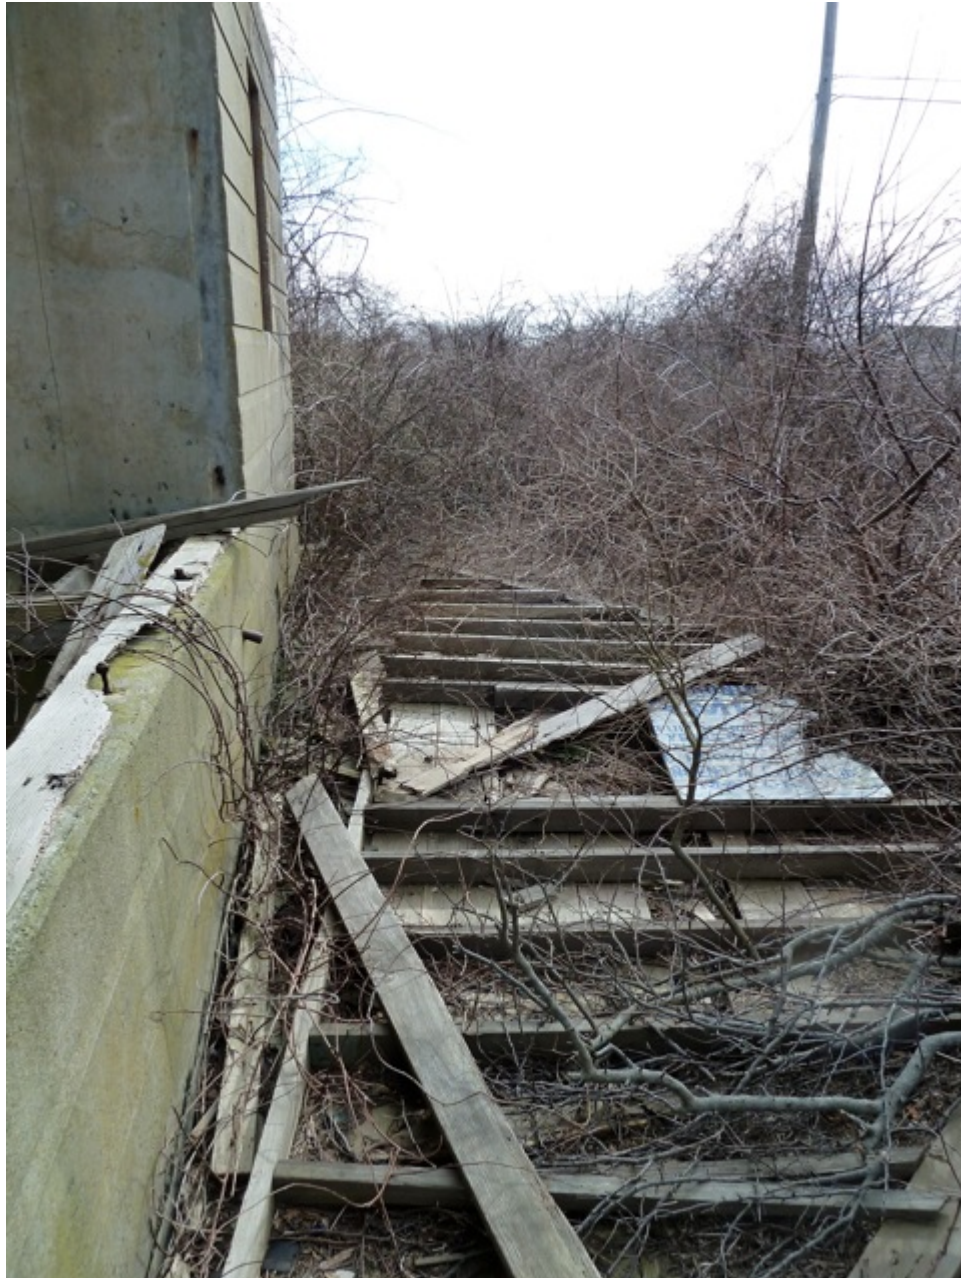
[Fig. 28] Fallen wooden wall for west elevation, looking south.

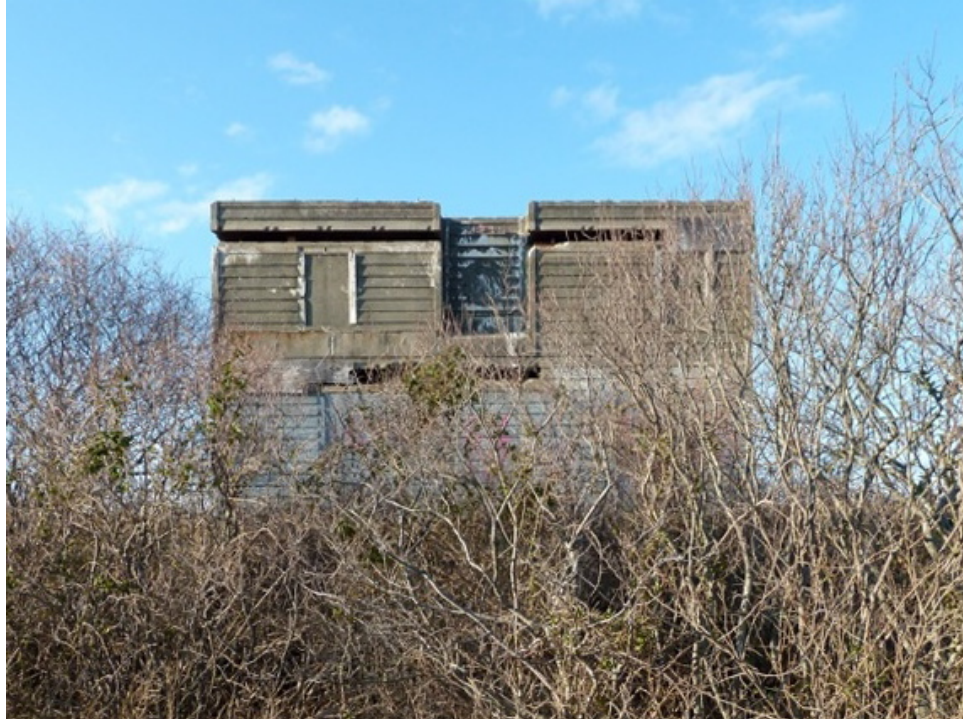
[Fig. 3] South elevation, looking north.

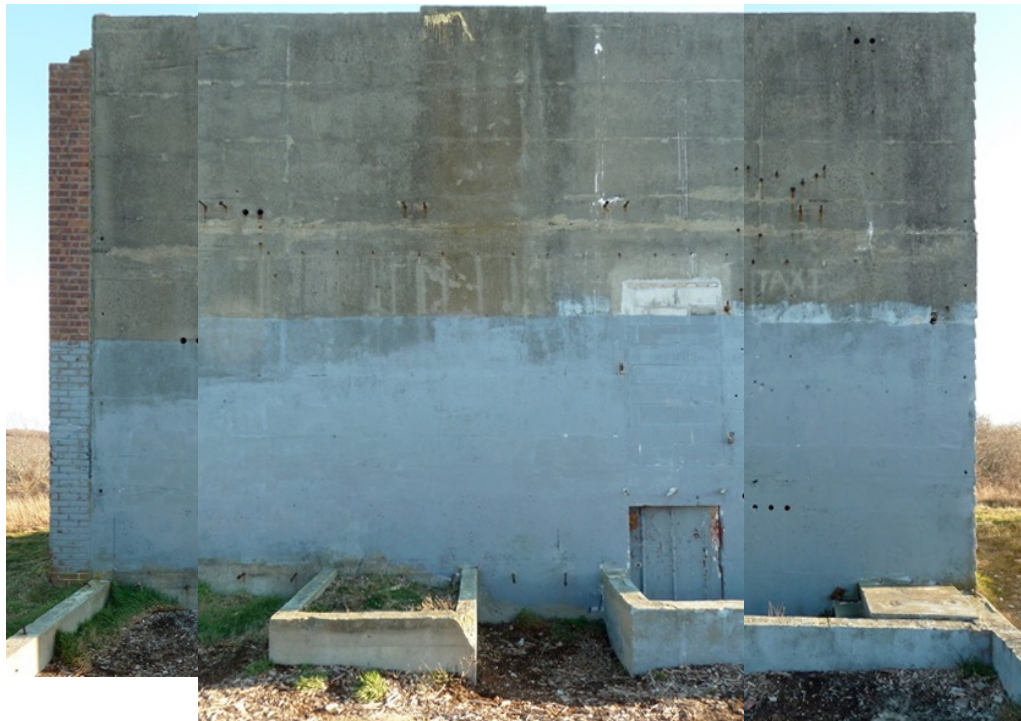
[Fig. 4] Collage of north elevation, looking south. Note the split-level transition between the concrete and foundation levels.

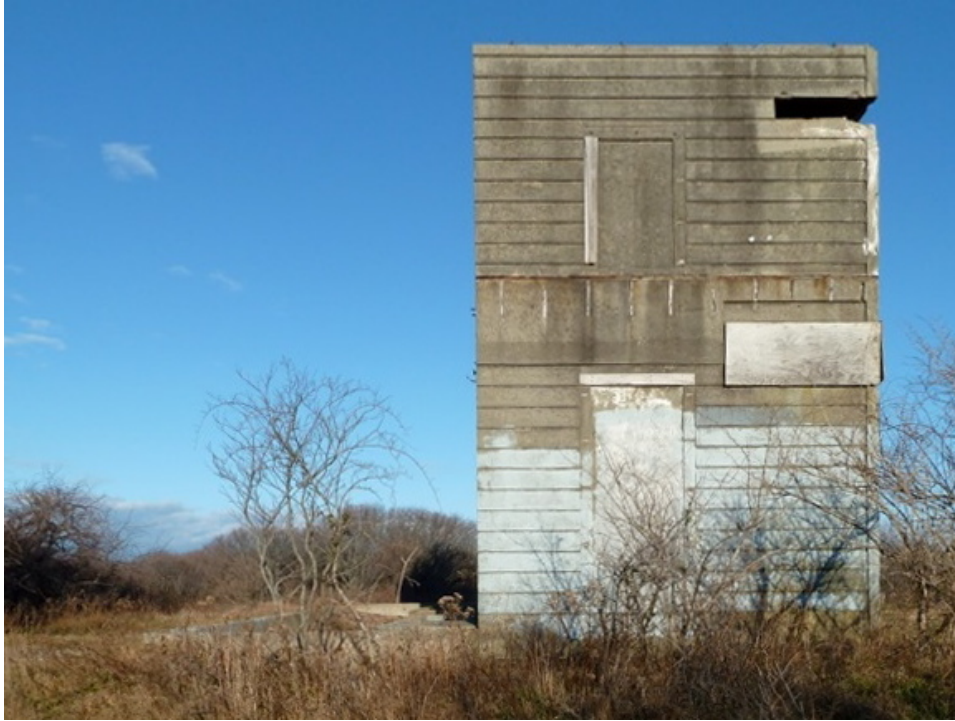
A false lintel had remained in place on top of the blind door, and a false window jamb remained on the northern side of the blind window [Appendix 6.1.2, Figs. 10, 11]

[Fig. 5] West elevation, looking east. Note the remaining door lintel and window jamb.

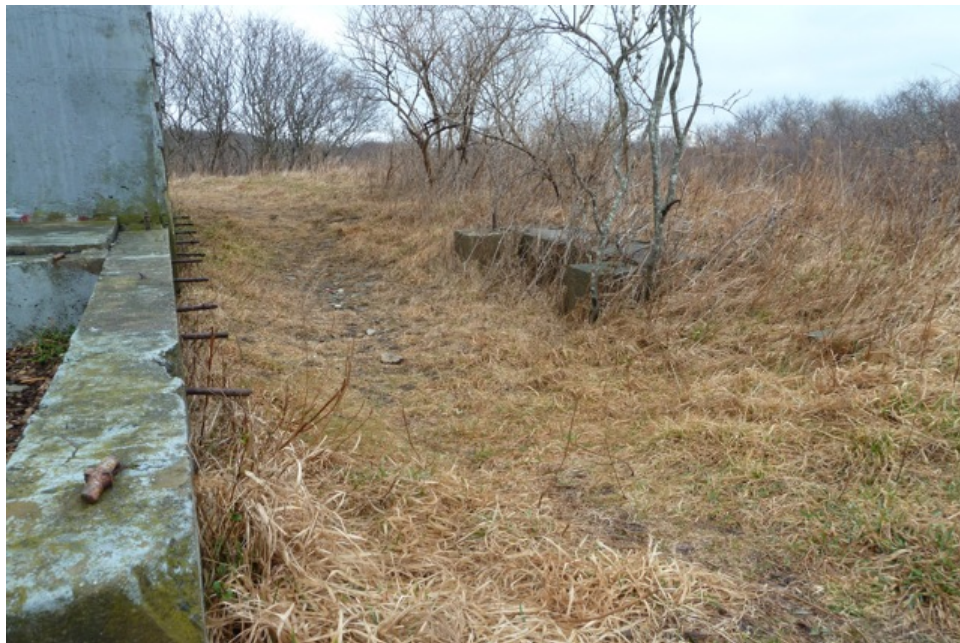
[Fig. 8] Detail of attached porch location, looking south. Note the numerous steel ties and concrete pylons west of the main structure.

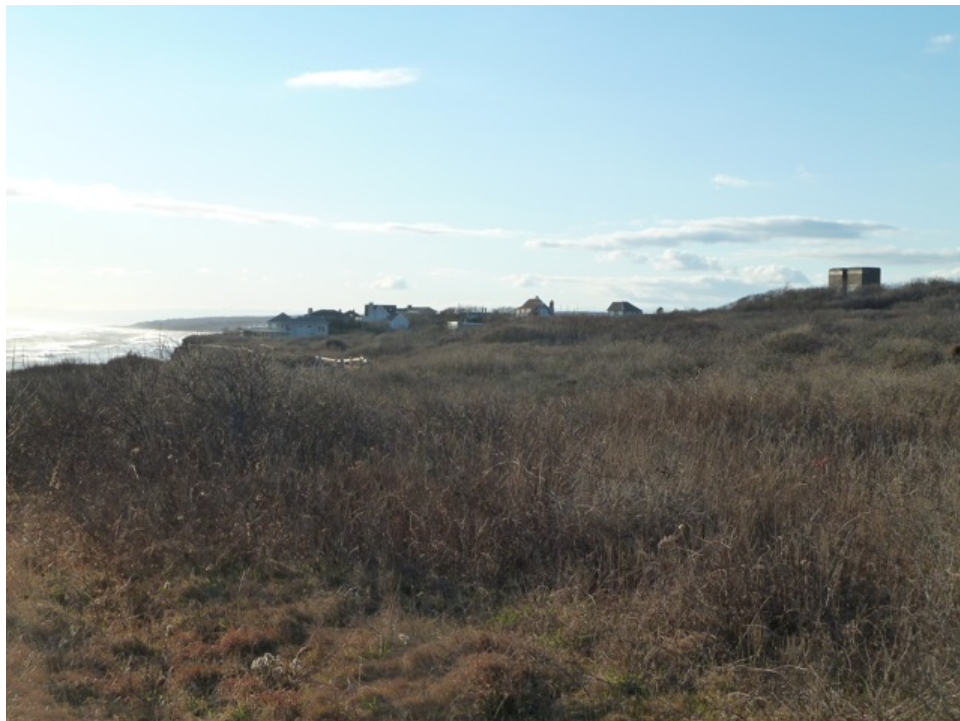
[Fig. 2] View of Station 3-A from afar, looking west. Note the station's proximity to nearby development and the coastline.

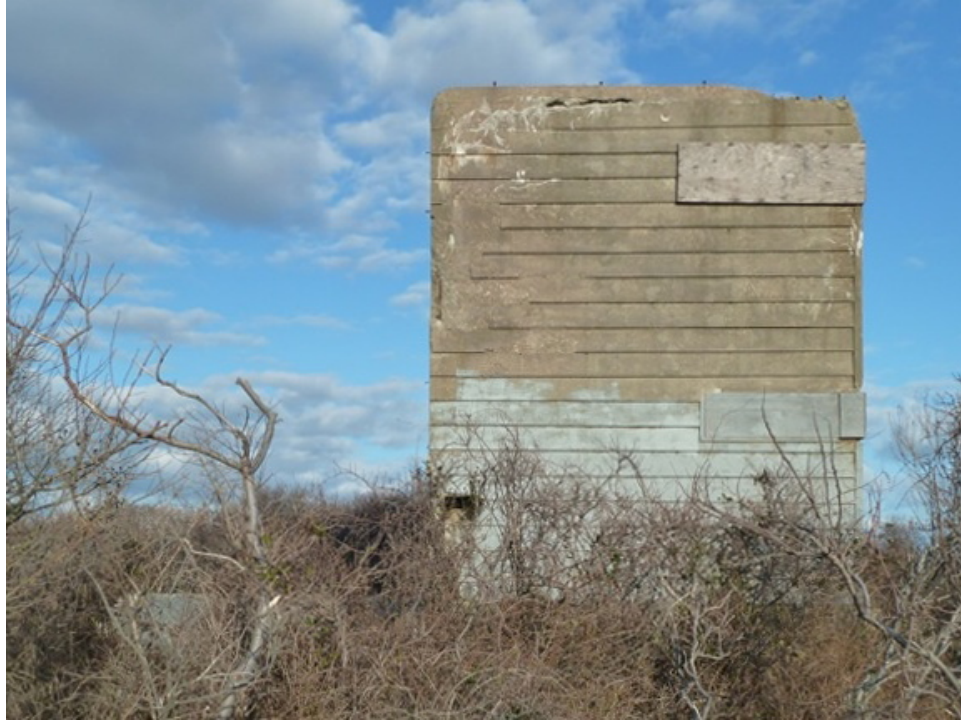
[Fig. 5] View of the southwest elevation, looking southeast. Note the excessive erosion and efflorescence.
