Cultural Resource Survey of College Heights in Fredericksburg, Virginia

Master of Science

Historic Preservation

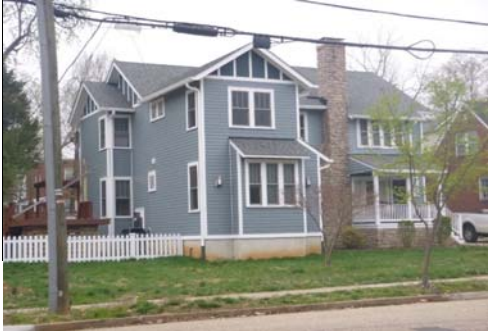
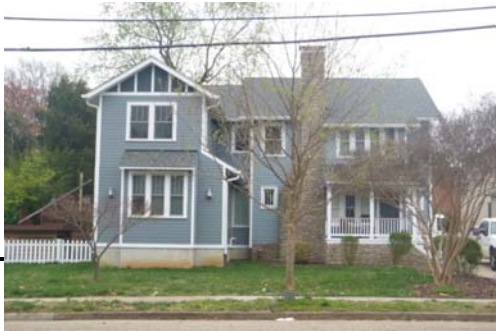
Name of Surveyors	Kimberly Packett		Survey Date	3/26/2016
ADDRESS	Street		Number	
	Brent	Street	1216	
TYPE & NUMBER OF BLGS & STRUCTURES	Type		Number	
	Single Family House		1	
Current Use of Primary Building	Single Family	Historic Use of Primary Building	Single Family	
Style of Primary Bldg	Craftsman			
Number of Stories	2 1/2	Width (bays)	3	
Foundation Material	Cinderblock	Depth (rooms)	3	
Year Built	1913	Wall Cladding Material	Hardboard Siding	
Roof Shape	Side Gable	Roof Material	Composition Shingle	
Decorative Details/Unique Features	White surround around doors and windows. Front gable on left side of house. Gable ends have decorative dark blue and white siding.			
Evidence of Integrity Location/Materials	None.			
Additions/Alterations to Primary Building	New windows, siding, and roof.			
Condition of Primary Building	Excellent		code	E
Observable Threats	None			
Compatibility with Adjacent Land Uses	Fair, style doesn't fit with surrounding houses

Potential NR Eligibility	Non-Contributing		code	N
Other Comments / Salient Details	Driveway on right side of the house. White picket fence around backyard. Brick front porch with white railings and a shed roof. Chimney on front of the house.			
Photo Views				
1 3/4 View	2 Front View	3	4

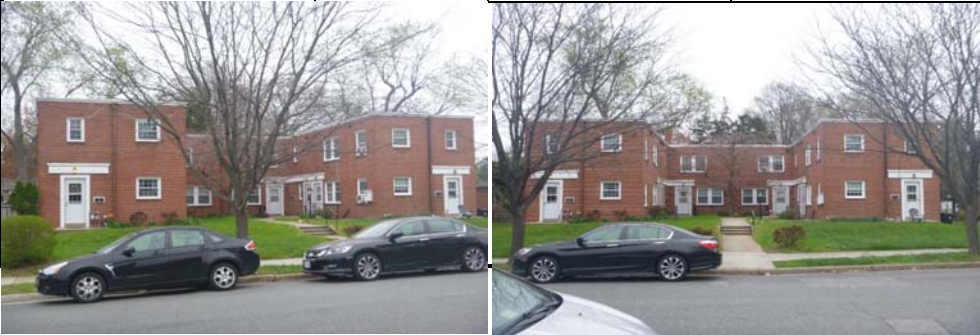
Name of Surveyors	Kimberly Packett		Survey Date	3/26/2016
ADDRESS	Street		Number	
	Colony	Street	1209-1219	
TYPE & NUMBER OF BLGS & STRUCTURES	Type		Number	
	Apartment Complex		1	
Current Use of Primary Building	Multi-Family	Historic Use of Primary Building	Multi-Family	
Style of Primary Bldg	Apartment Complex			
Number of Stories	2	Width (bays)	8	
Foundation Material	Concrete	Depth (rooms)	4	
Year Built	1959	Wall Cladding Material	Brick	
Roof Shape	Flat	Roof Material	Asphalt	
Decorative Details/Unique Features	White pediment above doors. Brick lintel above windows.			
Evidence of Integrity Location/Materials	Original brick siding and windows.			
Additions/Alterations to Primary Building	None visible.			
Condition of Primary Building	Fair		code	F
Observable Threats	None			
Compatibility with Adjacent Land Uses	Poor, surrounded by single family homes			
Potential NR Eligibility	Non-Contributing		code	N
Other Comments / Salient Details	Cement path and stairs leading to all doors. Bushes and flowers along base of building. Interior chimney in back left side of the apartment complex.

Photo Views				
1 3/4 View	2 Front View	3	4

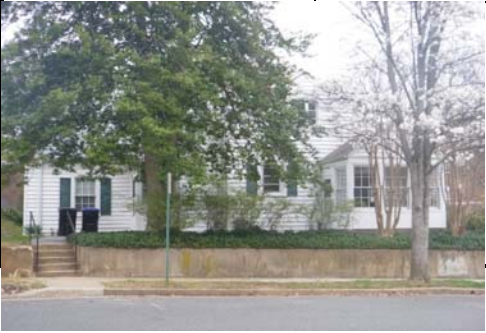
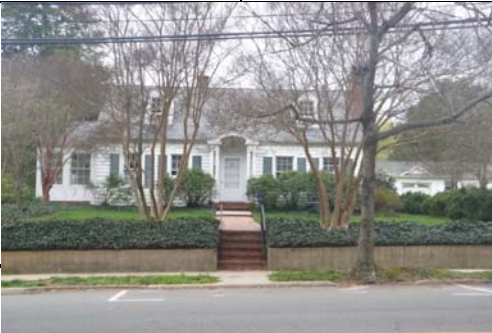
Name of Surveyors	Kimberly Packett		Survey Date	3/26/2016
ADDRESS	Street		Number	
	College	Avenue	1104	
TYPE & NUMBER OF BLGS & STRUCTURES	Type		Number	
	Single Family House		1	
Current Use of Primary Building	Single Family	Historic Use of Primary Building	Single Family	
Style of Primary Bldg	Cape cod			
Number of Stories	1 1/2	Width (bays)	5	
Foundation Material	Brick	Depth (rooms)	3	
Year Built	1935	Wall Cladding Material	Vinyl siding	
Roof Shape	Side gable	Roof Material	Slate	
Decorative Details/Unique Features	Green shutter on bottom windows. White front gable portico above front door. Two front gable dormers on front of roof. Central chimney and chimney on right end of the house. White surround around front windows.			
Evidence of Integrity Location/Materials	Front windows may be original.			
Additions/Alterations to Primary Building	Addition on rear of the house. New siding and roof.			
Condition of Primary Building	Good	code

G		
Observable Threats	Growth of UMW			
Compatibility with Adjacent Land Uses	Good			
Potential NR Eligibility	Non-Contributing	code		
		N		
Other Comments / Salient Details	Cement retaining wall along front and side of house. Ivy along retaining wall. Brick path and stairs with an iron railing leading to front door. Bushes along front of house. Cement stairs with iron railing and path leading to side door.			
Photo Views				
1 Side View	2 Front View	3	4

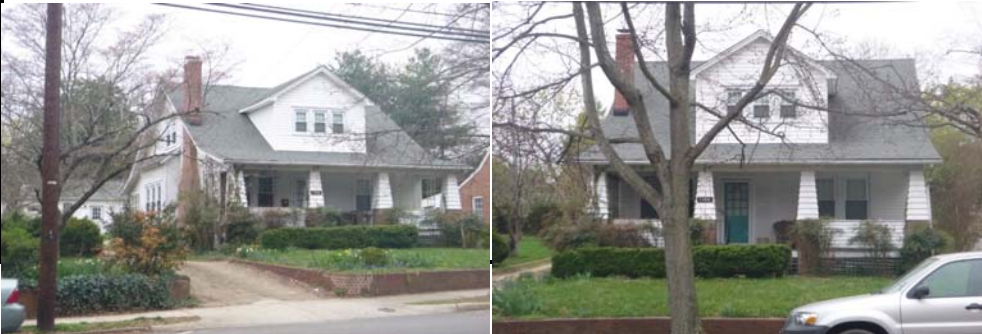
Name of Surveyors	Kimberly Packett		Survey Date	3/26/2016
ADDRESS	Street		Number	
	College	Avenue	1108	
TYPE & NUMBER OF BLGS & STRUCTURES	Type		Number	
	Single Family House		1	
	Shed		1	
Current Use of Primary Building	Single Family	Historic Use of Primary Building	Single Family	
Style of Primary Bldg	Bungalow			
Number of Stories	1 1/2	Width (bays)	3	
Foundation Material	Brick	Depth (rooms)	4	
Year Built	1925	Wall Cladding Material	Hardboard siding	
Roof Shape	Side Gable	Roof Material	Composition shingle	
Decorative Details/Unique Features	Front gable with three windows on front of house. White surround around front door. Roof extends and hangs over front porch with brick bottomed/siding on top pillars.			
Evidence of Integrity Location/Materials	None			
Additions/Alterations to Primary Building	New siding, roof, and windows.			
Condition of Primary Building	Good		code	G
Observable Threats	Growth of UMW

Compatibility with Adjacent Land Uses	Good			
Potential NR Eligibility	Non-Contributing		code	N
Other Comments / Salient Details	Brick retaining wall along front of property and sides of driveway. Dirt and gravel driveway on left side of the house. Cement path leading from driveway to front porch. Chimney on left end of the house. Shed in backyard. Bushes and flowers along driveway and house.			
Photo Views				
1 3/4 View	2 Front View	3	4

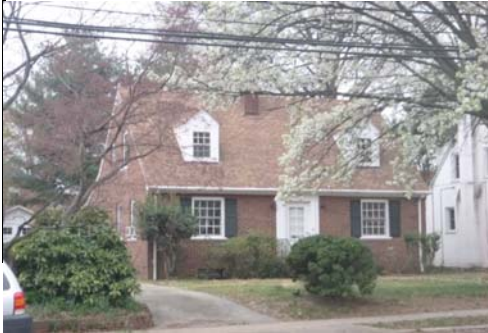
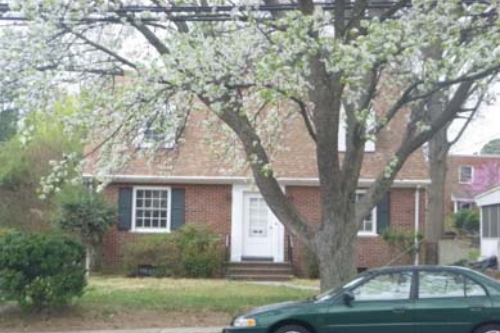
Name of Surveyors	Kimberly Packett		Survey Date	3/26/2016
ADDRESS	Street		Number	
	College	Avenue	1110	
TYPE & NUMBER OF BLGS & STRUCTURES	Type		Number	
	Single Family House		1	
	Shed		1	
Current Use of Primary Building	Single Family	Historic Use of Primary Building	Single Family	
Style of Primary Bldg	Cape Cod			
Number of Stories	1 1/2	Width (bays)	3	
Foundation Material	Concrete	Depth (rooms)	3	
Year Built	1939	Wall Cladding Material	Brick	
Roof Shape	Side Gable	Roof Material	Composition shingle	
Decorative Details/Unique Features	Black shutters on front first story windows. White pilasters and entablature around front door. Two front gable dormers with windows on front of roof.			
Evidence of Integrity Location/Materials	Original brick siding.			
Additions/Alterations to Primary Building	New roof and windows.			
Condition of Primary Building	Good			code G
Observable Threats	Growth of UMW			
Compatibility with Adjacent Land Uses	Good

Potential NR Eligibility	Non-Contributing			code N
Other Comments / Salient Details	Central chimney. Cement driveway on left side of the house. Cement path leading from sidewalk to brick stairs with iron railings leading to front door. Shed in the backyard.			
Photo Views				
1 3/4 View	2 Front View	3	4

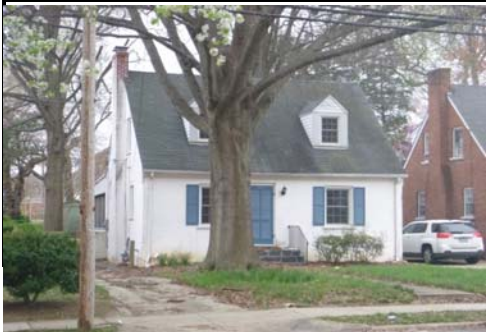
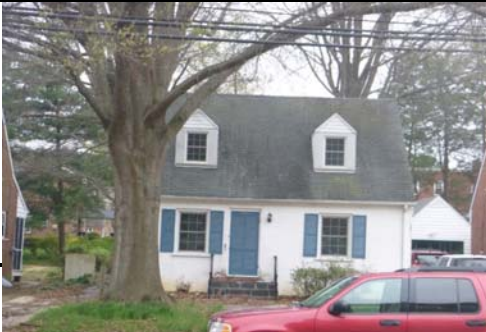
Name of Surveyors	Kimberly Packett		Survey Date	3/26/2016
ADDRESS	Street		Number	
	College	Avenue	1202	
TYPE & NUMBER OF BLGS & STRUCTURES	Type		Number	
	Single Family House		1	
Current Use of Primary Building	Single Family	Historic Use of Primary Building	Single Family	
Style of Primary Bldg	Cape Cod			
Number of Stories	1 1/2	Width (bays)	3	
Foundation Material	Concrete	Depth (rooms)	3	
Year Built	1939	Wall Cladding Material	Brick	
Roof Shape	Side Gable	Roof Material	Composition Shingle	
Decorative Details/Unique Features	Light blue front door and shutters on first story windows on front of house. Brick siding has been painted white. Two front gable dormers on front of roof with vinyl siding.			
Evidence of Integrity Location/Materials	Original brick siding and possibly original windows.			
Additions/Alterations to Primary Building	Addition on the rear of the house. New roof.			
Condition of Primary Building	Poor		code	P

Observable Threats	Growth of UMW			
Compatibility with Adjacent Land Uses	Good			
Potential NR Eligibility	Non-Contributing		code	N
Other Comments / Salient Details	Chimney on left end of house. Cement driveway on left side of house. Cement path leading from sidewalk to stone steps with black iron railing leading to front door.			
Photo Views				
1 3/4 View	2 Front View	3	4

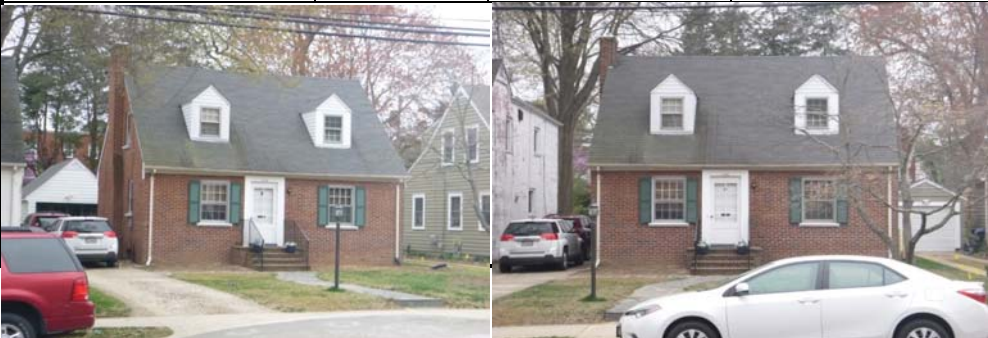
Name of Surveyors	Kimberly Packett		Survey Date	3/26/2016
ADDRESS	Street		Number	
	College	Avenue	1206	
TYPE & NUMBER OF BLGS & STRUCTURES	Type		Number	
	Single Family House		1	
	Detatched Garage		1	
Current Use of Primary Building	Single Family	Historic Use of Primary Building	Single Family	
Style of Primary Blg	Cape Cod			
Number of Stories	1 1/2	Width (bays)	3	
Foundation Material	Cinderblock	Depth (rooms)	2	
Year Built	1949	Wall Cladding Material	Brick	
Roof Shape	Side Gable	Roof Material	Composition shingle	
Decorative Details/Unique Features	Green shutters on front first story windows. White surround around front door. Two front gable dormers with vinyl siding on front of roof.			
Evidence of Integrity Location/Materials	Original brick siding and possibly original windows.			
Additions/Alterations to Primary Building	New roof.			
Condition of Primary Building	Fair			code F
Observable Threats	Growth of UMW

Compatibility with Adjacent Land Uses	Good			
Potential NR Eligibility	Contributing			code C
Other Comments / Salient Details	Dirt and gravel driveway on left side of the house leading to detached garage in backyard. Cement path leading from sidewalk to brick stairs with iron railing leading to front door. Chimney on left end of the house. Lamp post in front lawn.			
Photo Views				
1 3/4 View	2 Front View	3	4

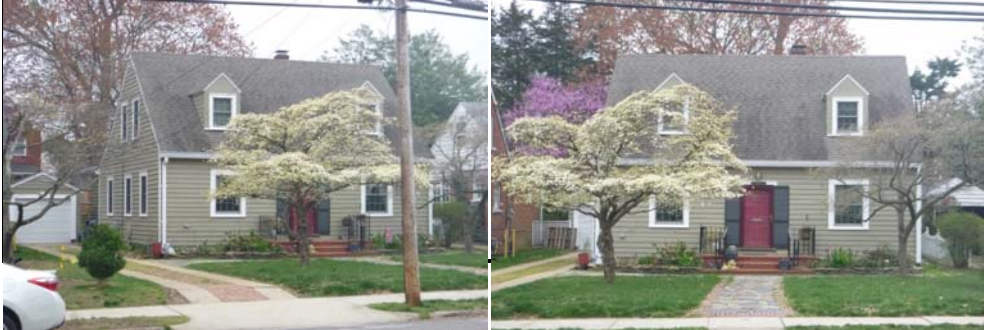
Name of Surveyors	Kimberly Packett		Survey Date	3/26/2016
ADDRESS	Street		Number	
	College	Avenue	1210	
TYPE & NUMBER OF BLGS & STRUCTURES	Type		Number	
	Single Family House		1	
	Detatched Garage		1	
Current Use of Primary Building	Single Family	Historic Use of Primary Building	Single Family	
Style of Primary Blg	Cape Cod			
Number of Stories	1 1/2	Width (bays)	3	
Foundation Material	Concrete	Depth (rooms)	3	
Year Built	1943	Wall Cladding Material	Hardboard siding	
Roof Shape	Side Gable	Roof Material	Composition shingle	
Decorative Details/Unique Features	White surround around windows. White crown above red front door with green shutters. Two front gable dormers on front of roof.			
Evidence of Integrity Location/Materials	None			
Additions/Alterations to Primary Building	New roof, siding, and windows.			
Condition of Primary Building	Good	code		
		G		
Observable Threats	Growth of UMW			
Compatibility with Adjacent Land Uses	Good

Potential NR Eligibility	Contributing	code		
		C		
Other Comments / Salient Details	Cement and brick driveway on left side of the house leading to detached garage in backyard. Brick and stone path leading from sidewalk to brick stairs with iron railing leading to front door. Central chimney.			
Photo Views				
1 3/4 View	2 Front View	3	4

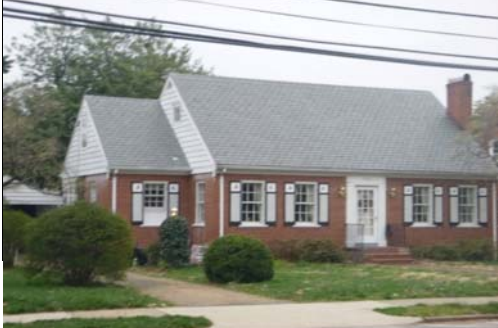
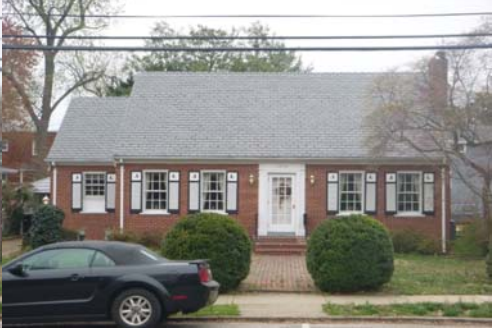
Name of Surveyors	Kimberly Packett		Survey Date	3/26/2016
ADDRESS	Street		Number	
	College	Avenue	1214	
TYPE & NUMBER OF BLGS & STRUCTURES	Type		Number	
	Single Family House		1	
Current Use of Primary Building	Single Family	Historic Use of Primary Building	Single Family	
Style of Primary Bldg	Cape Cod			
Number of Stories	1 1/2	Width (bays)	6	
Foundation Material	Cinderblock	Depth (rooms)	3	
Year Built	1941	Wall Cladding Material	Brick	
Roof Shape	Side Gable	Roof Material	Slate	
Decorative Details/Unique Features	White and black decorative shutters on front windows. White crown and pilasters around front door. White shingle siding on gable ends.			
Evidence of Integrity Location/Materials	Original brick siding.			
Additions/Alterations to Primary Building	New windows and roof.			
Condition of Primary Building	Good			code G
Observable Threats	Growth of UMW			
Compatibility with Adjacent Land Uses	Good			
Potential NR Eligibility	Contributing			code C

Other Comments / Salient Details	Brick driveway on left side of the house leading to carport in backyard. Brick path leading from sidewalk to brick stairs with iron railing leading to front door. Bushes along front of the house. Chimney on right end of the house.			
Photo Views				
1 3/4 View	2 Front View	3	4

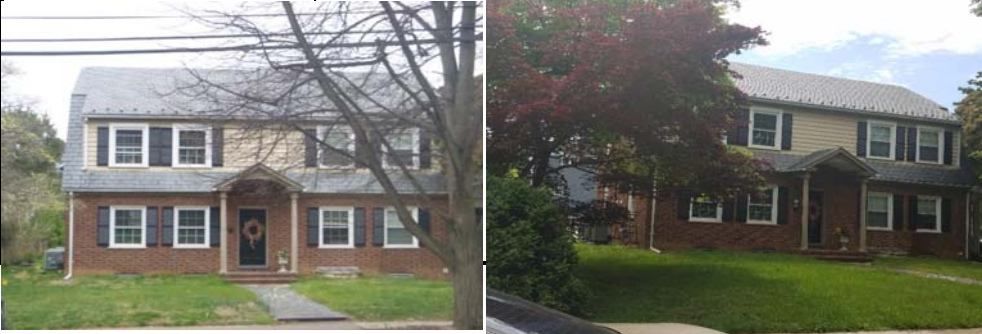
Name of Surveyors	Kimberly Packett		Survey Date	3/26/2016
ADDRESS	Street		Number	
	College	Avenue	1216	
TYPE & NUMBER OF BLGS & STRUCTURES	Type		Number	
	Single Family House		1	
Current Use of Primary Building	Single Family	Historic Use of Primary Building	Single Family	
Style of Primary Bldg	Dutch Colonial			
Number of Stories	2	Width (bays)	5	
Foundation Material	Cinderblock	Depth (rooms)	2	
Year Built	1949	Wall Cladding Material	Brick	
Roof Shape	Gambrel	Roof Material	Slate	
Decorative Details/Unique Features	Brick siding on first story, vinyl siding on second story. White surround around front windows. Black shutters on front windows. Front gable tan portico with tan columns above front door landing. Extended shed dormer with four windows on front of house.			
Evidence of Integrity Location/Materials	Original brick siding. Possibly original slate roof.			
Additions/Alterations to Primary Building	New vinyl siding and windows.

Condition of Primary Building	Good			code G
Observable Threats	Growth of UMW			
Compatibility with Adjacent Land Uses	Good			
Potential NR Eligibility	Contributing			code C
Other Comments / Salient Details	Stone path leading from sidewalk to brick stairs and landing in front of front door. Wood privacy fence around backyard.			
Photo Views				
1 Front View	2 3/4 view	3	4

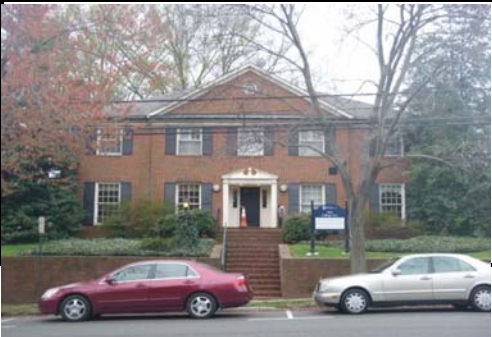
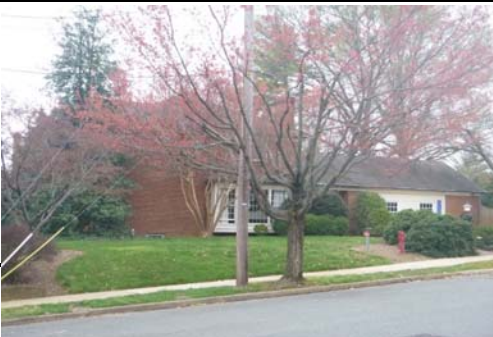
Name of Surveyors	Kimberly Packett		Survey Date	3/26/2016
ADDRESS	Street		Number	
	College	Avenue	1004	
TYPE & NUMBER OF BLGS & STRUCTURES	Type		Number	
	Academic Building		1	
Current Use of Primary Building	Academic	Historic Use of Primary Building	Single Family	
Style of Primary Bldg	Colonial Revival			
Number of Stories	2	Width (bays)	5	
Foundation Material	Cinderblock	Depth (rooms)	4	
Year Built	1975	Wall Cladding Material	Brick	
Roof Shape	Hip	Roof Material	Composition Shingle	
Decorative Details/Unique Features	Blue shutters on front windows. Front gable on front of house with decorative circular window. Vinyl siding on rear addition, with a gable roof, that was converted from a garage to a livable space. Tan broked pediment and pilasters around front door. Sidelights on either side of front door.			
Evidence of Integrity Location/Materials	Original brick siding and windows.			
Additions/Alterations to Primary Building	New roof, attached garage on rear of house was converted into a livable space.

Condition of Primary Building	Excellent			code E
Observable Threats	Growth of UMW			
Compatibility with Adjacent Land Uses	Poor, surrounded by residential buildings.			
Potential NR Eligibility	Contributing			code C
Other Comments / Salient Details	Brick retaining wall along front of property. Brick stairs and path with iron railing leading to front door. Brick path leading from sidewalk to side door. Lamp post on side of property. UMW sign in front yard.			
Photo Views				
1 Front View	2 Side View	3	4

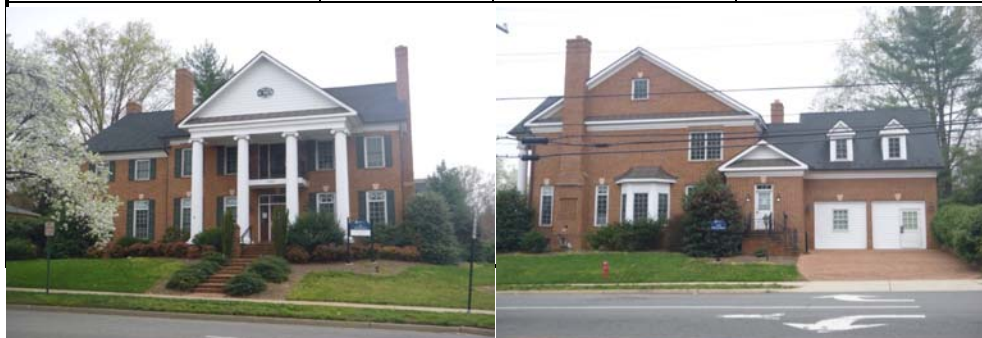
Name of Surveyors	Kimberly Packett		Survey Date	3/26/2016
ADDRESS	Street		Number	
	William Street		1201	
TYPE & NUMBER OF BLGS & STRUCTURES	Type		Number	
	Academic Building		1	
Current Use of Primary Building	Academic	Historic Use of Primary Building	Single Family	
Style of Primary Bldg	Neoclassical			
Number of Stories	2	Width (bays)	7	
Foundation Material	Concrete	Depth (rooms)	7	
Year Built	2003	Wall Cladding Material	Brick	
Roof Shape	Side Gable	Roof Material	Slate	
Decorative Details/Unique Features	Two front gable dormers on back right side of house. Front gable two story portico with columns above on front of house. Decorative circular window on front gable portico. Black shutters on front window. Decorative keystone above windows and doors. Transom and sidelights around front door, transom above side door. Small white balcony above front door with iron railing. Front gable has white vinyl siding. Decorative brick lintels above windows and doors.

Evidence of Integrity Location/Materials	Original brick siding, windows, and roof.			
Additions/Alterations to Primary Building	Attached garage on rear of house has been converted into a livable space. Previous garage door spaces have vinyl siding.			
Condition of Primary Building	Excellent		code	E
Observable Threats	None			
Compatibility with Adjacent Land Uses	Compatible with UMW across the street, not compatible to surround residential buildings.			
Potential NR Eligibility	Non-Contributing		code	N
Other Comments / Salient Details	Brick stairs and path with iron railing leading to brick front porch. Brick driveway on right side of house leading to attached garage that has been converted into a livable space. Brick stairs with iron railing leading to side door. Bushes along base of house and front pathway. Interior chimney on left side of house. End chimneys on right and left side of house.

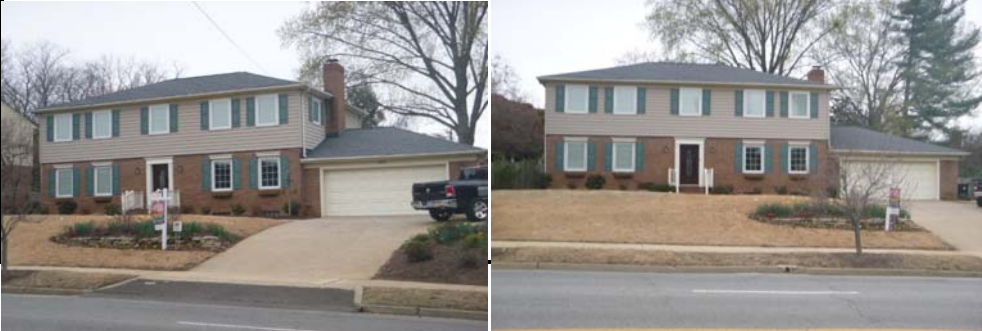
Name of Surveyors	Kimberly Packett		Survey Date	3/26/2016
ADDRESS	Street		Number	
	William Street		1203	
TYPE & NUMBER OF BLGS & STRUCTURES	Type		Number	
	Single Family House		1	
Current Use of Primary Building	Single Family	Historic Use of Primary Building	Single Family	
Style of Primary Bldg	Colonial Revival			
Number of Stories	2	Width (bays)	5	
Foundation Material	Cinderblock	Depth (rooms)	2	
Year Built	1969	Wall Cladding Material	Brick	
Roof Shape	Hip	Roof Material	Composition shingle	
Decorative Details/Unique Features	Tan crown and pilasters around front door. Green shutters on windows. Tan crown above first story windows. Tan surround around second floor windows. Brick window sills below first story front windows.			
Evidence of Integrity Location/Materials	Original brick siding and possibly original vinyl siding.			
Additions/Alterations to Primary Building	New windows and roof.			
Condition of Primary Building	Good			code

G
Observable Threats	None			
Compatibility with Adjacent Land Uses	Good			
Potential NR Eligibility	Non-Contributing			code
				N
Other Comments / Salient Details	Cement driveway on right side of house leading to attached garage. Cement path leading from driveway to brick stairs with white iron railing leading to front door. Small bushes along front of house. Chimney on right end of house. Wood privacy fence around backyard.			
Photo Views				
1 3/4 View	2 Front View	3	4

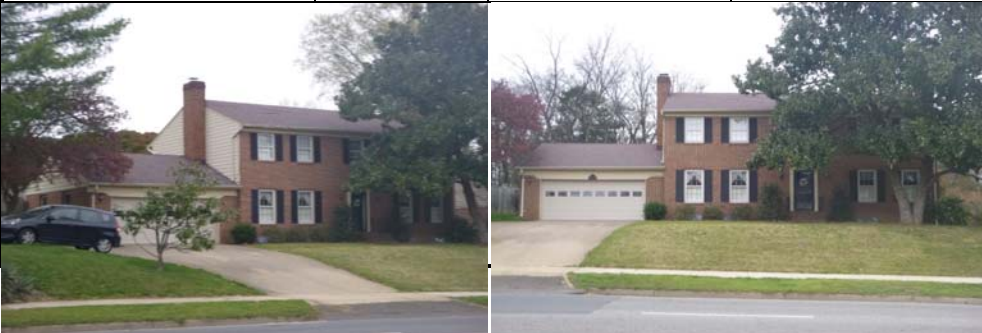
Name of Surveyors	Kimberly Packett		Survey Date	3/26/2016
ADDRESS	Street		Number	
	William Street		1205	
TYPE & NUMBER OF BLGS & STRUCTURES	Type		Number	
	Single Family House		1	
Current Use of Primary Building	Single Family	Historic Use of Primary Building	Single Family	
Style of Primary Bldg	Federal			
Number of Stories	2	Width (bays)	5	
Foundation Material	Cinderblock	Depth (rooms)	2	
Year Built	1975	Wall Cladding Material	Brick	
Roof Shape	Side Gable	Roof Material	Composition shingle	
Decorative Details/Unique Features	Black shutters on front windows. Tan vinyl siding on ends of house. Tan crown and pilasters around front door.			
Evidence of Integrity Location/Materials	Original brick siding, possibly original vinyl siding and windows.			
Additions/Alterations to Primary Building	New roof.			
Condition of Primary Building	Good			code G
Observable Threats	None			
Compatibility with Adjacent Land Uses	Good

Potential NR Eligibility	Non-Contributing			code N
Other Comments / Salient Details	Chimneys on either end of the house. Cement driveway leading to attached garage on left side of the house. Brick path and stairs with iron railing leading to front door. Bushes along front of house.			
Photo Views				
1 3/4 View	2 Front View	3	4

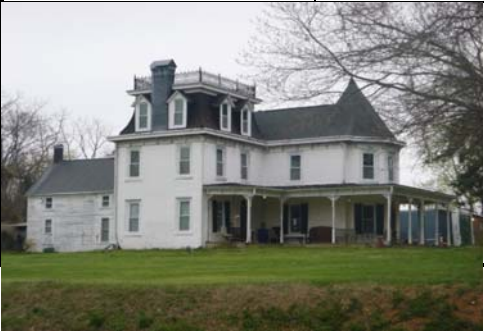
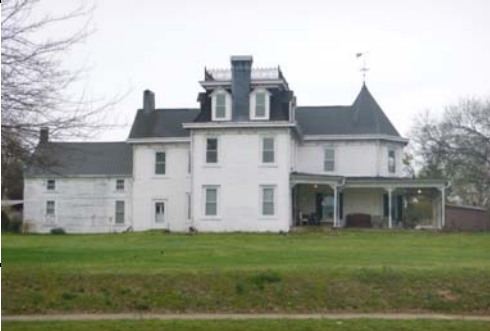
Name of Surveyors	Kimberly Packett		Survey Date	3/26/2016
ADDRESS	Street		Number	
	William Street		1211	
TYPE & NUMBER OF BLGS & STRUCTURES	Type		Number	
	Single Family House		1	
	Shed		1	
Current Use of Primary Building	Single Family	Historic Use of Primary Building	Single Family	
Style of Primary Bldg	Chateausque			
Number of Stories	3	Width (bays)	4	
Foundation Material	Brick	Depth (rooms)	7	
Year Built	1831	Wall Cladding Material	Brick	
Roof Shape	Side Gable	Roof Material	Composition shingle	
Decorative Details/Unique Features	White dentils and modillions along second story and front porch. Two front gable dormers on each side of the roof of the tower. Cresting along top of mansard roof tower. White surround around windows and doors. Black shutters on first story windows at front of house with front porch. Spire roof on front of house with weathervane on point. Brick siding is painted white.			
Evidence of Integrity Location/Materials	Original brick siding.

Additions/Alterations to Primary Building	New roof and windows. Addition on rear of house with what appears to be wood siding.			
Condition of Primary Building	Fair	code		
		F		
Observable Threats	None			
Compatibility with Adjacent Land Uses	Good			
Potential NR Eligibility	Non-Contributing	code		
		N		
Other Comments / Salient Details	Wraparound front porch with hip roof. Chimney on rear of house, interior chimney towards rear of house. Metal chimney on mansard roof tower.			
Photo Views				
1 3/4 View	2 Side View	3	4

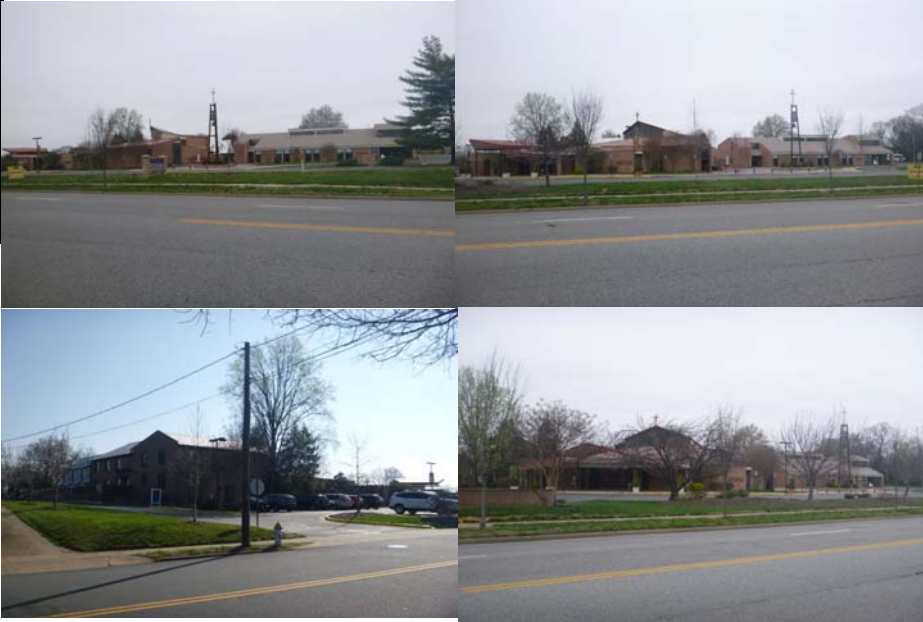
Name of Surveyors	Kimberly Packett		Survey Date	3/26/2016
ADDRESS	Street		Number	
	Stafford	Avenue	1009	
TYPE & NUMBER OF BLGS & STRUCTURES	Type		Number	
	Religious Structure		1	
	Pre-school		1	
Current Use of Primary Building	Religious	Historic Use of Primary Building	Religious	
Style of Primary Bldg	Catholic Church			
Number of Stories	1	Width (bays)	9	
Foundation Material	Cinderblock	Depth (rooms)	4	
Year Built	1971	Wall Cladding Material	Brick	
Roof Shape	Gable	Roof Material	Composition shingle	
Decorative Details/Unique Features	Main structure is the chapel with what appears to be offices and possibly living space in the back. Structure on the right side of the property is a catholic pre-school. Front gable overhang above entrancway to chapel. Front gable with windows and a cross on top on top of the chapel. Pre-school has side gable roof with extended shed roof dormer with windows. Vinyl siding on second story on rear of chapel.

Evidence of Integrity Location/Materials	Original brick siding.			
Additions/Alterations to Primary Building	New windows and roof.			
Condition of Primary Building	Good			code G
Observable Threats	None			
Compatibility with Adjacent Land Uses	Not compatible with surrounding single family homes			
Potential NR Eligibility	Non-Contributing			code N
Other Comments / Salient Details	A large paved parking lot is around both structures. Metal bell tower with cross inbetween both strtructures.			
Photo Views				
1 3/4 View	2 Front View	3 3/4 View	4 Side View

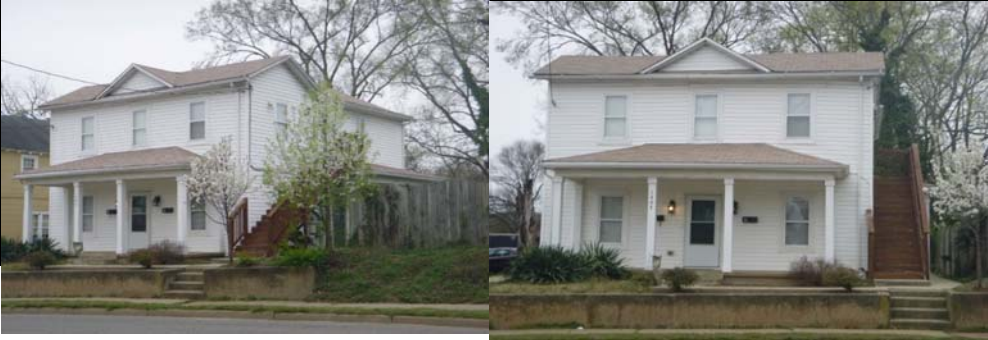
Name of Surveyors	Kimberly Packett		Survey Date	3/26/2016
ADDRESS	Street		Number	
	William Street		1407	
TYPE & NUMBER OF BLGS & STRUCTURES	Type		Number	
	Multi-Family House		1	
Current Use of Primary Building	Multi-Family	Historic Use of Primary Building	Single Family	
Style of Primary Bldg	Prairie			
Number of Stories	2	Width (bays)	3	
Foundation Material	Concrete	Depth (rooms)	2	
Year Built	1929	Wall Cladding Material	Vinyl Siding	
Roof Shape	Side Gable	Roof Material	Composition shingle	
Decorative Details/Unique Features	Front porch with white columns and hip roof overhang. White surround around windows. Front gable in middle front of house. Modillions along second story.			
Evidence of Integrity Location/Materials	None			
Additions/Alterations to Primary Building	New vinyl siding, roof, and windows. Addition on rear of house.			
Condition of Primary Building	Good		code	
			G	
Observable Threats	None

Compatibility with Adjacent Land Uses	Good			
Potential NR Eligibility	Non-Contributing		code	
			N	
Other Comments / Salient Details	Cement retaining wall along front of property. Cement stairs and path leading to cement front porch. Wood stairs leading to second story apartment with side entrance on the right side of the house. Cement driveway on left side of the house.			
Photo Views				
1 3/4 View	2 Front View	3	4

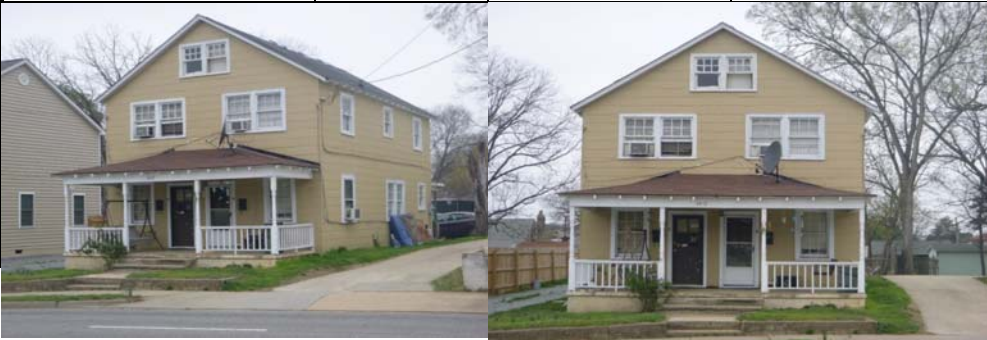
Name of Surveyors	Kimberly Packett		Survey Date	3/26/2016
ADDRESS	Street		Number	
	William Street		1417	
TYPE & NUMBER OF BLGS & STRUCTURES	Type		Number	
	Multi-Family House		1	
Current Use of Primary Building	Multi-Family	Historic Use of Primary Building	Single Family	
Style of Primary Bldg	Craftsman			
Number of Stories	2	Width (bays)	4	
Foundation Material	Cinderblock	Depth (rooms)	3	
Year Built	1909	Wall Cladding Material	Asbestos siding	
Roof Shape	Front Gable	Roof Material	Composition shingle	
Decorative Details/Unique Features	White surround around doors and windows. Hip roof front porch with white modillions, pillars, and fence.			
Evidence of Integrity Location/Materials	Possibly original asbestos siding.			
Additions/Alterations to Primary Building	New roof and windows.			
Condition of Primary Building	Fair			code F
Observable Threats	None			
Compatibility with Adjacent Land Uses	Good			
Potential NR Eligibility	Non-Contributing			code N

Other Comments / Salient Details	Gravel driveway on left side of house. Cement path and stairs leading to front porch. Short cement retaining wall along front of property.			
Photo Views				
1 3/4 View	2 Front View	3	4

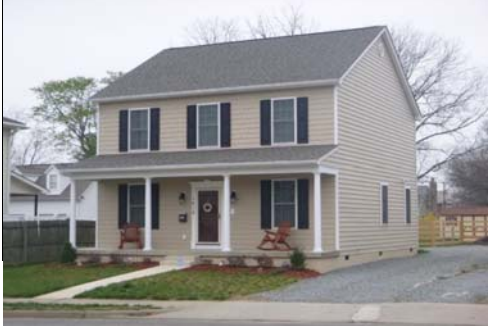
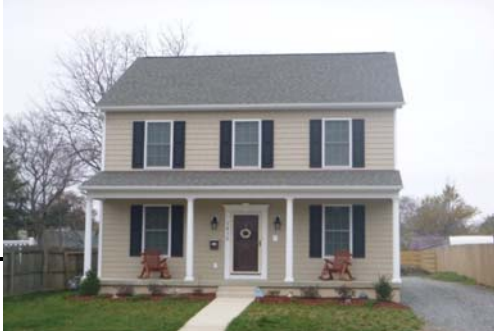
Name of Surveyors	Kimberly Packett		Survey Date	3/26/2016
ADDRESS	Street		Number	
	William	Street	1419	
TYPE & NUMBER OF BLGS & STRUCTURES	Type		Number	
	Single Family House		1	
	Shed		1	
Current Use of Primary Building	Single Family	Historic Use of Primary Building	Single Family	
Style of Primary Bldg	Neo-Colonial			
Number of Stories	2	Width (bays)	3	
Foundation Material	Concrete	Depth (rooms)	2	
Year Built	2015	Wall Cladding Material	Vinyl Siding	
Roof Shape	Side Gable	Roof Material	Composition Shingle	
Decorative Details/Unique Features	White crown and pilasters around front door with keystone. Dark blue shutters on front windows. Shed roof overhand above front porch with white columns. Decorative circular window on each gable end.			
Evidence of Integrity Location/Materials	All original materials.			
Additions/Alterations to Primary Building	None.			
Condition of Primary Building	Excellent			code E

Observable Threats	None			
Compatibility with Adjacent Land Uses	Good			
Potential NR Eligibility	Non-Contributing			code N
Other Comments / Salient Details	Gravel driveway on right side of house. Cement path and stairs leading from the sidewalk to the front porch. Small bushes along front of porch.			
Photo Views				
1 3/4 View	2 Front View	3	4

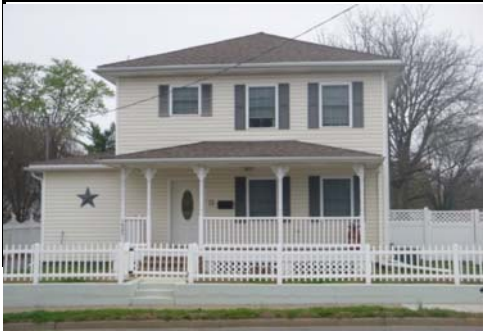
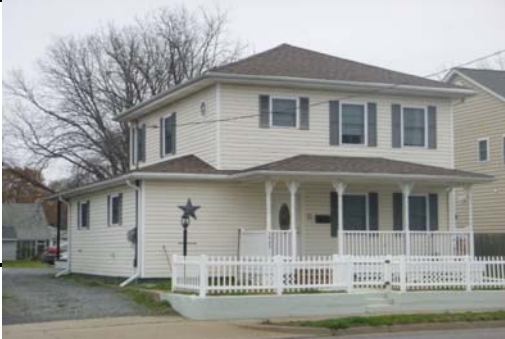
Name of Surveyors	Kimberly Packett		Survey Date	3/26/2016
ADDRESS	Street		Number	
	William Street		1423	
TYPE & NUMBER OF BLGS & STRUCTURES	Type		Number	
	Single Family House		1	
Current Use of Primary Building	Single Family	Historic Use of Primary Building	Single Family	
Style of Primary Bldg	Prarie			
Number of Stories	2	Width (bays)	3	
Foundation Material	Concrete	Depth (rooms)	2	
Year Built	1922	Wall Cladding Material	Hardboard siding	
Roof Shape	Hip	Roof Material	Composition Shingle	
Decorative Details/Unique Features	Grey shutters on windows. Hip roof overhang above front porch with decorative white pillars. Decorative star on first story left side of house. Decorative circular window on second story left side of house.			
Evidence of Integrity Location/Materials	None.			
Additions/Alterations to Primary Building	New siding, roof, and windows.			
Condition of Primary Building	Excellent		code	E
Observable Threats	None

Compatibility with Adjacent Land Uses	Good			
Potential NR Eligibility	Non-Contributing		code	N
Other Comments / Salient Details	Cement retaining wall along front of property. White picket fence along front of property, white privacy fence around backyard. Gravel driveway laong left side of house. Cement stairs and path leading to front porch. Lamp post in front yard.			
Photo Views				
1 Front View	2 3/4 View	3	4

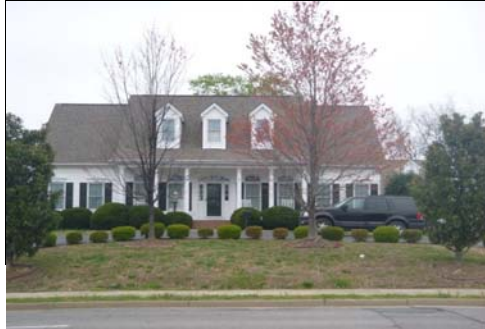
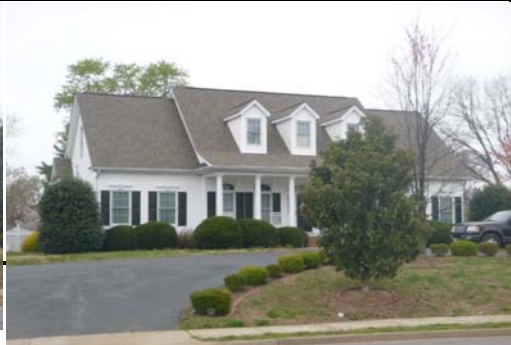
Name of Surveyors	Kimberly Packett		Survey Date	3/26/2016
ADDRESS	Street		Number	
	William Street		1501	
TYPE & NUMBER OF BLGS & STRUCTURES	Type		Number	
	Single Family House		1	
Current Use of Primary Building	Single Family	Historic Use of Primary Building	Single Family	
Style of Primary Bldg	Neo-colonial			
Number of Stories	1 1/2	Width (bays)	9	
Foundation Material	Brick	Depth (rooms)	3	
Year Built	2002	Wall Cladding Material	Vinyl siding	
Roof Shape	Side Gable	Roof Material	Composition shingle	
Decorative Details/Unique Features	Three front gable dormers on front middle of house. Roof overhang above front porch with white columns. Black shutters on front first story windows. Side lights and fanlight around front door. Fanlights above windows in center of building. Lintel with keystone above windows on either end of the building.			
Evidence of Integrity Location/Materials	Original siding, roof, and windows.

Additions/Alterations to Primary Building	None.			
Condition of Primary Building	Excellent			code E
Observable Threats	None			
Compatibility with Adjacent Land Uses	Good			
Potential NR Eligibility	Non-Contributing			code N
Other Comments / Salient Details	Curved cement driveway with bushes along either side. Driveway is shared with 1505 William. Bushes along front of house. White picket fence around backyard.			
Photo Views				
1 Front View	2 3/4 View	3	4

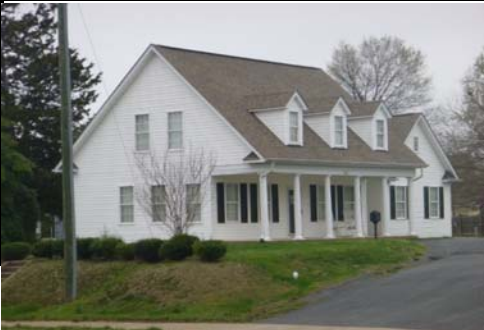
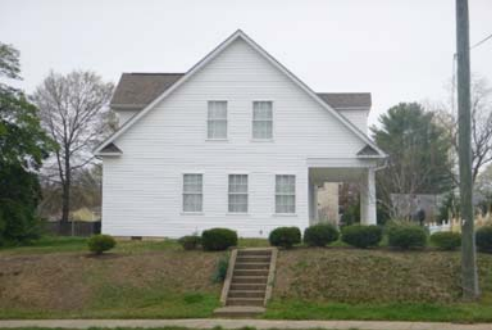
Name of Surveyors	Kimberly Packett		Survey Date	3/26/2016
ADDRESS	Street		Number	
	William Street		1505	
TYPE & NUMBER OF BLGS & STRUCTURES	Type		Number	
	Single Family House		1	
Current Use of Primary Building	Single Family	Historic Use of Primary Building	Single Family	
Style of Primary Bldg	Neo-Classical			
Number of Stories	1 1/2	Width (bays)	7	
Foundation Material	Concrete	Depth (rooms)	3	
Year Built	2005	Wall Cladding Material	Vinyl Siding	
Roof Shape	Side Gable	Roof Material	Composition shingle	
Decorative Details/Unique Features	Three front gable dormers on front of house. Front gable on rear of house. Front gable on front right side of house. Roof extends over front porch with white columns. Black shutters on first story front windows. White surround around front door.			
Evidence of Integrity Location/Materials	All original materials			
Additions/Alterations to Primary Building	None.			
Condition of Primary Building	Excellent			code E

Observable Threats	None			
Compatibility with Adjacent Land Uses	Good			
Potential NR Eligibility	Non-Contributing			code N
Other Comments / Salient Details	Cement stairs and path leading to front porch. Curved driveway is shared with 1501 William. Bushes along front of property.			
Photo Views				
1 3/4 View	2 Side View	3	4

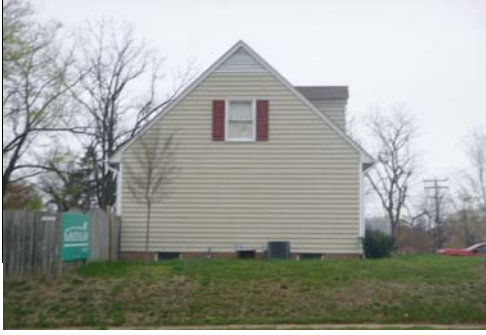
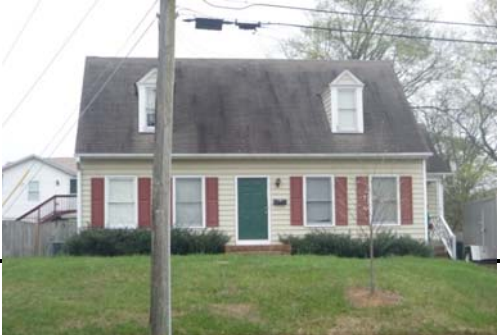
Photo Views				
1 Side View	2 Front View	3	4

Name of Surveyors	Kimberly Packett		Survey Date	3/26/2016
ADDRESS	Street		Number	
	Stafford Avenue		1002	
TYPE & NUMBER OF BLGS & STRUCTURES	Type		Number	
	Single Family House		1	
Current Use of Primary Building	Single Family	Historic Use of Primary Building	Single Family	
Style of Primary Bldg	Cape Cod			
Number of Stories	1 1/2	Width (bays)	6	
Foundation Material	Concrete	Depth (rooms)	2	
Year Built	1995	Wall Cladding Material	Vinyl siding	
Roof Shape	Side Gable	Roof Material	Composition shingle	
Decorative Details/Unique Features	Red shutters on windows. Green front door. Two front gable dormers on front of house.			
Evidence of Integrity Location/Materials	All original materials.			
Additions/Alterations to Primary Building	None.			
Condition of Primary Building	Good		code	
			G	
Observable Threats	None			
Compatibility with Adjacent Land Uses	Good			
Potential NR Eligibility	Contributing		code	
			C	
Other Comments / Salient Details	Wood privacy fence around backyard. Cement driveway on right side of house. Cement stairs leading to brick stairs leading to front door. Brick stairs with white railing leading to side door on right side of the house. Bushes along front of house.

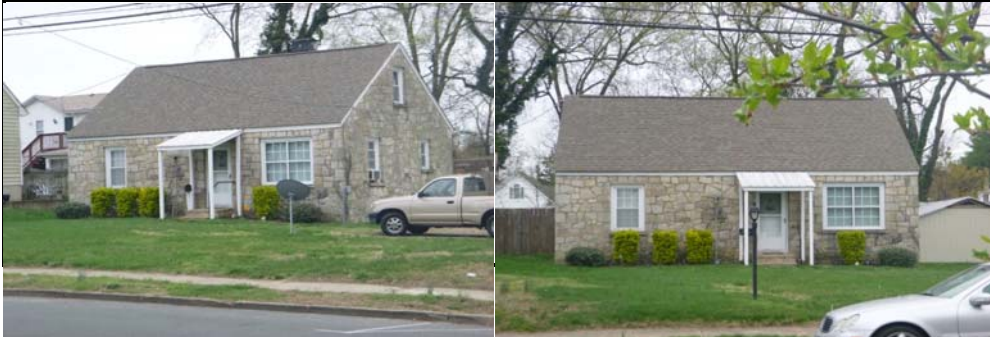
Photo Views				
1 3/4 View	2 Front View	3	4

Name of Surveyors	Kimberly Packett		Survey Date	3/26/2016
ADDRESS	Street		Number	
	Stafford	Avenue	1004	
TYPE & NUMBER OF BLGS & STRUCTURES	Type		Number	
	Single Family House		1	
	Shed		1	
Current Use of Primary Building	Single Family	Historic Use of Primary Building	Single Family	
Style of Primary Bldg	Cape Cod			
Number of Stories	1 1/2	Width (bays)	3	
Foundation Material	Cinderblock	Depth (rooms)	2	
Year Built	1949	Wall Cladding Material	Stone	
Roof Shape	Side Gable	Roof Material	Composition shingle	
Decorative Details/Unique Features	Shed roof overhand with white supports above front stoop.			
Evidence of Integrity Location/Materials	Original stone siding.			
Additions/Alterations to Primary Building	New roof and windows.			
Condition of Primary Building	Good			code G
Observable Threats	None			
Compatibility with Adjacent Land Uses	Good			
Potential NR Eligibility	Contributing			code C
Other Comments / Salient Details	Brick stairs leading to front door. Bushes along front of house. Lamp post in front yard. Gravel driveway on right side of house.

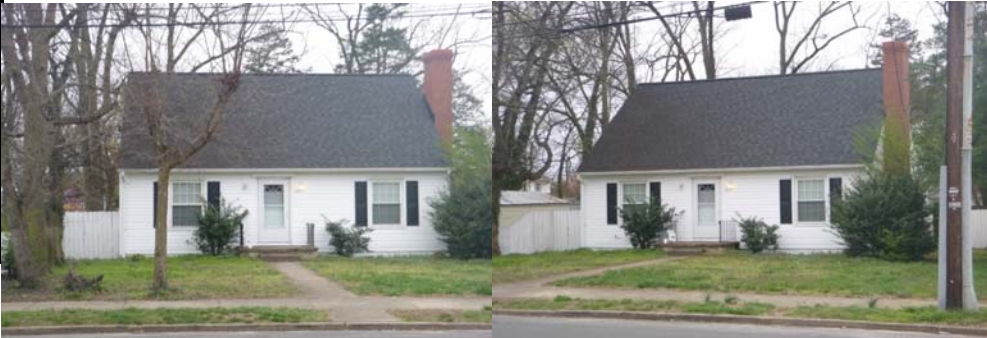
Name of Surveyors	Kimberly Packett		Survey Date	3/26/2016
ADDRESS	Street		Number	
	Stafford Avenue		1012	
TYPE & NUMBER OF BLGS & STRUCTURES	Type		Number	
	Single Family House		1	
Current Use of Primary Building	Single Family	Historic Use of Primary Building	Single Family	
Style of Primary Bldg	Cape Cod			
Number of Stories	1 1/2	Width (bays)	3	
Foundation Material	Cinderblock	Depth (rooms)	2	
Year Built	1952	Wall Cladding Material	Hardboard siding	
Roof Shape	Side Gable	Roof Material	Composition shingle	
Decorative Details/Unique Features	White surround around windows and black shutters. White crown above front door.			
Evidence of Integrity Location/Materials	Original siding and appears to be original windows.			
Additions/Alterations to Primary Building	New roof.			
Condition of Primary Building	Good		code	
			G	
Observable Threats	None			
Compatibility with Adjacent Land Uses	Good			
Potential NR Eligibility	Contributing		code

C	
Other Comments / Salient Details	White privacy fence around backyard. Cement path leading to brick and cement steps and landing with iron railing in front of front door. Bushes on either side of landing. Chimney on right end of house.			
Photo Views				
1 Front View	2 3/4 View	3	4

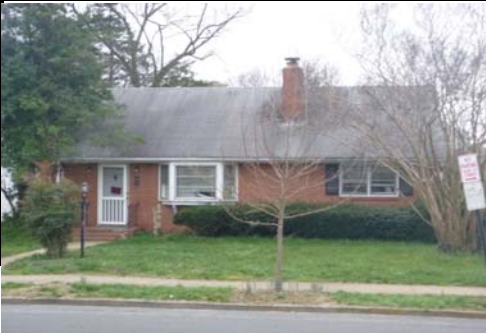
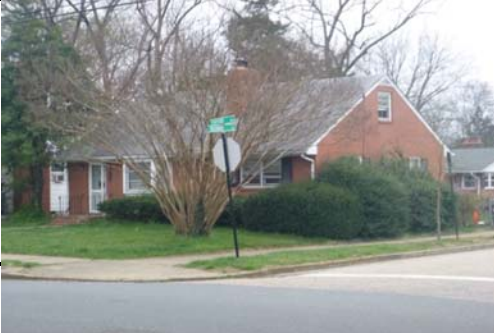
Name of Surveyors	Kimberly Packett		Survey Date	3/26/2016
ADDRESS	Street		Number	
	Stafford	Avenue	1014	
TYPE & NUMBER OF BLGS & STRUCTURES	Type		Number	
	Single Family House		1	
Current Use of Primary Building	Single Family	Historic Use of Primary Building	Single Family	
Style of Primary Bldg	Minimal Traditional			
Number of Stories	1 1/2	Width (bays)	3	
Foundation Material	Cinderblock	Depth (rooms)	2	
Year Built	1949	Wall Cladding Material	Brick	
Roof Shape	Side Gable	Roof Material	Composition Shingle	
Decorative Details/Unique Features	Black shutters on windows on the front right side of house. Bay window to the right of the front door.			
Evidence of Integrity Location/Materials	Original brick siding and windows.			
Additions/Alterations to Primary Building	New roof.			
Condition of Primary Building	Fair	code		
		F		
Observable Threats	None			
Compatibility with Adjacent Land Uses	Good			
Potential NR Eligibility	Contributing	code

C		
Other Comments / Salient Details	Bushes along front of house. Cement path leading to brick stairs and landing with iron railing in front of front door. Interior chimney. Chain link fence around backyard.			
Photo Views				
1 Front View	2 3/4 View	3	4

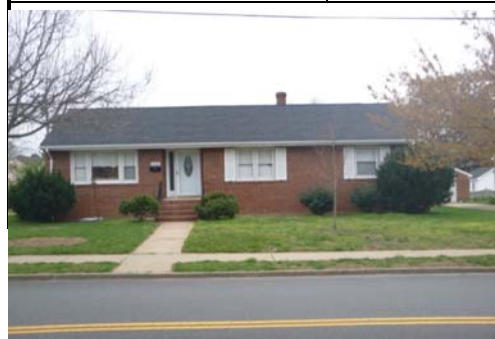
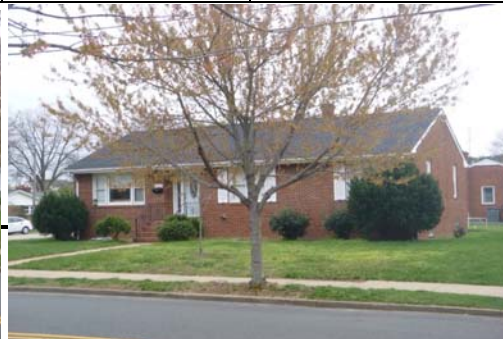
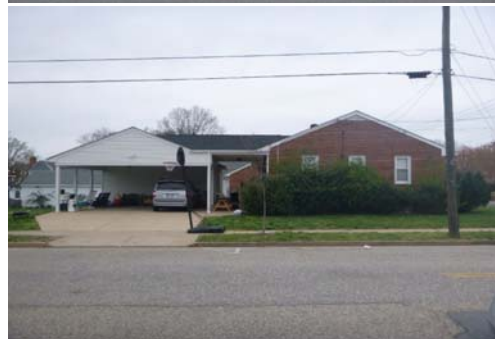
1 Front View	2 3/4 View	3 Side View	4
--------------	------------	-------------	---

Name of Surveyors	Kimberly Packett		Survey Date	2/21/2016
ADDRESS	Street		Number	
	Stafford	Avenue	1100	
TYPE & NUMBER OF BLGS & STRUCTURES	Type		Number	
	Single Family House		1	
	Shed		1	
Current Use of Primary Building	Single Family	Historic Use of Primary Building	Single Family	
Style of Primary Bldg	Minimal Traditional			
Number of Stories	1	Width (bays)	4	
Foundation Material	Cinderblock	Depth (rooms)	3	
Year Built	1960	Wall Cladding Material	Brick	
Roof Shape	Side gable	Roof Material	Composite shingles	
Decorative Details/Unique Features	White shutters on front windows. Sidelight on either side of front door. Back door with iron railing and brick stairs by car port. Roof connects carport to main house			
Evidence of Integrity Location/Materials	Original windows and brick siding.			
Additions/Alterations to Primary Building	New roof, carport and roof connection to main house.			
Condition of Primary Building	Good			code G

Observable Threats	None			
Compatibility with Adjacent Land Uses	Good			
Potential NR Eligibility	Contributing			code C
Other Comments / Salient Details	Shrubs along the front and side of house. Cement walkway leading up to brick stairs with iron railing leading to front door, paved driveway in back of house leading to carport. Interior chimney.

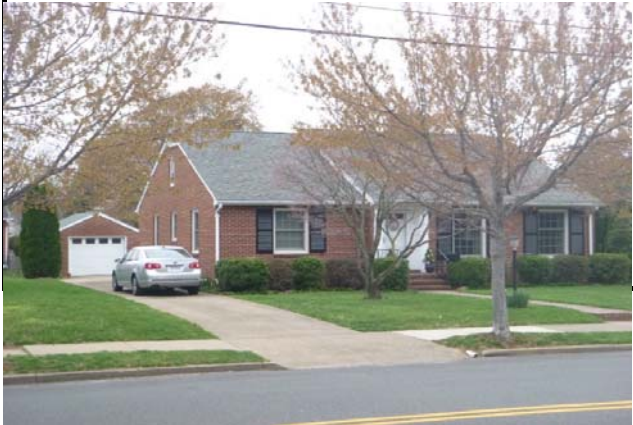
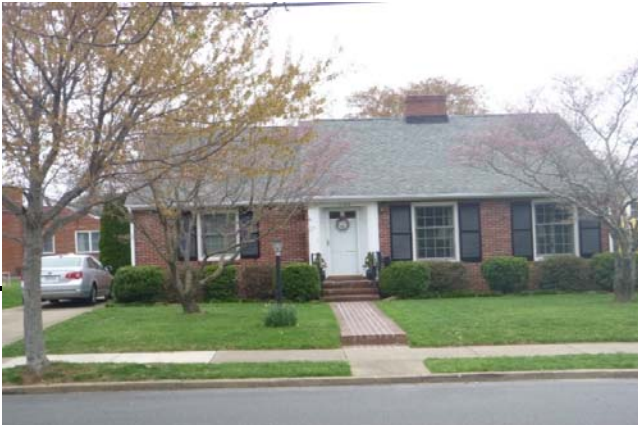
Name of Surveyors	Kimberly Packett	Survey Date	2/21/2016
ADDRESS	Street	Number	
	Stafford Avenue	1106	
TYPE & NUMBER OF BLGS & STRUCTURES	Type	Number	
	Single Family House	1	
	Detached Garage	1	
Current Use of Primary Building	Single Family	Historic Use of Primary Building	Single Family
Style of Primary Blg	Minimal Traditional		
Number of Stories	1	Width (bays)	4
Foundation Material	Cinderblock	Depth (rooms)	2
Year Built	1960	Wall Cladding Material	Brick
Roof Shape	Side gable	Roof Material	Composition shingle
Decorative Details/Unique Features	Black shutters on front windows. White crown and pilasters around front door.		
Evidence of Integrity Location/Materials	Original door surround, original brick siding		
Additions/Alterations to Primary Building	Addition on the back of the house, with white vinyl and gable roof. New windows, new roof.		
Condition of Primary Building	Good	code G	
Observable Threats	None

Compatibility with Adjacent Land Uses	Good		
Potential NR Eligibility	Contributing	code C	
Other Comments / Salient Details	Cement driveway on left side of house leading to garage. Brick stairs and pathway leading up to front door with an iron railing, gardens along the sides of the house, Bushes along the front of the house. Lamppost on front lawn. Central chimney.		
Photo Views			
1 3/4 View	2 Front View	3	4

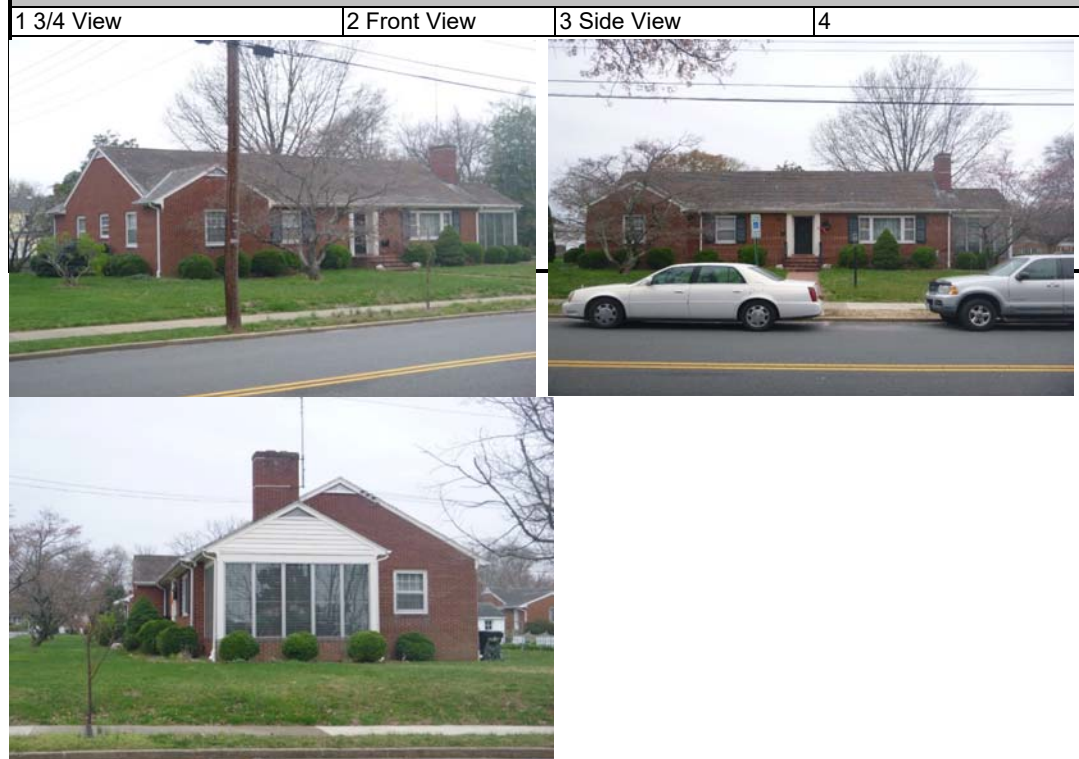
Photo Views

Name of Surveyors	Kimberly Packett		Survey Date	2/21/2016
ADDRESS	Street		Number	
	Stafford Avenue		1114	
TYPE & NUMBER OF BLGS & STRUCTURES	Type		Number	
	Single Family House		1	
Current Use of Primary Building	Single Family	Historic Use of Primary Building	Single Family	
Style of Primary Bldg	Minimal Traditional			
Number of Stories	1	Width (bays)	4	
Foundation Material	Cinderblock	Depth (rooms)	2	
Year Built	1959	Wall Cladding Material	Brick	
Roof Shape	Side gable	Roof Material	Asbestos shingle	
Decorative Details/Unique Features	Black shutters on windows on either side of house. Sun porch on right side of house. Front gable on left side addition. Tan crown and pilaster around front door.			
Evidence of Integrity Location/Materials	Original windows on either side of front door and original brick siding.			
Additions/Alterations to Primary Building	Addition on left side of house, new roof.			
Condition of Primary Building	Fair		code	F

Observable Threats	None			
Compatibility with Adjacent Land Uses	Good			
Potential NR Eligibility	Contributing		code	C
Other Comments / Salient Details	Brick pathway and stairs with iron railing leading to front door. Lamp post in front yard. Bushes along front and sides of house. Chimney on right end of house.
