Cultural Resource Survey of College Heights in Fredericksburg, Virginia

Master of Science

Historic Preservation

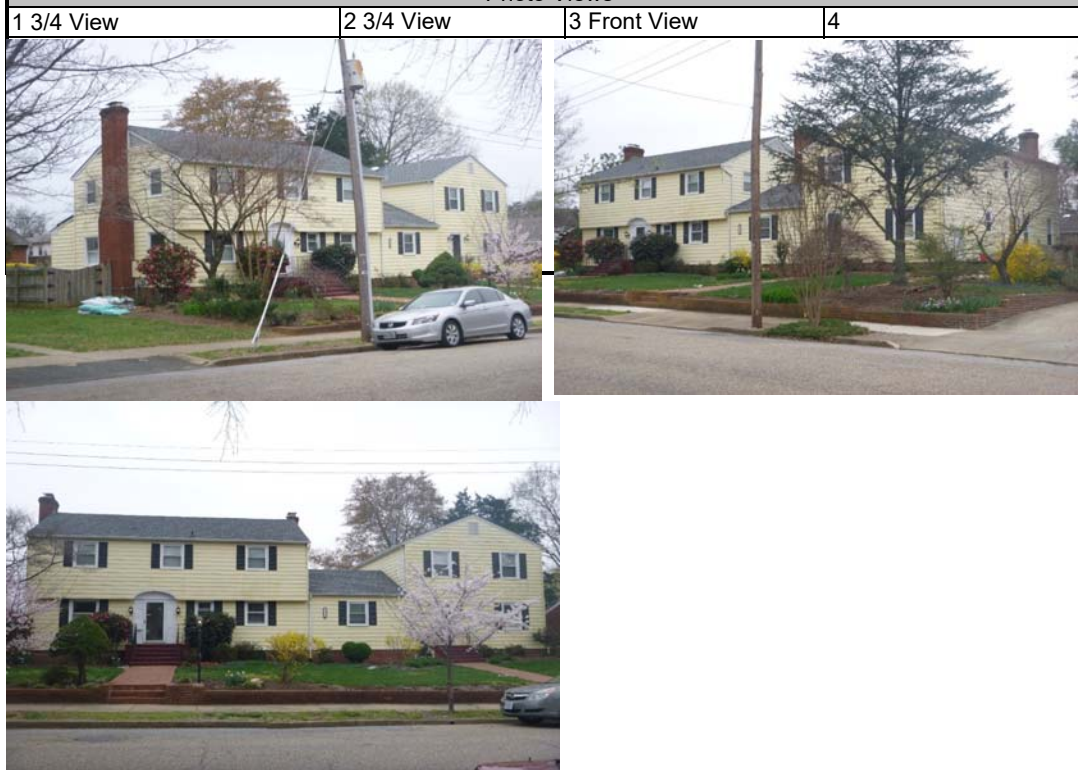
Photo Views

Name of Surveyors	Kimberly Packett		Survey Date	2/21/2016
ADDRESS	Street		Number	
	Royston	Street	1410	
TYPE & NUMBER OF BLGS & STRUCTURES	Type		Number	
	Single Family House		1	
Current Use of Primary Building	Single Family	Historic Use of Primary Building	Single Family	
Style of Primary Bldg	Neocolonial			
Number of Stories	2	Width (bays)	7	
Foundation Material	Cinderblock	Depth (rooms)	2	
Year Built	1965	Wall Cladding Material	Vinyl siding	
Roof Shape	Gable	Roof Material	Composition shingles	
Decorative Details/Unique Features	Door surround-neocolonial with holding fanlight, black shutters on windows, basement, chimney on left end of house			
Evidence of Integrity Location/Materials	None			
Additions/Alterations to Primary Building	New vinyl siding, new windows, addition on rear of house, large two story			
Condition of Primary Building	Good		code	G
Observable Threats	None			
Compatibility with Adjacent Land Uses	Good

Potential NR Eligibility	Non-Contributing		code	N
Other Comments / Salient Details	Brick retaining wall along front of property, brick steps and walkway with iron railing leading to front door, lamppost in front yard, trees and shrubs along front of property and house

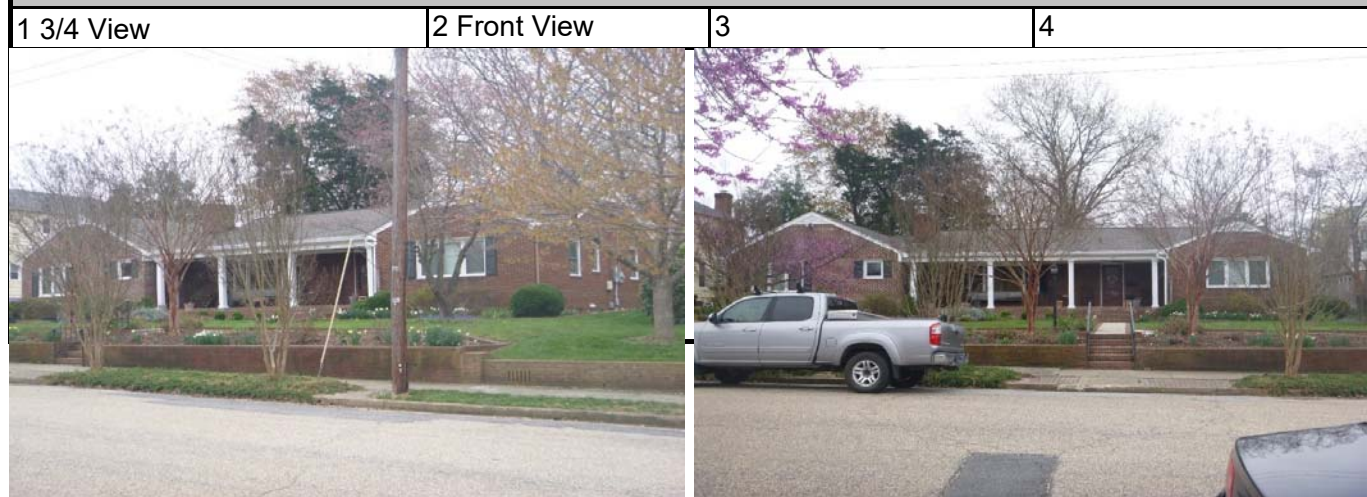
Photo Views

Name of Surveyors	Kimberly Packett		Survey Date	2/21/2016
ADDRESS	Street		Number	
	Royston	Street	1420	
TYPE & NUMBER OF BLGS & STRUCTURES	Type		Number	
	Single Family House		1	
Current Use of Primary Building	Single Family	Historic Use of Primary Building	Single Family	
Style of Primary Blg	Ranch			
Number of Stories	1	Width (bays)	5	
Foundation Material	Cinderblock	Depth (rooms)	2	
Year Built	1958	Wall Cladding Material	Brick	
Roof Shape	Gable	Roof Material	Composition shingles	
Decorative Details/Unique Features	Front gables on either side of the house. Black shutters on front windows. Roof overhang with square white columns above front porch.			
Evidence of Integrity Location/Materials	Original brick siding			
Additions/Alterations to Primary Building	Converted attached garage on the left side of the house to a livable space, new windows, new roof			
Condition of Primary Building	Good			code G
Observable Threats	None

Compatibility with Adjacent Land Uses	Good			
Potential NR Eligibility	Contributing			code C
Other Comments / Salient Details	Cement driveway on left side of house. Brick retaining wall along front of property. Cement and brick path leading to brick front porch. Bushes and gardens along front of the property and front of the house. Interior chimney on left side of the house.

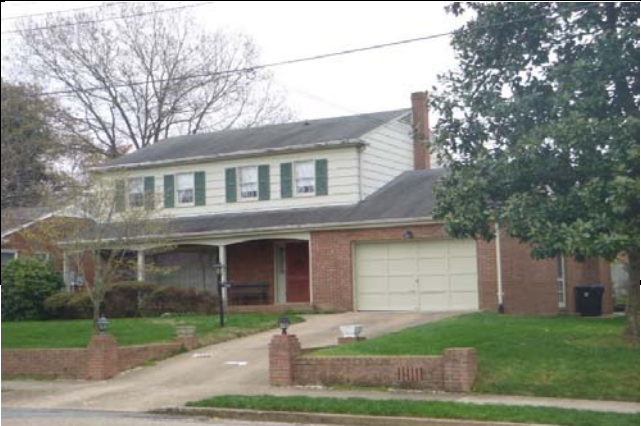
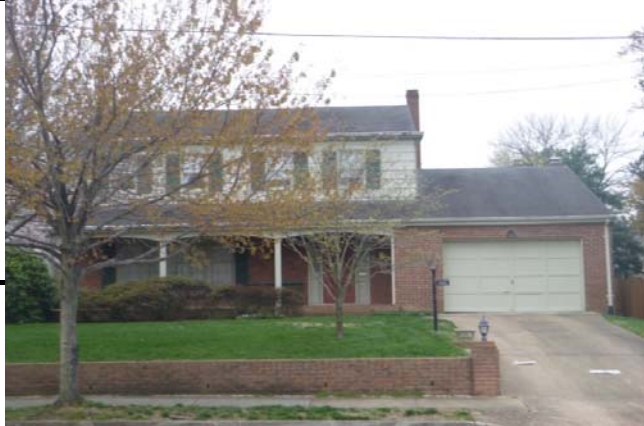
Name of Surveyors	Kimberly Packett		Survey Date	2/21/2016
ADDRESS	Street		Number	
	Royston	Street	1424	
TYPE & NUMBER OF BLGS & STRUCTURES	Type		Number	
	Single Family House		1	
Current Use of Primary Building	Single Family	Historic Use of Primary Building	Single Family	
Style of Primary Blg	Neo-colonial			
Number of Stories	2	Width (bays)	3	
Foundation Material	Cinderblock	Depth (rooms)	2	
Year Built	1966	Wall Cladding Material	Brick & hardboard siding	
Roof Shape	Gable	Roof Material	Composition shingles	
Decorative Details/Unique Features	Large Porch with three support square columns with decorative arches in between. Green shutters on second story windows. Sidelights on either side of front door, attached garage on right side. Brick siding on first story, hardboard siding on second story.			
Evidence of Integrity Location/Materials	Original brick siding and windows			
Additions/Alterations to Primary Building	Sunroom addition on back of house, new roof.

Condition of Primary Building	Excellent		code	
			E	
Observable Threats	None			
Compatibility with Adjacent Land Uses	Good			
Potential NR Eligibility	Contributing		code	
			C	
Other Comments / Salient Details	Brick retaining wall along front of property, driveway leading up to garage on right side. Cement path and brick stairs leading to front porch. Bushes in front of porch, lamppost on front lawn. Chimney on right end of house. Side door on right side of house.			
Photo Views				
1 3/4 View	2 Front View	3	4

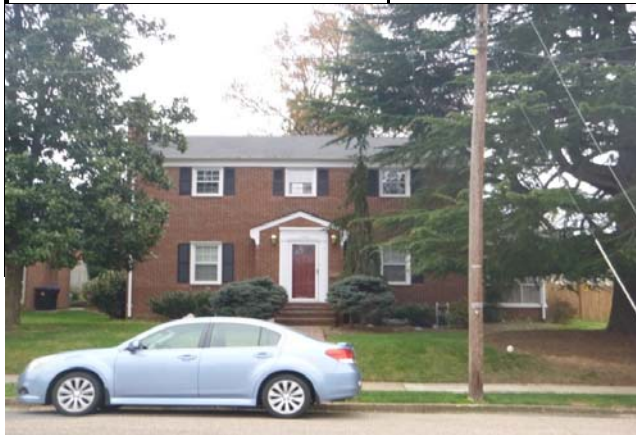
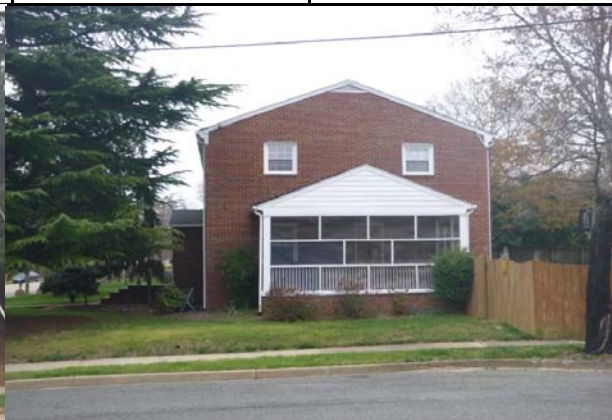
Name of Surveyors	Kimberly Packett		Survey Date	2/21/2016
ADDRESS	Street		Number	
	Royston	Street	1428	
TYPE & NUMBER OF BLGS & STRUCTURES	Type		Number	
	Single Family House		1	
	Shed		1	
Current Use of Primary Building	Single Family	Historic Use of Primary Building	Single Family	
Style of Primary Bldg	Colonial Revival			
Number of Stories	2	Width (bays)	3	
Foundation Material	Cinderblock	Depth (rooms)	2	
Year Built	1954	Wall Cladding Material	Brick	
Roof Shape	Side gable	Roof Material	Composition shingle	
Decorative Details/Unique Features	Black shutters on front windows. Protruded entryway with front gable roof. White crown and pilasters around front door.			
Evidence of Integrity Location/Materials	Original brick siding, original windows			
Additions/Alterations to Primary Building	Porch on the right side of the house is an addition, new roof.			
Condition of Primary Building	Good			code G
Observable Threats	None

Compatibility with Adjacent Land Uses	Good			
Potential NR Eligibility	Contributing			code C
Other Comments / Salient Details	Brick path and stairs leading to front door. Privacy fence around backyard. Bushes along front and side of house. Sunroom on right side of the house. Chimney on left end of house.			
Photo Views				
1 Front View	2 Side View	3	4

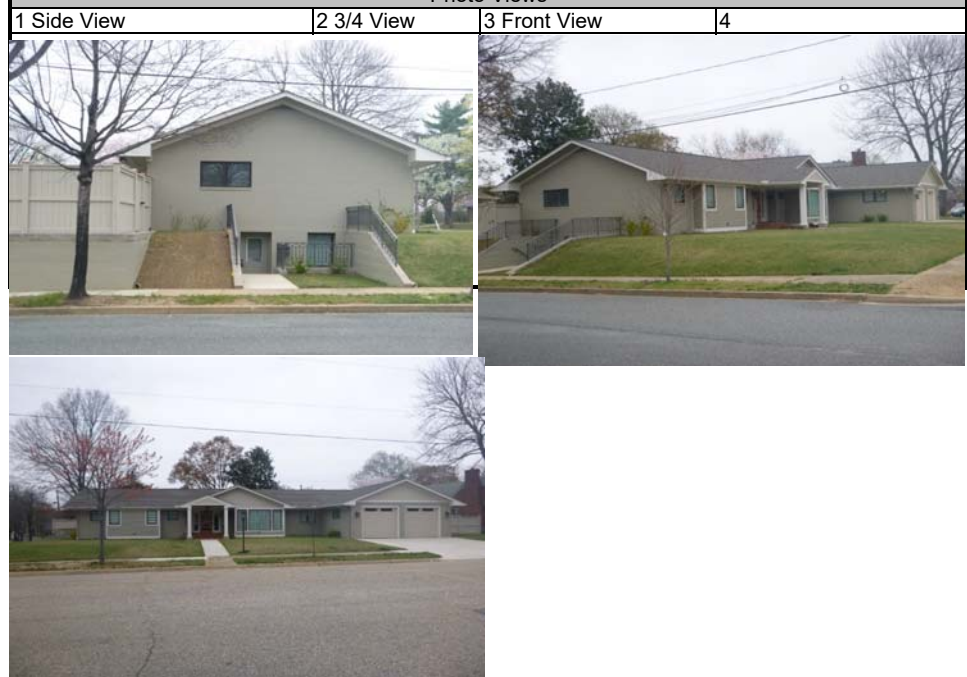
Photo Views

Name of Surveyors	Kimberly Packett	Survey Date	3/26/2016
ADDRESS	Street	Number	
	Buckner Street	1429	
TYPE & NUMBER OF BLGS & STRUCTURES	Type	Number	
	Single Family House	1	
Current Use of Primary Building	Single Family	Historic Use of Primary Building	Single Family
Style of Primary Bldg	Ranch		
Number of Stories	1	Width (bays)	7
Foundation Material	Cinderblock	Depth (rooms)	2
Year Built	1963	Wall Cladding Material	Brick
Roof Shape	Cross Gable	Roof Material	Composition Shingle
Decorative Details/Unique Features	Front gable portico with white columns above small front porch. Front gable in center of building and on attached garage on right side of house. Sidelights on either side of front door.		
Evidence of Integrity Location/Materials	None		
Additions/Alterations to Primary Building	New siding, windows, and roof.		
Condition of Primary Building	Excellent	code E	
Observable Threats	None		
Compatibility with Adjacent Land Uses	Good

Potential NR Eligibility	Non-Contributing	code N	
Other Comments / Salient Details	Basement entrance on left side of house with brick retaining walls on either side of entranceway. Backyard is elevated with a brick retaining wall. Privacy fence around backyard. Driveway on right side of house leading to attached double garage. Cement path and brick stairs leading to front door.

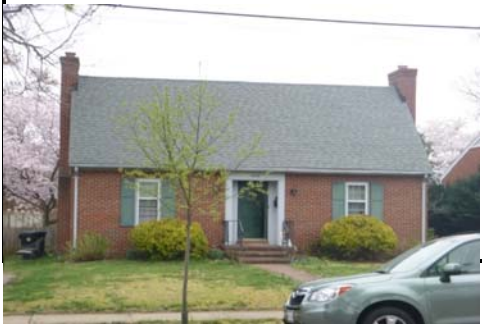
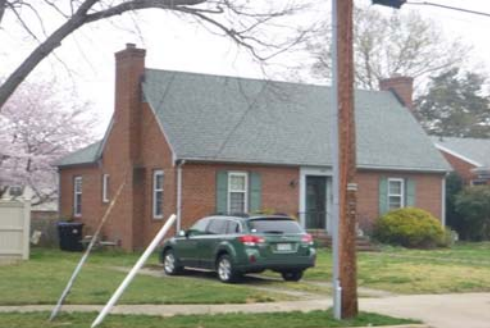
Name of Surveyors	Kimberly Packett		Survey Date	3/26/2016
ADDRESS	Street		Number	
	Buckner	Street	1425	
TYPE & NUMBER OF BLGS & STRUCTURES	Type		Number	
	Single Family House		1	
Current Use of Primary Building	Single Family	Historic Use of Primary Building	Single Family	
Style of Primary Bldg	Cape Cod			
Number of Stories	1	Width (bays)	3	
Foundation Material	Cinderblock	Depth (rooms)	3	
Year Built	1957	Wall Cladding Material	Brick	
Roof Shape	Side Gable	Roof Material	Composition shingle	
Decorative Details/Unique Features	White crown and pilasters around front door. Green shutters on front windows.			
Evidence of Integrity Location/Materials	Original brick siding. Appears to be original windows.			
Additions/Alterations to Primary Building	Addition on rear of house. New roof.			
Condition of Primary Building	Good		code	G
Observable Threats	None			
Compatibility with Adjacent Land Uses	Good			
Potential NR Eligibility	Contributing		code	C

Other Comments / Salient Details	Brick path and stairs with iron railing leading to front door. Chimneys on either end of house. Bushes along front of house. Cement driveway on left side of house.			
Photo Views				
1 Front View	2 3/4 View	3	4

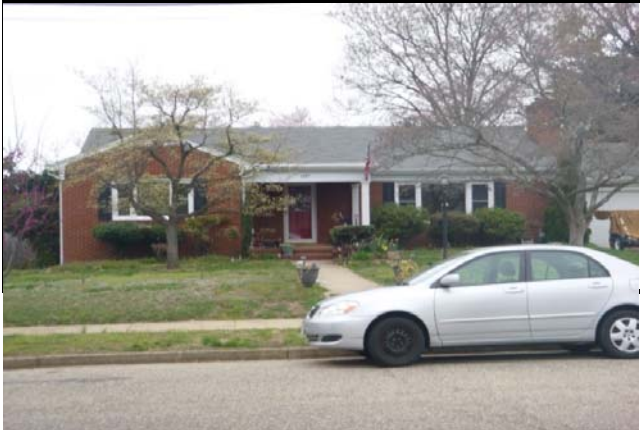
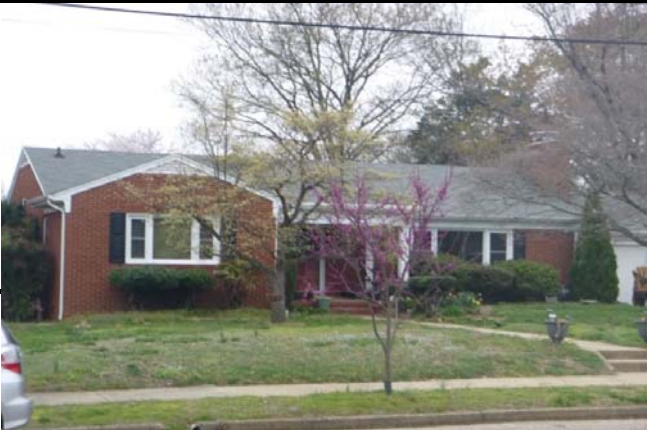
Name of Surveyors	Kimberly Packett		Survey Date	2/21/2016
ADDRESS	Street		Number	
	Buckner	Street	1419	
TYPE & NUMBER OF BLGS & STRUCTURES	Type		Number	
	Single Family House		1	
	Shed		1	
Current Use of Primary Building	Single Family	Historic Use of Primary Building	Single Family	
Style of Primary Blg	Minimal Traditional			
Number of Stories	1	Width (bays)	3	
Foundation Material	Cinderblock	Depth (rooms)	2	
Year Built	1958	Wall Cladding Material	Brick	
Roof Shape	Gable	Roof Material	Composition shingles	
Decorative Details/Unique Features	Left side of the house has a front gable. Overhang over over front porch supported by column, white pilasters where overhang hits walls. White surround around front windows. Blue shutters on front windows.			
Evidence of Integrity Location/Materials	Original brick siding and windows on original part of house.			
Additions/Alterations to Primary Building	Addition on left side of house. New roof.

Condition of Primary Building	Good			code
				G
Observable Threats	None			
Compatibility with Adjacent Land Uses	Good			
Potential NR Eligibility	Contributing			code
				C
Other Comments / Salient Details	Paved driveway on right side of house leading to attached garage. Bushes along front of house. Cement path and brick stairs leading to front door. Chimney on right end of the house. Lamp post in front yard.			
Photo Views				
1 Front View	2 3/4 View	3	4

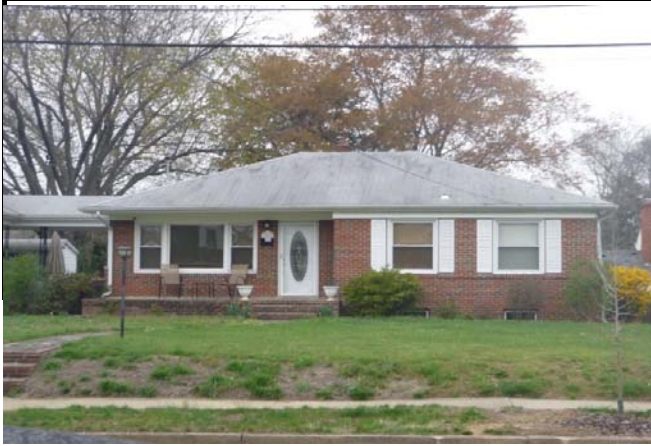
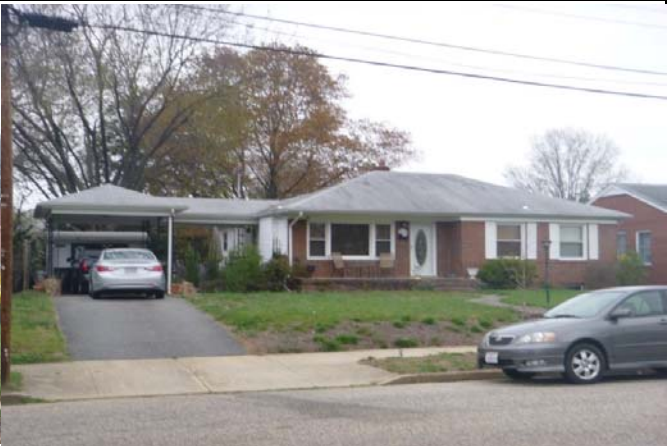
Name of Surveyors	Kimberly Packett	Survey Date	2/21/2016
ADDRESS	Street	Number	
	Buckner Street	1415	
TYPE & NUMBER OF BLGS & STRUCTURES	Type	Number	
	Single Family House	1	
	Shed	1	
Current Use of Primary Building	Single Family	Historic Use of Primary Building	Single Family
Style of Primary Blg	Minimal Traditional		
Number of Stories	1	Width (bays)	4
Foundation Material	Cinderblock	Depth (rooms)	3
Year Built	1957	Wall Cladding Material	Brick
Roof Shape	Hip	Roof Material	Composition shingle
Decorative Details/Unique Features	White shutters on windows on right side of house, carport attached by roof to main house. Vinyl siding on sides of house.		
Evidence of Integrity Location/Materials	Original brick siding on front of house.		
Additions/Alterations to Primary Building	New windows, addition on back of house. New roof and new vinyl siding on sides of house.		
Condition of Primary Building	Fair	code	
		F

Observable Threats	None		
Compatibility with Adjacent Land Uses	Good		
Potential NR Eligibility	Contributing	code	
		C	
Other Comments / Salient Details	Wooden fence along part of backyard, shrubs along walkway between carport and house, brick steps and brick walkway leading up to front door, lamppost in front yard, paved driveway on left side of the house leading to car port.		
Photo Views			
1 Front View	2 3/4 View	3	4

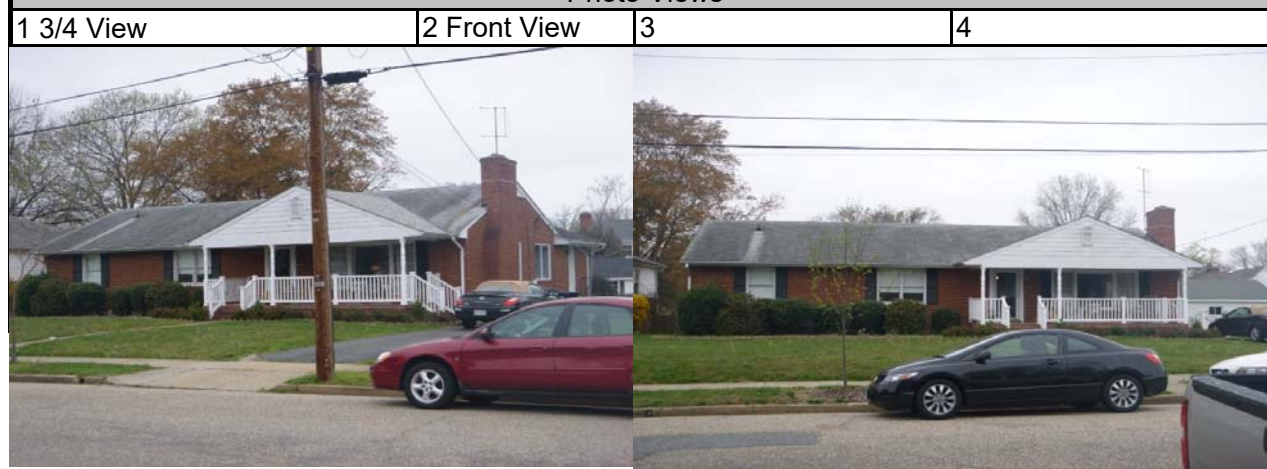
Name of Surveyors	Kimberly Packett		Survey Date	2/21/2016
ADDRESS	Street		Number	
	Buckner	Street	1411	
TYPE & NUMBER OF BLGS & STRUCTURES	Type		Number	
	Single Family House		1	
	Shed		1	
Current Use of Primary Building	Single Family	Historic Use of Primary Building	Single Family	
Style of Primary Blg	Minimal Traditional			
Number of Stories	1	Width (bays)	4	
Foundation Material	Cinderblock	Depth (rooms)	3	
Year Built	1963	Wall Cladding Material	Brick	
Roof Shape	Side gable	Roof Material	Composition shingles	
Decorative Details/Unique Features	Brick porch with white railing and three supporting columns, front gable roof on overhang with vinyl siding. Black shutters on front windows. White surround around front door.			
Evidence of Integrity Location/Materials	Original brick siding.			
Additions/Alterations to Primary Building	New windows, new roof.			
Condition of Primary Building	Fair			code F
Observable Threats	None

Compatibility with Adjacent Land Uses	Good			
Potential NR Eligibility	Contributing			code C
Other Comments / Salient Details	Shrubs along the front of the house. Paved driveway on right side of house. Cement path from sidewalk leading to brick stairs and brick porch with white columns and railings. Brick stairs leading from the driveway on right side of porch. Chimney on right end of house.

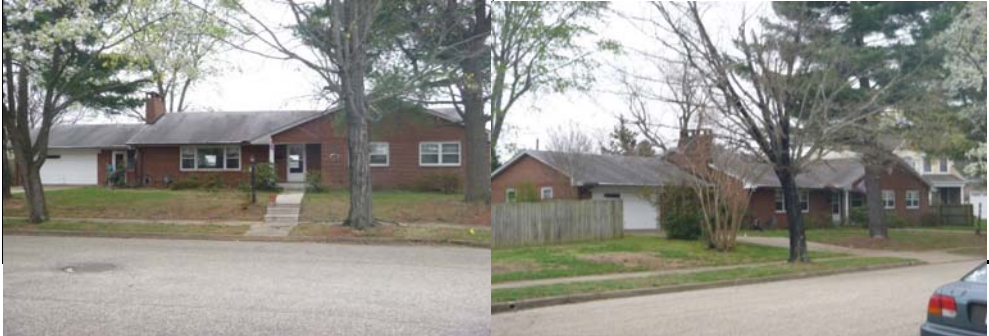
Name of Surveyors	Kimberly Packett		Survey Date	3/26/2016
ADDRESS	Street		Number	
	Buckner	Street	1430	
TYPE & NUMBER OF BLGS & STRUCTURES	Type		Number	
	Single Family House		1	
Current Use of Primary Building	Single Family	Historic Use of Primary Building	Single Family	
Style of Primary Bldg	Minimal Traditional			
Number of Stories	1	Width (bays)	6	
Foundation Material	Cinderblock	Depth (rooms)	2	
Year Built	1957	Wall Cladding Material	Brick	
Roof Shape	Side Gable	Roof Material	Composition Shingle	
Decorative Details/Unique Features	Frotn gable on right side of house that overhangs above small landing in front of front door with one white column. Door to the right of the garage door.			
Evidence of Integrity Location/Materials	Original brick siding and windows.			
Additions/Alterations to Primary Building	New roof			
Condition of Primary Building	Fair			code F
Observable Threats	None			
Compatibility with Adjacent Land Uses	Good

Potential NR Eligibility	Contributing			code C
Other Comments / Salient Details	Cement driveway leading to attached garage on left side of house. Bushes along front of house. Cement path and stairs leading to front door. Interior chimney on left side of the house. Wood privacy fence around backyard.			
Photo Views				
1 Front View	2 3/4 View	3	4

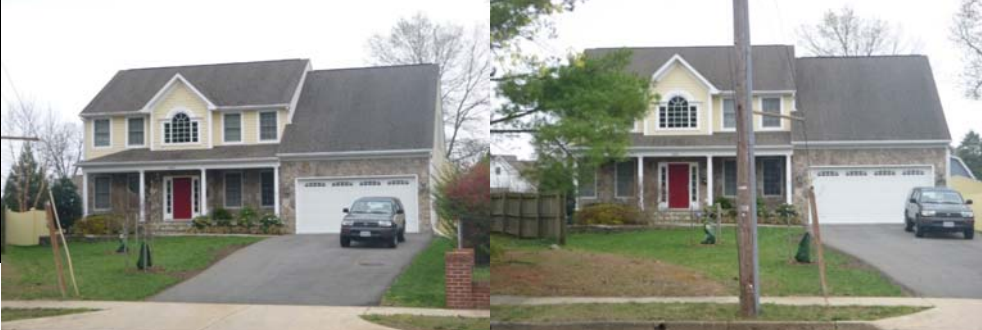
Name of Surveyors	Kimberly Packett		Survey Date	3/26/2016
ADDRESS	Street		Number	
	Buckner	Street	1434	
TYPE & NUMBER OF BLGS & STRUCTURES	Type		Number	
	Single Family House		1	
Current Use of Primary Building	Single Family	Historic Use of Primary Building	Single Family	
Style of Primary Bldg	Neo-colonial			
Number of Stories	2	Width (bays)	6	
Foundation Material	Concrete	Depth (rooms)	2	
Year Built	2007	Wall Cladding Material	Hardboard siding	
Roof Shape	Side Gable	Roof Material	Composition shingle	
Decorative Details/Unique Features	Sidelights on either side of red front door. Front gable in middle of second story with palladian window. Stone façade on the front first story.			
Evidence of Integrity Location/Materials	All original materials.			
Additions/Alterations to Primary Building	None			
Condition of Primary Building	Excellent			code E
Observable Threats	None			
Compatibility with Adjacent Land Uses	Good

Potential NR Eligibility	Non-contributing			code N
Other Comments / Salient Details	Paved driveway leading to attached garage on the left side of the house. Cement path leading from the driveway to the brick front porch. Bushes along front porch. Wood privacy fence around backyard.			
Photo Views				
1 3/4 View	2 Front View	3	4

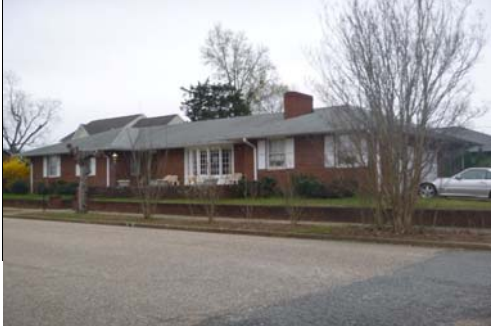
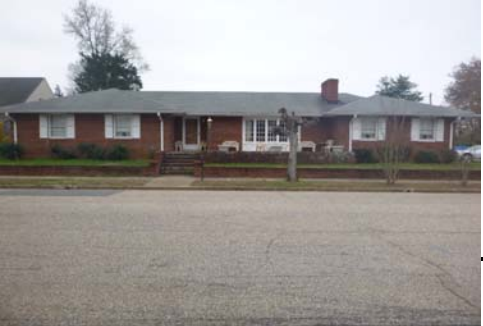
Name of Surveyors	Kimberly Packett		Survey Date	3/26/2016
ADDRESS	Street		Number	
	Buckner	Street	1436	
TYPE & NUMBER OF BLGS & STRUCTURES	Type		Number	
	Single Family House		1	
Current Use of Primary Building	Single Family	Historic Use of Primary Building	Single Family	
Style of Primary Bldg	Ranch			
Number of Stories	1	Width (bays)	6	
Foundation Material	Cinderblock	Depth (rooms)	1	
Year Built	1966	Wall Cladding Material	Brick	
Roof Shape	Hip	Roof Material	Composition shingle	
Decorative Details/Unique Features	White shutters on front windows on either end of the house. Small brick front porch by front door. Bay window to the right of the front door with decorative white siding below.			
Evidence of Integrity Location/Materials	Original brick siding. Windows on either end of the front of the house appear to be original.			
Additions/Alterations to Primary Building	New window to the right of the front door, new roof.

Condition of Primary Building	Good			code
				G
Observable Threats	None			
Compatibility with Adjacent Land Uses	Good			
Potential NR Eligibility	Contributing			code
				C
Other Comments / Salient Details	Brick retaining wall along front of property. Brick stairs and path leading to front door. Bushes along front of house. Interior chimney on right side of the house. Paved driveway leading to attached garage on right side of the house. Lamp post in front yard.			
Photo Views				
1 3/4 View	2 Front View	3	4

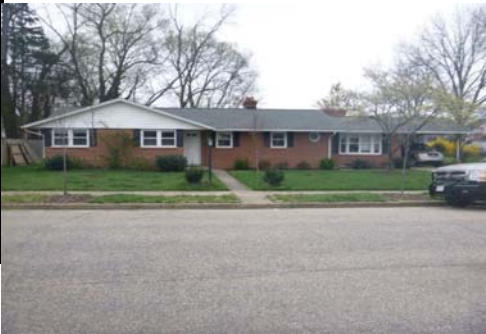
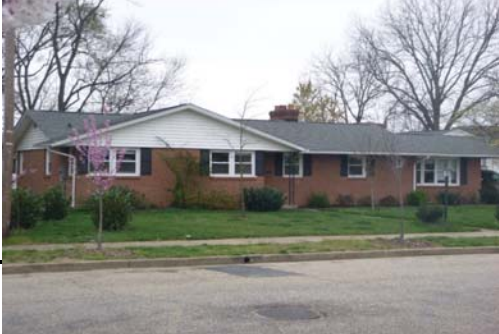
Name of Surveyors	Kimberly Packett		Survey Date	3/26/2016
ADDRESS	Street		Number	
	Buckner	Street	1410	
TYPE & NUMBER OF BLGS & STRUCTURES	Type		Number	
	Single Family House		1	
Current Use of Primary Building	Single Family	Historic Use of Primary Building	Single Family	
Style of Primary Bldg	Ranch			
Number of Stories	1	Width (bays)	6	
Foundation Material	Cinderblock	Depth (rooms)	2	
Year Built	1961	Wall Cladding Material	Brick	
Roof Shape	Side Gable	Roof Material	Composition shingle	
Decorative Details/Unique Features	Front gable with vinyl siding on left side of house. Black shutters on front windows. Attached carport on right side of house. Vinyl siding on either gable end.			
Evidence of Integrity Location/Materials	Original brick siding.			
Additions/Alterations to Primary Building	New roof and windows.			
Condition of Primary Building	Good		code	
			G	
Observable Threats	None			
Compatibility with Adjacent Land Uses	Good

Potential NR Eligibility	Contributing		code	
			C	
Other Comments / Salient Details	Central chimney. Cement path leading from sidewalk to small cement front porch with overhang supported by iron support. Paved driveway leading to carport on right side of the house. Small bushes along front of the house.			
Photo Views				
1 Front View	2 3/4 View	3	4

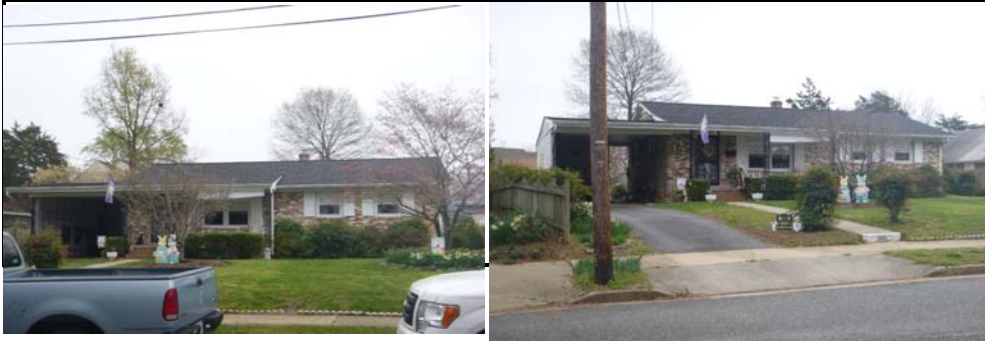
Name of Surveyors	Kimberly Packett		Survey Date	3/26/2016
ADDRESS	Street		Number	
	Rappahannock Avenue		1005	
TYPE & NUMBER OF BLGS & STRUCTURES	Type		Number	
	Single Family House		1	
Current Use of Primary Building	Single Family	Historic Use of Primary Building	Single Family	
Style of Primary Bldg	Minimal Traditional			
Number of Stories	1	Width (bays)	4	
Foundation Material	Cinderblock	Depth (rooms)	2	
Year Built	1968	Wall Cladding Material	Brick	
Roof Shape	Side Gable	Roof Material	Composition shingle	
Decorative Details/Unique Features	White shutters on front windows. Multi-colored brick siding.			
Evidence of Integrity Location/Materials	Original brick siding. Original windows.			
Additions/Alterations to Primary Building	New roof. Attached carport on left side of the house.			
Condition of Primary Building	Good		code	G
Observable Threats	None			
Compatibility with Adjacent Land Uses	Good			
Potential NR Eligibility	Non-Contributing		code	N

Other Comments / Salient Details	Cement path leading from sidewalk to brick stairs with iron railing leading to small cement front porch. Front porch has roof overhand supported by iron supports. Interior chimney. Paved driveway leading to attached carport on left side of the house. Bushes along front of house. Vinyl siding on left side of carport.			
Photo Views				
1 Front View	2 3/4 View	3	4

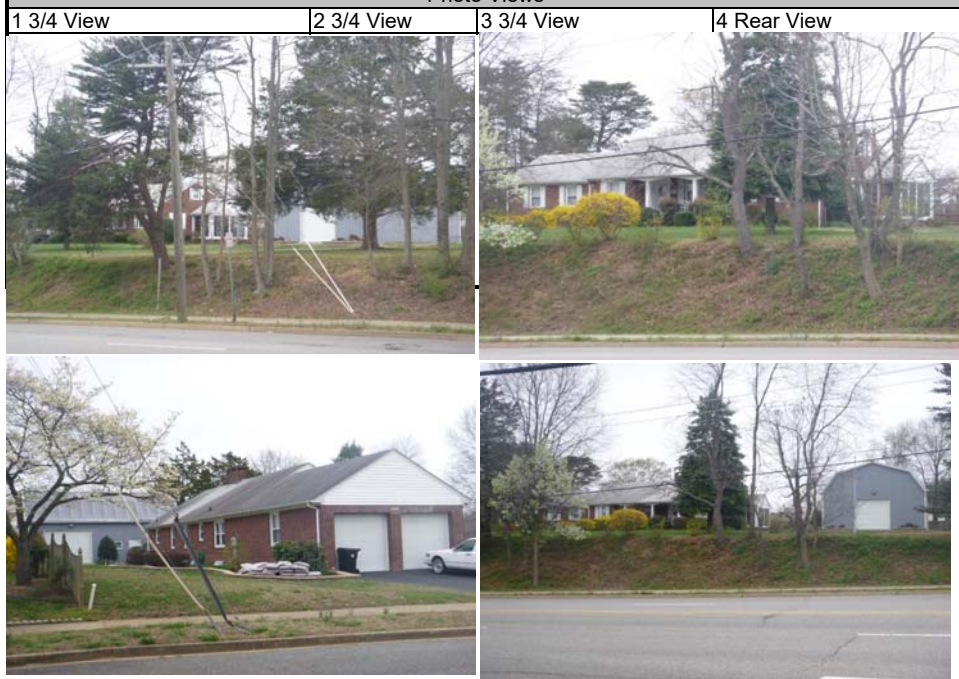
Name of Surveyors	Kimberly Packett	Survey Date	3/26/2016
ADDRESS	Street	Number	
	Rappahannock Avenue	1001	
TYPE & NUMBER OF BLGS & STRUCTURES	Type	Number	
	Single Family House	1	
	Shed/Barn	1	
Current Use of Primary Building	Single Family	Historic Use of Primary Building	Single Family
Style of Primary Bldg	Ranch		
Number of Stories	1	Width (bays)	6
Foundation Material	Cinderblock	Depth (rooms)	2
Year Built	1957	Wall Cladding Material	Brick
Roof Shape	Side gable	Roof Material	Composition Shingle
Decorative Details/Unique Features	White shutters on front windows. Roof overhang above front porch with white columns and decorative archway between columns.		
Evidence of Integrity Location/Materials	Original brick siding.		
Additions/Alterations to Primary Building	New roof and windows.		
Condition of Primary Building	Good	code G	
Observable Threats	None		
Compatibility with Adjacent Land Uses	Good		
Potential NR Eligibility	Contributing	code C

Other Comments / Salient Details	Paved driveway leading to attached garage on left side of house. Cement path leading from driveway to brick front porch. Central chimney. Sunroom on right side of the house. Blue barn with a gambrel roof on the property.

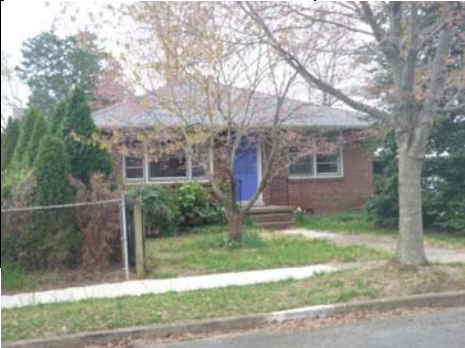
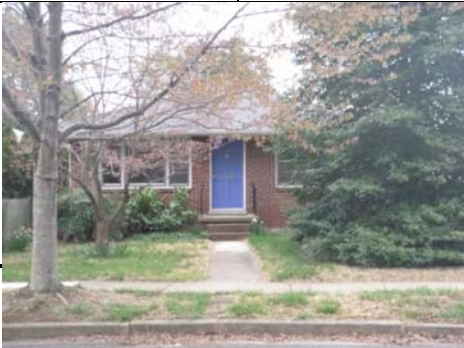
Name of Surveyors	Kimberly Packett		Survey Date	3/26/2016
ADDRESS	Street		Number	
	Rappahannock Avenue		1009	
TYPE & NUMBER OF BLGS & STRUCTURES	Type		Number	
	Single Family House		1	
Current Use of Primary Building	Single Family	Historic Use of Primary Building	Single Family	
Style of Primary Bldg	Minimal Traditional			
Number of Stories	1	Width (bays)	3	
Foundation Material	Cinderblock	Depth (rooms)	2	
Year Built	1958	Wall Cladding Material	Brick	
Roof Shape	Hip	Roof Material	Composition shingle	
Decorative Details/Unique Features	Brigh blue front door. Decorative brick mantel below windows on either side of front door.			
Evidence of Integrity Location/Materials	Original brick siding and windows.			
Additions/Alterations to Primary Building	New roof.			
Condition of Primary Building	Fair		code	
			F	
Observable Threats	None			
Compatibility with Adjacent Land Uses	Good			
Potential NR Eligibility	Contributing		code

C	
Other Comments / Salient Details	Cement path and stairs with iron railing leading from the sidewalk to the front door. Overgrown bushes and trees make it difficult to see the rest of the house.			
Photo Views				
1 3/4 View	2 Front View	3	4

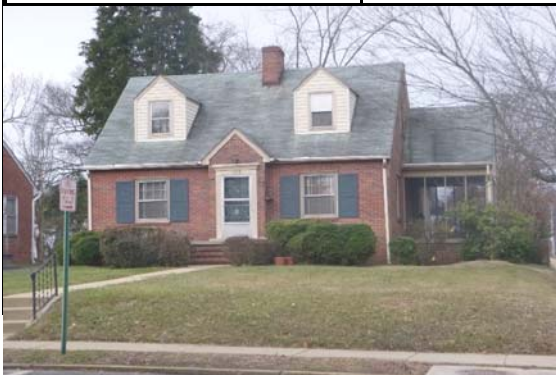
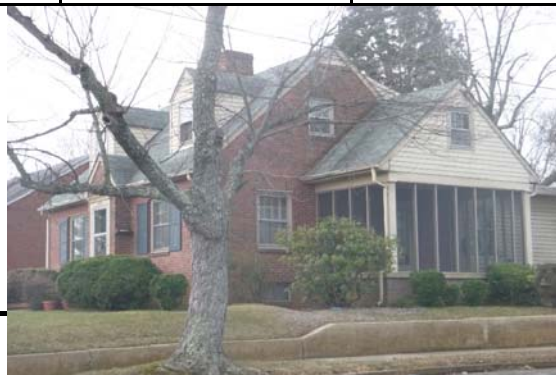
Name of Surveyors	Kimberly Packett		Survey Date	2/21/2016
ADDRESS	Street		Number	
	College	Avenue	1818	
TYPE & NUMBER OF BLGS & STRUCTURES	Type		Number	
	Single Family House		1	
	Shed		1	
Current Use of Primary Building	Single Family	Historic Use of Primary Building	Single Family	
Style of Primary Blg	Cape Cod			
Number of Stories	1 1/2	Width (bays)	3	
Foundation Material	Cinderblock	Depth (rooms)	3	
Year Built	1954	Wall Cladding Material	Brick	
Roof Shape	Side gable	Roof Material	Composition shingles	
Decorative Details/Unique Features	Two dormers on front of roof with vinyl siding, central chimney, blue shutters on front windows, tan surround around front door, storm door, sun porch on right side			
Evidence of Integrity Location/Materials	Appears to be original windows on original part of house			
Additions/Alterations to Primary Building	Addition on back of house with vinyl siding and new windows

Condition of Primary Building	Excellent		code	
			E	
Observable Threats	Growth of UMW			
Compatibility with Adjacent Land Uses	Good			
Potential NR Eligibility	Contributing		code	
			C	
Other Comments / Salient Details	Gravel driveway on the left side of the house, shrubs along the front and side of the house, cement steps with iron railing at front of property, cement path leading to brick stairs by front door, chain link fence around backyard			
Photo Views				
1 Front view	2 3/4 view	3	4

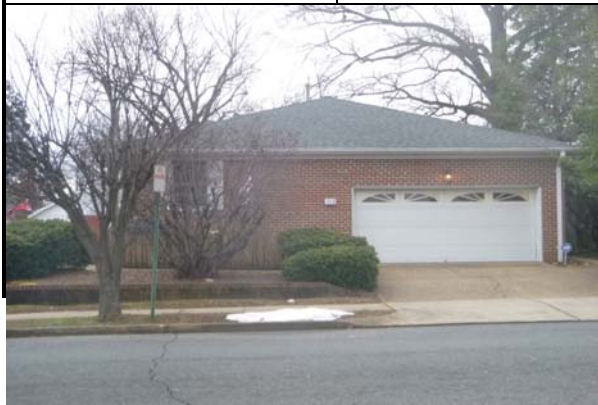
1 Front View

Name of Surveyors	Kimberly Packett		Survey Date	2/21/2016
ADDRESS	Street		Number	
	Thornton	Street	1212	
TYPE & NUMBER OF BLGS & STRUCTURES	Type		Number	
	Single Family House		1	
Current Use of Primary Building	Single Family	Historic Use of Primary Building	Single Family	
Style of Primary Blg	Ranch			
Number of Stories	1	Width (bays)	4	
Foundation Material	Cinderblock	Depth (rooms)	2	
Year Built	1994	Wall Cladding Material	Brick	
Roof Shape	Hip	Roof Material	Composition shingles	
Decorative Details/Unique Features	White shutters on windows, attached garage, front door on the left side of the house			
Evidence of Integrity Location/Materials	Appears to be all original materials			
Additions/Alterations to Primary Building	None noticeable, recent construction			
Condition of Primary Building	Good		code	
			G	
Observable Threats	Commerical land use nearby			
Compatibility with Adjacent Land Uses	Bad, not compatible with surrounding styles

Potential NR Eligibility	Non-Contributing		code	
			N	
Other Comments / Salient Details	Driveway with bushes along it leading to attached garage, brick retaining wall along front of property, cement porch with white railing in front of front door, wood fence along street side of house

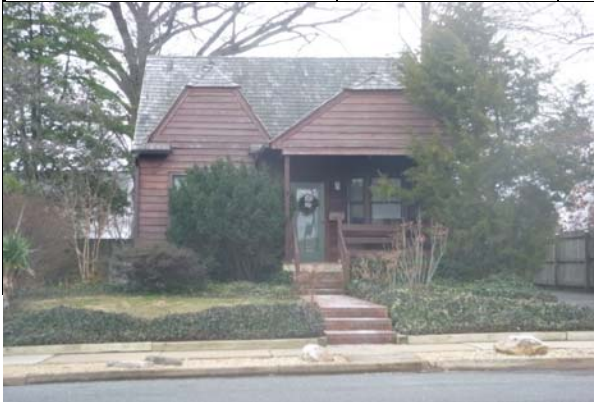
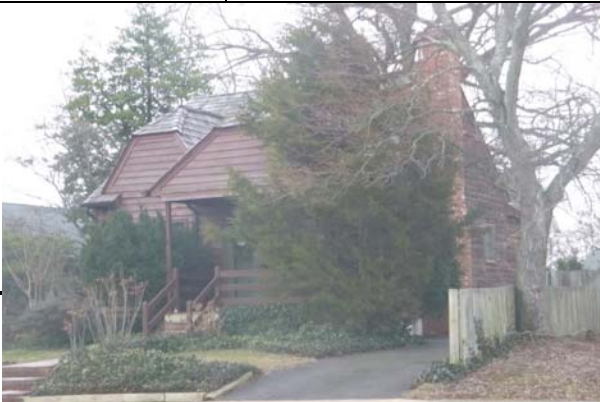
Name of Surveyors	Kimberly Packett		Survey Date	2/21/2016
ADDRESS	Street		Number	
	Thornton	Street	1216	
TYPE & NUMBER OF BLGS & STRUCTURES	Type		Number	
	Single Family House		1	
Current Use of Primary Building	Single Family	Historic Use of Primary Building	Single Family	
Style of Primary Bldg	Tudor			
Number of Stories	1 1/2	Width (bays)	3	
Foundation Material	Concrete	Depth (rooms)	2	
Year Built	1948	Wall Cladding Material	Wood siding	
Roof Shape	Side Gable	Roof Material	Cedar shake	
Decorative Details/Unique Features	Red wooden siding, two clipped gables on the front of the house			
Evidence of Integrity Location/Materials	Appears to be original siding			
Additions/Alterations to Primary Building	Addition on the back of the house			
Condition of Primary Building	Good	code		
		G		
Observable Threats	None			
Compatibility with Adjacent Land Uses	Good			
Potential NR Eligibility	Non-Contributing	code		
		N

Other Comments / Salient Details	Paved driveway on right side of the house, chimney on right side of house, cement stairs and steps leading up to cement porch and red wooden railing on stairs and porch. Many bushes and ivy on property, large tree on right side of house. Wooden fence around property.			
Photo Views				
1 Front view	2 3/4 view	3	4

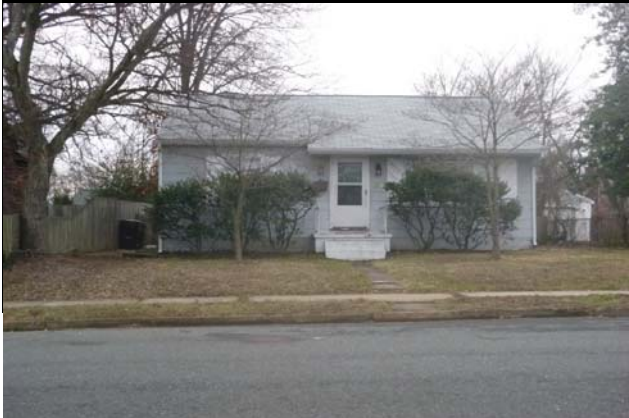
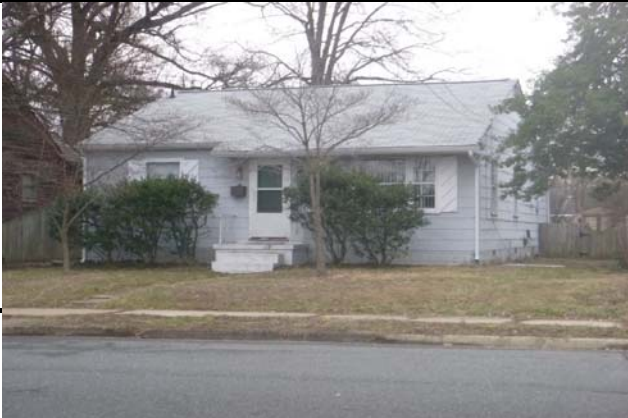
Name of Surveyors	Kimberly Packett		Survey Date	2/21/2016
ADDRESS	Street		Number	
	Thornton	Street	1218	
TYPE & NUMBER OF BLGS & STRUCTURES	Type		Number	
	Single Family House		1	
	Shed		1	
Current Use of Primary Building	Single Family	Historic Use of Primary Building	Single Family	
Style of Primary Blg	Cape Cod			
Number of Stories	1	Width (bays)	3	
Foundation Material	Cinderblock	Depth (rooms)	3	
Year Built	1949	Wall Cladding Material	Asbestos shingles	
Roof Shape	Side gable	Roof Material	Composition shingles	
Decorative Details/Unique Features	White horizontal shutters. Lanterns connected to house on either side of front door.			
Evidence of Integrity Location/Materials	Appears to be original siding.			
Additions/Alterations to Primary Building	New roof and windows.			
Condition of Primary Building	Good		code	
			G	
Observable Threats	None			
Compatibility with Adjacent Land Uses	Good			
Potential NR Eligibility	Contributing		code

C	
Other Comments / Salient Details	Short wooden fence around backyard. Cement path and stairs leading to small porch with white metal railings. Trees and shrubs in front of house.			
Photo Views				
1 Front view	2 3/4 view	3	4

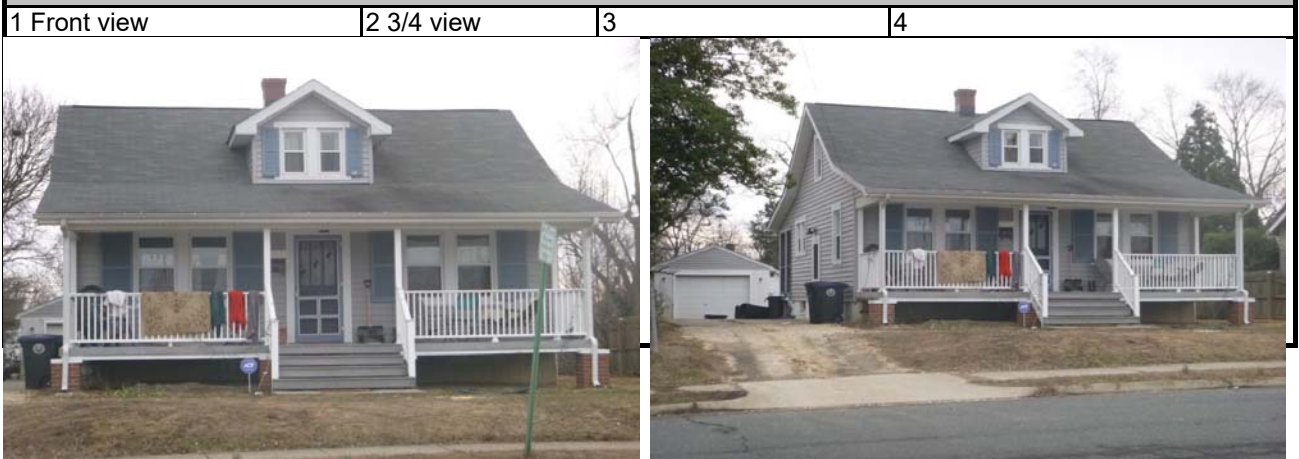
Name of Surveyors	Kimberly Packett		Survey Date	2/21/2016
ADDRESS	Street		Number	
	Thornton	Street	1224	
TYPE & NUMBER OF BLGS & STRUCTURES	Type		Number	
	Single Family House		1	
	Detatched Garage		1	
Current Use of Primary Building	Single Family	Historic Use of Primary Building	Single Family	
Style of Primary Blg	Bungalow			
Number of Stories	1 1/2	Width (bays)	3	
Foundation Material	Concrete	Depth (rooms)	3	
Year Built	1937	Wall Cladding Material	Vinyl siding	
Roof Shape	Gable-on-hip	Roof Material	Composition shingles	
Decorative Details/Unique Features	Blue shutters, white surround around front foer, central dormer on front of house.			
Evidence of Integrity Location/Materials	None			
Additions/Alterations to Primary Building	New siding, windows, door, and porch railing.			
Condition of Primary Building	Good		code	
			G	
Observable Threats	None			
Compatibility with Adjacent Land Uses	Good			
Potential NR Eligibility	Non-Contributing		code

N	
Other Comments / Salient Details	Central chimney, dirt driveway on left side of house leading to detatched garage, screened in porch on back of house, composited stairs leading to composite front porch with white railings and pillars.

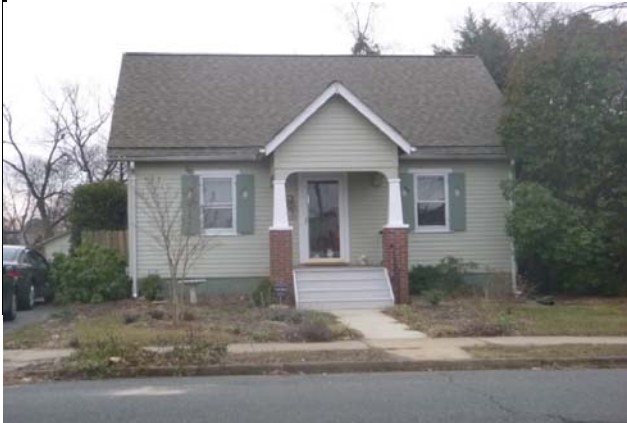
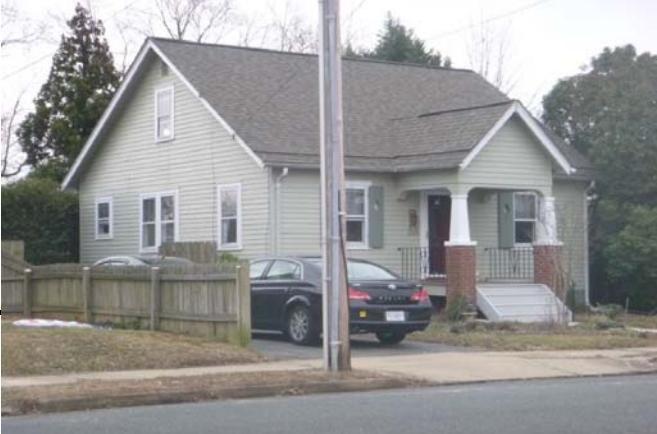
Name of Surveyors	Kimberly Packett		Survey Date	2/21/2016
ADDRESS	Street		Number	
	Thornton	Street	1228	
TYPE & NUMBER OF BLGS & STRUCTURES	Type		Number	
	Single Family House		1	
	Shed		1	
Current Use of Primary Building	Single Family	Historic Use of Primary Building	Single Family	
Style of Primary Blg	Cape Cod			
Number of Stories	1 1/2	Width (bays)	3	
Foundation Material	Concrete	Depth (rooms)	3	
Year Built	1937	Wall Cladding Material	Vinyl siding	
Roof Shape	Side gable	Roof Material	Composition shingle	
Decorative Details/Unique Features	Front gable entry porch with brick based columns. Green shutters on front of the house with diamond cutouts.			
Evidence of Integrity Location/Materials	None			
Additions/Alterations to Primary Building	New siding, windows, and roof. Entry porch was added to the building.			
Condition of Primary Building	Excellent		code	
			E	
Observable Threats	None			
Compatibility with Adjacent Land Uses	Good.

Potential NR Eligibility	Non-Contributing		code	
			N	
Other Comments / Salient Details	Wooden fence around property, paved driveway on left side of the house, cement pathway leading to composite board porch with black iron railings.			
Photo Views				
1 Front view	2 3/4 view	3	4

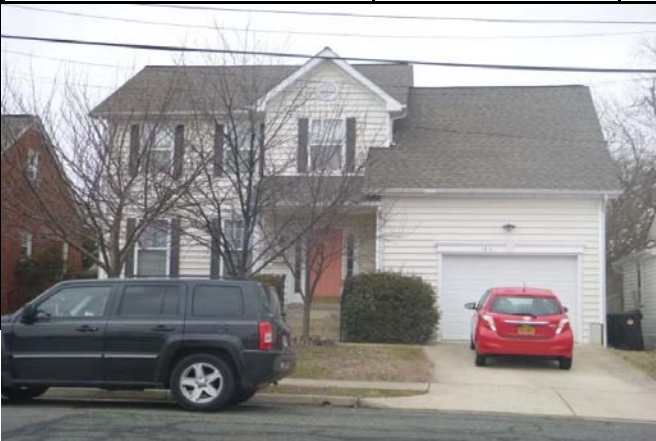
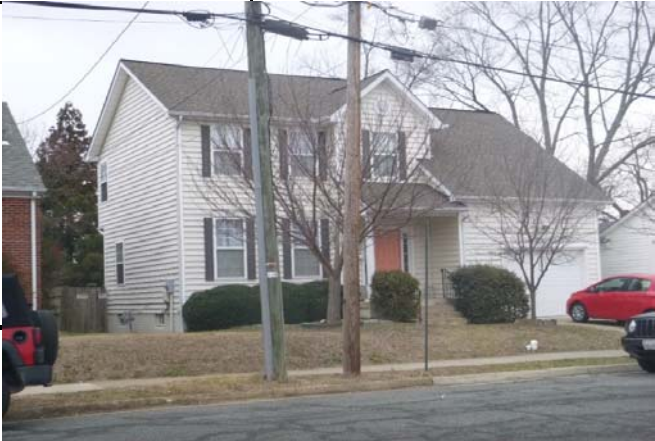
Name of Surveyors	Kimberly Packett		Survey Date	2/21/2016
ADDRESS	Street		Number	
	Augustine Avenue		1811	
TYPE & NUMBER OF BLGS & STRUCTURES	Type		Number	
	Single Family House		1	
Current Use of Primary Building	Single Family	Historic Use of Primary Building	Single Family	
Style of Primary Blg	Colonial Revival			
Number of Stories	2	Width (bays)	4	
Foundation Material	Concrete	Depth (rooms)	1	
Year Built	2004	Wall Cladding Material	Vinyl siding	
Roof Shape	Side gable	Roof Material	Composition shingle	
Decorative Details/Unique Features	Dark grey shutters on front windows, sidelights on either side of front door. Small covered landing in front of front door. Circular attic window below front gable.			
Evidence of Integrity Location/Materials	Most likely all orginial materials since house was built twelve years ago.			
Additions/Alterations to Primary Building	None.			
Condition of Primary Building	Excellent		code

E	
Observable Threats	None			
Compatibility with Adjacent Land Uses	Poor, new construction.			
Potential NR Eligibility	Non-Contributing		code	
			N	
Other Comments / Salient Details	Wooden fence around backyard, cement driveway leading to attached garage. Bushes along front of house. Trees in front of property.			
Photo Views				
1 Front View	2 3/4 view	3	4

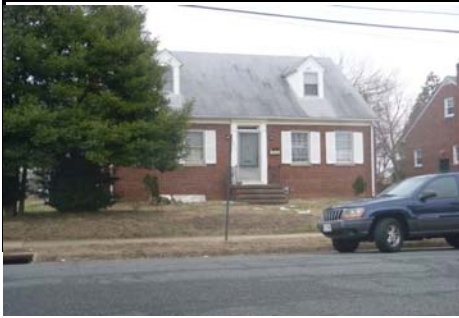
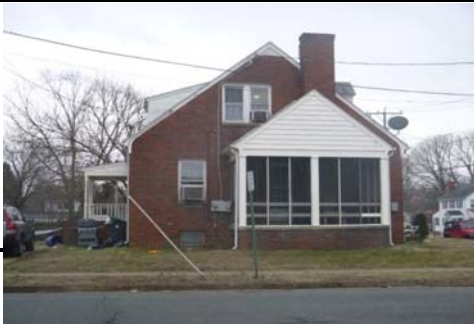
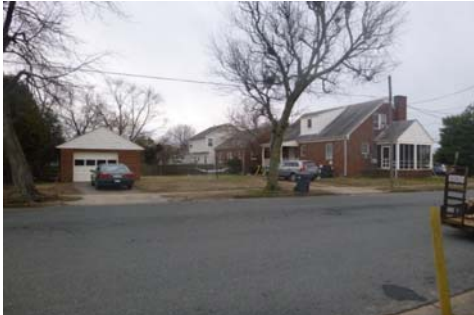
Name of Surveyors	Kimberly Packett	Survey Date	2/21/2016
ADDRESS	Street	Number	
	Augustine Avenue	1819	
TYPE & NUMBER OF BLGS & STRUCTURES	Type	Number	
	Single Family House	1	
	Detached Garage	1	
Current Use of Primary Building	Single Family	Historic Use of Primary Building	Single Family
Style of Primary Blg	Cape Cod		
Number of Stories	1 1/2	Width (bays)	5
Foundation Material	Cinderblock	Depth (rooms)	2
Year Built	1948	Wall Cladding Material	Brick
Roof Shape	Side gable	Roof Material	Composition shingle
Decorative Details/Unique Features	White shutters on windows on front of house. Simple surround around front door with transom. Two small gables on front of the house. One gable on back of the house. Gables have asbestos siding.		
Evidence of Integrity Location/Materials	Original brick siding and appears to be original windows.		
Additions/Alterations to Primary Building	New roof, sun porch on left side of the house.

Condition of Primary Building	Fair	code	
		F	
Observable Threats	None		
Compatibility with Adjacent Land Uses	Good		
Potential NR Eligibility	Contributing	code	
		C	
Other Comments / Salient Details	Covered patio on back of the house, screened in porch on left side of the house. Cement path leading to front door with small landing with iron railing. Two driveways in backyard one leading to detached garage.		
Photo Views			
1 Front view	2 Side view	3 Backyard view	4

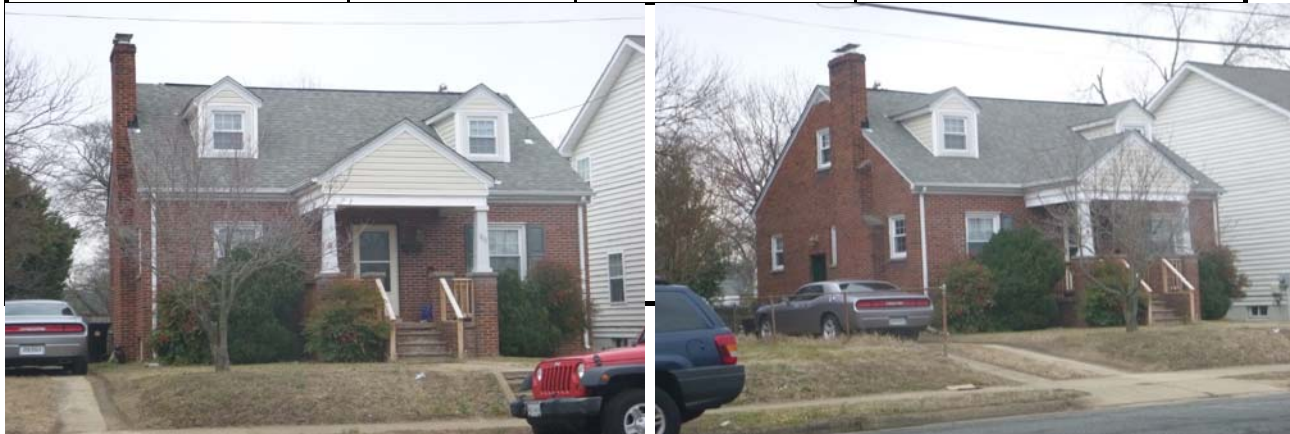
Name of Surveyors	Kimberly Packett	Survey Date	2/21/2016
ADDRESS	Street	Number	
	Augustine Avenue	1815	
TYPE & NUMBER OF BLGS & STRUCTURES	Type	Number	
	Single Family House	1	
Current Use of Primary Building	Single Family	Historic Use of Primary Building	Single Family
Style of Primary Blg	Cape Cod		
Number of Stories	1 1/2	Width (bays)	3
Foundation Material	Cinderblock	Depth (rooms)	3
Year Built	1946	Wall Cladding Material	Brick
Roof Shape	Side gable	Roof Material	Asbestos shingle
Decorative Details/Unique Features	Front gable entry porch and two front dormers have hardboard siding. Black shutters on front windows. Front porch columns have brick bottoms.		
Evidence of Integrity Location/Materials	Original brick siding, original roof.		
Additions/Alterations to Primary Building	Entry porch addition on front of house, appears to be new windows.		
Condition of Primary Building	Good	code G	
Observable Threats	None

Compatibility with Adjacent Land Uses	Good		
Potential NR Eligibility	Contributing	code C	
Other Comments / Salient Details	Chimney on left side of building, cement pathway and steps leading to small covered front porch, porch has bare wood railing. Bushes along front of house, cement driveway on left side of the house.		
Photo Views			
1 Front view	2 3/4 view	3	4
