Cultural Resource Survey of College Heights in Fredericksburg, Virginia

Master of Science

Historic Preservation

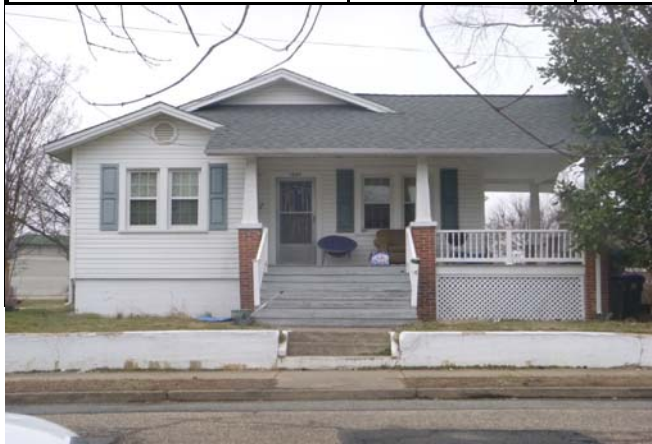
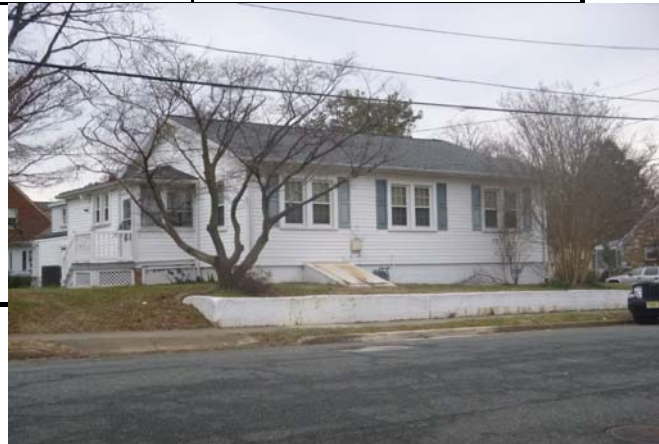
Name of Surveyors	Kimberly Packett		Survey Date	2/21/2016
ADDRESS	Street		Number	
	Seacobeck	Street	1237	
TYPE & NUMBER OF BLGS & STRUCTURES	Type		Number	
	Single Family House		1	
Current Use of Primary Building	Single Family	Historic Use of Primary Building	Single Family	
Style of Primary Blg	Bungalow			
Number of Stories	1	Width (bays)	3	
Foundation Material	Concrete	Depth (rooms)	3	
Year Built	1949	Wall Cladding Material	Vinyl siding	
Roof Shape	Front gable	Roof Material	Composition shingle	
Decorative Details/Unique Features	Green shutters on windows. Side gable roof on porch. Porch columns have brick bottoms. Circular attic vent on front dormer.			
Evidence of Integrity Location/Materials	None			
Additions/Alterations to Primary Building	New siding and windows.			
Condition of Primary Building	Good		code	
			G	
Observable Threats	None			
Compatibility with Adjacent Land Uses	Good			
Potential NR Eligibility	Non-Contributing		code

N	
Other Comments / Salient Details	Cement retaining wall along front and left side of property. Basement access on left side of house. Cement stairs and path leading to porch. Stairs and small landing on back of house leading to back door.			
Photo Views				
1 Front view	2 Side view	3	4

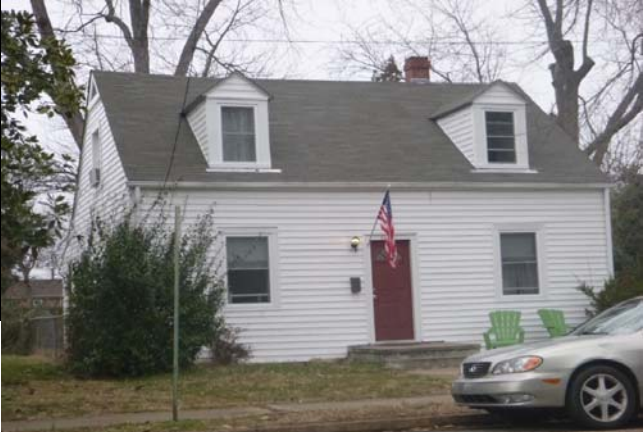
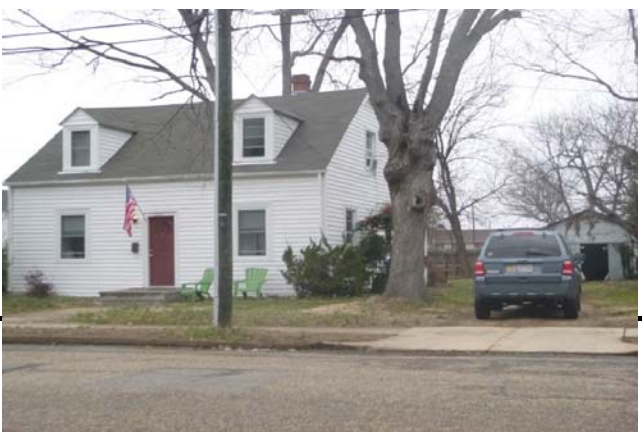
Name of Surveyors	Kimberly Packett		Survey Date	2/21/2016
ADDRESS	Street		Number	
	Seacobeck	Street	1233	
TYPE & NUMBER OF BLGS & STRUCTURES	Type		Number	
	Single Family House		1	
	Detatched Garage		1	
Current Use of Primary Building	Single Family	Historic Use of Primary Building	Single Family	
Style of Primary Blg	Cape Cod			
Number of Stories	1 1/2	Width (bays)	3	
Foundation Material	Concrete	Depth (rooms)	2	
Year Built	1948	Wall Cladding Material	Vinyl siding	
Roof Shape	Side gable	Roof Material	Composition shingle	
Decorative Details/Unique Features	White surround around fron doors and windows. Two dormers on front of house. Red front door.			
Evidence of Integrity Location/Materials	None			
Additions/Alterations to Primary Building	New siding and roof. Appears to be new windows. Addition on back of house.			
Condition of Primary Building	Good	code		
		G		
Observable Threats	None			
Compatibility with Adjacent Land Uses	Good

Potential NR Eligibility	Contributing	code		
		C		
Other Comments / Salient Details	Chainlink and wood fence around property. Cement path leading to stairs and small landing at front door. Interior chimney on right side of house. Dirt driveway on right side of house. Large bushes at front ends of house.			
Photo Views				
1 Front view	2 3/4 view	3	4

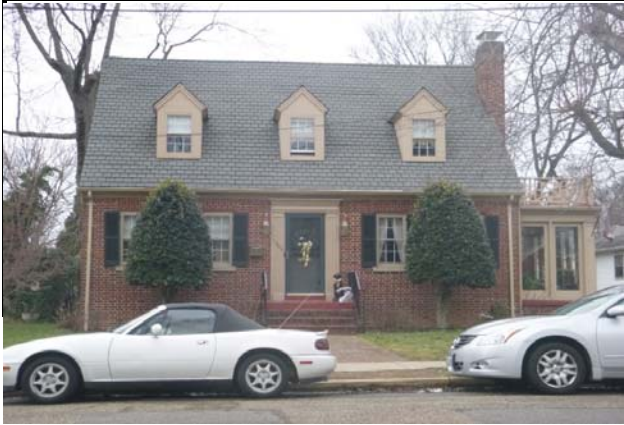
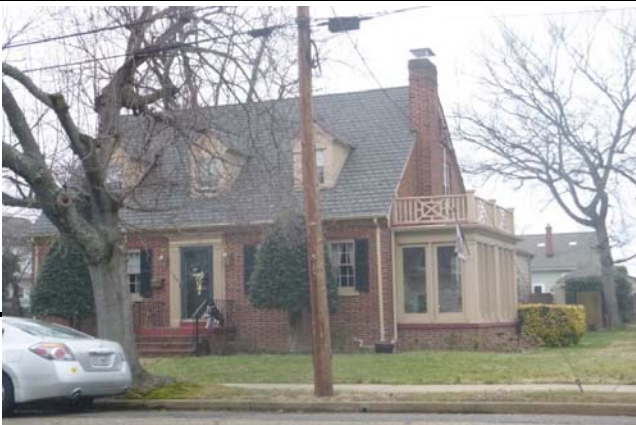
Name of Surveyors	Kimberly Packett		Survey Date	2/21/2016
ADDRESS	Street		Number	
	Seacobeck	Street	1229	
TYPE & NUMBER OF BLGS & STRUCTURES	Type		Number	
	Single Family House		1	
	Shed		1	
Current Use of Primary Building	Single Family	Historic Use of Primary Building	Single Family	
Style of Primary Blg	Cape Cod			
Number of Stories	1 1/2	Width (bays)	5	
Foundation Material	Cinderblock	Depth (rooms)	2	
Year Built	1953	Wall Cladding Material	Brick	
Roof Shape	Side gable	Roof Material	Composition shingle	
Decorative Details/Unique Features	Sunroom on right side of house with flat roof with decorative railing along the edge. Blue shutter on front windows. Three dormers on front of house. Tan entablature around front door.			
Evidence of Integrity Location/Materials	Original brick siding.			
Additions/Alterations to Primary Building	Addition with vinyl siding on back of house. Possibly original windows.

Condition of Primary Building	Excellent			code
				E
Observable Threats	None			
Compatibility with Adjacent Land Uses	Good			
Potential NR Eligibility	Contributing			code
				C
Other Comments / Salient Details	End chimney on right side of house. Cement path leading to front door with brick stairs with iron railing. Nicely manicured trees in front of house.			
Photo Views				
1 Front view	2 3/4 view	3	4

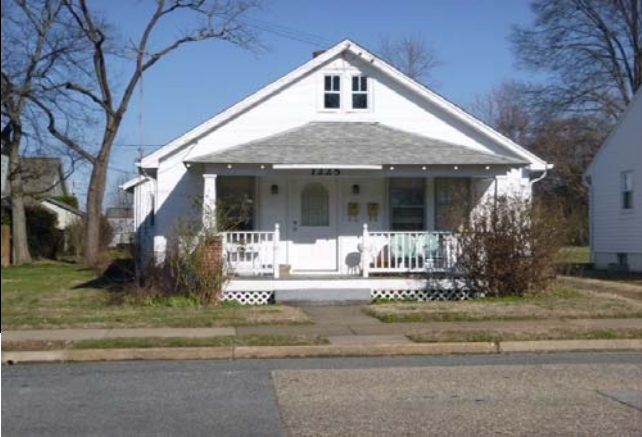
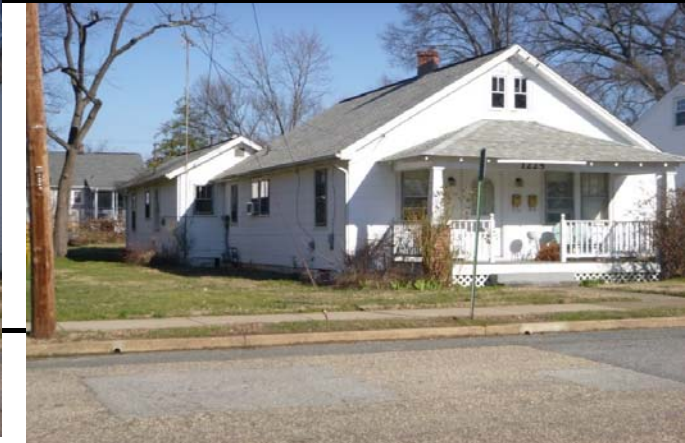
Name of Surveyors	Kimberly Packett		Survey Date	2/21/2016
ADDRESS	Street		Number	
	Seacobeck	Street	1225	
TYPE & NUMBER OF BLGS & STRUCTURES	Type		Number	
	Single Family House		1	
Current Use of Primary Building	Multi-Family	Historic Use of Primary Building	Single Family	
Style of Primary Blg	Bungalow			
Number of Stories	1	Width (bays)	3	
Foundation Material	Cinderblock	Depth (rooms)	6	
Year Built	1939	Wall Cladding Material	Asbestos siding	
Roof Shape	Front gable	Roof Material	Composition shingle	
Decorative Details/Unique Features	Two small attics windows on front of house. Front porch with exposed roof beams. Attachment is a separate apartment.			
Evidence of Integrity Location/Materials	Original siding and possibly original windows.			
Additions/Alterations to Primary Building	Addition on back left of house. New roof.			
Condition of Primary Building	Good	code		
		G		
Observable Threats	None			
Compatibility with Adjacent Land Uses	Good

Potential NR Eligibility	Non-Contributing	code		
		N		
Other Comments / Salient Details	Central chimney. Cement path leading to wood front porch with white railing and pillars with brick bottoms. Bushes in front of porch.			
Photo Views				
1 Front view	2 3/4 view	3	4

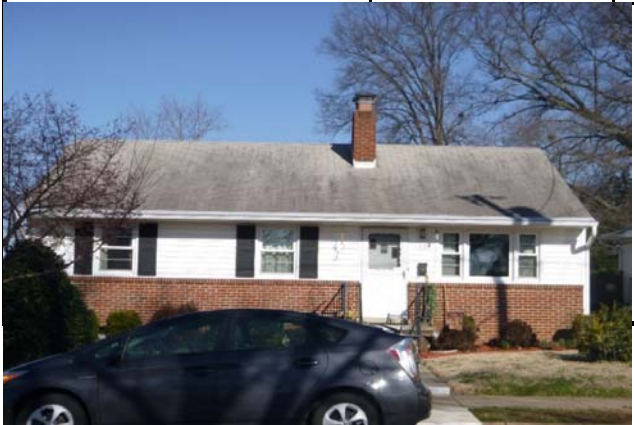
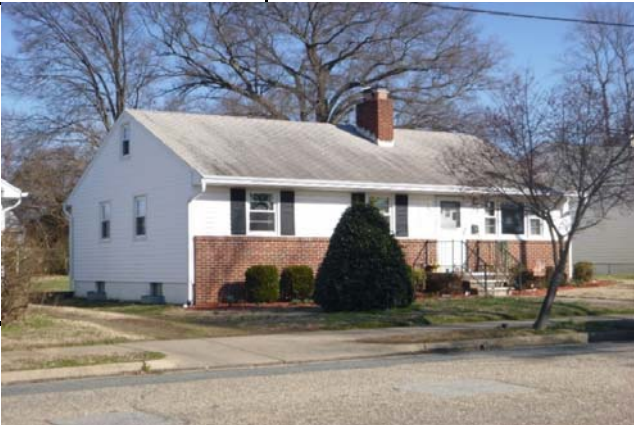
Name of Surveyors	Kimberly Packett		Survey Date	2/21/2016
ADDRESS	Street		Number	
	Seacobeck	Street	1221	
TYPE & NUMBER OF BLGS & STRUCTURES	Type		Number	
	Single Family House		1	
Current Use of Primary Building	Single Family	Historic Use of Primary Building	Single Family	
Style of Primary Blg	Ranch			
Number of Stories	1	Width (bays)	4	
Foundation Material	Cinderblock	Depth (rooms)	2	
Year Built	1962	Wall Cladding Material	Vinyl siding	
Roof Shape	Side gable	Roof Material	Composition shingle	
Decorative Details/Unique Features	Bottom half of front façade is brick. Black shutters on front windows.			
Evidence of Integrity Location/Materials	Appears to be original siding.			
Additions/Alterations to Primary Building	New windows.			
Condition of Primary Building	Good		code	
			G	
Observable Threats	None			
Compatibility with Adjacent Land Uses	Good			
Potential NR Eligibility	Contributing		code	
			C	
Other Comments / Salient Details	Gravel driveway on left side of the house. Cement path and stairs leading up to front door with landing with iron railings. Central chimney. Small bushes along front of the house. Has a basement with small small windows.

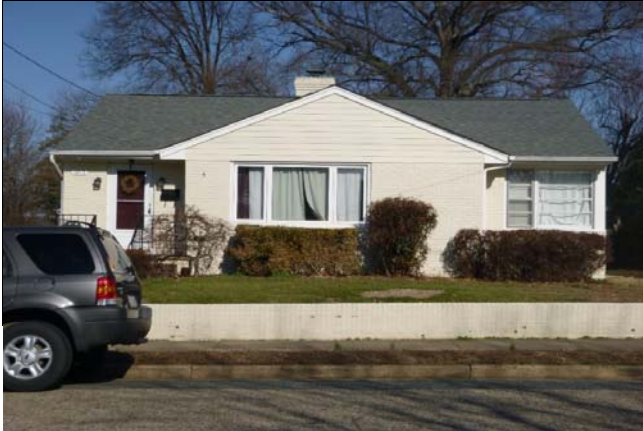
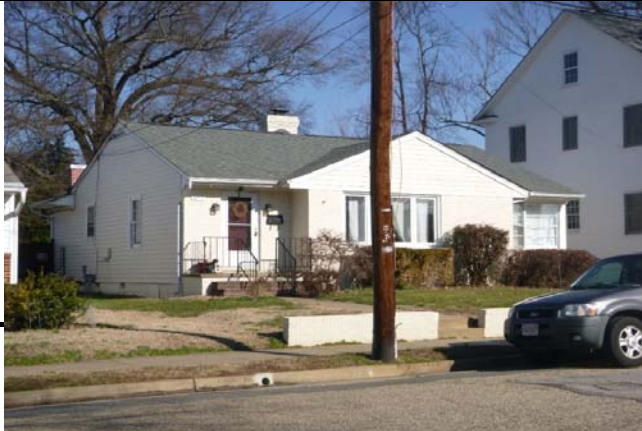
Name of Surveyors	Kimberly Packett		Survey Date	2/21/2016
ADDRESS	Street		Number	
	Seacobeck	Street	1215	
TYPE & NUMBER OF BLGS & STRUCTURES	Type		Number	
	Single Family House		1	
Current Use of Primary Building	Single Family	Historic Use of Primary Building	Single Family	
Style of Primary Blg	Ranch			
Number of Stories	1	Width (bays)	3	
Foundation Material	Cinderblock	Depth (rooms)	2	
Year Built	1954	Wall Cladding Material	Aluminum siding	
Roof Shape	Side gable	Roof Material	Composition shingle	
Decorative Details/Unique Features	Painted white brick on protruding front façade of house with front gable.			
Evidence of Integrity Location/Materials	Original siding.			
Additions/Alterations to Primary Building	New roof and windows.			
Condition of Primary Building	Excellent	code		
		E		
Observable Threats	None			
Compatibility with Adjacent Land Uses	Good			
Potential NR Eligibility	Contributing	code		
		C		
Other Comments / Salient Details	Short brick wall along front of property. Cement path leading to front door with brick stairs and landing with iron railing. Bushes along front of house. Central chimney and chimney on back left of house.

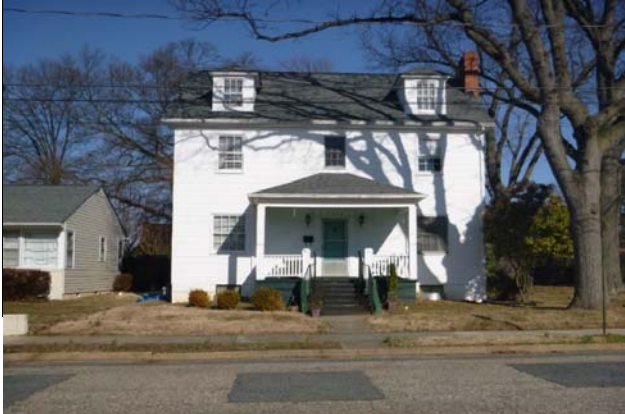
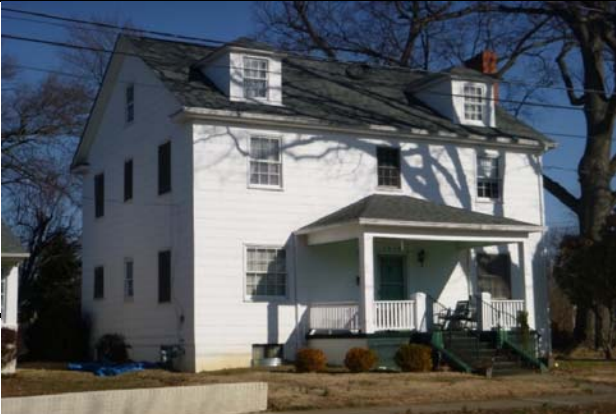
Name of Surveyors	Kimberly Packett		Survey Date	2/21/2016
ADDRESS	Street		Number	
	Seacobeck	Street	1213	
TYPE & NUMBER OF BLGS & STRUCTURES	Type		Number	
	Single Family House		1	
	Shed		1	
Current Use of Primary Building	Single Family	Historic Use of Primary Building	Single Family	
Style of Primary Blg	Colonial Revival			
Number of Stories	2 1/2	Width (bays)	3	
Foundation Material	Concrete	Depth (rooms)	3	
Year Built	1954	Wall Cladding Material	Asbestos siding	
Roof Shape	Side gable	Roof Material	Composition shingle	
Decorative Details/Unique Features	Front porch with hip roof. Two large tree to the right of the house. Two gables on front of the house.			
Evidence of Integrity Location/Materials	Original siding and possibly original windows.			
Additions/Alterations to Primary Building	Appears to be new roof.			
Condition of Primary Building	Good	code		
		G		
Observable Threats	None			
Compatibility with Adjacent Land Uses	Good

Potential NR Eligibility	Contributing	code		
		C		
Other Comments / Salient Details	Chimney on right end of house. Small bushes along front of house, large bushes along right side of house. Cement path leading to front door with covered porch with hip roof. Stairs have black iron railing while porch has white railing with white pillars.			
Photo Views				
1 Front view	2 3/4 view	3	4

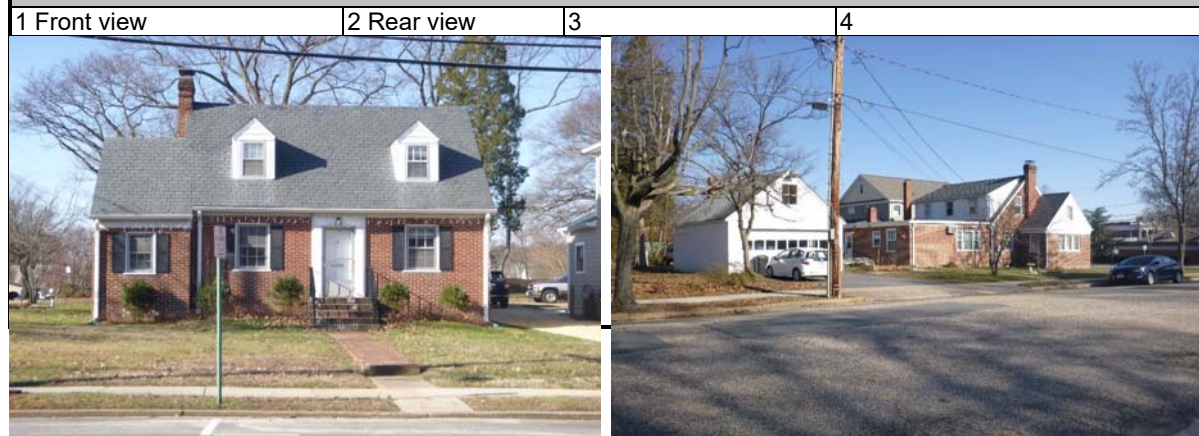
Name of Surveyors	Kimberly Packett		Survey Date	2/21/2016
ADDRESS	Street		Number	
	College	Avenue	1802	
TYPE & NUMBER OF BLGS & STRUCTURES	Type		Number	
	Single Family House		1	
	Detached Garage		1	
Current Use of Primary Building	Single Family	Historic Use of Primary Building	Single Family	
Style of Primary Blg	Cape Cod			
Number of Stories	1 1/2	Width (bays)	4	
Foundation Material	Concrete	Depth (rooms)	3	
Year Built	1941	Wall Cladding Material	Brick	
Roof Shape	Side gable	Roof Material	Slate	
Decorative Details/Unique Features	White entablature around front door. Dark blue shutters on front windows. Two gables on front of house. One large dormer that runs the length of the house on the back with wood siding.			
Evidence of Integrity Location/Materials	Original siding.			
Additions/Alterations to Primary Building	Addition on the back of the house. New roof.			
Condition of Primary Building	Excellent		code	E

Observable Threats	Growth of UMW			
Compatibility with Adjacent Land Uses	Good			
Potential NR Eligibility	Contributing		code	C
Other Comments / Salient Details	Interior chimney on left side of house. Cement driveway leading to detached garage in backyard. Small bushes along front of house.

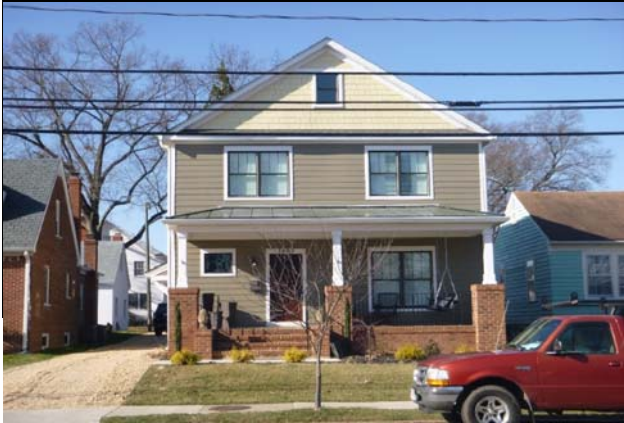
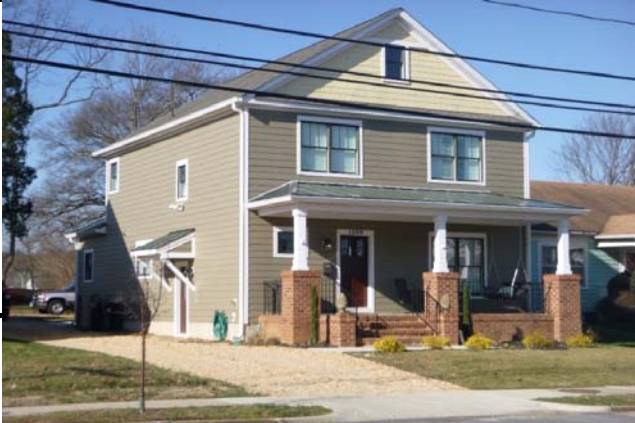
Name of Surveyors	Kimberly Packett		Survey Date	2/21/2016
ADDRESS	Street		Number	
	College	Avenue	1806	
TYPE & NUMBER OF BLGS & STRUCTURES	Type		Number	
	Single Family House		1	
Current Use of Primary Building	Single Family	Historic Use of Primary Building	Single Family	
Style of Primary Blg	Bungalow			
Number of Stories	2	Width (bays)	3	
Foundation Material	Concrete	Depth (rooms)	3	
Year Built	2016	Wall Cladding Material	Vinyl siding	
Roof Shape	Front gable	Roof Material	Composition shingle	
Decorative Details/Unique Features	Brick front porch with black iron railings. Porch columns have brick bases and white tops. Porch has a hip metal roof. Decorative shingle on front gable on front of house. White surround around doors and windows.			
Evidence of Integrity Location/Materials	All original materials most likely since house was built this year.			
Additions/Alterations to Primary Building	None			
Condition of Primary Building	Excellent			code E

Observable Threats	Growth of UMW			
Compatibility with Adjacent Land Uses	Bad, does not match surrounding styles			
Potential NR Eligibility	Non-contributing			code N
Other Comments / Salient Details	Pebble driveway on left side of house. Cement path from driveway to brick front proch. Side door with metal overhang on left side of house.			
Photo Views				
1 Front view	2 3/4 view	3	4

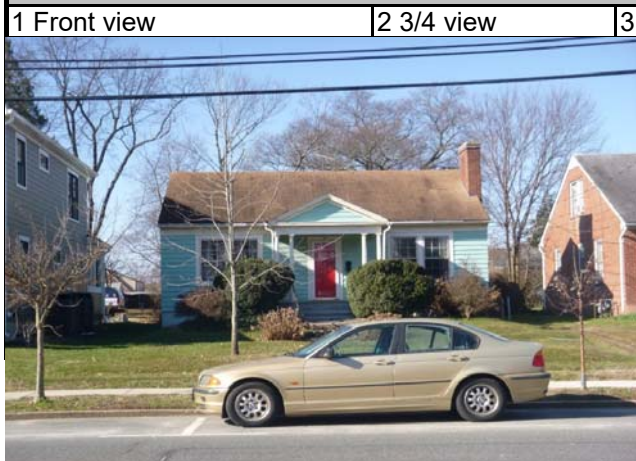
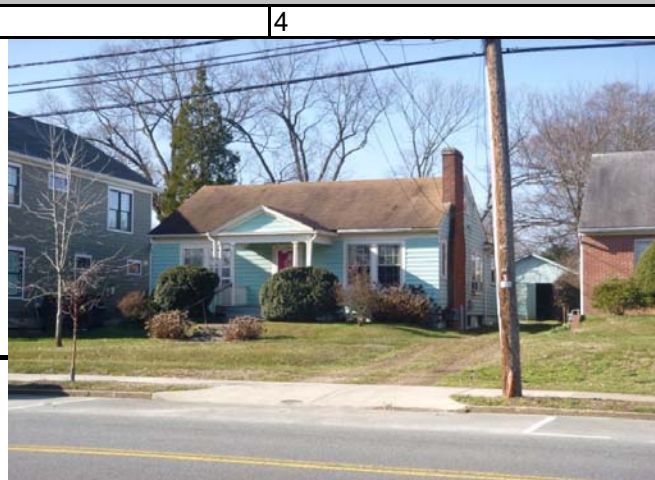
Name of Surveyors	Kimberly Packett		Survey Date	2/21/2016
ADDRESS	Street		Number	
	College	Avenue	1810	
TYPE & NUMBER OF BLGS & STRUCTURES	Type		Number	
	Single Family House		1	
	Shed		1	
Current Use of Primary Building	Single Family	Historic Use of Primary Building	Single Family	
Style of Primary Blg	Cape Cod			
Number of Stories	1	Width (bays)	3	
Foundation Material	Cinderblock	Depth (rooms)	3	
Year Built	1935	Wall Cladding Material	Vinyl siding	
Roof Shape	Side gable	Roof Material	Composition shingle	
Decorative Details/Unique Features	Sky blue vinyl siding. Front gable entry porch above front door with white columns, white railing, and front gable. Cement stairs and landing leading at front door. White entablature around door, white surround around windows.			
Evidence of Integrity Location/Materials	None.			
Additions/Alterations to Primary Building	Addition on rear of house. New windows, new siding, new roof.

Condition of Primary Building	Good		code	G
Observable Threats	Growth of UMW			
Compatibility with Adjacent Land Uses	Good			
Potential NR Eligibility	Non-Contributing		code	N
Other Comments / Salient Details	Chimney on right end of house. Dirt driveway on right side of house. Bushes along front of house.

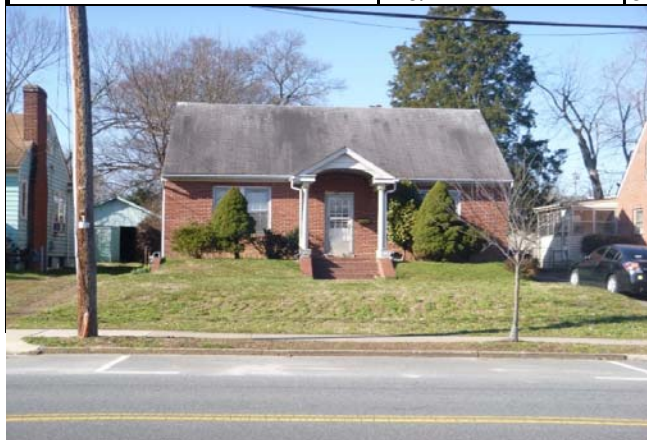
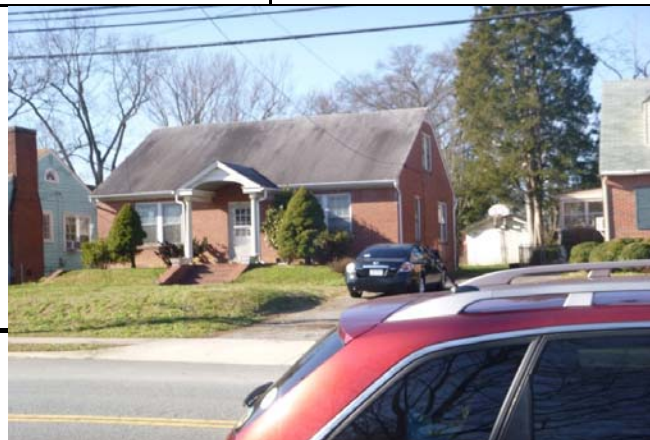
Name of Surveyors	Kimberly Packett		Survey Date	2/21/2016
ADDRESS	Street		Number	
	College	Avenue	1814	
TYPE & NUMBER OF BLGS & STRUCTURES	Type		Number	
	Single Family House		1	
	Shed		1	
Current Use of Primary Building	Single Family	Historic Use of Primary Building	Single Family	
Style of Primary Blg	Cape Cod			
Number of Stories	1 1/2	Width (bays)	3	
Foundation Material	Cinderblock	Depth (rooms)	2	
Year Built	1938	Wall Cladding Material	Brick	
Roof Shape	Side gable	Roof Material	Composition shingle	
Decorative Details/Unique Features	Front gable entry porch with white columns over front door.			
Evidence of Integrity Location/Materials	Original siding.			
Additions/Alterations to Primary Building	New roof, appears to be new windows.			
Condition of Primary Building	Fair		code	
			F	
Observable Threats	None			
Compatibility with Adjacent Land Uses	Good			
Potential NR Eligibility	Non-Contributing		code	
			N

Other Comments / Salient Details	Paved driveway on right side of house. Brick stairs and landing leading to front door. Bushes and small trees along front of house. Basketball hoop in front of shed.

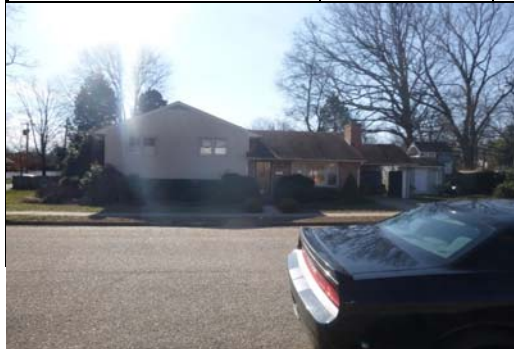
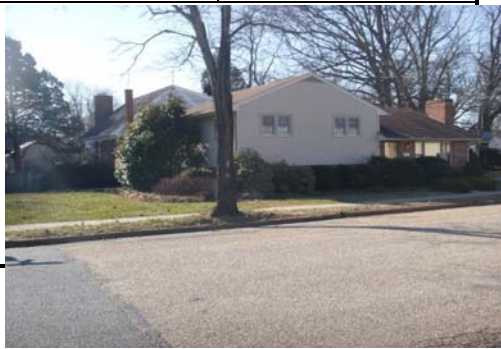
Name of Surveyors	Kimberly Packett		Survey Date	2/21/2016
ADDRESS	Street		Number	
	Seacobeck	Street	1300	
TYPE & NUMBER OF BLGS & STRUCTURES	Type		Number	
	Single Family House		1	
	Shed		1	
Current Use of Primary Building	Single Family	Historic Use of Primary Building	Single Family	
Style of Primary Bldg	Split level			
Number of Stories	2	Width (bays)	4	
Foundation Material	Cinderblock	Depth (rooms)	2	
Year Built	1968	Wall Cladding Material	Brick	
Roof Shape	Cross gable	Roof Material	Composition shingle	
Decorative Details/Unique Features	Vinyl siding on left side of house. Diamond pane windows on front right side of house.			
Evidence of Integrity Location/Materials	Appears to be original brick siding and windows.			
Additions/Alterations to Primary Building	Vinyl siding appears new.			
Condition of Primary Building	Good			code
				G
Observable Threats	None			
Compatibility with Adjacent Land Uses	Good

Potential NR Eligibility	Non-Contributing			code
				N
Other Comments / Salient Details	Bushes and trees along front and left side of house. Cement driveway leading to attached carport on right side of house. Large end chimney on right side of house. Cement pathway and stairs leading to front door.			
Photo Views				
1 Front view	2 3/4 view	3	4

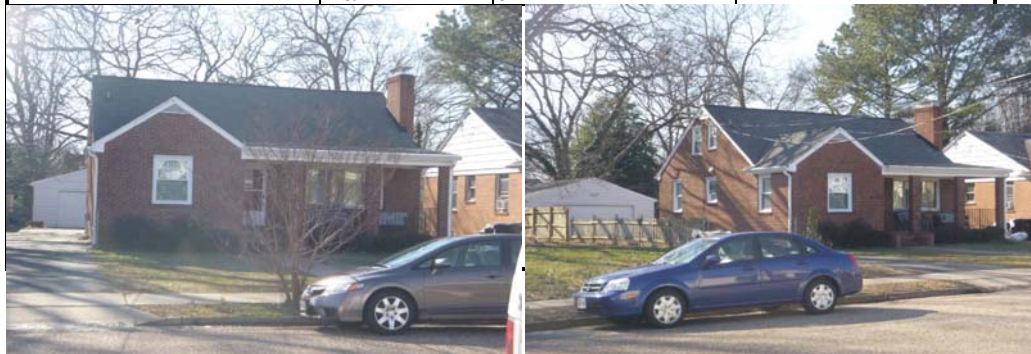
Name of Surveyors	Kimberly Packett		Survey Date	2/21/2016
ADDRESS	Street		Number	
	Seacobeck	Street	1312	
TYPE & NUMBER OF BLGS & STRUCTURES	Type		Number	
	Single Family House		1	
	Detatched Garage		1	
Current Use of Primary Building	Single Family	Historic Use of Primary Building	Single Family	
Style of Primary Blg	Minimal Traditional			
Number of Stories	1 1/2	Width (bays)	3	
Foundation Material	Concrete	Depth (rooms)	3	
Year Built	1960	Wall Cladding Material	Brick	
Roof Shape	Gable-on-hip	Roof Material	Composition shingle	
Decorative Details/Unique Features	Front gable on left side of house.			
Evidence of Integrity Location/Materials	Original brick siding.			
Additions/Alterations to Primary Building	Addition on back. Appears to be new windows and roof.			
Condition of Primary Building	Good		code	G
Observable Threats	None			
Compatibility with Adjacent Land Uses	Good			
Potential NR Eligibility	Contributing		code	C

Other Comments / Salient Details	Cement driveway leading to detached garage on left side of property. Cement path leading to brick porch with brick columns, iron railings, and an overhang. Bushes along front of house. Chimney on right end of house.			
Photo Views				
1 Front view	2 3/4 view	3	4

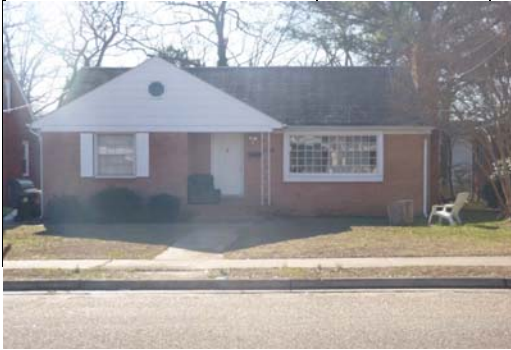
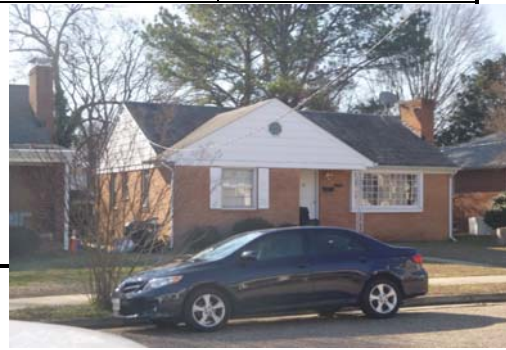
Name of Surveyors	Kimberly Packett		Survey Date	2/21/2016
ADDRESS	Street		Number	
	Seacobeck	Sreet	1316	
TYPE & NUMBER OF BLGS & STRUCTURES	Type		Number	
	Single Family House		1	
Current Use of Primary Building	Single Family	Historic Use of Primary Building	Single Family	
Style of Primary Blg	Minimal Traditional			
Number of Stories	1	Width (bays)	3	
Foundation Material	Cinderblock	Depth (rooms)	3	
Year Built	1969	Wall Cladding Material	Brick	
Roof Shape	Side gable	Roof Material	Composition shingle	
Decorative Details/Unique Features	Small octagon window on front gable on right side of house. Front gable and side gables have wood siding. White shutters on window to the left of the front door. Window to the right of the front door has small square panes.			
Evidence of Integrity Location/Materials	Appears to be original windows and siding.			
Additions/Alterations to Primary Building	New roof.			
Condition of Primary Building	Good		code	G

Observable Threats	None			
Compatibility with Adjacent Land Uses	Good			
Potential NR Eligibility	Non-Contributing		code	N
Other Comments / Salient Details	Bushes along front of house. Cement path and bricks stairs leading to front door with a small landing with a metal white decorative column. Chimney on right end of house.			
Photo Views				
1 Front view	2 3/4 view	3	4

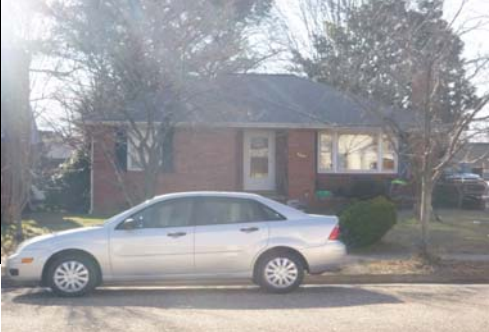
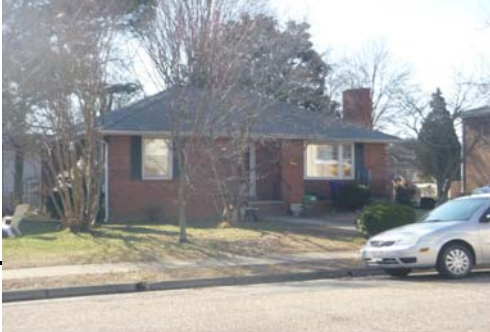
Name of Surveyors	Kimberly Packett		Survey Date	2/21/2016
ADDRESS	Street		Number	
	Seacobeck	Street	1320	
TYPE & NUMBER OF BLGS & STRUCTURES	Type		Number	
	Single Family House		1	
Current Use of Primary Building	Single Family	Historic Use of Primary Building	Single Family	
Style of Primary Bldg	Minimal Traditional			
Number of Stories	1	Width (bays)	3	
Foundation Material	Cinderblock	Depth (rooms)	2	
Year Built	1950	Wall Cladding Material	Brick	
Roof Shape	Hip	Roof Material	Composition shingle	
Decorative Details/Unique Features	Blue shutters on front windows.			
Evidence of Integrity Location/Materials	Original brick siding and possibly new windows.			
Additions/Alterations to Primary Building	Addition on rear of building, new roof.			
Condition of Primary Building	Good			code G
Observable Threats	None			
Compatibility with Adjacent Land Uses	Good			
Potential NR Eligibility	Contributing			code C
Other Comments / Salient Details	Cement pathway leading to front door with brick steps and small cement porch with iron railing. Brick column holds up overhang above front door. End chimney on right side of house. Small bushes along front of house.

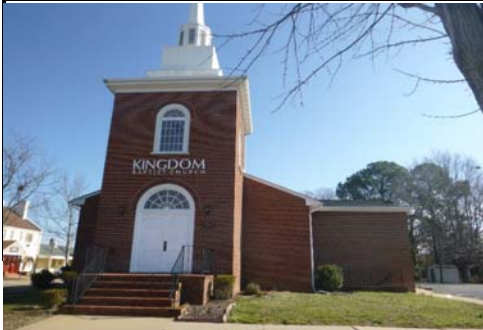
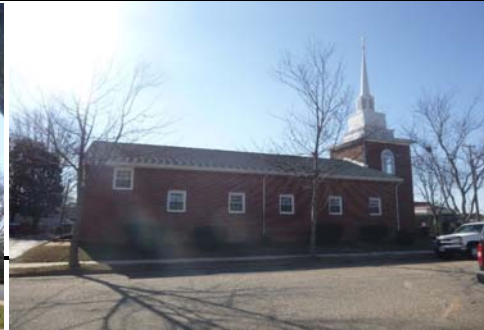
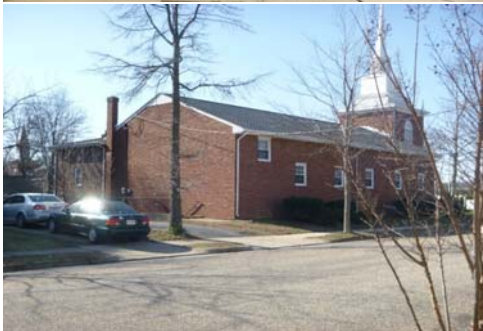
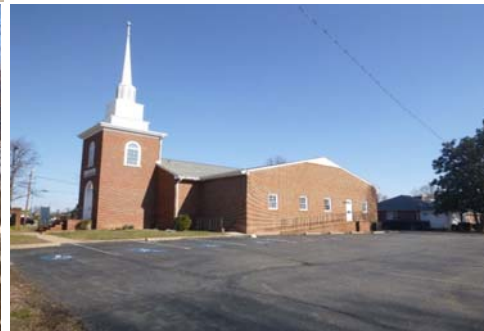
Name of Surveyors	Kimberly Packett		Survey Date	2/21/2016
ADDRESS	Street		Number	
	Stafford	Avenue	1717	
TYPE & NUMBER OF BLGS & STRUCTURES	Type		Number	
	Church		1	
Current Use of Primary Building	Religious	Historic Use of Primary Building	Religious	
Style of Primary Bldg	Baptist Church			
Number of Stories	1	Width (bays)	1	
Foundation Material	Concrete	Depth (rooms)	6	
Year Built	1970	Wall Cladding Material	Brick	
Roof Shape	Gable	Roof Material	Composition shingle	
Decorative Details/Unique Features	White spire on front of church.			
Evidence of Integrity Location/Materials	Original brick siding.			
Additions/Alterations to Primary Building	New windows.			
Condition of Primary Building	Good		code	G
Observable Threats	Building is for sale.			
Compatibility with Adjacent Land Uses	Not good, surrounding by commercial and residential properties			
Potential NR Eligibility	Non-Contributing		code	N
Other Comments / Salient Details	Cement path leading to brick stairs and landing with iron raililngs in front of white double doors with half circle transom. Large parking lot on the right of the church.

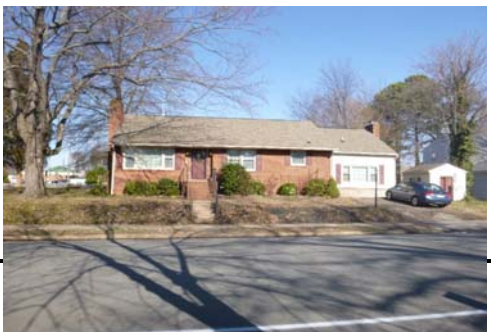
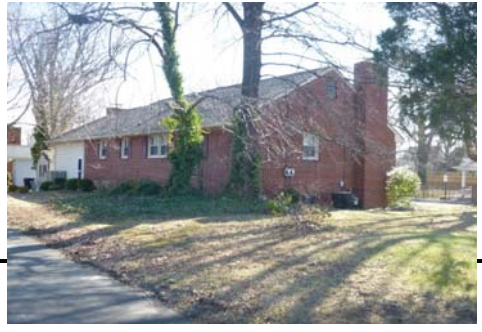
Name of Surveyors	Kimberly Packett		Survey Date	2/21/2016
ADDRESS	Street		Number	
	Rowe	Street	1321	
TYPE & NUMBER OF BLGS & STRUCTURES	Type		Number	
	Single Family House		1	
	Shed		1	
Current Use of Primary Building	Single Family	Historic Use of Primary Building	Single Family	
Style of Primary Blg	Ranch			
Number of Stories	1	Width (bays)	5	
Foundation Material	Cinderblock	Depth (rooms)	1	
Year Built	1970	Wall Cladding Material	Brick	
Roof Shape	Side gable	Roof Material	Composition shingle	
Decorative Details/Unique Features	Red shutters on front windows. Small attic window on left side of house.			
Evidence of Integrity Location/Materials	Original brick siding. Appears to be original windows on the back and sides of house.			
Additions/Alterations to Primary Building	Right side of the building was changed from a garage to a livable space. Right side of building has new vinyl siding. New windows on front of house.

Condition of Primary Building	Good		code	
			G	
Observable Threats	None			
Compatibility with Adjacent Land Uses	Good			
Potential NR Eligibility	Non-Contributing		code	
			N	
Other Comments / Salient Details	Dirt driveway leading to right side of house. Chimneys on either end of the house. Shrubs and trees along edge of house. Rear door on right side of house. Cement path leading to front door with brick stairs, landing with iron railing.			
Photo Views				
1 Front view	2 3/4 rear view	3	4

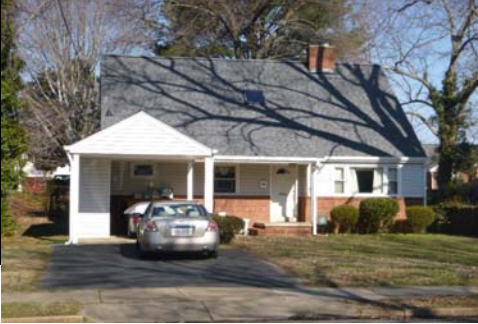
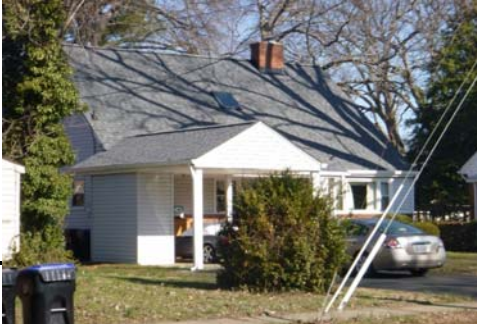
Name of Surveyors	Kimberly Packett		Survey Date	2/21/2016
ADDRESS	Street		Number	
	Rowe	Street	1319	
TYPE & NUMBER OF BLGS & STRUCTURES	Type		Number	
	Single Family House		1	
Current Use of Primary Building	Single Family	Historic Use of Primary Building	Single Family	
Style of Primary Bldg	Cape Cod			
Number of Stories	1 1/2	Width (bays)	4	
Foundation Material	Cinderblock	Depth (rooms)	2	
Year Built	1960	Wall Cladding Material	Vinyl siding	
Roof Shape	Salt box	Roof Material	Composition shingle	
Decorative Details/Unique Features	Brick bottom on the front façade. Carport with front gable roof attached to left side of house. Roof is extended over left side of house and front door. Skylight on front of roof.			
Evidence of Integrity Location/Materials	Brick is possibly original.			
Additions/Alterations to Primary Building	Deck attached to the back. New vinyl siding. New windows.			
Condition of Primary Building	Good			code G

Observable Threats	None			
Compatibility with Adjacent Land Uses	Good			
Potential NR Eligibility	Contributing			code C
Other Comments / Salient Details	Paved driveway on left side of house leading to carport. Small bushes along front of house. Cement path leading from driveway to brick steps and cement landing in front of front door. Central chimney on the right side of the house.			
Photo Views				
1 Front view	2 3/4 view	3	4

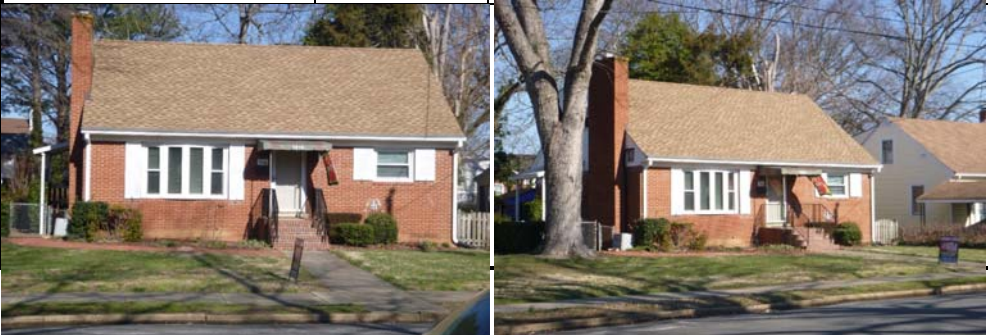
Name of Surveyors	Kimberly Packett		Survey Date	2/21/2016
ADDRESS	Street		Number	
	Rowe	Street	1315	
TYPE & NUMBER OF BLGS & STRUCTURES	Type		Number	
	Single Family House		1	
Current Use of Primary Building	Single Family	Historic Use of Primary Building	Single Family	
Style of Primary Bldg	Cape Cod			
Number of Stories	1 1/2	Width (bays)	3	
Foundation Material	Cinderblock	Depth (rooms)	2	
Year Built	1960	Wall Cladding Material	Brick	
Roof Shape	Side gable	Roof Material	Composition shingle	
Decorative Details/Unique Features	White shutters on front windows. Fabric awning over front door. Vinyl siding on gables on either side of house and on roof extension on back of house.			
Evidence of Integrity Location/Materials	Appears to be original windows. Original brick siding.			
Additions/Alterations to Primary Building	Deck on the back. New roof.			
Condition of Primary Building	Good		code	G
Observable Threats	None

Compatibility with Adjacent Land Uses	Good			
Potential NR Eligibility	Contributing		code	C
Other Comments / Salient Details	Chimney on the left end of the house. Cement path leading to front door with brick stairs and iron railing. Chain link fence around backyard. Small bushes and garden around front of house.			
Photo Views				
1 Front view	2 3/4 view	3	4

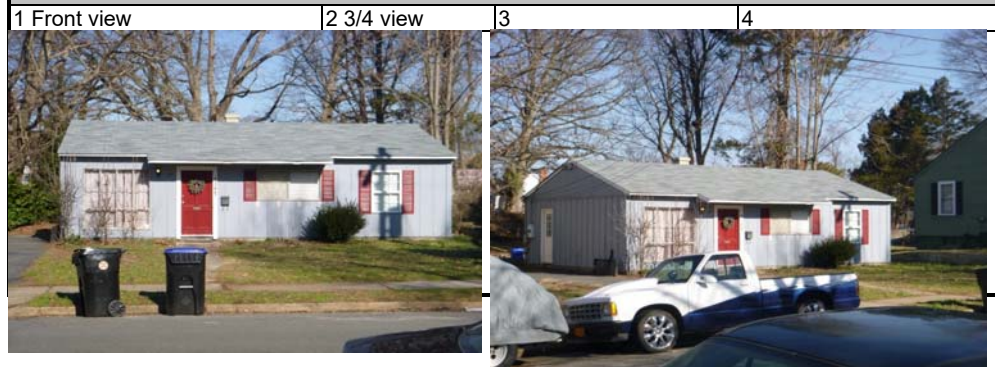
Name of Surveyors	Kimberly Packett		Survey Date	2/21/2016
ADDRESS	Street		Number	
	Rowe	Street	1309	
TYPE & NUMBER OF BLGS & STRUCTURES	Type		Number	
	Single Family House		1	
Current Use of Primary Building	Single Family	Historic Use of Primary Building	Single Family	
Style of Primary Bldg	Minimal Traditional			
Number of Stories	1	Width (bays)	4	
Foundation Material	Cinderblock	Depth (rooms)	1	
Year Built	1959	Wall Cladding Material	Wood siding	
Roof Shape	Side gable	Roof Material	Composition shingle	
Decorative Details/Unique Features	Red shutters on front windows. Diamond paned window on front of house. White surround around front door.			
Evidence of Integrity Location/Materials	Original windows and possibly original siding.			
Additions/Alterations to Primary Building	New roof, front right window appears new.			
Condition of Primary Building	Good		code G	
Observable Threats	None			
Compatibility with Adjacent Land Uses	Good

Potential NR Eligibility	Contributing		code C	
Other Comments / Salient Details	Central chimney. Paved driveway on left side of house. Side door on left side of house. Cement path with cement step leading to front door.

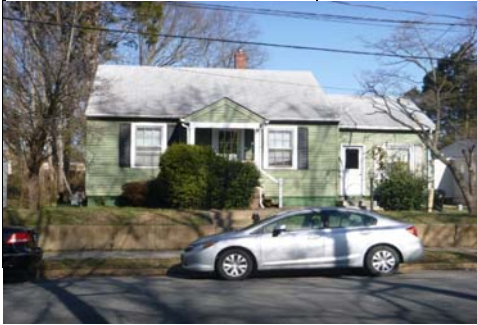
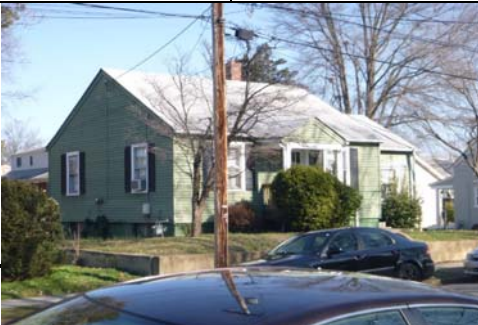
Name of Surveyors	Kimberly Packett		Survey Date	2/21/2016
ADDRESS	Street		Number	
	Rowe	Street	1305	
TYPE & NUMBER OF BLGS & STRUCTURES	Type		Number	
	Single Family House		1	
Current Use of Primary Building	Single Family	Historic Use of Primary Building	Single Family	
Style of Primary Bldg	Cape Cod			
Number of Stories	1	Width (bays)	5	
Foundation Material	Concrete	Depth (rooms)	2	
Year Built	1949	Wall Cladding Material	Aluminum siding	
Roof Shape	Side gable	Roof Material	Composition shingle	
Decorative Details/Unique Features	Front gable entry porch with white columns over front door. Black shutters on windows. White surround around front door.			
Evidence of Integrity Location/Materials	Possibly original windows.			
Additions/Alterations to Primary Building	New roof and appears to be new siding.			
Condition of Primary Building	Good		code	G
Observable Threats	None			
Compatibility with Adjacent Land Uses	Good

Potential NR Eligibility	Non-Contributing		code	N
Other Comments / Salient Details	Additional exterior door on the right side of the house with cement stairs. Cement retaining wall along front of property. Cement path leading to front door with brick stairs and landing with white railing. Central chimney. Large bushes along front of house. Black lamppost on front lawn.			
Photo Views				
1 Front view	2 3/4 view	3	4

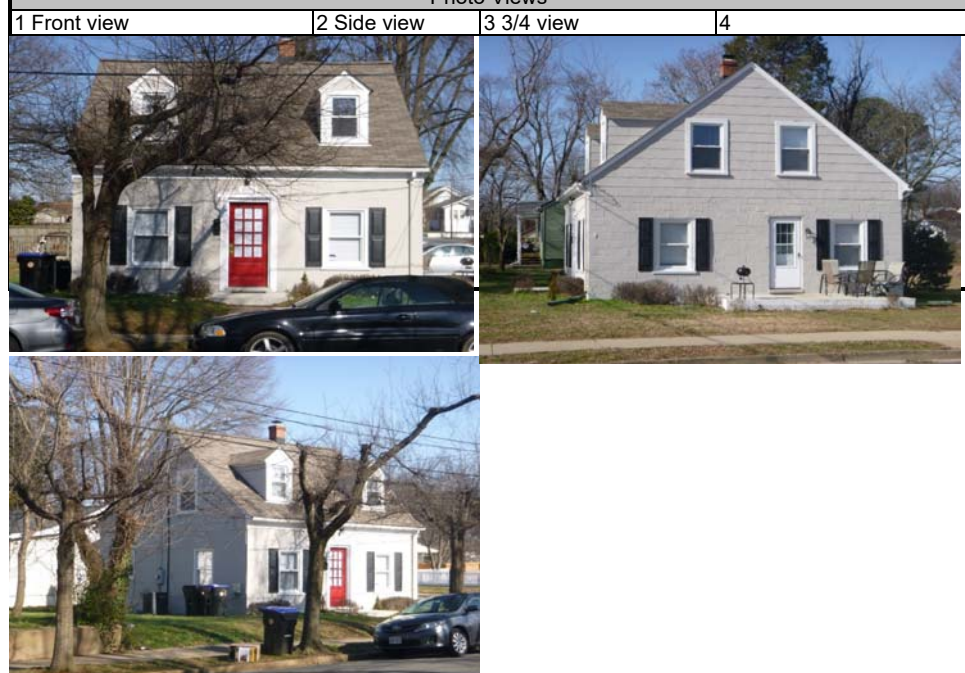
Name of Surveyors	Kimberly Packett		Survey Date	2/21/2016
ADDRESS	Street		Number	
	Rowe	Street	1301	
TYPE & NUMBER OF BLGS & STRUCTURES	Type		Number	
	Single Family House		1	
Current Use of Primary Building	Single Family	Historic Use of Primary Building	Single Family	
Style of Primary Bldg	Cape Cod			
Number of Stories	1 1/2	Width (bays)	3	
Foundation Material	Cinderblock	Depth (rooms)	3	
Year Built	1944	Wall Cladding Material	Cinderblock	
Roof Shape	Side gable	Roof Material	Composition shingle	
Decorative Details/Unique Features	Black shutters on windows on bottom story. White surround around front door and windows. Two dormers on front of house. Asbestos shingle on gable ends of house.			
Evidence of Integrity Location/Materials	Original siding.			
Additions/Alterations to Primary Building	New roof, appears to be new windows.			
Condition of Primary Building	Good			code G
Observable Threats	None			
Compatibility with Adjacent Land Uses	Good

Potential NR Eligibility	Contributing			code C
Other Comments / Salient Details	Central chimney. Side door on right side of house with small porch. Cement landing at base of front door. Small bushes along front of house.

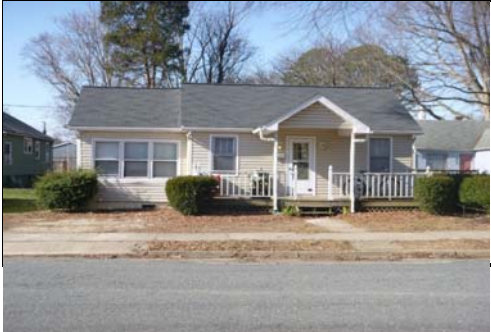
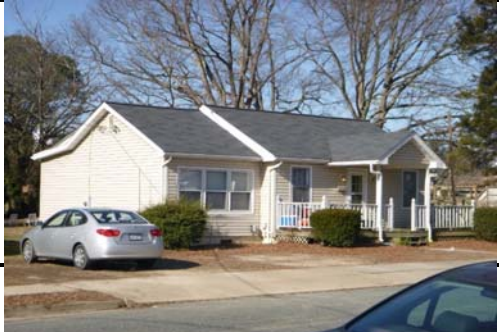
Name of Surveyors	Kimberly Packett		Survey Date	2/21/2016
ADDRESS	Street		Number	
	Augustine Avenue		1706	
TYPE & NUMBER OF BLGS & STRUCTURES	Type		Number	
	Single Family House		1	
Current Use of Primary Building	Single Family	Historic Use of Primary Building	Single Family	
Style of Primary Bldg	Cape Cod			
Number of Stories	1	Width (bays)	4	
Foundation Material	Cinderblock	Depth (rooms)	1	
Year Built	1959	Wall Cladding Material	Vinyl siding	
Roof Shape	Side gable	Roof Material	Composition shingle	
Decorative Details/Unique Features	Entry porch with front gable and white columns. Front porch has a white wooden railing.			
Evidence of Integrity Location/Materials	Appears to be original windows on main part of house.			
Additions/Alterations to Primary Building	Attached garage on left turned into livable space. New roof and siding.			
Condition of Primary Building	Good		code	G
Observable Threats	None			
Compatibility with Adjacent Land Uses	Good

Potential NR Eligibility	Contributing		code	C
Other Comments / Salient Details	Cement path leading to wood front porch. Cement driveway on right side of property. Bushes along front of house.			
Photo Views				
1 Front view	2 3/4 view	3	4

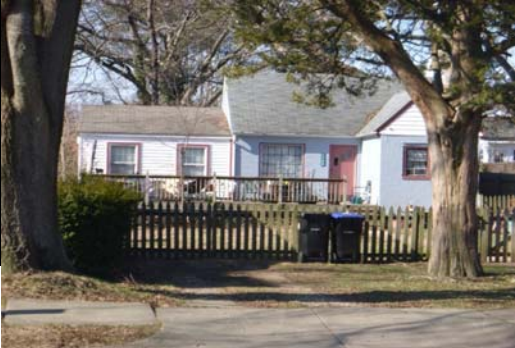
Name of Surveyors	Kimberly Packett		Survey Date	2/21/2016
ADDRESS	Street		Number	
	Augustine Avenue		1708	
TYPE & NUMBER OF BLGS & STRUCTURES	Type		Number	
	Single Family House		1	
Current Use of Primary Building	Single Family	Historic Use of Primary Building	Single Family	
Style of Primary Bldg	Minimal Traditional			
Number of Stories	1	Width (bays)	5	
Foundation Material	Cinderblock	Depth (rooms)	2	
Year Built	1959	Wall Cladding Material	Cinderblock	
Roof Shape	Side gable	Roof Material	Composition shingle	
Decorative Details/Unique Features	White vinyl siding on left side of house and front gable on right side of house. Red surround around windows and front door, matches the color of the front door. Large square 6 by 6 paned window to the right of the front door.			
Evidence of Integrity Location/Materials	Original windows and siding on right side of house.			
Additions/Alterations to Primary Building	Addition on left side of house.

Condition of Primary Building	Fair		code	
			F	
Observable Threats	None			
Compatibility with Adjacent Land Uses	Good			
Potential NR Eligibility	Contributing		code	
			C	
Other Comments / Salient Details	This house is set far back from the street, almost behind two other houses. Wood picket fence along property line. Unusable dirt driveway on left side of the house. Cement path leading to wood porch with wood railing along front left side of the house.			
Photo Views				
1 Front view	2	3	4

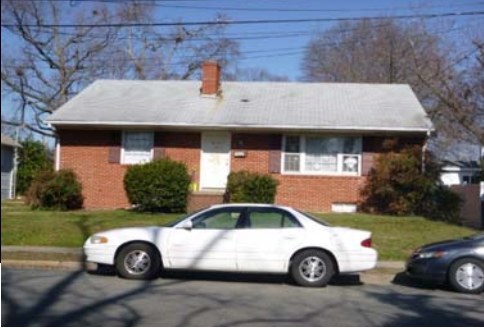
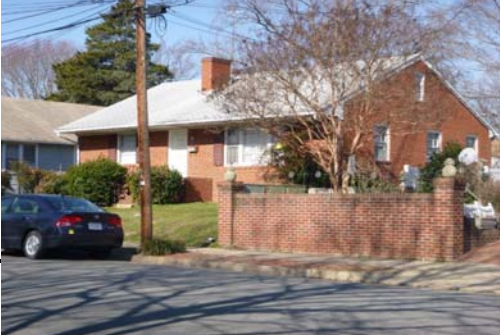
Name of Surveyors	Kimberly Packett		Survey Date	2/21/2016
ADDRESS	Street		Number	
	Rowe	Street	1209	
TYPE & NUMBER OF BLGS & STRUCTURES	Type		Number	
	Single Family Home		1	
Current Use of Primary Building	Single Family	Historic Use of Primary Building	Single Family	
Style of Primary Bldg	Minimal Traditional			
Number of Stories	1	Width (bays)	3	
Foundation Material	Cinderblock	Depth (rooms)	3	
Year Built	1963	Wall Cladding Material	Brick	
Roof Shape	Side gable	Roof Material	Composition shingle	
Decorative Details/Unique Features	Maroon shutters on front windows.			
Evidence of Integrity Location/Materials	Original brick siding and appears to be original windows.			
Additions/Alterations to Primary Building	New roof.			
Condition of Primary Building	Excellent		code	E
Observable Threats	None			
Compatibility with Adjacent Land Uses	Good			
Potential NR Eligibility	Contributing		code	C
Other Comments / Salient Details	Central chimney. Cement path leading to front door with brick stairs and iron railings. Bushes along front of house. Brick wall along right of property that belongs to adjacent house.

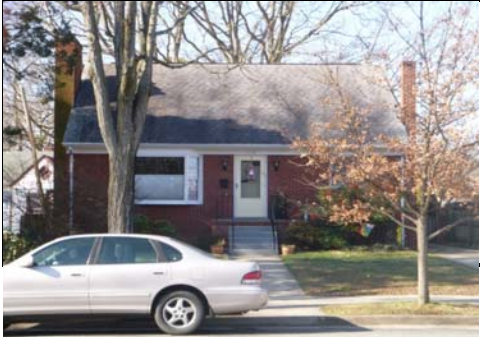
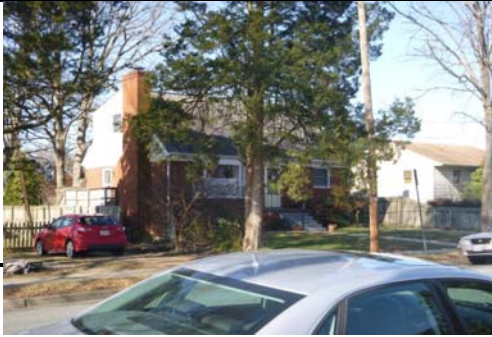
Name of Surveyors	Kimberly Packett		Survey Date	2/21/2016
ADDRESS	Street		Number	
	Augustine Avenue		1712	
TYPE & NUMBER OF BLGS & STRUCTURES	Type		Number	
	Single Family House		1	
Current Use of Primary Building	Single Family	Historic Use of Primary Building	Single Family	
Style of Primary Bldg	Cape Cod			
Number of Stories	1 1/2	Width (bays)	3	
Foundation Material	Cinderblock	Depth (rooms)	1	
Year Built	1953	Wall Cladding Material	Brick	
Roof Shape	Side gable	Roof Material	Composition shingle	
Decorative Details/Unique Features	Bay window on front left side of house. Two dormers on roof on the back side of the house. Lamp attached to the wall on either side of the front door.			
Evidence of Integrity Location/Materials	Original brick siding.			
Additions/Alterations to Primary Building	Patio on the back of the property. New windows and roof.			
Condition of Primary Building	Good		code	G
Observable Threats	None

Compatibility with Adjacent Land Uses	Good			
Potential NR Eligibility	Contributing		code	C
Other Comments / Salient Details	Chimneys on either end of the house. Cement path leading to brick landing with cement steps with iron railings. Wood privacy fence around backyard. Paved driveway on right side of the house. Bushes along front of the house.			
Photo Views				
1 Front view	2 3/4 view	3	4

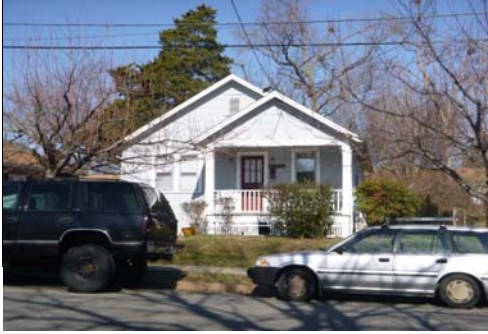
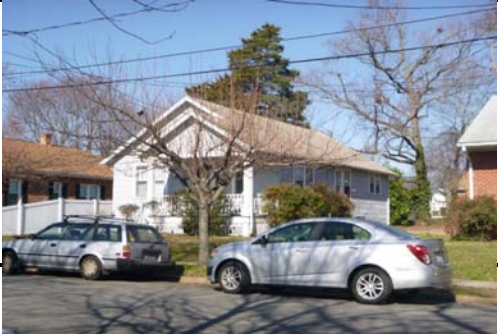
Name of Surveyors	Kimberly Packett		Survey Date	2/21/2016
ADDRESS	Street		Number	
	Rowe	Street	1213	
TYPE & NUMBER OF BLGS & STRUCTURES	Type		Number	
	Single Family House		1	
Current Use of Primary Building	Single Family	Historic Use of Primary Building	Single Family	
Style of Primary Bldg	Craftsman			
Number of Stories	1	Width (bays)	3	
Foundation Material	Concrete	Depth (rooms)	3	
Year Built	1935	Wall Cladding Material	Asbestos siding	
Roof Shape	Front gable	Roof Material	Composition shingle	
Decorative Details/Unique Features	Front gable roof over front porch along right side of house. Decorative attic vent on front of house. White surround around door and windows. Lanterns attached to the wall on either side of the front door.			
Evidence of Integrity Location/Materials	Original siding.			
Additions/Alterations to Primary Building	New windows and new roof.			
Condition of Primary Building	Good		code

G	
Observable Threats	None			
Compatibility with Adjacent Land Uses	Good			
Potential NR Eligibility	Non-Contributing		code	
			N	
Other Comments / Salient Details	Cement path leading to wood porch with white railings and columns. Large bushes along front and side of porch.			
Photo Views				
1 Front view	2 3/4 view	3	4

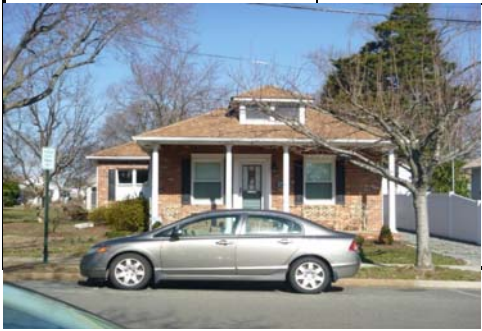
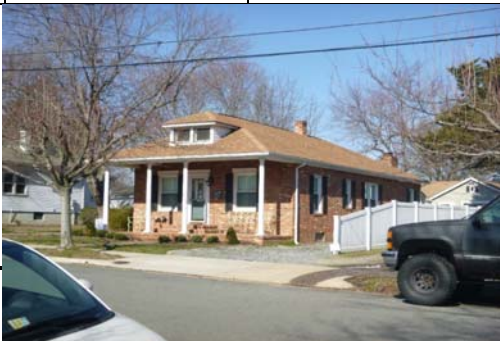
Name of Surveyors	Kimberly Packett		Survey Date	2/21/2016
ADDRESS	Street		Number	
	Rowe	Street	1217	
TYPE & NUMBER OF BLGS & STRUCTURES	Type		Number	
	Single Family House		1	
	Detached Garage		2	
Current Use of Primary Building	Single Family	Historic Use of Primary Building	Single Family	
Style of Primary Bldg	Bungalow			
Number of Stories	1	Width (bays)	4	
Foundation Material	Concrete	Depth (rooms)	4	
Year Built	1932	Wall Cladding Material	Brick	
Roof Shape	Hip	Roof Material	Composition shingle	
Decorative Details/Unique Features	White surround around door and windows. Dark green shutters on windows. Dormer with hip roof on front of house.			
Evidence of Integrity Location/Materials	Original brick siding.			
Additions/Alterations to Primary Building	New roof and new windows.			
Condition of Primary Building	Excellent		code	E
Observable Threats	None			
Compatibility with Adjacent Land Uses	Good			
Potential NR Eligibility	Non-Contributing		code	N

Other Comments / Salient Details	Gravel driveway on the right side of the house leading to detached garage. White plastic fence along the right side of the property. Central chimney. Cement path leading to brick porch that spans the length of the front of the house with four white columns. Small bushes along front of the house, large bushes on the left side of the house.			
Photo Views				
1 Front view	2 3/4 view	3	4
