Cultural Resource Survey of College Heights in Fredericksburg, Virginia

Master of Science

Historic Preservation

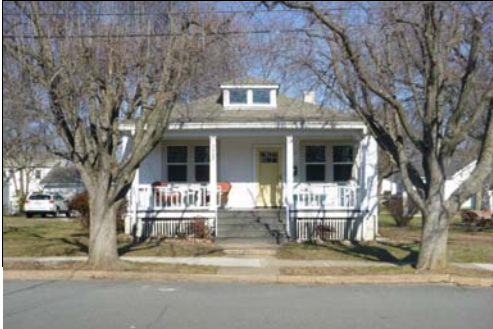
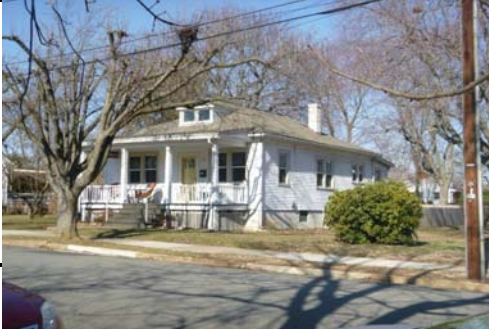
Name of Surveyors	Kimberly Packett		Survey Date	2/21/2016
ADDRESS	Street		Number	
	Rowe	Street	1225	
TYPE & NUMBER OF BLGS & STRUCTURES	Type		Number	
	Single Family House		1	
Current Use of Primary Building	Single Family	Historic Use of Primary Building	Single Family	
Style of Primary Bldg	Bungalow			
Number of Stories	1	Width (bays)	3	
Foundation Material	Concrete	Depth (rooms)	4	
Year Built	1926	Wall Cladding Material	Aluminum siding	
Roof Shape	Hip	Roof Material	Composition shingle	
Decorative Details/Unique Features	Dormer with hip roof on front of building. Tan surround around windows.			
Evidence of Integrity Location/Materials	Original siding.			
Additions/Alterations to Primary Building	New roof and new windows. Addition on the back of the house.			
Condition of Primary Building	Good		code	
			G	
Observable Threats	None			
Compatibility with Adjacent Land Uses	Good			
Potential NR Eligibility	Non-Contributing		code

N	
Other Comments / Salient Details	Dirt path leading to cement stairs and wood porch with white railings and white columns. Two large trees on either side of house. Central chimney on back right of the house. Roof extends over wood porch with white railings and white columns.			
Photo Views				
1 Front view	2 3/4 view	3	4

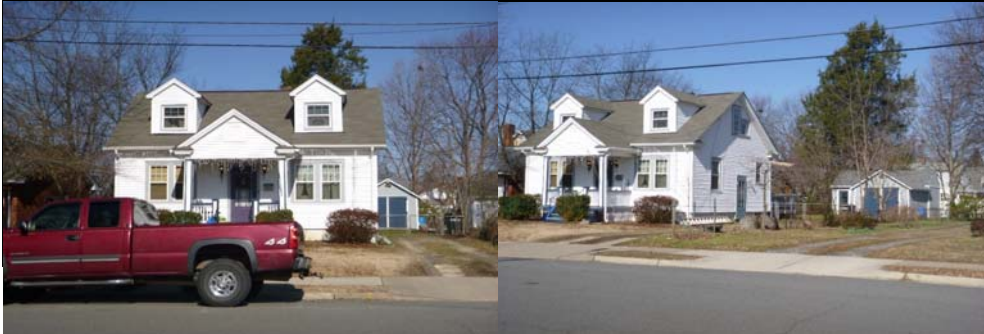
Name of Surveyors	Kimberly Packett		Survey Date	2/21/2016
ADDRESS	Street		Number	
	Rowe	Street	1229	
TYPE & NUMBER OF BLGS & STRUCTURES	Type		Number	
	Single Family House		1	
	Shed		1	
Current Use of Primary Building	Single Family	Historic Use of Primary Building	Single Family	
Style of Primary Bldg	Cape Cod			
Number of Stories	1 1/2	Width (bays)	3	
Foundation Material	Concrete	Depth (rooms)	3	
Year Built	1935	Wall Cladding Material	Vinyl siding	
Roof Shape	Side gable	Roof Material	Composition shingle	
Decorative Details/Unique Features	Grey surround around windows and door. Two dormers on front of house. Front gable entry porch.			
Evidence of Integrity Location/Materials	None			
Additions/Alterations to Primary Building	Addition and deck on the rear of the house. New roof, siding, and windows.			
Condition of Primary Building	Good		code	
			G	
Observable Threats	None			
Compatibility with Adjacent Land Uses	Good

Potential NR Eligibility	Non-Contributing		code	
			N	
Other Comments / Salient Details	Dirt driveway on the right side of the house leading to shed. Dirt path leading to wood stairs and landing with white columns and railings at foot of front door. Bushes along front of house. Chain link fence around backyard.			
Photo Views				
1 Front view	2 3/4 view	3	4

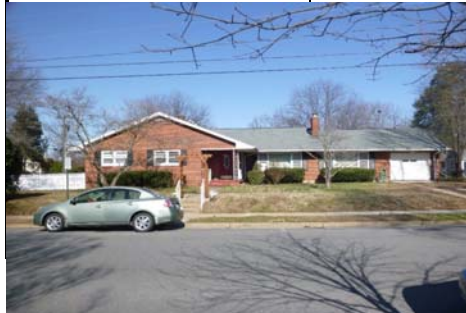
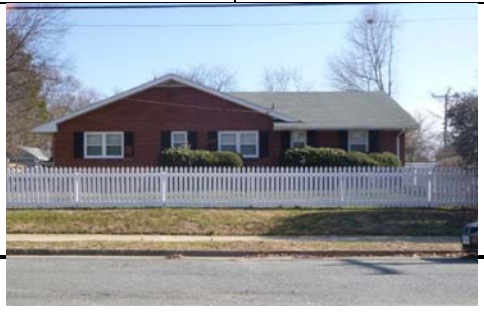
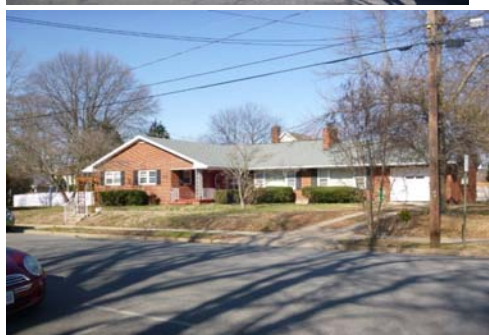
Name of Surveyors	Kimberly Packett		Survey Date	2/21/2016
ADDRESS	Street		Number	
	Rowe	Street	1231	
TYPE & NUMBER OF BLGS & STRUCTURES	Type		Number	
	Single Family Houst		1	
Current Use of Primary Building	Single Family	Historic Use of Primary Building	Single Family	
Style of Primary Blg	Ranch			
Number of Stories	1	Width (bays)	6	
Foundation Material	Cinderblock	Depth (rooms)	5	
Year Built	1958	Wall Cladding Material	Brick	
Roof Shape	Side gable	Roof Material	Composition shingle	
Decorative Details/Unique Features	Decorative wood arch over cement pathway. White metal decorative column on front porch holding up roof overhang. Black shutters on windows.			
Evidence of Integrity Location/Materials	Original brick siding.			
Additions/Alterations to Primary Building	New roof and windows.			
Condition of Primary Building	Excellent			code E
Observable Threats	None			
Compatibility with Adjacent Land Uses	Good

Potential NR Eligibility	Contributing			code C
Other Comments / Salient Details	Central chimney on right side of house. Cement driveway leading to the attached garage on right side of the house. White picket fence around the backyard. Cement stairs and path with white railing leading to brich porch at foot of front door. Bushes along edge of house.

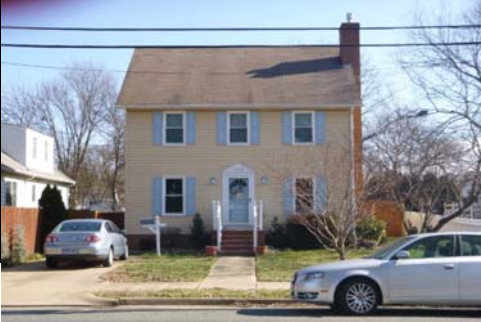
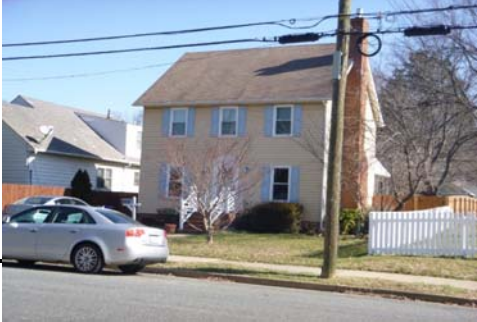
Name of Surveyors	Kimberly Packett		Survey Date	2/21/2016
ADDRESS	Street		Number	
	Augustine Avenue		1711	
TYPE & NUMBER OF BLGS & STRUCTURES	Type		Number	
	Single Family House		1	
Current Use of Primary Building	Single Family	Historic Use of Primary Building	Single Family	
Style of Primary Bldg	Neo-colonial			
Number of Stories	2	Width (bays)	3	
Foundation Material	Cinderblock	Depth (rooms)	1	
Year Built	1988	Wall Cladding Material	Vinyl siding	
Roof Shape	Side gable	Roof Material	Composition shingle	
Decorative Details/Unique Features	Light blue shutters on windows that match front door. White surround around windows. White pedimented surround around front door. Yellow siding.			
Evidence of Integrity Location/Materials	Appears to be all original materials.			
Additions/Alterations to Primary Building	None			
Condition of Primary Building	Excellent			code E
Observable Threats	None			
Compatibility with Adjacent Land Uses	Different style than surrounding houses.

Potential NR Eligibility	Non-Contributing			code N
Other Comments / Salient Details	Chimney on right end of house. Cement driveway on left side of house. Cement path leading to brick stairs with white railing leading to front door. Bushes along front of house. Wood privacy fence around backyard.			
Photo Views				
1 Front view	2 3/4 view	3	4

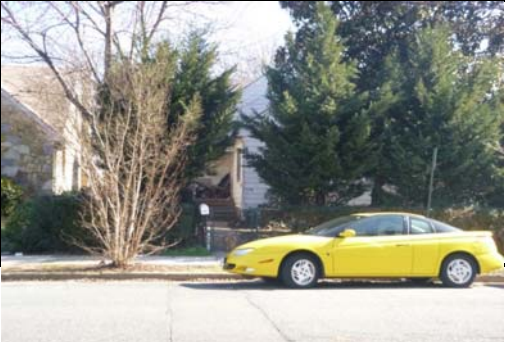
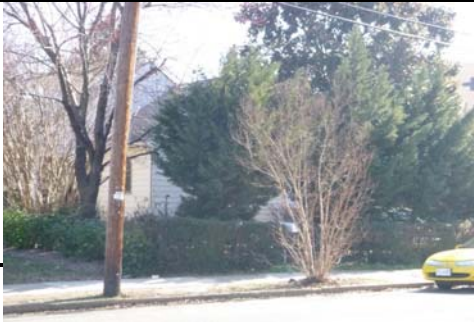
Name of Surveyors	Kimberly Packett		Survey Date	2/21/2016
ADDRESS	Street		Number	
	Augustine Avenue		1715	
TYPE & NUMBER OF BLGS & STRUCTURES	Type		Number	
	Single Family House		1	
Current Use of Primary Building	Single Family	Historic Use of Primary Building	Single Family	
Style of Primary Bldg	Minimal Traditional			
Number of Stories	1 1/2	Width (bays)	?	
Foundation Material	Brick	Depth (rooms)	?	
Year Built	1961	Wall Cladding Material	Aluminum siding	
Roof Shape	Front gable	Roof Material	Composition shingle	
Decorative Details/Unique Features	Shrubs and trees cover the front of the property. Multiple front gables.			
Evidence of Integrity Location/Materials	Appears to be original siding.			
Additions/Alterations to Primary Building	Hard to tell due to trees and shrubs.			
Condition of Primary Building	Poor		code	P
Observable Threats	Trees and plants are taking over the property and attaching to the house.

Compatibility with Adjacent Land Uses	Good			
Potential NR Eligibility	Non-Contributing		code	N
Other Comments / Salient Details	Chain link fence around entire property. Cement path leading to brick stairs and cement porch at front door.			
Photo Views				
1 Front view	2 3/4 view	3	4

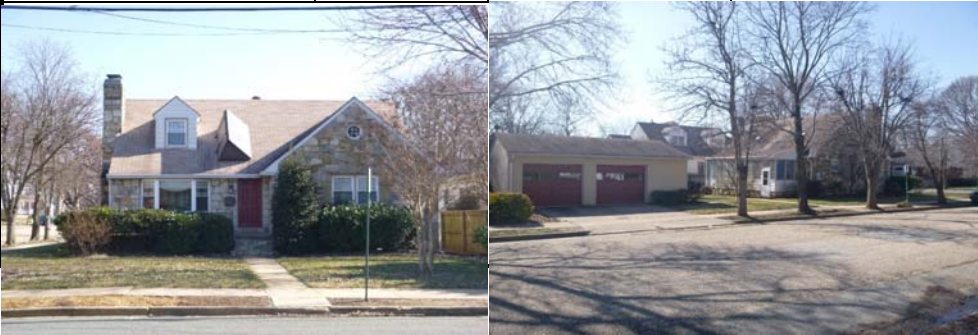
Name of Surveyors	Kimberly Packett		Survey Date	2/21/2016
ADDRESS	Street		Number	
	Augustine Avenue		1719	
TYPE & NUMBER OF BLGS & STRUCTURES	Type		Number	
	Single Family House		1	
	Detatched Garage		1	
Current Use of Primary Building	Single Family	Historic Use of Primary Building	Single Family	
Style of Primary Blg	Minimal Traditional			
Number of Stories	1 1/2	Width (bays)	3	
Foundation Material	Concrete	Depth (rooms)	3	
Year Built	1950	Wall Cladding Material	Stone	
Roof Shape	Side gable	Roof Material	Composition shingle	
Decorative Details/Unique Features	Front gable on right side of house. Octagon shaped window on front gable. One dormer with vinyl siding on front of roof. Solar panels on front of roof.			
Evidence of Integrity Location/Materials	None.			
Additions/Alterations to Primary Building	New roof, stone siding, and windows. Screened I porch on back of property.			
Condition of Primary Building	Excellent		code	E

Observable Threats	None			
Compatibility with Adjacent Land Uses	Good			
Potential NR Eligibility	Non-Contributing		code	N
Other Comments / Salient Details	Cement path leading to front door with stone steps. Chimney on left end of house. Detatched two car garage in backyard with cement driveway. Cement path leading to back door. Bushes along front and side of house.			
Photo Views				
1 Front view	2 3/4 view	3	4

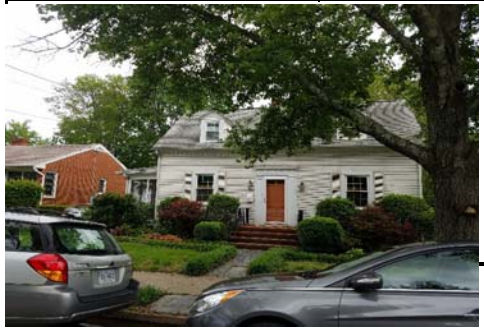
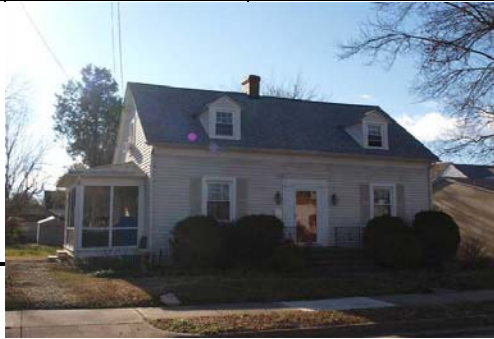
Name of Surveyors	Kimberly Packett		Survey Date	2/21/2016
ADDRESS	Street		Number	
	Seacobeck	Street	1228	
TYPE & NUMBER OF BLGS & STRUCTURES	Type		Number	
	Single Family House		1	
Current Use of Primary Building	Single Family	Historic Use of Primary Building	Single Family	
Style of Primary Bldg	Cape Cod			
Number of Stories	1 1/2	Width (bays)	3	
Foundation Material	Concrete	Depth (rooms)	2	
Year Built	1936	Wall Cladding Material	Hardboard siding	
Roof Shape	Side gable	Roof Material	Composition shingle	
Decorative Details/Unique Features	Two dormers on front of roof. White surround around windows with tan shutters. Front door has white surround with pilasters.			
Evidence of Integrity Location/Materials	None			
Additions/Alterations to Primary Building	New siding, roof, and windows.			
Condition of Primary Building	Good			code G
Observable Threats	None			
Compatibility with Adjacent Land Uses	Good			
Potential NR Eligibility	Non-Contributing			code N

Other Comments / Salient Details	Bushes along front of house. Central chimney. Cement path leading to front door with brick stairs and iron railing. Screened in porch on left side of the house.			
Photo Views				
1 Front view	2 3/4 view	3	4

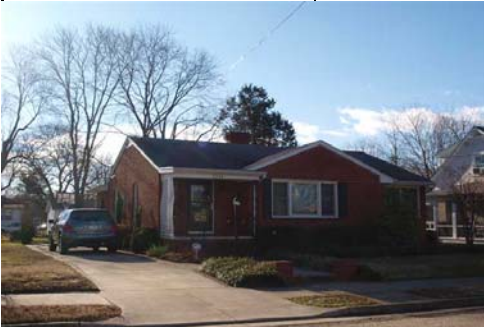
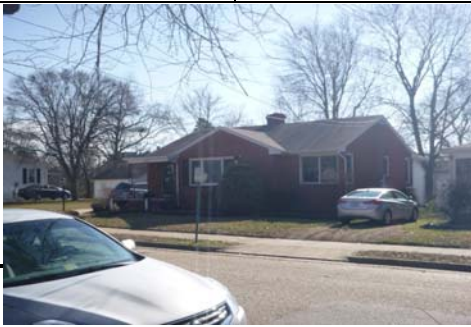
Name of Surveyors	Kimberly Packett		Survey Date	2/21/2016
ADDRESS	Street		Number	
	Seacobeck	Street	1224	
TYPE & NUMBER OF BLGS & STRUCTURES	Type		Number	
	Single Family House		1	
Current Use of Primary Building	Single Family	Historic Use of Primary Building	Single Family	
Style of Primary Bldg	Minimal Traditional			
Number of Stories	1	Width (bays)	3	
Foundation Material	Cinderblock	Depth (rooms)	3	
Year Built	1949	Wall Cladding Material	Brick	
Roof Shape	Side gable	Roof Material	Composition shingle	
Decorative Details/Unique Features	Front gable on middle, front of the house. Blue shutters on windows. Left side of front porch has white crosshatching wall. Black lamppost on front lawn.			
Evidence of Integrity Location/Materials	Original brick siding and possible original windows.			
Additions/Alterations to Primary Building	New roof.			
Condition of Primary Building	Good		code	
			G	
Observable Threats	None

Compatibility with Adjacent Land Uses	Good			
Potential NR Eligibility	Contributing		code	
			C	
Other Comments / Salient Details	Central chimney. Paved driveway on left side of the house. Bushes along front of house. Short brick columns on either side of the beginning of the cement path leading to front door. Path lead to front door with brick steps and cement landing.			
Photo Views				
1 Front view	2 3/4 view	3	4

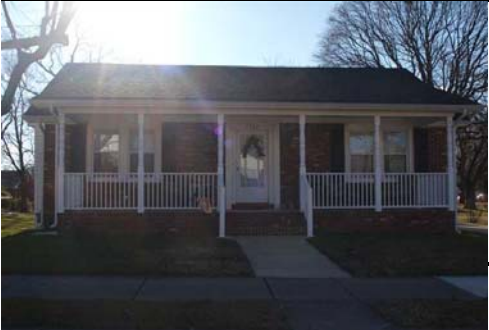
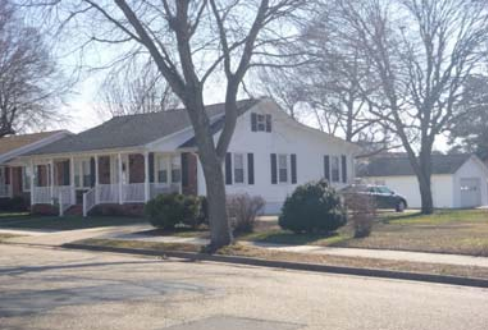
Name of Surveyors	Kimberly Packett		Survey Date	2/21/2016
ADDRESS	Street		Number	
	Seacobeck	Street	1216	
TYPE & NUMBER OF BLGS & STRUCTURES	Type		Number	
	Single Family House		1	
	Detatched Garage		1	
Current Use of Primary Building	Single Family	Historic Use of Primary Building	Single Family	
Style of Primary Blg	Cape Cod			
Number of Stories	1	Width (bays)	3	
Foundation Material	Concrete	Depth (rooms)	3	
Year Built	1932	Wall Cladding Material	Vinyl siding	
Roof Shape	Gable-on-hip	Roof Material	Composition shingle	
Decorative Details/Unique Features	White surround around door and . Blue shutters on windows.			
Evidence of Integrity Location/Materials	Possible original brick front façade.			
Additions/Alterations to Primary Building	Addition on the back of the house. New windows, roof, and vinyl siding.			
Condition of Primary Building	Excellent		code	
			E	
Observable Threats	None			
Compatibility with Adjacent Land Uses	Good

Potential NR Eligibility	Non-Contributing		code	
			N	
Other Comments / Salient Details	Cement path leading to front door with brick stairs and porch that spans the length of the front of the house. Porch has white railing and columns. Cement driveway on right side of house leads to detached garage.			
Photo Views				
1 Front view	2 3/4 view	3	4

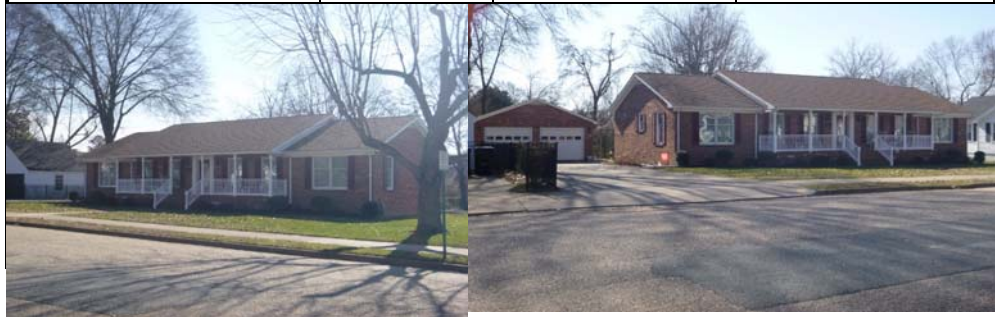
Name of Surveyors	Kimberly Packett		Survey Date	2/21/2016
ADDRESS	Street		Number	
	Seacobeck	Street	1212	
TYPE & NUMBER OF BLGS & STRUCTURES	Type		Number	
	Single Family House		1	
	Detatched Garage		1	
Current Use of Primary Building	Single Family	Historic Use of Primary Building	Single Family	
Style of Primary Blg	Ranch			
Number of Stories	1	Width (bays)	7	
Foundation Material	Cinderblock	Depth (rooms)	2	
Year Built	1979	Wall Cladding Material	Brick	
Roof Shape	Side gable	Roof Material	Composition shingle	
Decorative Details/Unique Features	Red shutters on windows and white surround around front door.			
Evidence of Integrity Location/Materials	Original windows and brick siding.			
Additions/Alterations to Primary Building	New roof.			
Condition of Primary Building	Excellent		code	E
Observable Threats	None			
Compatibility with Adjacent Land Uses	Good			
Potential NR Eligibility	Non-Contributing		code	N
Other Comments / Salient Details	Cement driveway on left side of house leads to two car garage. Brick front porch with white railing and columns. Small bushes along front of house.

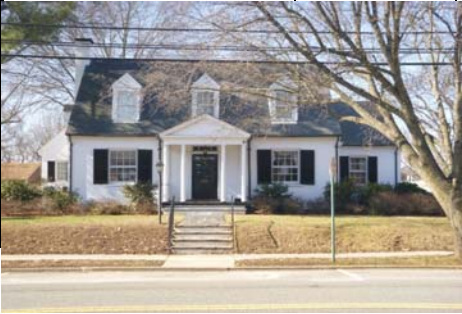
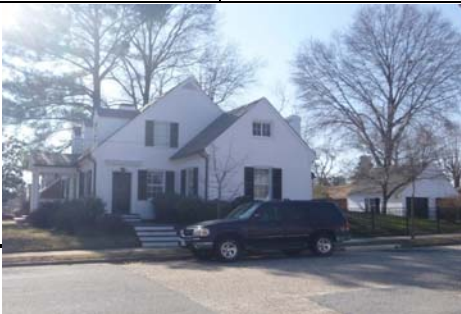
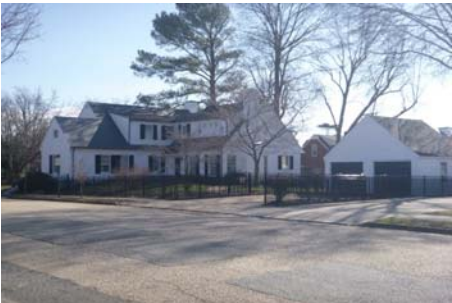
Name of Surveyors	Kimberly Packett		Survey Date	2/21/2016
ADDRESS	Street		Number	
	College	Avenue	1718	
TYPE & NUMBER OF BLGS & STRUCTURES	Type		Number	
	Single Family House		1	
	Detatched Garage		1	
Current Use of Primary Building	Single Family	Historic Use of Primary Building	Single Family	
Style of Primary Blg	Neo-colonial			
Number of Stories	1 1/2	Width (bays)	3	
Foundation Material	Cinderblock	Depth (rooms)	4	
Year Built	1935	Wall Cladding Material	Brick	
Roof Shape	Side gable	Roof Material	Slate	
Decorative Details/Unique Features	Black shutters on majority of the windows. Three dormers on front of house. Front gable entry porch with white columns. White surround around front door with transom. Two extended dormers on back roof of house. Addition in back has a front gable roof. Side door with white surround and white entablature.			
Evidence of Integrity Location/Materials	Original brick siding.

Additions/Alterations to Primary Building	Addition on back of house. New roof and windows.			
Condition of Primary Building	Excellent			code E
Observable Threats	Growth of UMW			
Compatibility with Adjacent Land Uses	Good			
Potential NR Eligibility	Non-Contributing			code N
Other Comments / Salient Details	One chimney on the end of the left side of the house and one chimney on the end of the back addition. Two car garage in backyard with cement driveway. Short iron fence around backyard. Small bushes along foot of house. Black lamppost in frontyard. Cement path and stairs leading to both the front door and the side door. Brick path leading to back door.			
Photo Views				
1 Front view	2 Side view	3 Rear view	4

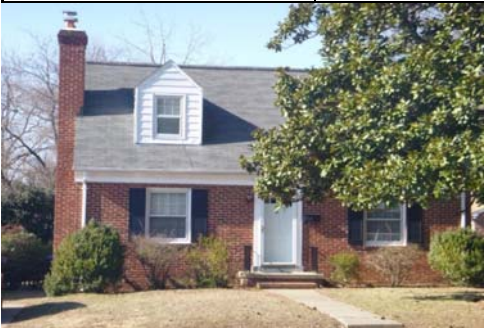
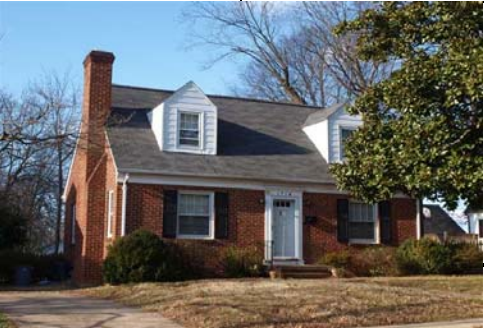
Name of Surveyors	Kimberly Packett		Survey Date	2/21/2016
ADDRESS	Street		Number	
	College	Avenue	1714	
TYPE & NUMBER OF BLGS & STRUCTURES	Type		Number	
	Single Family House		1	
Current Use of Primary Building	Single Family	Historic Use of Primary Building	Single Family	
Style of Primary Bldg	Cape Cod			
Number of Stories	1 1/2	Width (bays)	3	
Foundation Material	Cinderblock	Depth (rooms)	2	
Year Built	1953	Wall Cladding Material	Brick	
Roof Shape	Side gable	Roof Material	Composition shingle	
Decorative Details/Unique Features	White surround around front door with entablature. Two dormers on front side of roof. Dark blue shutters on front windows.			
Evidence of Integrity Location/Materials	Original brick siding and possibly original windows.			
Additions/Alterations to Primary Building	New roof, new vinyl siding on dormers.			
Condition of Primary Building	Good		code	G
Observable Threats	Growth of UMW

Compatibility with Adjacent Land Uses	Good			
Potential NR Eligibility	Contributing		code	C
Other Comments / Salient Details	Paved driveway on left side of house. Small bushes along front of house. Cement path and brick and cement stairs leading to front door with iron railing. Chimney on left side of house.			
Photo Views				
1 Front view	2 3/4 view	3	4

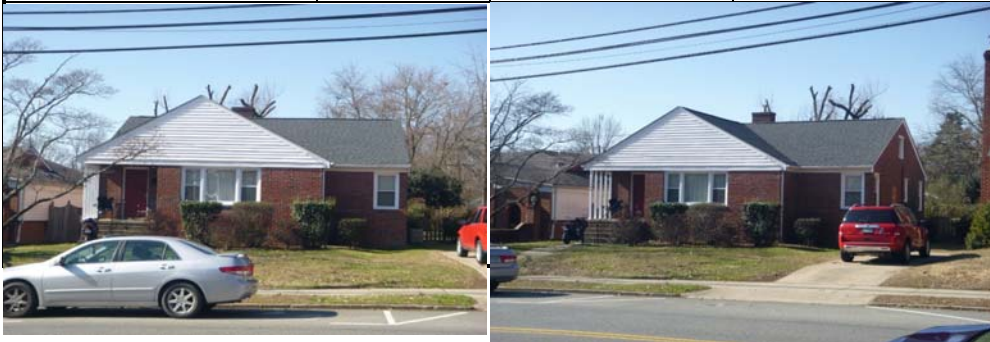
Name of Surveyors	Kimberly Packett		Survey Date	2/21/2016
ADDRESS	Street		Number	
	College	Avenue	1706	
TYPE & NUMBER OF BLGS & STRUCTURES	Type		Number	
	Single Family House		1	
Current Use of Primary Building	Single Family	Historic Use of Primary Building	Single Family	
Style of Primary Bldg	Minimal Traditional			
Number of Stories	1	Width (bays)	3	
Foundation Material	Cinderblock	Depth (rooms)	3	
Year Built	1954	Wall Cladding Material	Brick	
Roof Shape	Side gable	Roof Material	Composition shingle	
Decorative Details/Unique Features	Front gable on left side of house that hangs over small front porch. Front gable has white vinyl siding.			
Evidence of Integrity Location/Materials	Original brick siding and appears to be original windows.			
Additions/Alterations to Primary Building	Appears to be new vinyl siding on front gable.			
Condition of Primary Building	Good			code G
Observable Threats	Growth of UMW

Compatibility with Adjacent Land Uses	Good			
Potential NR Eligibility	Contributing			code C
Other Comments / Salient Details	Wood fence around backyard. Bushes along front of house. Skinny paved driveway on left side of house for motorcycle. Paved driveway on right side of house for car. Central chimney. Cement path leading to front door with brick stairs and landing with iron railing. White columns holding up overhang above front door.			
Photo Views				
1 Front view	2 3/4 view	3	4

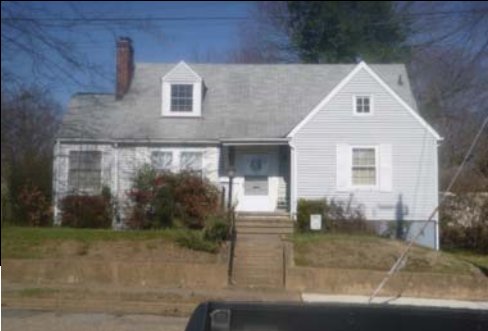
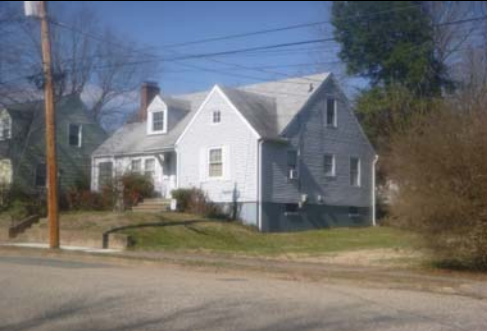
Name of Surveyors	Kimberly Packett		Survey Date	2/21/2016
ADDRESS	Street		Number	
	Parcel	Street	1309	
TYPE & NUMBER OF BLGS & STRUCTURES	Type		Number	
	Single Family House		1	
Current Use of Primary Building	Single Family	Historic Use of Primary Building	Single Family	
Style of Primary Bldg	Cape Cod			
Number of Stories	1 1/2	Width (bays)	4	
Foundation Material	Concrete	Depth (rooms)	3	
Year Built	1954	Wall Cladding Material	Vinyl siding	
Roof Shape	Side gable	Roof Material	Composition shingle	
Decorative Details/Unique Features	Front gable on right side of house. Dormer on front left of roof. White surround around front door and windows. White shutters on front window.			
Evidence of Integrity Location/Materials	Appears to be original windows.			
Additions/Alterations to Primary Building	Addition on the left side of the house. New roof and vinyl siding.			
Condition of Primary Building	Good		code	G
Observable Threats	None

Compatibility with Adjacent Land Uses	Good			
Potential NR Eligibility	Contributing		code	C
Other Comments / Salient Details	Bushes along front of house. Cement retaining wall along front of property. Cement stairs and path leading to front door with cement landing and iron railings. Iron lamppost in front yard. Central chimney on left side of house.			
Photo Views				
1 Front view	2 3/4 view	3	4

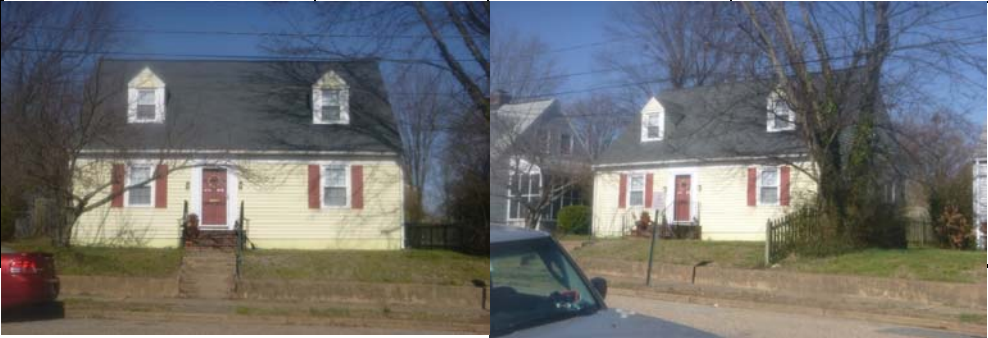
Name of Surveyors	Kimberly Packett		Survey Date	2/21/2016
ADDRESS	Street	Number		
	Parcel	Street	1313	
TYPE & NUMBER OF BLGS & STRUCTURES	Type	Number		
	Single Family House		1	
Current Use of Primary Building	Single Family	Historic Use of Primary Building	Single Family	
Style of Primary Bldg	Cape Cod			
Number of Stories	1 1/2	Width (bays)	3	
Foundation Material	Cinderblock	Depth (rooms)	2	
Year Built	1946	Wall Cladding Material	Vinyl siding	
Roof Shape	Side gable	Roof Material	Composition shingle	
Decorative Details/Unique Features	Red shutters on bottom front windows. Two gables on front of roof. White surround around front door.			
Evidence of Integrity Location/Materials	Appears to be original windows.			
Additions/Alterations to Primary Building	New roof and vinyl siding.			
Condition of Primary Building	Good		code	G
Observable Threats	None			
Compatibility with Adjacent Land Uses	Good			
Potential NR Eligibility	Contributing		code	C

Other Comments / Salient Details	Cement retaining wall along front of property. Cement stairs and path leading to front door with cement landing with brick steps and iron railings. Short wood picket fence in backyard and right of property.			
Photo Views				
1 Front view	2 3/4 view	3	4

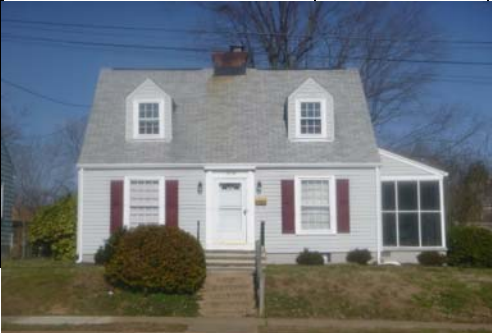
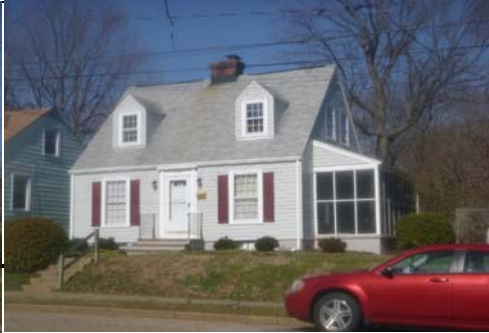
Name of Surveyors	Kimberly Packett		Survey Date	2/21/2016
ADDRESS	Street		Number	
	Parcel	Street	1319	
TYPE & NUMBER OF BLGS & STRUCTURES	Type		Number	
	Single Family House		1	
Current Use of Primary Building	Single Family	Historic Use of Primary Building	Single Family	
Style of Primary Bldg	Cape Cod			
Number of Stories	1 1/2	Width (bays)	3	
Foundation Material	Cinderblock	Depth (rooms)	2	
Year Built	1954	Wall Cladding Material	Vinyl siding	
Roof Shape	Side gable	Roof Material	Composition shingle	
Decorative Details/Unique Features	White surround around door with entablature. White surround around windows. Red shutters on front windows.			
Evidence of Integrity Location/Materials	Appears to be original windows.			
Additions/Alterations to Primary Building	New roof and vinyl siding.			
Condition of Primary Building	Excellent		code	E
Observable Threats	None			
Compatibility with Adjacent Land Uses	Good

Potential NR Eligibility	Contributing		code	C
Other Comments / Salient Details	Central chimney. Screened in porch on right side. Bushes along base of house. Chainlink fence around backyard. Cement steps with wood railing leading to cement path leading to brick/cement steps with iron railings that leads to front door.			
Photo Views				
1 Front view	2 3/4 view	3	4

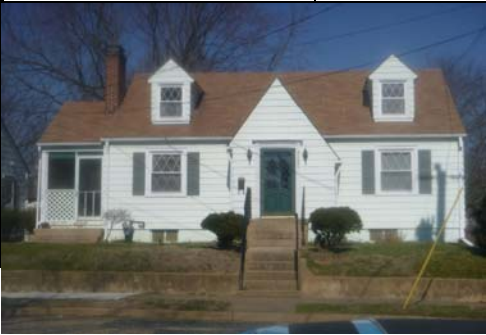
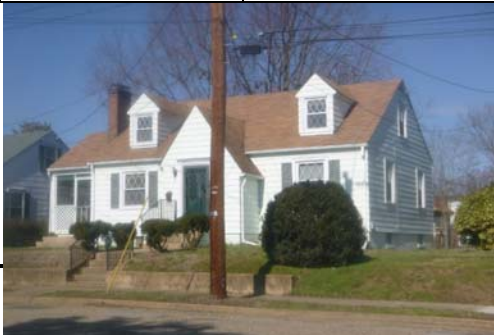
Name of Surveyors	Kimberly Packett		Survey Date	2/21/2016
ADDRESS	Street	Number		
	Parcel	Street	1321	
TYPE & NUMBER OF BLGS & STRUCTURES	Type	Number		
	Single Family House		1	
Current Use of Primary Building	Single Family	Historic Use of Primary Building	Single Family	
Style of Primary Bldg	Cape Cod			
Number of Stories	1 1/2	Width (bays)	3	
Foundation Material	Concrete	Depth (rooms)	2	
Year Built	1942	Wall Cladding Material	Aluminum siding	
Roof Shape	Side gable	Roof Material	Composition shingle	
Decorative Details/Unique Features	Diamond paned windows. Two dormers on front of house. Uneven front gable in center of house with front door.			
Evidence of Integrity Location/Materials	Original windows. Possible original siding.			
Additions/Alterations to Primary Building	New roof.			
Condition of Primary Building	Good		code	G
Observable Threats	None			
Compatibility with Adjacent Land Uses	Good			
Potential NR Eligibility	Contributing		code	C

Other Comments / Salient Details	Cement retaining wall along front of property. Cement stairs and path with iron railing leading to front door. Bushes along cement path. Chimney on left side of the house.			
Photo Views				
1 Front view	2 3/4 view	3	4

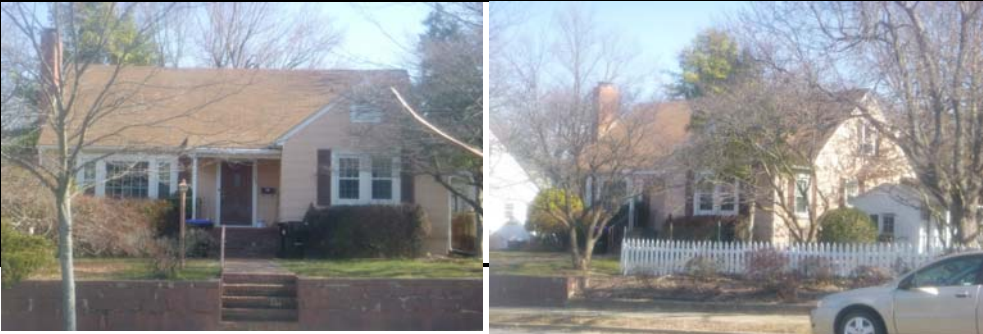
Name of Surveyors	Kimberly Packett	Survey Date	2/21/2016
ADDRESS	Street	Number	
	Stafford Avenue	1605	
TYPE & NUMBER OF BLGS & STRUCTURES	Type	Number	
	Single Family House	1	
Current Use of Primary Building	Single Family	Historic Use of Primary Building	Single Family
Style of Primary Bldg	Minimal Traditional		
Number of Stories	1 1/2	Width (bays)	3
Foundation Material	Cinderblock	Depth (rooms)	3
Year Built	1951	Wall Cladding Material	Asbestos siding
Roof Shape	Side gable	Roof Material	Composition shingle
Decorative Details/Unique Features	Front gable on right side of house. Red shutters on bottom front windows that match front door. White surround around front door. White decorative vent on front gable. Overhang over front door with white column.		
Evidence of Integrity Location/Materials	Original siding.		
Additions/Alterations to Primary Building	New roof and appears to be new windows.		
Condition of Primary Building	Good	code G

Observable Threats	None		
Compatibility with Adjacent Land Uses	Good		
Potential NR Eligibility	Contributing	Or C	
Other Comments / Salient Details	Chimney on left end of house. Cinderblock retaining wall along front of property. Gold lamppost on front lawn. Bushes along front of house. Brick steps and cement path with iron railing leading to front door with small landing with brick steps and iron railing.		
Photo Views			
1 Front view	2 3/4 view	3	4

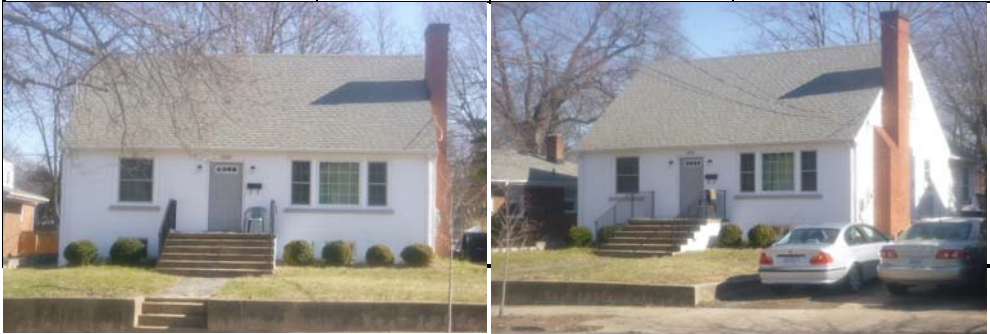
Name of Surveyors	Kimberly Packett		Survey Date	2/21/2016
ADDRESS	Street		Number	
	Stafford Avenue		1609	
TYPE & NUMBER OF BLGS & STRUCTURES	Type		Number	
	Single Family House		1	
	Detatched Garage		1	
Current Use of Primary Building	Single Family	Historic Use of Primary Building	Single Family	
Style of Primary Blg	Cape Cod			
Number of Stories	1 1/2	Width (bays)	3	
Foundation Material	Cinderblock	Depth (rooms)		
Year Built	1949	Wall Cladding Material	Cinderblock	
Roof Shape	Side gable	Roof Material	Composition shingle	
Decorative Details/Unique Features	Windows have a grey sill. Addition on the back of the house has vinyl siding and front gable.			
Evidence of Integrity Location/Materials	Original siding and windows.			
Additions/Alterations to Primary Building	New roof. Addition on the back of the house.			
Condition of Primary Building	Fair	code		
		F		
Observable Threats	None			
Compatibility with Adjacent Land Uses	Good

Potential NR Eligibility	Contributing	code		
		C		
Other Comments / Salient Details	Cement retaining wall along front of property with cement steps leading to stone pathway. Cement steps with iron railing leading to front door. Chimney on right side of the house. Paved double driveway on right side of house. Side door with cement steps and iron railing on right side of house. Small bushes along front of house.			
Photo Views				
1 Front view	2 3/4 view	3	4

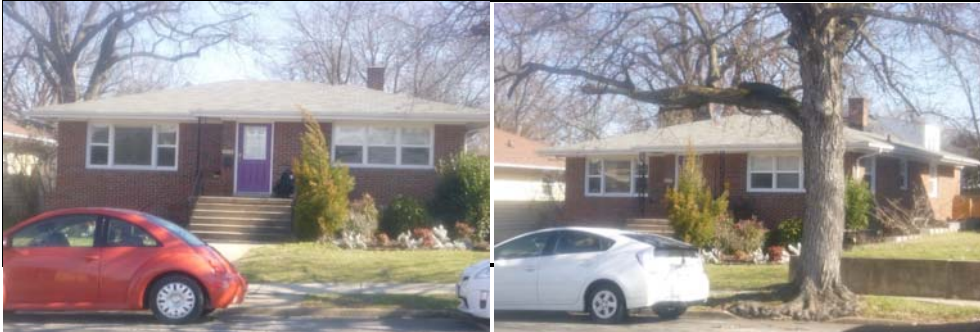
Name of Surveyors	Kimberly Packett		Survey Date	2/21/2016
ADDRESS	Street		Number	
	Stafford Avenue		1615	
TYPE & NUMBER OF BLGS & STRUCTURES	Type		Number	
	Single Family House		1	
Current Use of Primary Building	Single Family	Historic Use of Primary Building	Single Family	
Style of Primary Bldg	Minimal Traditional			
Number of Stories	1	Width (bays)	3	
Foundation Material	Cinderblock	Depth (rooms)	3	
Year Built	1956	Wall Cladding Material	Brick	
Roof Shape	Hip	Roof Material	Composition shingle	
Decorative Details/Unique Features	Gable with vinyl siding on right side of building. Simple white surround around purple front door.			
Evidence of Integrity Location/Materials	Original brick siding and windows.			
Additions/Alterations to Primary Building	New roof.			
Condition of Primary Building	Good		code	
			G	
Observable Threats	None			
Compatibility with Adjacent Land Uses	Good			
Potential NR Eligibility	Contributing		code

C	
Other Comments / Salient Details	Bushes and garden on front right side of house. Brick and cement retaining wall along right side of property. Cement driveway and stairs with iron railing leading to front door. Two decorative iron columns holding up overhang above front door. Central chimney on right side of the house.			
Photo Views				
1 Front view	2 3/4 view	3	4

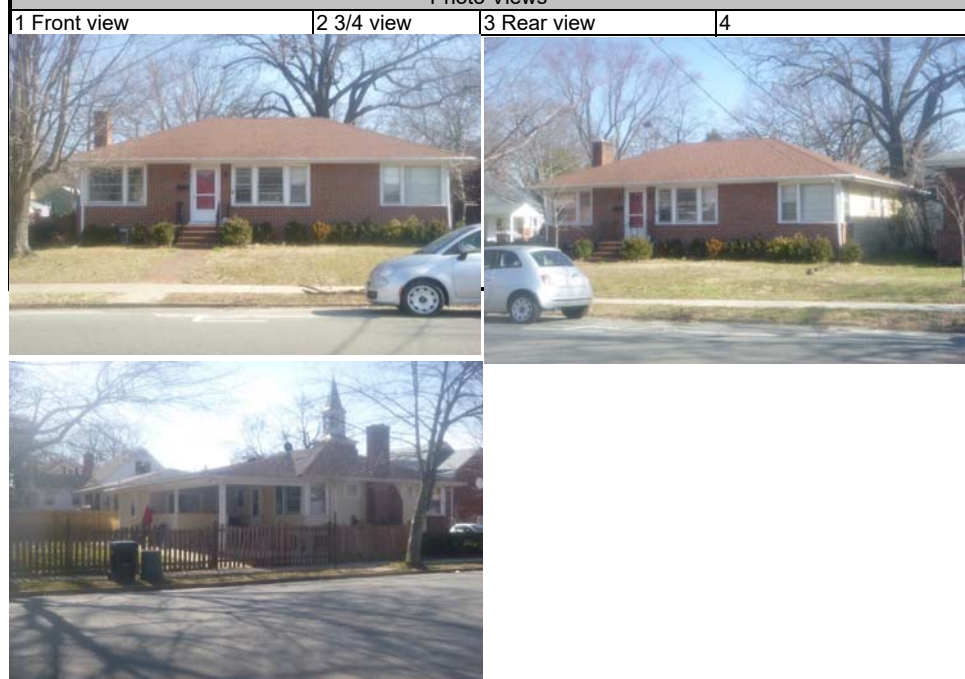
Name of Surveyors	Kimberly Packett	Survey Date	2/21/2016
ADDRESS	Street	Number	
	Stafford Avenue	1617	
TYPE & NUMBER OF BLGS & STRUCTURES	Type	Number	
	Single Family House	1	
Current Use of Primary Building	Single Family	Historic Use of Primary Building	Single Family
Style of Primary Bldg	Ranch		
Number of Stories	1	Width (bays)	4
Foundation Material	Cinderblock	Depth (rooms)	5
Year Built	1949	Wall Cladding Material	Hardboard siding
Roof Shape	Hip	Roof Material	Composition shingle
Decorative Details/Unique Features	Brick front façade. Simple white surround around front door and windows.		
Evidence of Integrity Location/Materials	Original windows.		
Additions/Alterations to Primary Building	New hardboard siding and brick façade doesn't look original. New roof.		
Condition of Primary Building	Good	code G	
Observable Threats	None		
Compatibility with Adjacent Land Uses	Good		
Potential NR Eligibility	Contributing	code C

Other Comments / Salient Details	Small bushes along front of house. Brick path leading to front door with brick stairs and iron railings Chimney on the left end of the house. Wooden fence around backyard. Cement patio in backyard with roof overhang with white columns. Back door leading to porch.

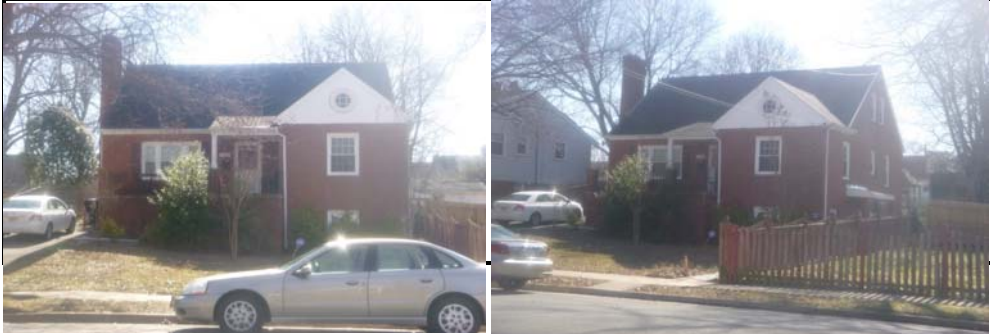
Name of Surveyors	Kimberly Packett		Survey Date	2/21/2016
ADDRESS	Street		Number	
	Rowe	Street	1320	
TYPE & NUMBER OF BLGS & STRUCTURES	Type		Number	
	Single Family House		1	
Current Use of Primary Building	Single Family	Historic Use of Primary Building	Single Family	
Style of Primary Bldg	Minimal Traditional			
Number of Stories	1 1/2	Width (bays)	3	
Foundation Material	Cinderblock	Depth (rooms)	3	
Year Built	1954	Wall Cladding Material	Brick	
Roof Shape	Side gable	Roof Material	Composition shingle	
Decorative Details/Unique Features	Shed roof overhang above front door. Side door has awning. Front gable with hardboard siding on right side of house. Decrative circle window on front gable.			
Evidence of Integrity Location/Materials	Original brick siding and windows.			
Additions/Alterations to Primary Building	New roof.			
Condition of Primary Building	Good			code G
Observable Threats	None			
Compatibility with Adjacent Land Uses	Good

Potential NR Eligibility	Contributing			code C
Other Comments / Salient Details	Paved driveway on left side of the house. Cement path leading from driveway to front door. Cement and brick steps and landing leading to front door with iron railing. Cement path leading from sidewalk to side door. Chimney on the left side of the house. Woof privacy fence around backyard. Bushes along front of the house.			
Photo Views				
1 Front view	2 3/4 view	3	4

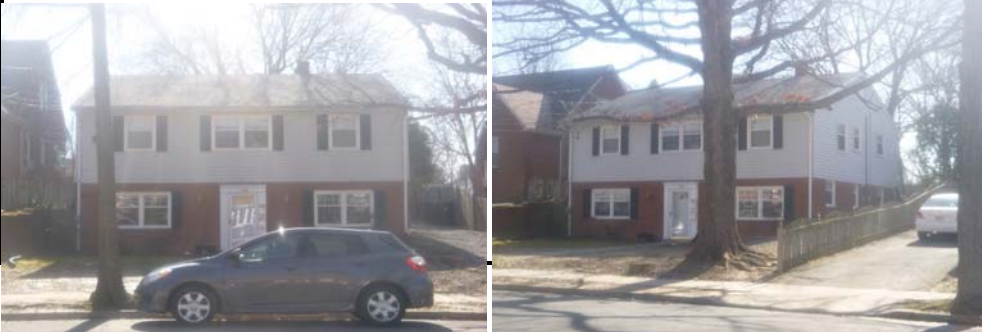
Name of Surveyors	Kimberly Packett		Survey Date	2/21/2016
ADDRESS	Street		Number	
	Rowe	Street	1316	
TYPE & NUMBER OF BLGS & STRUCTURES	Type		Number	
	Single Family House		1	
	Shed		1	
Current Use of Primary Building	Single Family	Historic Use of Primary Building	Single Family	
Style of Primary Bldg	Colonial Revival			
Number of Stories	2	Width (bays)	3	
Foundation Material	Concrete	Depth (rooms)	3	
Year Built	1958	Wall Cladding Material	Vinyl siding	
Roof Shape	Side gable	Roof Material	Composition shingle	
Decorative Details/Unique Features	Brick façade on the bottom front of the building. Blue shutter on front windows. White surround around front door with entablature			
Evidence of Integrity Location/Materials	None			
Additions/Alterations to Primary Building	New windows, vinyl siding, and roof.			
Condition of Primary Building	Good			code
				G
Observable Threats	None			
Compatibility with Adjacent Land Uses	Good

Potential NR Eligibility	Contributing			code
				C
Other Comments / Salient Details	Central chimney on right side of the house. Cement path leading to front door. Small bushes along front of the house.			
Photo Views				
1 Front view	2 3/4 view	3	4

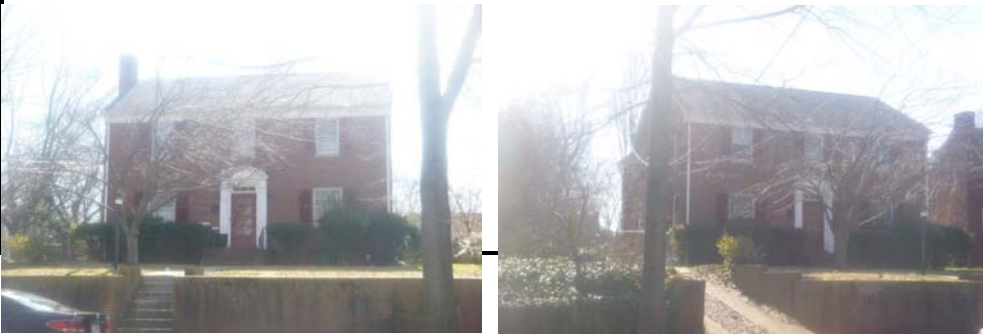
Name of Surveyors	Kimberly Packett		Survey Date	2/21/2016
ADDRESS	Street		Number	
	Rowe	Street	1306	
TYPE & NUMBER OF BLGS & STRUCTURES	Type		Number	
	Single Family House		1	
Current Use of Primary Building	Single Family	Historic Use of Primary Building	Single Family	
Style of Primary Bldg	Colonial Revival			
Number of Stories	2	Width (bays)	3	
Foundation Material	Cinderblock	Depth (rooms)	2	
Year Built	1949	Wall Cladding Material	Brick	
Roof Shape	Side gable	Roof Material	Composition shingle	
Decorative Details/Unique Features	Red shutters on front windows that match front door. Curved white pediment above front door with pilasters on either sides. Transom above front door.			
Evidence of Integrity Location/Materials	Original siding and appears to be original windows.			
Additions/Alterations to Primary Building	New roof.			
Condition of Primary Building	Excellent		code	E
Observable Threats	None			
Compatibility with Adjacent Land Uses	Good

Potential NR Eligibility	Contributing		code	C
Other Comments / Salient Details	Cement and gravel driveway on left side of the house. Brick retaining wall along front of property and driveway. Chimney on left end of house. Bushes along front of house.			
Photo Views				
1 Front view	2 3/4 view	3	4

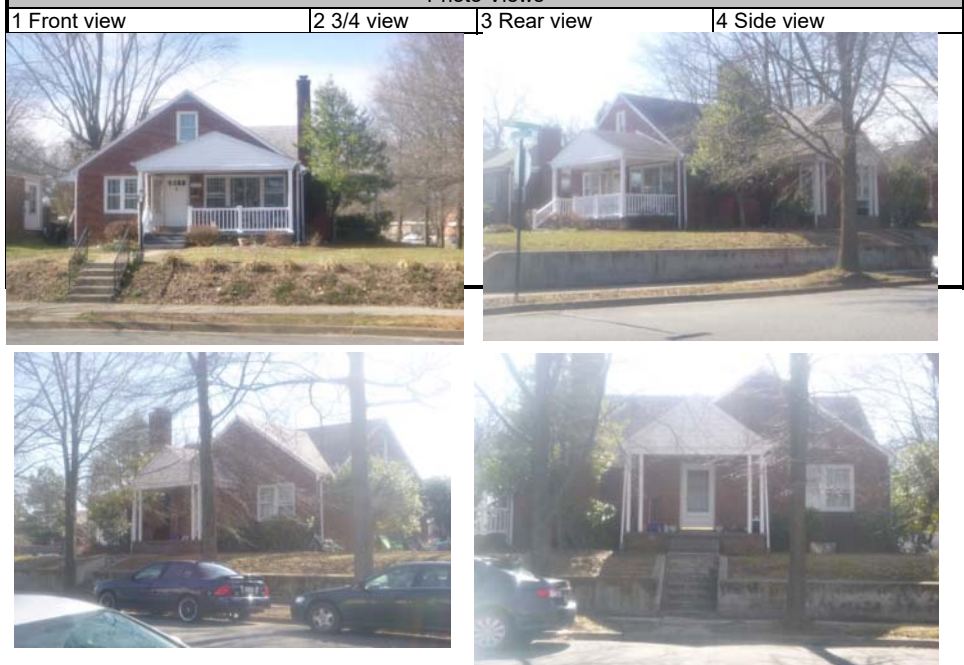
Name of Surveyors	Kimberly Packett	Survey Date	2/21/2016
ADDRESS	Street	Number	
	Augustine Avenue	1620	
TYPE & NUMBER OF BLGS & STRUCTURES	Type	Number	
	Single Family House	1	
Current Use of Primary Building	Single Family	Historic Use of Primary Building	Single Family
Style of Primary Bldg	Craftsman		
Number of Stories	1 1/2	Width (bays)	3
Foundation Material	Cinderblock	Depth (rooms)	3
Year Built	1951	Wall Cladding Material	Brick
Roof Shape	Cross gable	Roof Material	Compositon shingle
Decorative Details/Unique Features	White surround around doors and windows. Entry porch with front gable and white columns and railings above front door that stretches to the right edge of the house. Entry porch with front gable over side door.		
Evidence of Integrity Location/Materials	Original brick siding.		
Additions/Alterations to Primary Building	New roof and windows.		
Condition of Primary Building	Good	code G	
Observable Threats	None

Compatibility with Adjacent Land Uses	Good		
Potential NR Eligibility	Non-Contributing	code N	
Other Comments / Salient Details	Chimney on right end of house. Cement retaining wall along right side of the house. Cement stairs and path leading to side door with brick porch and front gable overhang with vinyl siding and white columns. Cement stairs and path with iron railings leading to front porch with wood railing and front gable overhang with vinyl siding.

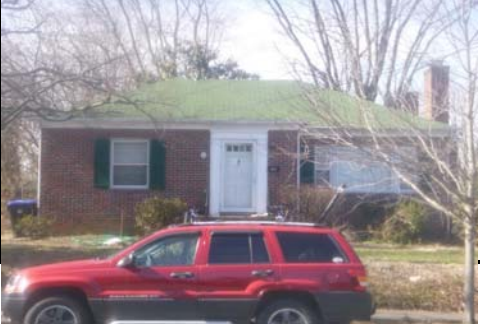
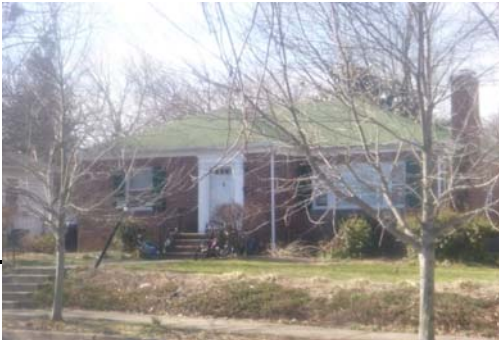
Name of Surveyors	Kimberly Packett		Survey Date	2/21/2016
ADDRESS	Street		Number	
	Augustine Avenue		1614	
TYPE & NUMBER OF BLGS & STRUCTURES	Type		Number	
	Single Family House		1	
Current Use of Primary Building	Single Family	Historic Use of Primary Building	Single Family	
Style of Primary Bldg	Minimal Traditional			
Number of Stories	1	Width (bays)	3	
Foundation Material	Concrete	Depth (rooms)	2	
Year Built	1939	Wall Cladding Material	Brick	
Roof Shape	Hip	Roof Material	Composition shingle	
Decorative Details/Unique Features	Dark green shutters on front windows. White surround around front door with entablature. Green roof.			
Evidence of Integrity Location/Materials	Original windows and brick siding.			
Additions/Alterations to Primary Building	New roof.			
Condition of Primary Building	Good		code	
			G	
Observable Threats	None			
Compatibility with Adjacent Land Uses	Good			
Potential NR Eligibility	Non-Contributing		code

N	
Other Comments / Salient Details	Chimney on right end of the house. Bushes along front of house. Cement stairs and path with iron railings leading to front door.			
Photo Views				
1 Front view	2 3/4 view	3	4

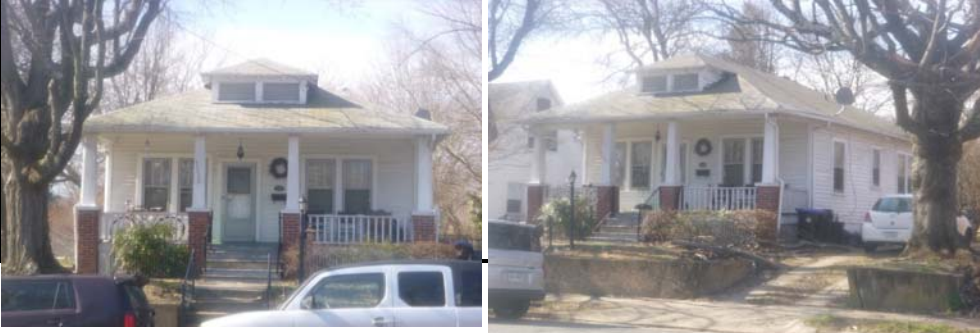
Name of Surveyors	Kimberly Packett		Survey Date	2/21/2016
ADDRESS	Street		Number	
	Augustine Avenue		1610	
TYPE & NUMBER OF BLGS & STRUCTURES	Type		Number	
	Single Family House		1	
Current Use of Primary Building	Single Family	Historic Use of Primary Building	Single Family	
Style of Primary Bldg	Bungalow			
Number of Stories	1	Width (bays)	3	
Foundation Material	Concrete	Depth (rooms)	3	
Year Built	1944	Wall Cladding Material	Hardboard siding	
Roof Shape	Hip	Roof Material	Composition shingle	
Decorative Details/Unique Features	White surround around front door and windows. Dormer with hip roof on front of house. Porch with wood railing and half brick, half wood columns.			
Evidence of Integrity Location/Materials	Original windows.			
Additions/Alterations to Primary Building	New siding and roof.			
Condition of Primary Building	Good		code	G
Observable Threats	None			
Compatibility with Adjacent Land Uses	Good

Potential NR Eligibility	Non-Contributing		code	N
Other Comments / Salient Details	Paved driveway on right side of the house. Cement retaining wall along front of property. Black lamppost in front lawn. Cement stairs and path with iron railing leading to front porch.			
Photo Views				
1 Front view	2 3/4 view	3	4

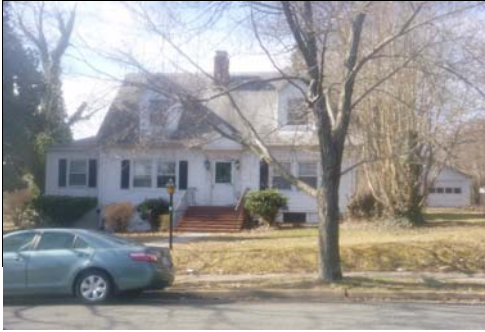
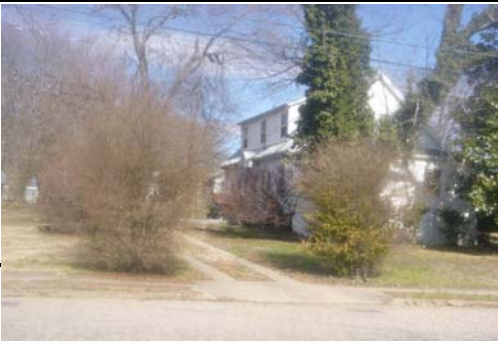
Name of Surveyors	Kimberly Packett		Survey Date	2/21/2016
ADDRESS	Street		Number	
	Augustine Avenue		1600	
TYPE & NUMBER OF BLGS & STRUCTURES	Type		Number	
	Single Family House		1	
	Detatched Garage		1	
Current Use of Primary Building	Single Family	Historic Use of Primary Building	Single Family	
Style of Primary Bldg	Cape Cod			
Number of Stories	1 1/2	Width (bays)	4	
Foundation Material	Cinderblock	Depth (rooms)	2	
Year Built	1949	Wall Cladding Material	Vinyl siding	
Roof Shape	Side gable	Roof Material	Composition shingle	
Decorative Details/Unique Features	Two front gable dormers on front of roof. Extended three window dormer on back of roof. White surround around front door. Dark blue shutters on front bottom windows.			
Evidence of Integrity Location/Materials	Appears to be original siding and windows.			
Additions/Alterations to Primary Building	New roof.			
Condition of Primary Building	Fair	code

G		
Observable Threats	None			
Compatibility with Adjacent Land Uses	Good			
Potential NR Eligibility	Contributing	code		
		C		
Other Comments / Salient Details	Cement driveway in backyard. Bushes along base of house. Cement path leading to brick stairs with iron railing that leads to front door. Central chimney.			
Photo Views				
Front view	2	Rear view	3	4

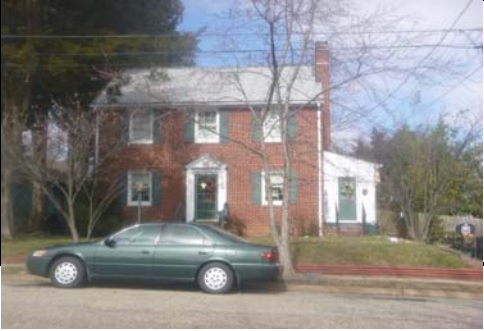
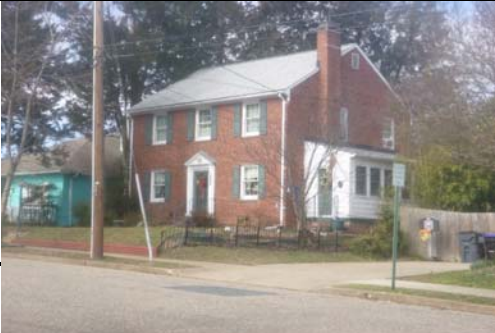
Name of Surveyors	Kimberly Packett		Survey Date	2/21/2016
ADDRESS	Street	Number		
	Parcel	Street	1209	
TYPE & NUMBER OF BLGS & STRUCTURES	Type	Number		
	Single Family House	1		
	Shed	1		
Current Use of Primary Building	Single Family	Historic Use of Primary Building	Single Family	
Style of Primary Bldg	Neo-colonial			
Number of Stories	2	Width (bays)	3	
Foundation Material	Cinderblock	Depth (rooms)	2	
Year Built	1939	Wall Cladding Material	Brick	
Roof Shape	Side gable	Roof Material	Composition shingle	
Decorative Details/Unique Features	Green shutters on front windows that match front door. White pilasters and triangular pediment.			
Evidence of Integrity Location/Materials	Original brick siding.			
Additions/Alterations to Primary Building	Small addition on right side of the house. New roof. Appears to be new windows.			
Condition of Primary Building	Good		code	G
Observable Threats	None			
Compatibility with Adjacent Land Uses	Good

Potential NR Eligibility	Non-Contributing		code	N
Other Comments / Salient Details	Addition on right side of house has vinyl siding and exterior door. Brick stairs and iron railing lead to door on addition. Chimney on right end of house. Short brick retaining wall along front of property.			
Photo Views				
1 Front view	2 3/4 view	3	4

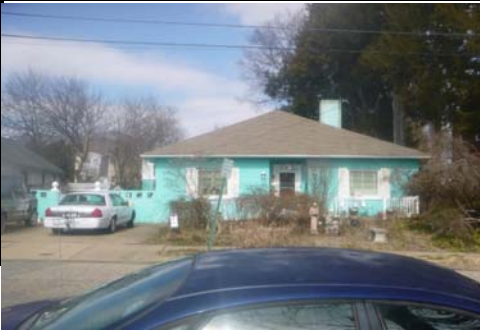
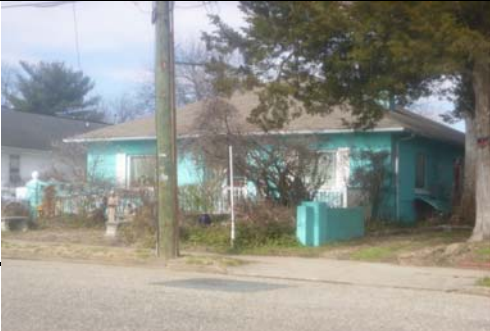
Name of Surveyors	Kimberly Packett		Survey Date	2/21/2016
ADDRESS	Street	Number		
	Parcel	Street	1213	
TYPE & NUMBER OF BLGS & STRUCTURES	Type	Number		
	Single Family House		1	
Current Use of Primary Building	Single Family	Historic Use of Primary Building	Single Family	
Style of Primary Bldg	Minimal Traditional			
Number of Stories	1	Width (bays)	3	
Foundation Material	Cinderblock	Depth (rooms)	3	
Year Built	1954	Wall Cladding Material	Cinderblock	
Roof Shape	Hip	Roof Material	Composition shingle	
Decorative Details/Unique Features	Siding has been painted turquoise. White shutters on front windows and white surround around front door. Many bushes, plants and decorative lawn ornaments in front yard.			
Evidence of Integrity Location/Materials	Original siding and windows.			
Additions/Alterations to Primary Building	Addition on the back of the property, new roof.			
Condition of Primary Building	Fair	code

F		
Observable Threats	None			
Compatibility with Adjacent Land Uses	Good			
Potential NR Eligibility	Contributing	code		
		C		
Other Comments / Salient Details	Interior chimney on back of house. Short cinderblock wall around back yard and front right of property. Paved driveway on front left side of property. Cement path leading from driveway to front door. Side door on left side of house.			
Photo Views				
1 Front view	2 3/4 view	3	4
