Cultural Resource Survey of College Heights in Fredericksburg, Virginia

Master of Science

Historic Preservation

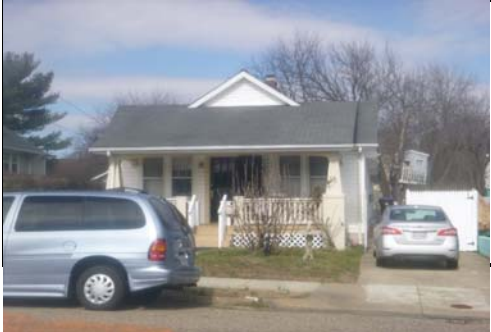
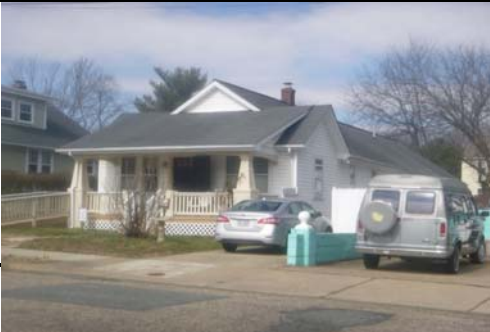
Name of Surveyors	Kimberly Packett		Survey Date	2/21/2016
ADDRESS	Street	Number		
	Parcel	Street	1217	
TYPE & NUMBER OF BLGS & STRUCTURES	Type	Number		
	Single Family House	1		
	Shed	1		
Current Use of Primary Building	Single Family	Historic Use of Primary Building	Single Family	
Style of Primary Bldg	Bungalow			
Number of Stories	1	Width (bays)	2	
Foundation Material	Concrete	Depth (rooms)	5	
Year Built	1944	Wall Cladding Material	Vinyl siding	
Roof Shape	Cross gable	Roof Material	Composition shingle	
Decorative Details/Unique Features	Tan surround around front door. Green storm door and front door.			
Evidence of Integrity Location/Materials	None			
Additions/Alterations to Primary Building	Addition on the back of the house. New roof, siding, and windows. Overhang addition on front of house.			
Condition of Primary Building	Good			code G
Observable Threats	None			
Compatibility with Adjacent Land Uses	Good

Potential NR Eligibility	Non-Contributing			code N
Other Comments / Salient Details	Side gable has an extended roof to cover front porch. Wood ramp on left side of house leads to front porch. Cement driveway on right side of house. White privacy fence along right and back side of property. Cement path and wood stairs leading to wood front porch with tan and white railings and columns. Central chimney.			
Photo Views				
1 Front view	2 3/4 view	3	4

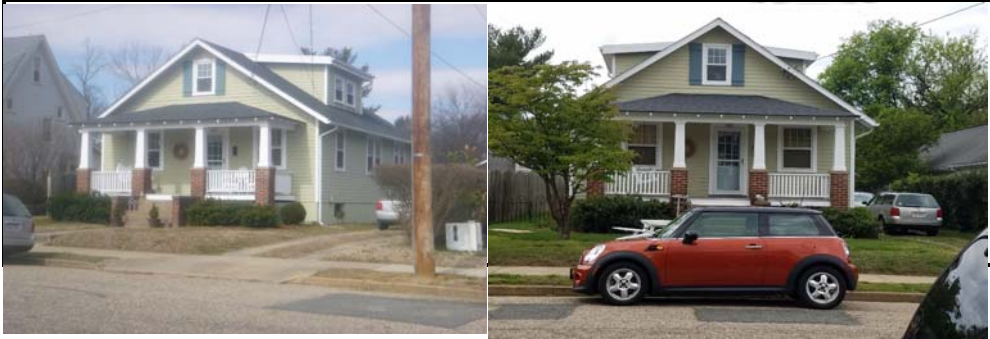
Name of Surveyors	Kimberly Packett		Survey Date	2/21/2016
ADDRESS	Street	Number		
	Parcel	Street	1221	
TYPE & NUMBER OF BLGS & STRUCTURES	Type	Number		
	Single Family House	1		
	Shed	1		
Current Use of Primary Building	Single Family	Historic Use of Primary Building	Single Family	
Style of Primary Bldg	Bungalow			
Number of Stories	1 1/2	Width (bays)	3	
Foundation Material	Cinderblock	Depth (rooms)	3	
Year Built	1938	Wall Cladding Material	Hardboard siding	
Roof Shape	Front gable	Roof Material	Composition shingle	
Decorative Details/Unique Features	Decorative dentils on eave of hip roof above front porch. White surround around front door and windows. Green shutters on front second story window. Extended shed roof two window dormer on right side of roof.			
Evidence of Integrity Location/Materials	None			
Additions/Alterations to Primary Building	Appears to be new roof, windows, and siding.			
Condition of Primary Building	Good	code

G		
Observable Threats	None			
Compatibility with Adjacent Land Uses	Good			
Potential NR Eligibility	Non-Contributing	code		
		N		
Other Comments / Salient Details	Small bushes along foot of front porch. Cement driveway along right side of house. Cement path and steps leading to front porch with brick and wood columns.			
Photo Views				
1 3/4 view	2 Front view	3	4

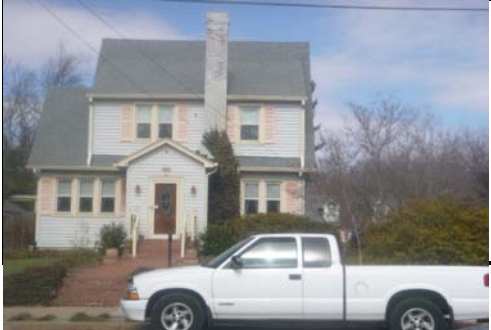
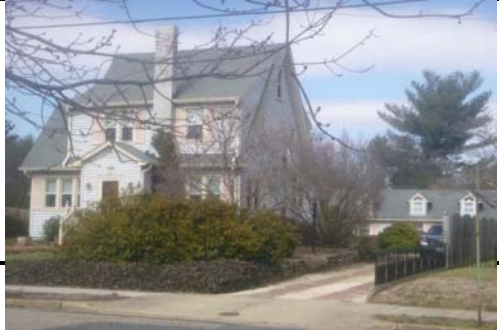
Name of Surveyors	Kimberly Packett		Survey Date	2/21/2016
ADDRESS	Street	Number		
	Parcel	Street	1225	
TYPE & NUMBER OF BLGS & STRUCTURES	Type	Number		
	Single Family House	1		
	Shed/Guest House	1		
Current Use of Primary Building	Single Family	Historic Use of Primary Building	Single Family	
Style of Primary Bldg	Tudor			
Number of Stories	2 1/2	Width (bays)	3	
Foundation Material	Concrete	Depth (rooms)	3	
Year Built	1934	Wall Cladding Material	Vinyl siding	
Roof Shape	Front gable	Roof Material	Composition shingle	
Decorative Details/Unique Features	Middle of first story protrudes and has a front gable and the front door. Tan surround around front door and windows. Front windows have pink shutters. Extended dormer with three windows along front of roof.			
Evidence of Integrity Location/Materials	Appears to be original windows.			
Additions/Alterations to Primary Building	New roof and vinyl siding.			
Condition of Primary Building	Good			code G

Observable Threats	None			
Compatibility with Adjacent Land Uses	Good			
Potential NR Eligibility	Non-Contributing			code N
Other Comments / Salient Details	Brick stairs and path with tan wood railings leading to front door. Chimney in on front of house. Paved driveway on right side of house leading to a possible guest house. Guest house has two front gable dormers on front of roof. Stone retaining wall along left side of driveway. Bushes and ivy on front lawn, iron lamppost on front lawn.			
Photo Views				
1 Front view	2 3/4 view	3	4

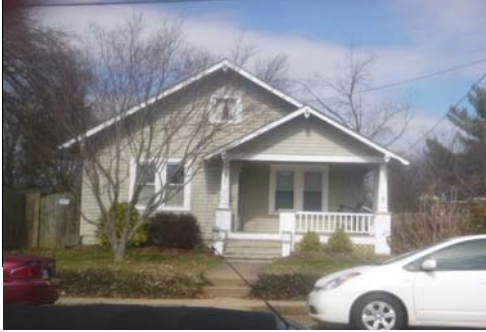
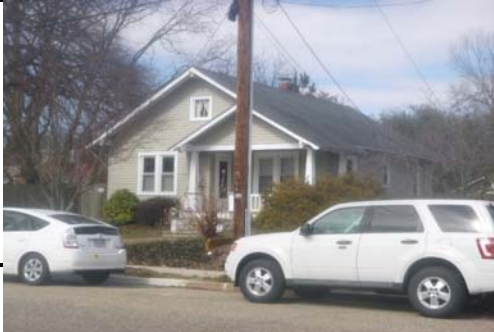
Name of Surveyors	Kimberly Packett		Survey Date	2/21/2016
ADDRESS	Street	Number		
	Parcel	Street	1229	
TYPE & NUMBER OF BLGS & STRUCTURES	Type	Number		
	Single Family House	1		
	Shed	1		
Current Use of Primary Building	Single Family	Historic Use of Primary Building	Single Family	
Style of Primary Bldg	Craftsman			
Number of Stories	1	Width (bays)	2	
Foundation Material	Cinderblock	Depth (rooms)	3	
Year Built	1933	Wall Cladding Material	Vinyl siding	
Roof Shape	Side gable	Roof Material	Composition shingle	
Decorative Details/Unique Features	White surround around front door and windows.			
Evidence of Integrity Location/Materials	None.			
Additions/Alterations to Primary Building	New vinyl siding, roof, and windows.			
Condition of Primary Building	Excellent			code E
Observable Threats	None			
Compatibility with Adjacent Land Uses	Good			
Potential NR Eligibility	Non-Contributing			code N
Other Comments / Salient Details	Wood privacy fence around backyard. Cement stairs and path leading to cement and wood front porch. Bushes along front left of house. Chimney on back left of house.

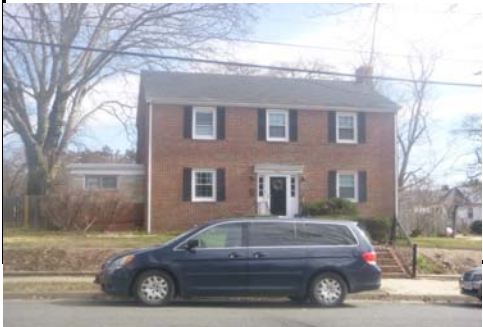
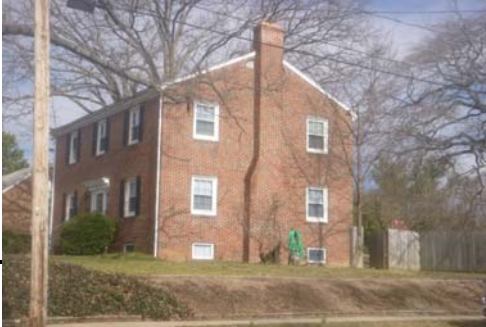
Name of Surveyors	Kimberly Packett		Survey Date	2/21/2016
ADDRESS	Street		Number	
	Augustine Avenue		1601	
TYPE & NUMBER OF BLGS & STRUCTURES	Type		Number	
	Single Family House		1	
Current Use of Primary Building	Single Family	Historic Use of Primary Building	Single Family	
Style of Primary Bldg	Neo-colonial			
Number of Stories	2	Width (bays)	3	
Foundation Material	Cinderblock	Depth (rooms)	2	
Year Built	1951	Wall Cladding Material	Brick	
Roof Shape	Side gable	Roof Material	Composition shingle	
Decorative Details/Unique Features	Green shutters on front windows that match front door. Entablature around front door with sidelights. White surround around windows.			
Evidence of Integrity Location/Materials	Original brick siding.			
Additions/Alterations to Primary Building	Appears to be new windows and roof. Addition on left side of the house made of stone with a flat roof.			
Condition of Primary Building	Good		code	G

Observable Threats	None			
Compatibility with Adjacent Land Uses	Good			
Potential NR Eligibility	Contributing		code	C
Other Comments / Salient Details	Chimney on right end of the house. Wood privacy fence around backyard. Brick stairs and path with iron railing leading to front door. Ivy incline along sides of property.			
Photo Views				
1 Front view	2 3/4 view	3	4

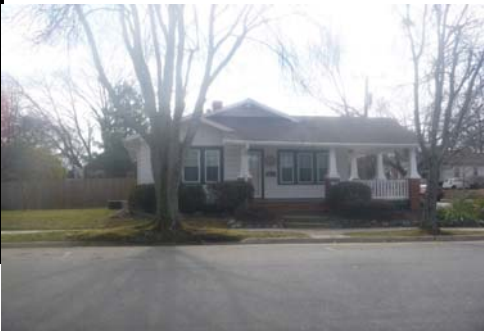
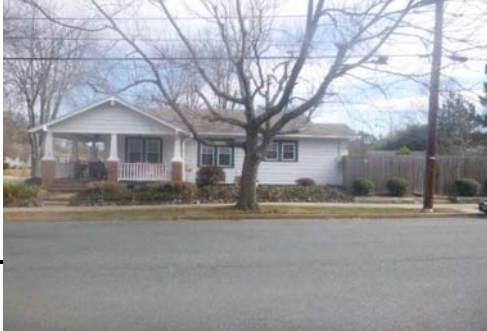
Name of Surveyors	Kimberly Packett		Survey Date	2/21/2016
ADDRESS	Street		Number	
	Rowe	Street	1236	
TYPE & NUMBER OF BLGS & STRUCTURES	Type		Number	
	Single Family House		1	
	Shed		1	
Current Use of Primary Building	Single Family	Historic Use of Primary Building	Single Family	
Style of Primary Bldg	Bungalow			
Number of Stories	2	Width (bays)	3	
Foundation Material	Cinderblock	Depth (rooms)	3	
Year Built	1934	Wall Cladding Material	Aluminum siding	
Roof Shape	Side gable	Roof Material	Composition shingle	
Decorative Details/Unique Features	Green surround around front door and windows. Front porch wraps around on right side of the house. Porch has white railings and brick bottom columns.			
Evidence of Integrity Location/Materials	Appears to be original siding and windows.			
Additions/Alterations to Primary Building	New roof.			
Condition of Primary Building	Excellent		code	
			E	
Observable Threats	None

Compatibility with Adjacent Land Uses	Good			
Potential NR Eligibility	Non-Contributing		code	
			N	
Other Comments / Salient Details	Wood privacy fence around backyard. Stone surrounding gardens around base of house. Cement path and stairs leading to front porch from the front and side of property. Chimney in back left side of the house.			
Photo Views				
1 Front view	2 Side view	3	4

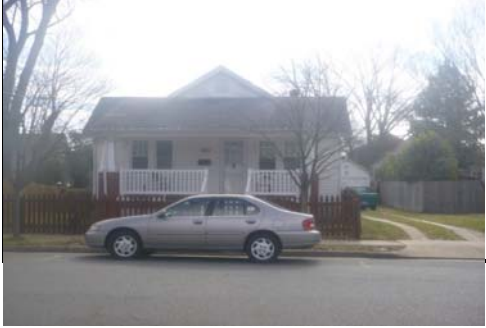
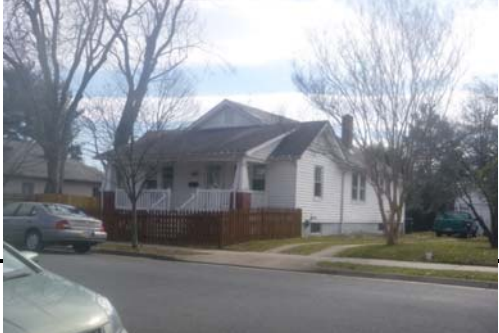
Name of Surveyors	Kimberly Packett		Survey Date	2/21/2016
ADDRESS	Street		Number	
	Rowe	Street	1232	
TYPE & NUMBER OF BLGS & STRUCTURES	Type		Number	
	Single Family House		1	
	Detatched Garage		1	
Current Use of Primary Building	Single Family	Historic Use of Primary Building	Single Family	
Style of Primary Blg	Bungalow			
Number of Stories	1	Width (bays)	3	
Foundation Material	Concrete	Depth (rooms)	3	
Year Built	1941	Wall Cladding Material	Vinyl siding	
Roof Shape	Cross gable	Roof Material	Composition shingle	
Decorative Details/Unique Features	Front gable with a side gable on the front. Large front porch with shed roof overhang supported by brick and wood columns.			
Evidence of Integrity Location/Materials	Original windows.			
Additions/Alterations to Primary Building	New siding and roof.			
Condition of Primary Building	Good		code	
			G	
Observable Threats	None			
Compatibility with Adjacent Land Uses	Good

Potential NR Eligibility	Non-Contributing		code	
			N	
Other Comments / Salient Details	Wood picket fence around front yard. Wood privacy fence around backyard. Cement driveway along right side of house leading to detached garage in backyard. Cement path leading to wood front porch. Chimney on back right of house.			
Photo Views				
1 Front view	2 3/4 view	3	4

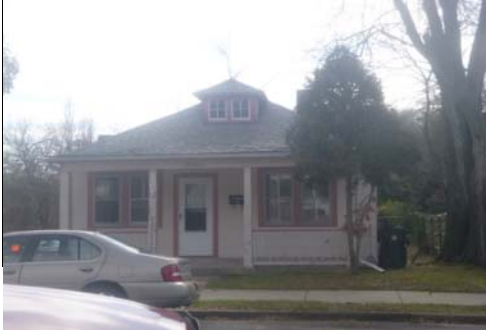
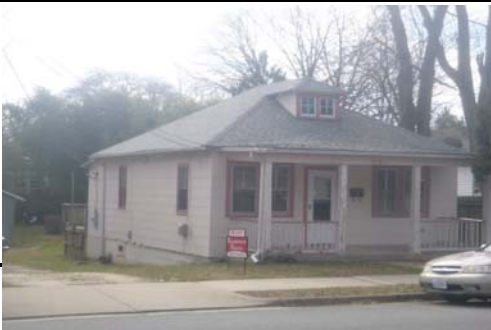
Name of Surveyors	Kimberly Packett		Survey Date	2/21/2016
ADDRESS	Street		Number	
	Rowe	Street	1228a	
TYPE & NUMBER OF BLGS & STRUCTURES	Type		Number	
	Single Family House		1	
	Shed		1	
Current Use of Primary Building	Single Family	Historic Use of Primary Building	Single Family	
Style of Primary Bldg	Bungalow			
Number of Stories	1	Width (bays)	3	
Foundation Material	Concrete	Depth (rooms)	2	
Year Built	1949	Wall Cladding Material	Asbestos siding	
Roof Shape	Hip	Roof Material	Composition shingle	
Decorative Details/Unique Features	Red surround around front door and front windows. Dormer with hip roof and two windows on front of roof.			
Evidence of Integrity Location/Materials	Original siding and windows. Could possibly be original roof, it's in poor condition.			
Additions/Alterations to Primary Building	None.			
Condition of Primary Building	Poor		code	P
Observable Threats	None			
Compatibility with Adjacent Land Uses	Good

Potential NR Eligibility	Non-Contributing		code	N
Other Comments / Salient Details	Wood deck on back of house. Cement path leading to wooden front porch with overhang and wood railings and columns.			
Photo Views				
1 Front view	2 3/4 view	3	4

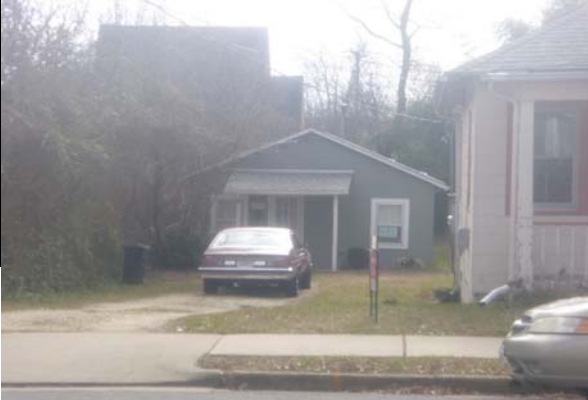
Name of Surveyors	Kimberly Packett		Survey Date	2/21/2016
ADDRESS	Street		Number	
	Rowe	Street	1228b	
TYPE & NUMBER OF BLGS & STRUCTURES	Type		Number	
	Single Family House		1	
Current Use of Primary Building	Single Family	Historic Use of Primary Building	Single Family	
Style of Primary Bldg	Minimal Traditional			
Number of Stories	1	Width (bays)	3	
Foundation Material	Concrete	Depth (rooms)	2	
Year Built	1949	Wall Cladding Material	Asbestos siding	
Roof Shape	Front gable	Roof Material	Composition shingle	
Decorative Details/Unique Features	White surround around front door and windows. Shed roof overhang supported by two white columns above front door.			
Evidence of Integrity Location/Materials	Original siding.			
Additions/Alterations to Primary Building	Appears to be new roof and windows.			
Condition of Primary Building	Fair		code	
			F	
Observable Threats	None			
Compatibility with Adjacent Land Uses	Good

Potential NR Eligibility	Contributing		code	
			C	
Other Comments / Salient Details	House in set in backyard of another property. Gravel driveway leads to front of house.			
Photo Views				
1 Front view	2	3	4

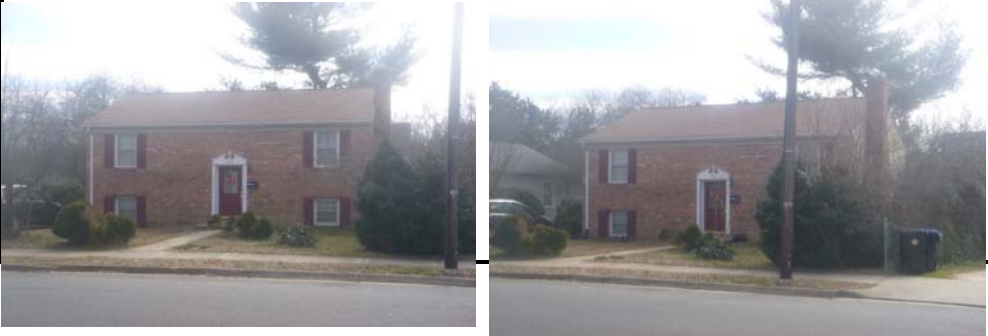
Name of Surveyors	Kimberly Packett		Survey Date	2/21/2016
ADDRESS	Street		Number	
	Rowe	Street	1224	
TYPE & NUMBER OF BLGS & STRUCTURES	Type		Number	
	Single Family House		1	
	Detatched Garage		1	
Current Use of Primary Building	Single Family	Historic Use of Primary Building	Single Family	
Style of Primary Blg	Split Level			
Number of Stories	2	Width (bays)	3	
Foundation Material	Cinderblock	Depth (rooms)	2	
Year Built	1973	Wall Cladding Material	Aluminum siding	
Roof Shape	Side gable	Roof Material	Composition shingle	
Decorative Details/Unique Features	Brick front façade. Broken pediment and white columns around front door. Red shutters on front windows that match front door.			
Evidence of Integrity Location/Materials	Original siding and windows.			
Additions/Alterations to Primary Building	Appears to be a new roof.			
Condition of Primary Building	Good		code	G
Observable Threats	None			
Compatibility with Adjacent Land Uses	Good

Potential NR Eligibility	Non-Contributing		code	N
Other Comments / Salient Details	Cement path and stairs leading to front door. Paved driveway on left side of house leading to detached garage. Chimney on right end of the house. Small bushes in front yard.			
Photo Views				
1 Front view	2 3/4 view	3	4

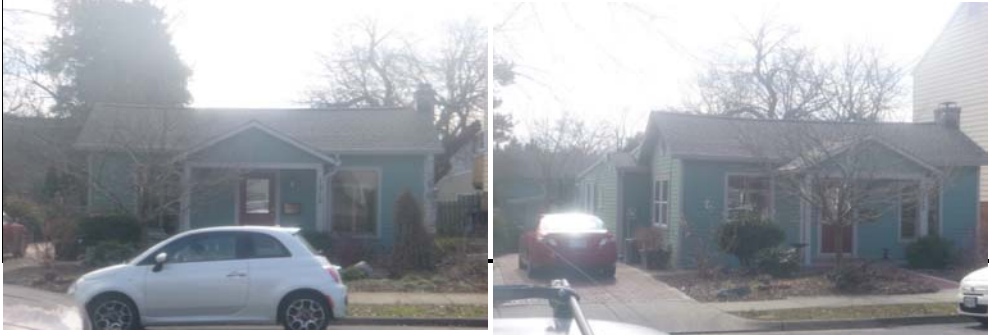
Name of Surveyors	Kimberly Packett		Survey Date	2/21/2016
ADDRESS	Street		Number	
	Rowe	Street	1212	
TYPE & NUMBER OF BLGS & STRUCTURES	Type		Number	
	Single Family House		1	
	Shed		1	
Current Use of Primary Building	Single Family	Historic Use of Primary Building	Single Family	
Style of Primary Bldg	Neo-colonial			
Number of Stories	1	Width (bays)	3	
Foundation Material	Concrete	Depth (rooms)	3	
Year Built	1949	Wall Cladding Material	Hardboard siding	
Roof Shape	Side gable	Roof Material	Composition shingle	
Decorative Details/Unique Features	Front gable entry porch and two white columns above front door. White surround around front door and windows.			
Evidence of Integrity Location/Materials	Possibly original siding hard to tell, freshly painted.			
Additions/Alterations to Primary Building	Addition on rear of house, new roof and windows.			
Condition of Primary Building	Fair		code	F
Observable Threats	None

Compatibility with Adjacent Land Uses	Good			
Potential NR Eligibility	Contributing		code	C
Other Comments / Salient Details	Chimney on right end of house. Brick driveway on left side of the house. Side door on left side of house. Wood chip garden with plants, bushes, and trees takes up the whole front yard.			
Photo Views				
1 Front view	2 3/4 view	3	4

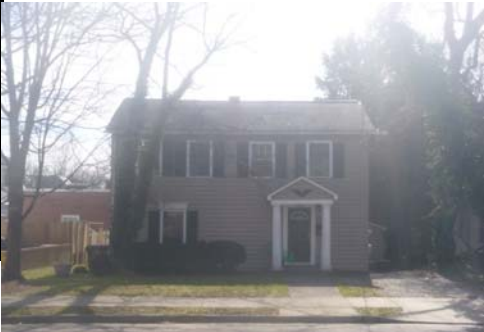
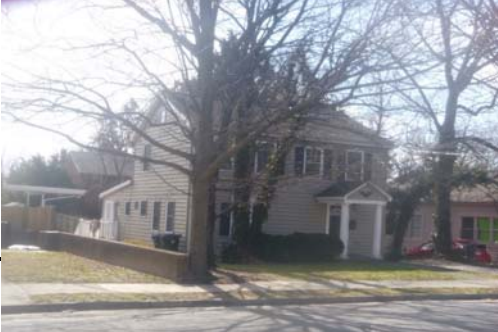
Name of Surveyors	Kimberly Packett		Survey Date	2/21/2016
ADDRESS	Street		Number	
	Rowe	Street	1208	
TYPE & NUMBER OF BLGS & STRUCTURES	Type		Number	
	Single Family House		1	
	Shed		1	
Current Use of Primary Building	Single Family	Historic Use of Primary Building	Single Family	
Style of Primary Bldg	Colonial Revival			
Number of Stories	2	Width (bays)	3	
Foundation Material	Cinderblock	Depth (rooms)	5	
Year Built	1934	Wall Cladding Material	Vinyl siding	
Roof Shape	Side gable	Roof Material	Composition shingle	
Decorative Details/Unique Features	Front gable entry porch and decorative eagle above front door with two white columns. Blue shutters on front windows. White crosshead above first story front window. White surround around front door.			
Evidence of Integrity Location/Materials	None			
Additions/Alterations to Primary Building	Addition on the back. New roof, vinyl siding, and windows.			
Condition of Primary Building	Good	code

G		
Observable Threats	None			
Compatibility with Adjacent Land Uses	Good			
Potential NR Eligibility	Non-Contributing	code		
		N		
Other Comments / Salient Details	Rear addition has shed roof. Gravel driveway on right side of house leading to shed in backyard. Central chimney in the back of the house. Side door on left side of rear addition. Cement path leading to front foor with cement landing. Bushes along front of house. Short white fence around backyard. Short brick wall along left side of property.			
Photo Views				
1 Front view	2 3/4 view	3	4

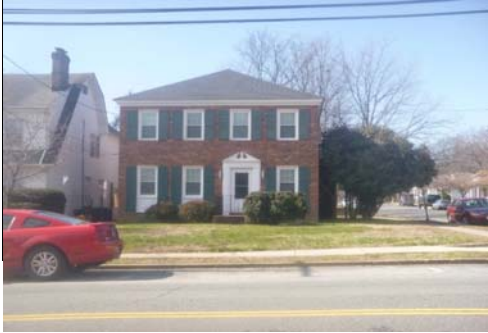
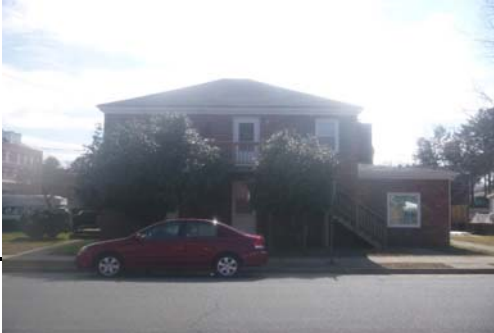
Name of Surveyors	Kimberly Packett		Survey Date	2/21/2016
ADDRESS	Street		Number	
	College	Avenue	1618a,b	
TYPE & NUMBER OF BLGS & STRUCTURES	Type		Number	
	Multi-Family House		1	
Current Use of Primary Building	Multi-Family	Historic Use of Primary Building	Single Family	
Style of Primary Bldg	Federal			
Number of Stories	2	Width (bays)	4	
Foundation Material	Cinderblock	Depth (rooms)	4	
Year Built	1949	Wall Cladding Material	Brick	
Roof Shape	Hip	Roof Material	Composition shingle	
Decorative Details/Unique Features	Broke triangular and segmental pediments around front door. Blue shutters on front windows and white surround around them as well. Brick steps and landing with iron railing leading to front door. White panels under first story windows.			
Evidence of Integrity Location/Materials	Original brick siding. Possibly original windows on original section of building.			
Additions/Alterations to Primary Building	Addition on the back. New roof.

Condition of Primary Building	Excellent		code	E
Observable Threats	Growth of UMW			
Compatibility with Adjacent Land Uses	Good			
Potential NR Eligibility	Contributing		code	C
Other Comments / Salient Details	Bushes along front of house. Wooden stairs on right side of the house lead to the entrance to the second story, which is a separate apartment.			
Photo Views				
1 Front view	2 Side view	3	4

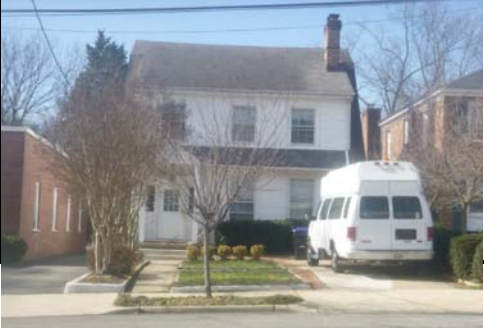
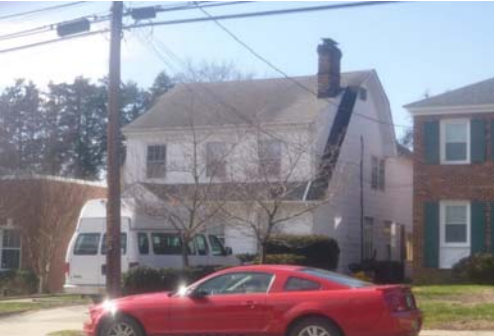
Name of Surveyors	Kimberly Packett		Survey Date	2/21/2016
ADDRESS	Street		Number	
	College	Avenue	1616	
TYPE & NUMBER OF BLGS & STRUCTURES	Type		Number	
	Single Family House		1	
Current Use of Primary Building	Single Family	Historic Use of Primary Building	Single Family	
Style of Primary Bldg	Dutch Colonial			
Number of Stories	3	Width (bays)	3	
Foundation Material	Cinderblock	Depth (rooms)	3	
Year Built	1930	Wall Cladding Material	Asbestos siding	
Roof Shape	Gambrel	Roof Material	Composition shingle	
Decorative Details/Unique Features	Rear addition has front gable roof. Extended dormer on front of roof with three windows. Front gable entry porch and two white columns above front door. Front foor has a window and sidelights.			
Evidence of Integrity Location/Materials	Possibly original siding and windows.			
Additions/Alterations to Primary Building	Addition on back of building. New roof.			
Condition of Primary Building	Fair		code	F

Observable Threats	Growth of UMW			
Compatibility with Adjacent Land Uses	Good			
Potential NR Eligibility	Non-Contributing		code	N
Other Comments / Salient Details	Chimney on interior front right side of the house. Cement walkway leading to front foor with cement landing. Bushes along front of house and right side of property. Brick and cement driveway on front right side of property. Low cement retaining wall around grass and garden areas in front yard.			
Photo Views				
1 Front view	2 3/4 view	3	4

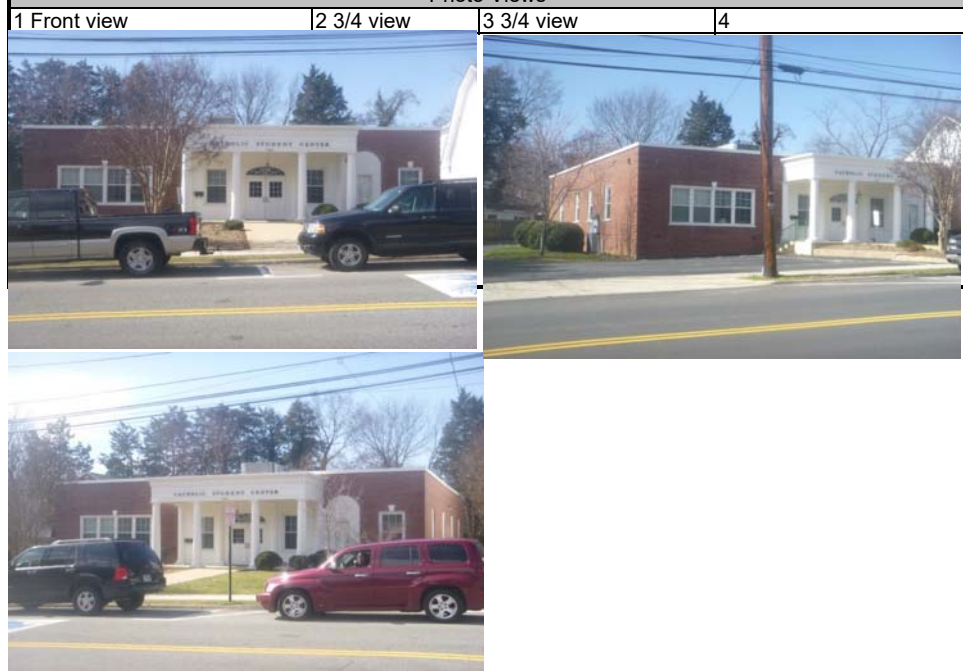
Name of Surveyors	Kimberly Packett		Survey Date	2/21/2016
ADDRESS	Street		Number	
	College Avenue		1614	
TYPE & NUMBER OF BLGS & STRUCTURES	Type		Number	
	Commerical Structure		1	
Current Use of Primary Building	Religious	Historic Use of Primary Building	Single Family	
Style of Primary Bldg	Neoclassical			
Number of Stories	2	Width (bays)	5	
Foundation Material	Concrete	Depth (rooms)	4	
Year Built	1929	Wall Cladding Material	Brick	
Roof Shape	Flat	Roof Material	Poured asphalt roof	
Decorative Details/Unique Features	Flat roof entry porch with white columns, wall under entry roof is painted white. White surround around double front doors and windows. Front doors have a semi-circular transom. White keystone above front windows.			
Evidence of Integrity Location/Materials	None			
Additions/Alterations to Primary Building	Roof, siding and windows all appear new.			
Condition of Primary Building	Excellent		code	E

Observable Threats	Growth of UMW			
Compatibility with Adjacent Land Uses	Surrounding buildings are mainly residential, besides UMW			
Potential NR Eligibility	Non-Contributing		code	N
Other Comments / Salient Details	Paved parking lot on front left side of property. Cement stairs with iron railing leading from parking lot of cement porch. Cement path leading from sidewalk to cement porch.

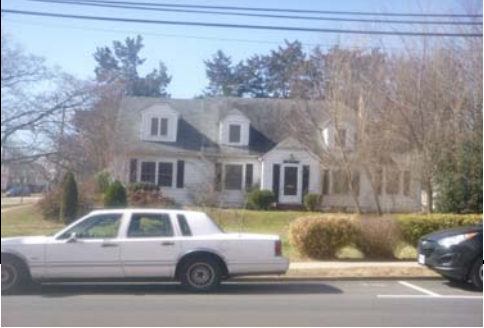
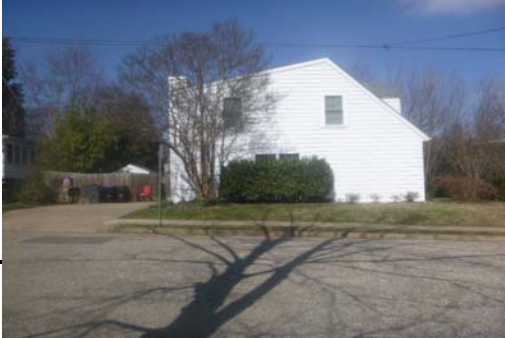
Name of Surveyors	Kimberly Packett		Survey Date	2/21/2016
ADDRESS	Street		Number	
	College	Avenue	1604	
TYPE & NUMBER OF BLGS & STRUCTURES	Type		Number	
	Single Family House		1	
Current Use of Primary Building	Single Family	Historic Use of Primary Building	Single Family	
Style of Primary Bldg	Cape Cod			
Number of Stories	2	Width (bays)	5	
Foundation Material	Cinderblock	Depth (rooms)	2	
Year Built	1949	Wall Cladding Material	Aluminum siding	
Roof Shape	Side gable	Roof Material	Composition shingle	
Decorative Details/Unique Features	Dark blue shutters on front window. White surround around front door with transom. Two front gable dormers on original part of building, one clipped roof dormer on the addition on the left side of the house. Saltbox roof on addition on left side of house.			
Evidence of Integrity Location/Materials	Appears to be original windows on original part of structure.			
Additions/Alterations to Primary Building	Additions on left and right of main structure

Condition of Primary Building	Good		code	
			G	
Observable Threats	Growth of UMW			
Compatibility with Adjacent Land Uses	Good			
Potential NR Eligibility	Contributing		code	
			C	
Other Comments / Salient Details	Cement driveway behind the house. Bushes along front and side of house. Cement path leading from driveway to front door with brick stairs and iron railing. Wood privacy fence around backyard.			
Photo Views				
1 Front view	2 Side view	3	4

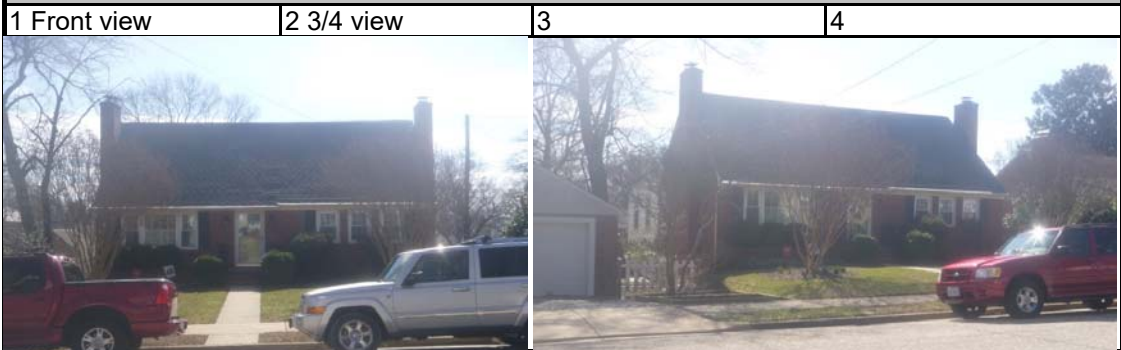
Name of Surveyors	Kimberly Packett		Survey Date	2/21/2016
ADDRESS	Street		Number	
	Parcel	Street	1308	
TYPE & NUMBER OF BLGS & STRUCTURES	Type		Number	
	Single Family House		1	
	Shed		1	
Current Use of Primary Building	Single Family	Historic Use of Primary Building	Single Family	
Style of Primary Bldg	Cape Cod			
Number of Stories	1.5	Width (bays)	3	
Foundation Material	Cinderblock	Depth (rooms)	4	
Year Built	1959	Wall Cladding Material	Brick & vinyl siding	
Roof Shape	Side Gable	Roof Material	Composition Shingles	
Decorative Details/Unique Features	Dark blue shutters on front windows. Brick gardening box on front left side of house.			
Evidence of Integrity Location/Materials	Original brick siding.			
Additions/Alterations to Primary Building	Screened in back porch, appears to be new windows and roof.			
Condition of Primary Building	Good		code	
			G	
Observable Threats	None			
Compatibility with Adjacent Land Uses	Good

Potential NR Eligibility	Contributing		code	
			C	
Other Comments / Salient Details	Chimneys on either end of the house. Cement path leading to front door with bricks stairs and iron railing. Bushes along front of house.

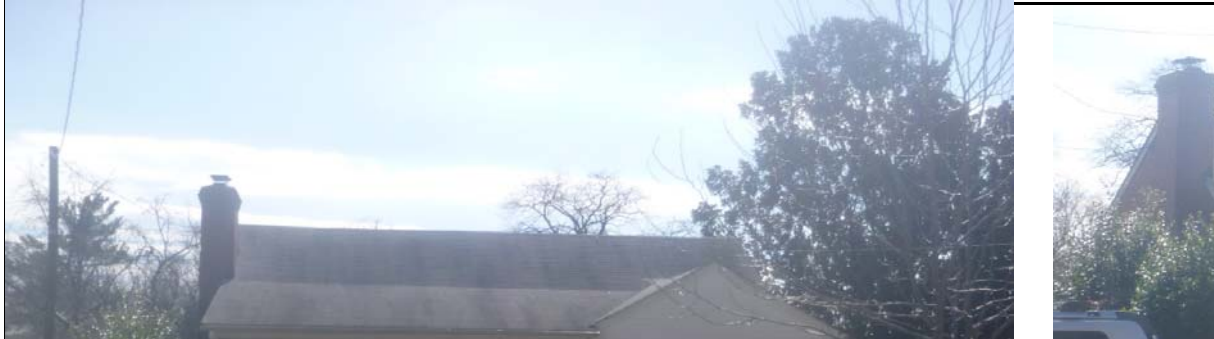
Name of Surveyors	Kimberly Packett		Survey Date	2/21/2016
ADDRESS	Street		Number	
	Parcel	Street	1312	
TYPE & NUMBER OF BLGS & STRUCTURES	Type		Number	
	Single Family House		1	
Current Use of Primary Building	Single Family	Historic Use of Primary Building	Single Family	
Style of Primary Blg	Minimal Traditional			
Number of Stories	1.5	Width (bays)	3	
Foundation Material	Concrete	Depth (rooms)	3	
Year Built	1950	Wall Cladding Material	Brick	
Roof Shape	Side Gable	Roof Material	Composition Shingles	
Decorative Details/Unique Features	Blue shutters that match front door. White surround around front door. Front gable on the right side of the house with white siding. Low pitch overhang above front porch.			
Evidence of Integrity Location/Materials	Appears to be original windows, original brick siding.			
Additions/Alterations to Primary Building	New roof			
Condition of Primary Building	Good			code
				G
Observable Threats	None

Compatibility with Adjacent Land Uses	Good			
Potential NR Eligibility	Contributing			code
				C
Other Comments / Salient Details	Concrete walkway leading to brick front porch with white railing and columns. Small bushes along front of house. Chimney on left end of house.			
Photo Views				
1 Front view	2 3/4 view	3	4

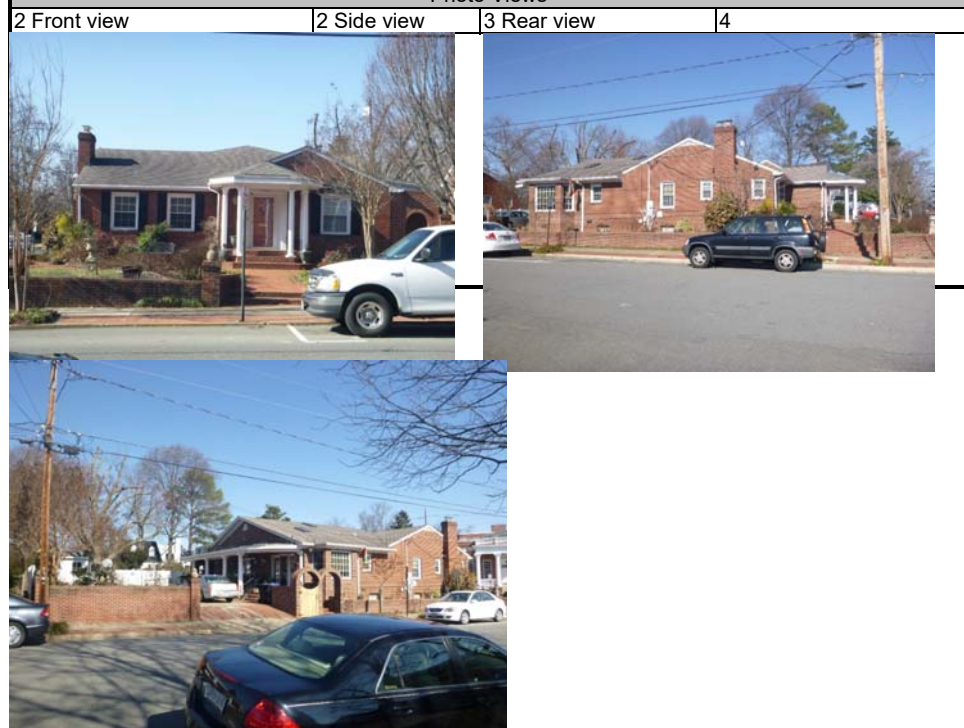
Name of Surveyors	Kimberly Packett		Survey Date	2/21/2016
ADDRESS	Street		Number	
	College Avenue		1702	
TYPE & NUMBER OF BLGS & STRUCTURES	Type		Number	
	Single Family House		1	
Current Use of Primary Building	Single Family	Historic Use of Primary Building	Single Family	
Style of Primary Bldg	Mixed Style			
Number of Stories	1	Width (bays)	4	
Foundation Material	Cinderblock	Depth (rooms)	5	
Year Built	1953	Wall Cladding Material	Brick	
Roof Shape	Cross gable	Roof Material	Composition shingle	
Decorative Details/Unique Features	Black shutters on front windows. Hip roof entry porch with white columns and a hip roof over front door. White surround around front door and windows. Overhang over back porch with white columns.			
Evidence of Integrity Location/Materials	Original brick siding and appears to be original windows.			
Additions/Alterations to Primary Building	Addition on back of house. New roof.

Condition of Primary Building	Excellent		code	E
Observable Threats	Growth of UMW			
Compatibility with Adjacent Land Uses	Good			
Potential NR Eligibility	Non-Contributing		code	N
Other Comments / Salient Details	Chimney on the left end of the house. Paved driveway in backyard. Decorative brick wall around property. Decorative pineapple statues on wall in front. Brick archways in brick wall to the right and side of the house. Brick stairs and path leading to front foor with small brick porch. Bushes and garden around base of house.

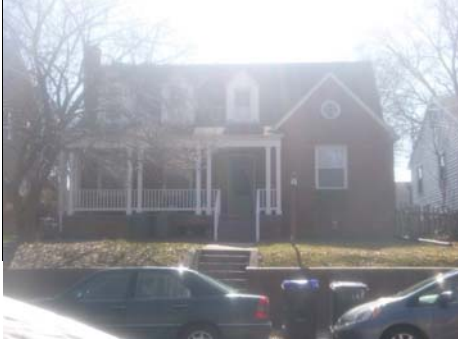
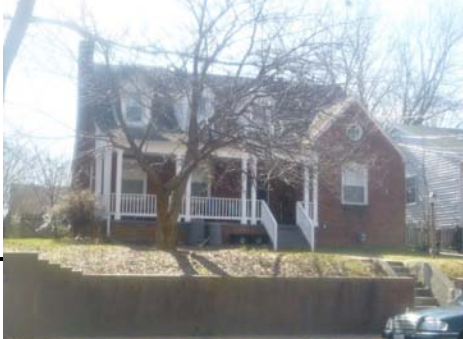
Name of Surveyors	Kimberly Packett		Survey Date	2/21/2016
ADDRESS	Street		Number	
	Rowe	Street	1312	
TYPE & NUMBER OF BLGS & STRUCTURES	Type		Number	
	Single Family House		1	
Current Use of Primary Building	Single Family	Historic Use of Primary Building	Single Family	
Style of Primary Bldg	Neo-Colonial			
Number of Stories	1 1/2	Width (bays)	4	
Foundation Material	Cinderblock	Depth (rooms)	3	
Year Built	1948	Wall Cladding Material	Brick	
Roof Shape	Hip-on-gable	Roof Material	Composition shingle	
Decorative Details/Unique Features	Three dormers on front of roof. Front gable on right side of house with decorative circular window. White vinyl siding on sides of house.			
Evidence of Integrity Location/Materials	Original windows and brick siding.			
Additions/Alterations to Primary Building	New roof.			
Condition of Primary Building	Excellent			code E
Observable Threats	None			
Compatibility with Adjacent Land Uses	Good

Potential NR Eligibility	Contributing			code C
Other Comments / Salient Details	Brick and cement retaining wall along front of property. Cement stairs and path leading to front porch. Chimney on left end of house. Brick front porch with white columns and railing. Black lamppost on front lawn.			
Photo Views				
1 Front view	2 3/4 view	3	4

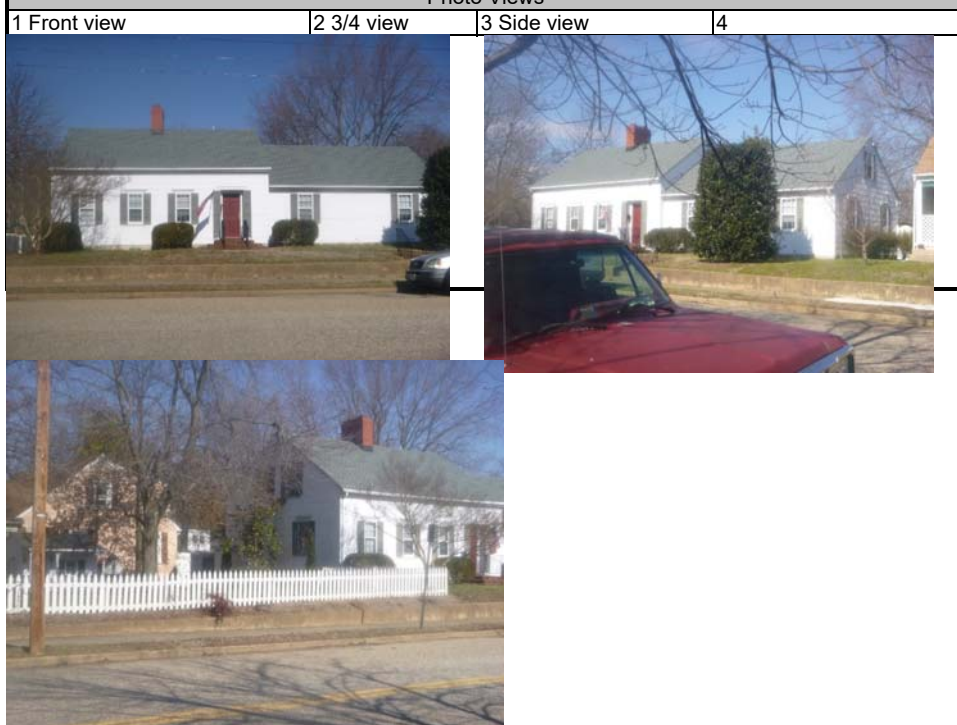
Name of Surveyors	Kimberly Packett		Survey Date	2/21/2016
ADDRESS	Street		Number	
	Parcel	Street	1323	
TYPE & NUMBER OF BLGS & STRUCTURES	Type		Number	
	Single Family House		1	
	Shed		1	
Current Use of Primary Building	Single Family	Historic Use of Primary Building	Single Family	
Style of Primary Bldg	Mixed Style			
Number of Stories	1 1/2	Width (bays)	6	
Foundation Material	Cinderblock	Depth (rooms)	2	
Year Built	1950	Wall Cladding Material	Asbestos siding	
Roof Shape	Side gable	Roof Material	Composition shingle	
Decorative Details/Unique Features	Grey shutters on windows and front door. White surround around front door and windows with entablature.			
Evidence of Integrity Location/Materials	Original siding and possibly original windows.			
Additions/Alterations to Primary Building	New roof.			
Condition of Primary Building	Good		code	G
Observable Threats	None			
Compatibility with Adjacent Land Uses	Good

Potential NR Eligibility	Non-Contributing		code	N
Other Comments / Salient Details	White picket fence around backyard. Brick steps with iron railing leading to front door. Central chimney. Shed in the backyard. Cement retaining wall along front of property with cement steps and iron railing. Bushes along front of house.

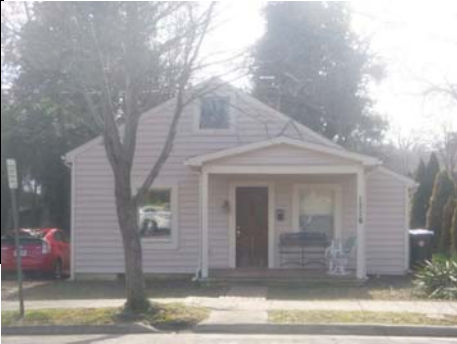
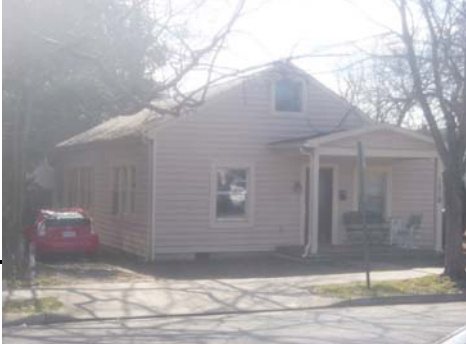
Name of Surveyors	Kimberly Packett		Survey Date	2/21/2016
ADDRESS	Street		Number	
	Rowe	Street	1210	
TYPE & NUMBER OF BLGS & STRUCTURES	Type		Number	
	Single Family House		1	
Current Use of Primary Building	Single Family	Historic Use of Primary Building	Single Family	
Style of Primary Bldg	Vernacular			
Number of Stories	1	Width (bays)	3	
Foundation Material	Concrete	Depth (rooms)	2	
Year Built	1934	Wall Cladding Material	Vinyl siding	
Roof Shape	Front gable	Roof Material	Composition shingle	
Decorative Details/Unique Features	White surround around front door and windows. Front gable entry porch with two white columns above front door.			
Evidence of Integrity Location/Materials	None			
Additions/Alterations to Primary Building	New siding, windows, and roof.			
Condition of Primary Building	Good			code
				G
Observable Threats	None			
Compatibility with Adjacent Land Uses	Good			
Potential NR Eligibility	Non-Contributing			code

N
Other Comments / Salient Details	Brick path leading to front door with small brick porch. Gravel driveway on the left side of the house.			
Photo Views				
1 Front view	2 3/4 view	3	4

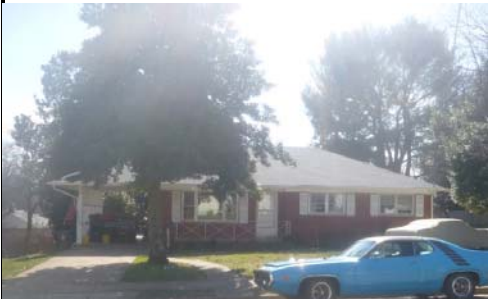
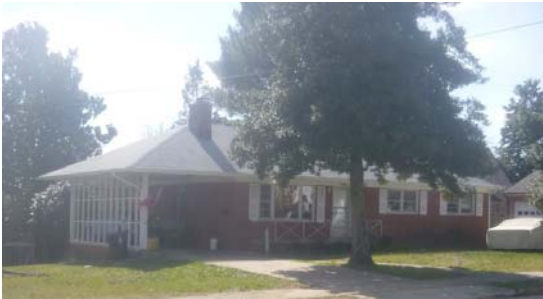
Name of Surveyors	Kimberly Packett		Survey Date	2/21/2016
ADDRESS	Street		Number	
	Parcel	Street	1320	
TYPE & NUMBER OF BLGS & STRUCTURES	Type		Number	
	Single Family House		1	
	Shed		1	
Current Use of Primary Building	Single Family	Historic Use of Primary Building	Single Family	
Style of Primary Bldg	Ranch			
Number of Stories	1	Width (bays)	4	
Foundation Material	Cinderblock	Depth (rooms)	2	
Year Built	1949	Wall Cladding Material	Brick	
Roof Shape	Hipped	Roof Material	Composition shingles	
Decorative Details/Unique Features	White shutters on front windows.			
Evidence of Integrity Location/Materials	Original windows and brick siding.			
Additions/Alterations to Primary Building	Addition to the back of the house. New roof.			
Condition of Primary Building	Good		code	
			G	
Observable Threats	None			
Compatibility with Adjacent Land Uses	Good			
Potential NR Eligibility	Contributing		code	
			C	
Other Comments / Salient Details	Cement driveway on left side of house leading to attached carport. White decorative metal wall supporting carport. Cement path leading from sidewalk to driveway. Cement path leading from driveway to front door with white metal railing. Interior chimney on left side of house.

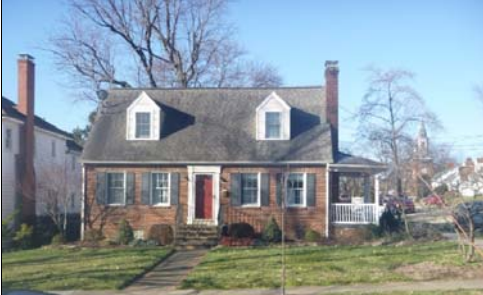
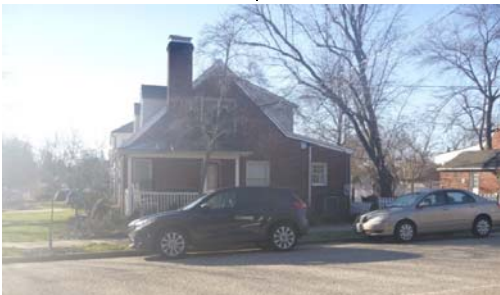
Name of Surveyors	Kimberly Packett		Survey Date	2/21/2016
ADDRESS	Street		Number	
	Augustine Avenue		1518	
TYPE & NUMBER OF BLGS & STRUCTURES	Type		Number	
	Single Family House		1	
	Detached Garage		1	
Current Use of Primary Building	Single Family	Historic Use of Primary Building	Single Family	
Style of Primary Blg	Cape Cod			
Number of Stories	1.5	Width (bays)	5	
Foundation Material	Cinder Block	Depth (rooms)	3	
Year Built	1959	Wall Cladding Material	Brick	
Roof Shape	Side Gable	Roof Material	Composition shingles	
Decorative Details/Unique Features	Gable dormers with aluminum siding on front of roof, pilasters on either side of the front door and crosshead above door, dark blue shutters on front windows. Extended dormer with two windows on back side of roof.			
Evidence of Integrity Location/Materials	Original brick siding.			
Additions/Alterations to Primary Building	Rear addition, side porch addition on the right. New windows and roof.

Condition of Primary Building	Good		code	
			G	
Observable Threats	None			
Compatibility with Adjacent Land Uses	Good			
Potential NR Eligibility	Contributing		code	
			C	
Other Comments / Salient Details	Garage in the back with gravel driveway. White fence around backyard. Stairs in the back leading to basement. Cement and brick path and stairs with iron railing leading to front door. Cement path and bricks stairs leading to side porch with overhang and side door. Porch has white railings and columns. Chimney on right end of house.			
Photo Views				
1 Front view	2 Side view	3 Backyard view	4

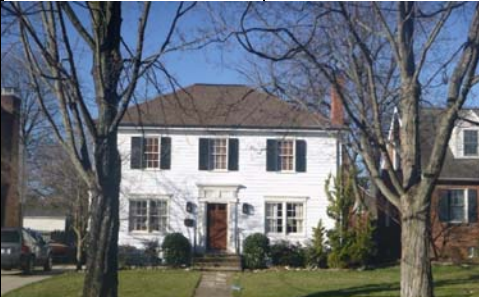
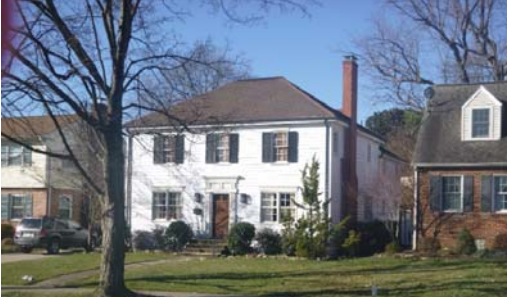
Name of Surveyors	Kimberly Packett		Survey Date	2/21/2016
ADDRESS	Street		Number	
	Augustine Avenue		1508	
TYPE & NUMBER OF BLGS & STRUCTURES	Type		Number	
	Single Family House		1	
Current Use of Primary Building	Single Family	Historic Use of Primary Building	Single Family	
Style of Primary Bldg	Federal Revival			
Number of Stories	2	Width (bays)	3	
Foundation Material	Concrete	Depth (rooms)	4	
Year Built	1951	Wall Cladding Material	Wood siding	
Roof Shape	Hipped roof	Roof Material	Composition shingles	
Decorative Details/Unique Features	Decorative surround on door with pilasters and crosshead. Dark blue shutters on second story windows. White surround around windows.			
Evidence of Integrity Location/Materials	Original windows.			
Additions/Alterations to Primary Building	Addition on back of house. New roof and siding.			
Condition of Primary Building	Excellent		code	
			E	
Observable Threats	None			
Compatibility with Adjacent Land Uses	Good

Potential NR Eligibility	Contributing		code	
			C	
Other Comments / Salient Details	Cement driveway on left side of house. Cement path leading to front door with brick stairs and iron railings. Chimney on right side. Wooden fence around property. Two large trees in front lawn. Bushes along front of house.			
Photo Views				
1 Front view	2 3/4 view	3	4

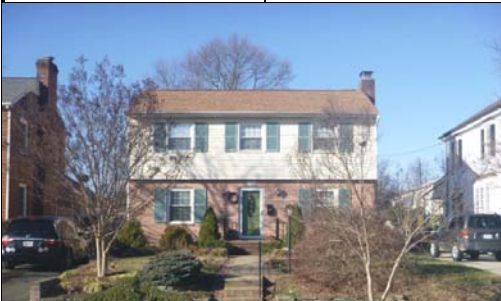
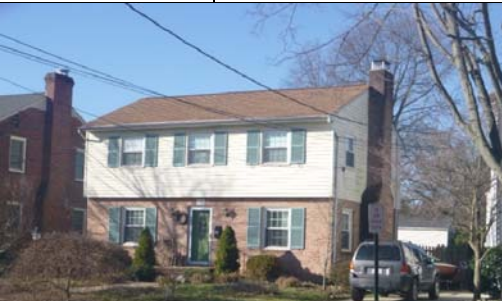
Name of Surveyors	Kimberly Packett		Survey Date	2/21/2016
ADDRESS	Street		Number	
	Augustine Avenue		1506	
TYPE & NUMBER OF BLGS & STRUCTURES	Type		Number	
	Single Family House		1	
	Shed		1	
Current Use of Primary Building	Single Family	Historic Use of Primary Building	Single Family	
Style of Primary Bldg	Neo-colonial			
Number of Stories	2	Width (bays)	3	
Foundation Material	Cinderblock	Depth (rooms)	2	
Year Built	1957	Wall Cladding Material	Vinyl Siding	
Roof Shape	Side gable	Roof Material	Composition shingles	
Decorative Details/Unique Features	Brick siding on first floor, vinyl siding on second story. Green shutters on front windows. Decorative keystone above front door. Second story has slight overhang.			
Evidence of Integrity Location/Materials	Possibly original brick siding on first floor.			
Additions/Alterations to Primary Building	New vinyl siding, windows, and roof.			
Condition of Primary Building	Good		code

G	
Observable Threats	None			
Compatibility with Adjacent Land Uses	Good			
Potential NR Eligibility	Contributing		code	
			C	
Other Comments / Salient Details	Paved driveway on right side of house, brick retaining wall along left side of property. Concrete and brick walkway leading to front door with iron railing and lamp. Chimney on right end of house.			
Photo Views				
1 Front view	2 3/4 view	3	4

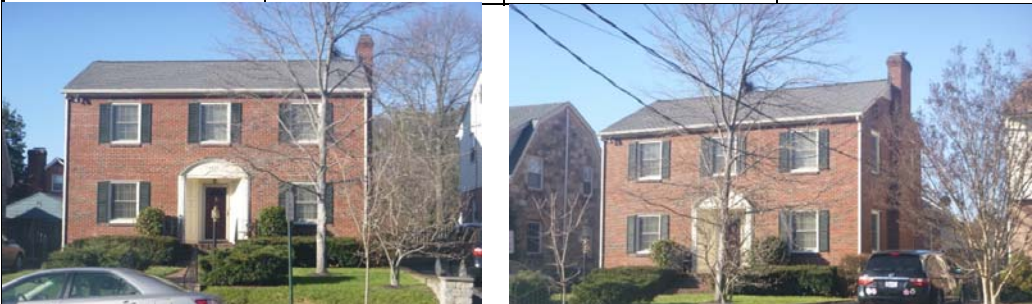
Name of Surveyors	Kimberly Packett		Survey Date	2/21/2016
ADDRESS	Street		Number	
	Augustine Avenue		1504	
TYPE & NUMBER OF BLGS & STRUCTURES	Type		Number	
	Single Family House		1	
	Small shed/Garage		1	
Current Use of Primary Building	Single Family	Historic Use of Primary Building	Single Family	
Style of Primary Bldg	Federal Revival			
Number of Stories	2	Width (bays)	3	
Foundation Material	Concrete	Depth (rooms)	3	
Year Built	1957	Wall Cladding Material	Brick	
Roof Shape	Side gable	Roof Material	Composition Shingles	
Decorative Details/Unique Features	An arch pediment over the door/shutters. Sunken in entry way with cream paneling on either side of front door and pilasters. Decorative brick around the windows. Dark blue shutters on front windows.			
Evidence of Integrity Location/Materials	Appears to be original windows and door surround details. Original brick siding.			
Additions/Alterations to Primary Building	A porch and addition on the back. Addition has vinyl siding. Porch is made of brick and iron railings. New roof.

Condition of Primary Building	Excellent		code	
			E	
Observable Threats	None			
Compatibility with Adjacent Land Uses	Good			
Potential NR Eligibility	Contributing		code	
			C	
Other Comments / Salient Details	A brick set of stairs and path to the front porch, with iron railings and iron lamp post. Driveway on the left side of the property leading to the shed/garage which is made of matching brick. Chain link gate on driveway. Brick fence around some of the property. Chimney on right end of house. Bushes along walkway and front of house.			
Photo Views				
1 Front view	2 3/4 view	3	4

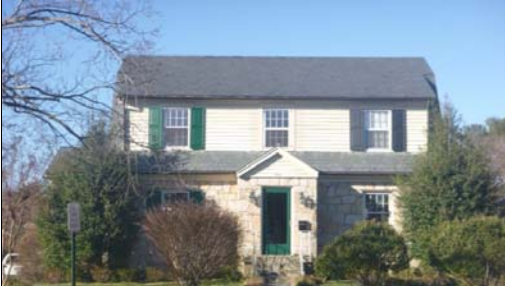
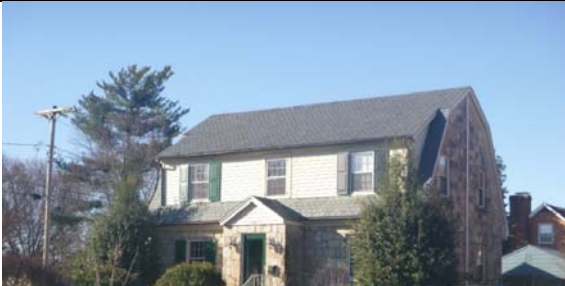
Name of Surveyors	Kimberly Packett		Survey Date	2/21/2016
ADDRESS	Street		Number	
	Augustine Avenue		1500	
TYPE & NUMBER OF BLGS & STRUCTURES	Type		Number	
	Single Family House		1	
	Small Shed		1	
Current Use of Primary Building	Single Family	Historic Use of Primary Building	Single Family	
Style of Primary Bldg	Dutch Revival			
Number of Stories	2	Width (bays)	3	
Foundation Material	Concrete	Depth (rooms)	2	
Year Built	1940	Wall Cladding Material	Stone	
Roof Shape	Gambrel	Roof Material	Slate	
Decorative Details/Unique Features	Front gable entrance extension out from main body of house. Green shutters on second story front windows and bottom left front window. Side entrance with stone porch and iron railing. Copper gutters. Vinyl siding on extended dormer.			
Evidence of Integrity Location/Materials	Appears to be original windows and original stone walls. Copper gutters			
Additions/Alterations to Primary Building	Addition hall connecting main house to secondary building has entrance and small porch with wooden stairs leading to a concrete path and stairs. Addition and hall made of aluminum siding and has glass brick windows and asphalt roof.

Condition of Primary Building	Good	code		
		G		
Observable Threats	None			
Compatibility with Adjacent Land Uses	Good			
Potential NR Eligibility	Contributing	code		
		C		
Other Comments / Salient Details	Slate and concrete steps and walkway up to the house and front porch (of the same material). Small wooden retaining wall with plants in the front yard. Wooden privacy fence around the house. Concrete retaining wall around the lawn on the side of the house.			
Photo Views				
1 Front view	2 3/4 view	3 Side view	4

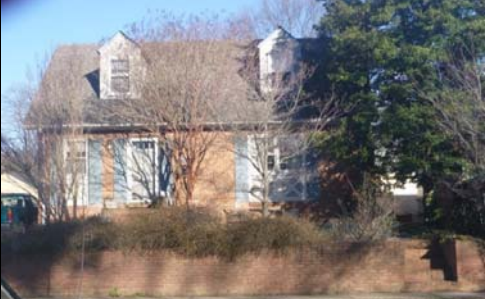
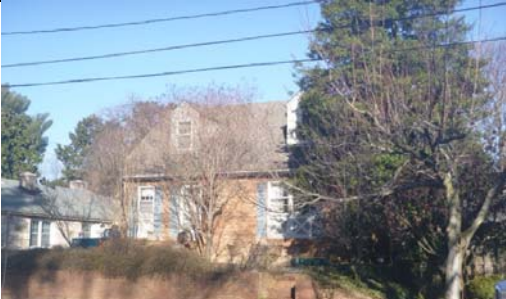
Name of Surveyors	Kimberly Packett		Survey Date	2/21/2016
ADDRESS	Street		Number	
	Payne	Street	1309	
TYPE & NUMBER OF BLGS & STRUCTURES	Type		Number	
	Single Family House		1	
	Shed		1	
Current Use of Primary Building	Single Family	Historic Use of Primary Building	Single Family	
Style of Primary Bldg	Cape Cod			
Number of Stories	1 1/2	Width (bays)	3	
Foundation Material	Cinderblock	Depth (rooms)	3	
Year Built	1965	Wall Cladding Material	Brick	
Roof Shape	Side gable	Roof Material	Composition shingles	
Decorative Details/Unique Features	Two dormer windows on the front of the house. Light blue shutters on front door and front windows. White surround around windows.			
Evidence of Integrity Location/Materials	Appears to be original windows, brick siding and porch.			
Additions/Alterations to Primary Building	Enclosed porch on the back of the house.			
Condition of Primary Building	Good		code	
			G	
Observable Threats	None

Compatibility with Adjacent Land Uses	Good			
Potential NR Eligibility	Contributing		code	
			C	
Other Comments / Salient Details	Driveway on left side, wooden fence, and lattice shed. Poured concrete driveway with brick retaining wall all around the front lawn of the house. Brick steps up to lawn then slate path to front door.			
Photo Views				
1 Front view	2 3/4 view	3	4

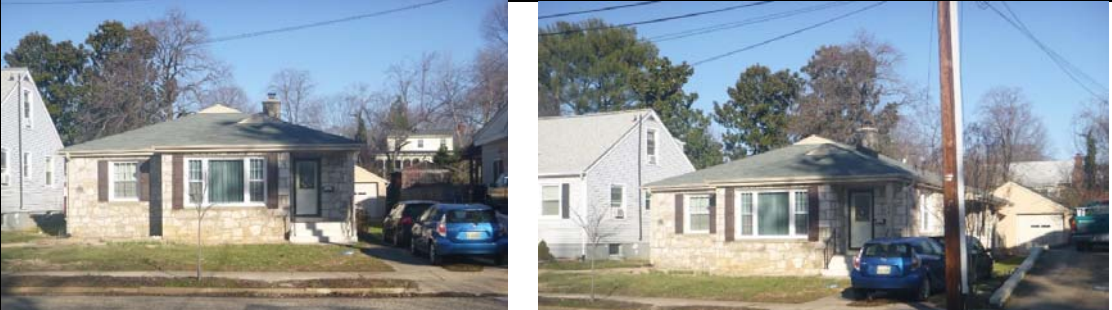
Name of Surveyors	Kimberly Packett		Survey Date	2/21/2016
ADDRESS	Street		Number	
	Payne	Street	1315	
TYPE & NUMBER OF BLGS & STRUCTURES	Type		Number	
	Single Family House		1	
	Detached Garage		1	
Current Use of Primary Building	Single Family	Historic Use of Primary Building	Single Family	
Style of Primary Bldg	Minimal Traditional			
Number of Stories	1	Width (bays)	3	
Foundation Material	Cinderblock	Depth (rooms)	5	
Year Built	1952	Wall Cladding Material	Stone	
Roof Shape	Hip	Roof Material	Composition shingles	
Decorative Details/Unique Features	Red shutters on windows match red surround around front door. Hip roof has two tiny front gables at peaks of roof.			
Evidence of Integrity Location/Materials	Appears to be original stone siding.			
Additions/Alterations to Primary Building	New windows and roof.			
Condition of Primary Building	Good	code		
		G		
Observable Threats	None			
Compatibility with Adjacent Land Uses	Good

Potential NR Eligibility	Contributing	code		
		C		
Other Comments / Salient Details	Cement driveway on right side of the house leading to detached garage. Cement path and stairs leading to front door from driveway. Iron railing on stairs. Central stone chimney. Cement retaining wall along right side of property.			
Photo Views				
1 Front view	2 3/4 view	3	4
