Cultural Resource Survey of College Heights in Fredericksburg, Virginia

Master of Science

Historic Preservation

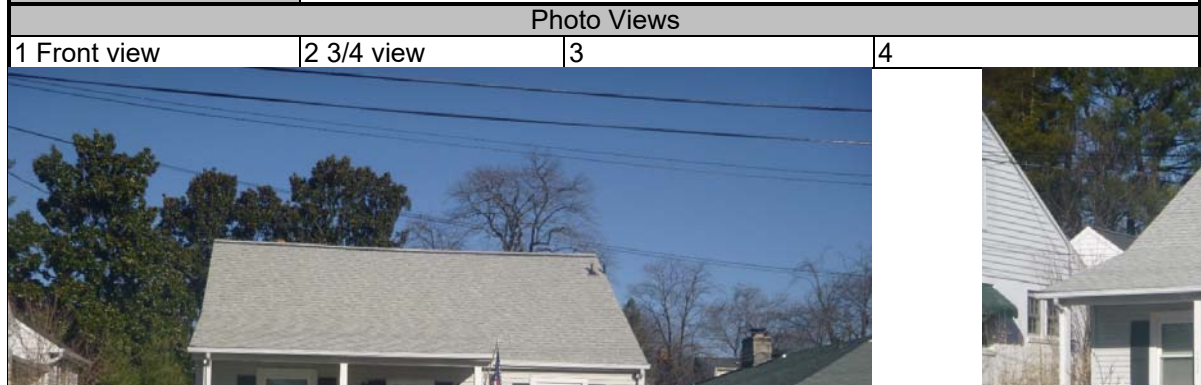
Name of Surveyors	Kimberly Packett		Survey Date	2/21/2016
ADDRESS	Street		Number	
	Payne	Street	1317	
TYPE & NUMBER OF BLGS & STRUCTURES	Type		Number	
	Single Family House		1	
	Shed		1	
Current Use of Primary Building	Single Family	Historic Use of Primary Building	Single Family	
Style of Primary Bldg	Cape Cod			
Number of Stories	1 1/2	Width (bays)	3	
Foundation Material	Cinderblock	Depth (rooms)	3	
Year Built	1957	Wall Cladding Material	Vinyl siding	
Roof Shape	Side gable	Roof Material	Composition shingle	
Decorative Details/Unique Features	Dark blue shutters on front windows and front door. White surround around front door and windows. Roof extended over front porch.			
Evidence of Integrity Location/Materials	None			
Additions/Alterations to Primary Building	New windows, roof, and vinyl siding.			
Condition of Primary Building	Good		code	
			G	
Observable Threats	None			
Compatibility with Adjacent Land Uses	Good

Potential NR Eligibility	Contributing		code	
			C	
Other Comments / Salient Details	Driveway of gravel and grass on left side of the property. Brick walkway to brick steps and poured concrete porch with iron railings and white columns.

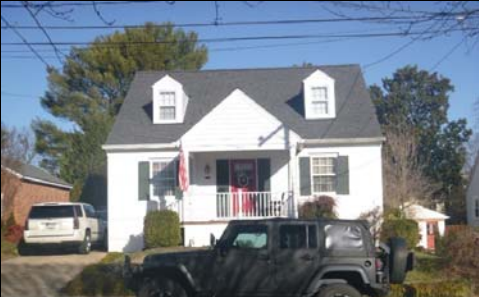
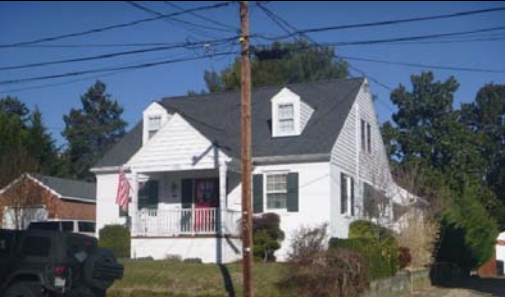
Name of Surveyors	Kimberly Packett		Survey Date	2/21/2016
ADDRESS	Street		Number	
	Payne	Street	1321	
TYPE & NUMBER OF BLGS & STRUCTURES	Type		Number	
	Single Family House		1	
Current Use of Primary Building	Single Family	Historic Use of Primary Building	Single Family	
Style of Primary Bldg	Cape Cod			
Number of Stories	1.5	Width (bays)	3	
Foundation Material	Concrete	Depth (rooms)	2	
Year Built	1955	Wall Cladding Material	Stucco	
Roof Shape	Side gable	Roof Material	Composition shingles	
Decorative Details/Unique Features	Front gable entryway with white columns, dark blue shutters on front windows and front door. Gables have vinyl siding. Two front gable dormers on front of roof.			
Evidence of Integrity Location/Materials	Appears to be original windows.			
Additions/Alterations to Primary Building	Stucco covers the original siding. New roof. One room addition on the back left of the house.			
Condition of Primary Building	Good		code

G	
Observable Threats	None			
Compatibility with Adjacent Land Uses	Good			
Potential NR Eligibility	Contributing		code	
			C	
Other Comments / Salient Details	Paved driveway on left side of property. A lot of landscaping from porch to sidewalk with flowers, shrubs, and a small tree. Cement path and stairs from driveway to front porch with iron railing. Wood retaining wall along right side of house.			
Photo Views				
1 Front view	2 3/4 view	3	4

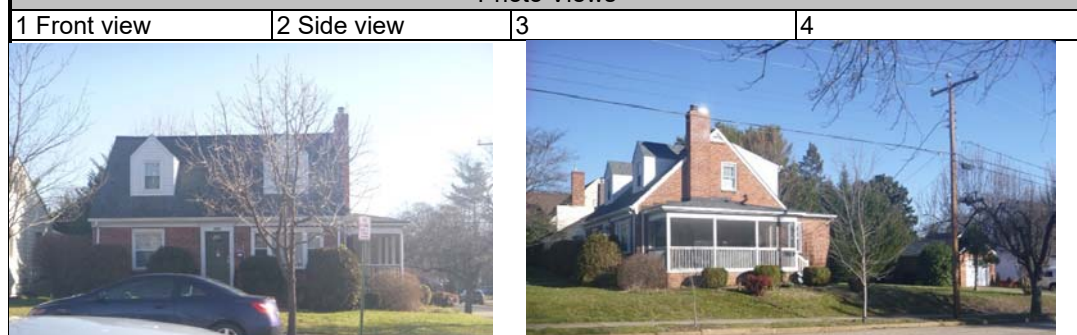
Name of Surveyors	Kimberly Packett		Survey Date	2/21/2016
ADDRESS	Street		Number	
	Stafford Ave		1503	
TYPE & NUMBER OF BLGS & STRUCTURES	Type		Number	
	Single Family House		1	
	Detatched Garage		1	
Current Use of Primary Building	Single Family	Historic Use of Primary Building	Single Family	
Style of Primary Bldg	Cape Cod			
Number of Stories	1.5	Width (bays)	3	
Foundation Material	Concrete	Depth (rooms)	3	
Year Built	1951	Wall Cladding Material	Brick	
Roof Shape	Side gable	Roof Material	Composition shingles	
Decorative Details/Unique Features	Front gable dormers with vinyl siding on front of roof. Extended dormer on back of roof. Hip roof on screened in porch on right side of house and hip roof on back addition. White surround around front door and windows.			
Evidence of Integrity Location/Materials	Original brick siding.			
Additions/Alterations to Primary Building	Screened in porch on the right side, addition on the back. New windows and roof.

Condition of Primary Building	Excellent		code	
			E	
Observable Threats	None			
Compatibility with Adjacent Land Uses	Good			
Potential NR Eligibility	Contributing		code	
			C	
Other Comments / Salient Details	Concrete driveway leading to detached garage in backyard. Cement path leading to front door. White wood stairs and railing leading to side screened in porch. Bushes along front and side of house.

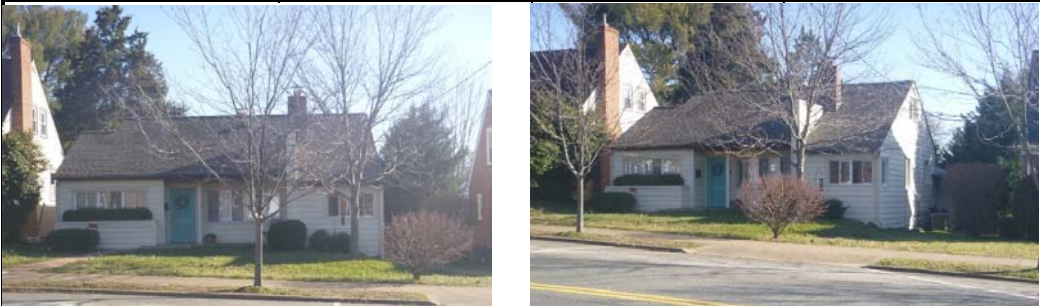
Name of Surveyors	Kimberly Packett		Survey Date	2/21/2016
ADDRESS	Street		Number	
	Stafford Ave		1505	
TYPE & NUMBER OF BLGS & STRUCTURES	Type		Number	
	Single Family House		1	
	Shed		1	
Current Use of Primary Building	Single Family	Historic Use of Primary Building	Single Family	
Style of Primary Bldg	Minimal traditional			
Number of Stories	1.5	Width (bays)	4	
Foundation Material	Cinderblock	Depth (rooms)	3	
Year Built	1948	Wall Cladding Material	Vinyl Siding	
Roof Shape	Side Gable	Roof Material	Composition shingles	
Decorative Details/Unique Features	Window boxes on the left side of house. Section of wall dividing roof on front right side.			
Evidence of Integrity Location/Materials	Appears to be original windows on original part of building.			
Additions/Alterations to Primary Building	Addition on the back of the house. New siding and roof.			
Condition of Primary Building	Good	code		
		G		
Observable Threats	None

Compatibility with Adjacent Land Uses	Good			
Potential NR Eligibility	Contributing	code		
		C		
Other Comments / Salient Details	Wood privacy fence in the backyard, brick walkway to the front door. Overhang above entrance way with white column. Interior chimney on right side of house.			
Photo Views				
1 Front view	2 3/4 view	3	4

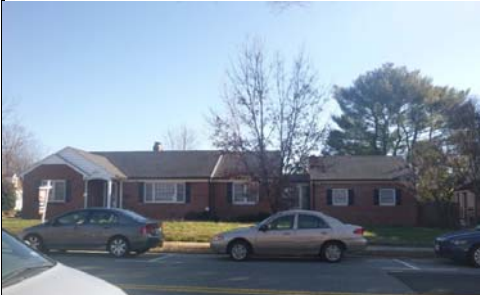
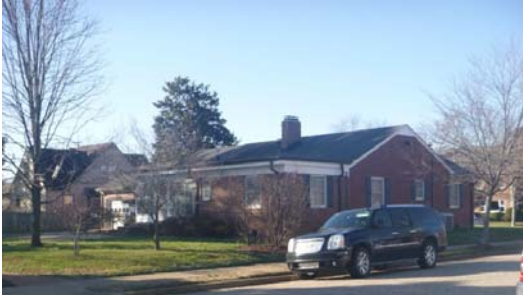
Name of Surveyors	Kimberly Packett		Survey Date	2/21/2016
ADDRESS	Street		Number	
	Stafford Ave		1511	
TYPE & NUMBER OF BLGS & STRUCTURES	Type		Number	
	Single Family House		1	
Current Use of Primary Building	Single Family	Historic Use of Primary Building	Single Family	
Style of Primary Bldg	Ranch			
Number of Stories	1	Width (bays)	4	
Foundation Material	Cinderblock	Depth (rooms)	4	
Year Built	1954	Wall Cladding Material	Brick	
Roof Shape	Side gable	Roof Material	Composition shingles	
Decorative Details/Unique Features	Dark blue shutters on front and side windows. White vinyl siding around screened in porch and front gable above front door.			
Evidence of Integrity Location/Materials	Appears to be original windows, replacement roof			
Additions/Alterations to Primary Building	Attached garage to the right, connected by enclosed walkway; Addition on the back with hip roof, part of addition is a screened in porch.

Condition of Primary Building	Good		code	
			G	
Observable Threats	None			
Compatibility with Adjacent Land Uses	Good			
Potential NR Eligibility	Contributing		code	
			C	
Other Comments / Salient Details	Brick walkway leading to the front door with overhand with white column, backyard surrounded by privacy fence, curved asphalt driveway in backyard leads to attached garage. Central chimney.			
Photo Views				
1 Front view	2 3/4 view	3 Side view	4

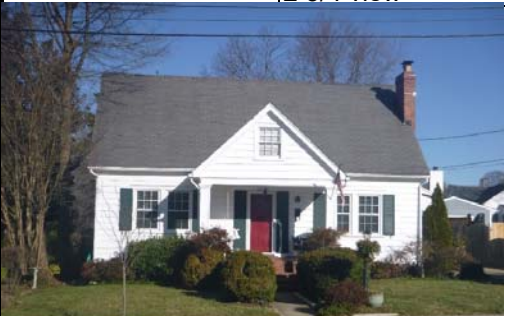
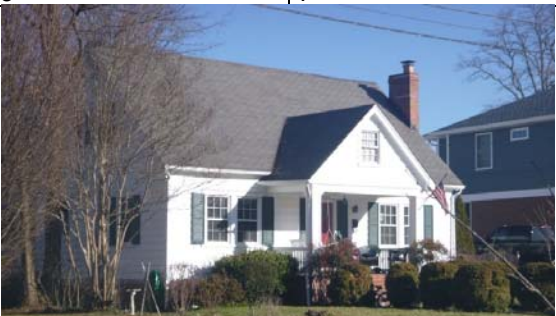
Name of Surveyors	Kimberly Packett		Survey Date	2/28/2016
ADDRESS	Street		Number	
	Payne	Street	1229	
TYPE & NUMBER OF BLGS & STRUCTURES	Type		Number	
	Single Family House		1	
Current Use of Primary Building	Single Family	Historic Use of Primary Building	Single Family	
Style of Primary Bldg	Cape Cod			
Number of Stories	1.5	Width (bays)	3	
Foundation Material	Brick	Depth (rooms)	3	
Year Built	1936	Wall Cladding Material	Hardboard siding	
Roof Shape	Side gable	Roof Material	Composition gable	
Decorative Details/Unique Features	Front gable entry way with white columns. Green shutters on front door and front and side windows. White surround around front door and windows.			
Evidence of Integrity Location/Materials	Appears to be original windows.			
Additions/Alterations to Primary Building	New siding and roof.			
Condition of Primary Building	Excellent		code	
			E	
Observable Threats	None			
Compatibility with Adjacent Land Uses	Good

Potential NR Eligibility	Non-Contributing		code	
			N	
Other Comments / Salient Details	Bushes along path and foot of house. Cement path leading to front door with bricks steps and small brick porch with iron railing. Iron lamppost in front yard. Chimney on right end of house.			
Photo Views				
1 Front view	2 3/4 view	3	4

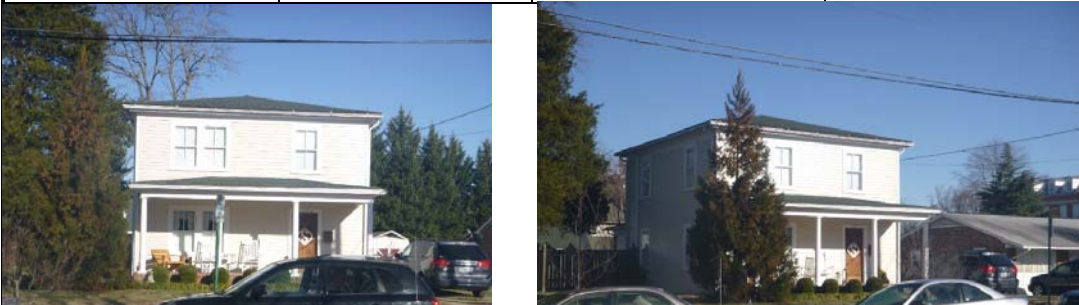
Name of Surveyors	Kimberly Packett		Survey Date	2/28/2016
ADDRESS	Street		Number	
	Payne	Street	1217	
TYPE & NUMBER OF BLGS & STRUCTURES	Type		Number	
	Single Family House		1	
	Shed		1	
Current Use of Primary Building	Single Family	Historic Use of Primary Building	Single Family	
Style of Primary Bldg	American Foursquare			
Number of Stories	2	Width (bays)	2	
Foundation Material	Concrete	Depth (rooms)	2	
Year Built	1929	Wall Cladding Material	Hardboard siding	
Roof Shape	Hip	Roof Material	Composition shingle	
Decorative Details/Unique Features	White surround around front door and windows.			
Evidence of Integrity Location/Materials	None			
Additions/Alterations to Primary Building	New roof and siding. Appears to be new windows.			
Condition of Primary Building	Good		code	
			G	
Observable Threats	None			
Compatibility with Adjacent Land Uses	Good			
Potential NR Eligibility	Non-Contributing		code	
			N	
Other Comments / Salient Details	Paved driveway on right side of house. Cement path from driveway to front porch. Front porch with hip roof and white columns spans the length of the house. Wood privacy fence around backyard. Small bushes along front porch.

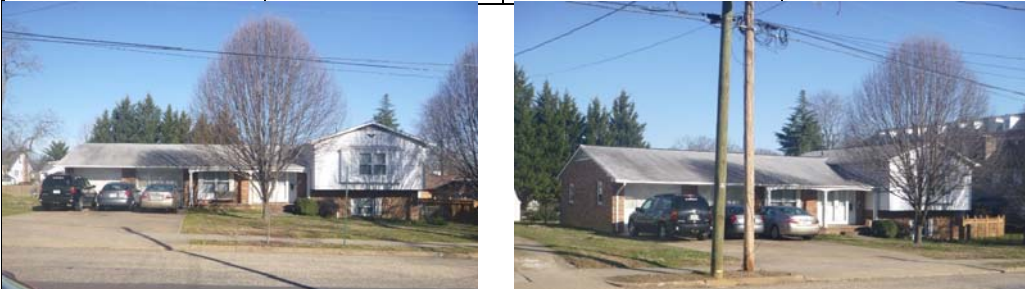
Name of Surveyors	Kimberly Packett		Survey Date	2/28/2016
ADDRESS	Street		Number	
	Payne	Street	1211	
TYPE & NUMBER OF BLGS & STRUCTURES	Type		Number	
	Single Family House		1	
Current Use of Primary Building	Single Family	Historic Use of Primary Building	Single Family	
Style of Primary Bldg	Split Level			
Number of Stories	1	Width (bays)	5	
Foundation Material	Cinderblock	Depth (rooms)	2	
Year Built	1979	Wall Cladding Material	Aluminum siding	
Roof Shape	Cross Gable	Roof Material	Composition shingle	
Decorative Details/Unique Features	Brick front porch with overhang and white columns. Bay window on front gable on second story of house on right side. White shutters on front windows. Aluminum siding around front door. Decorative eagle on front gable.			
Evidence of Integrity Location/Materials	Original siding and windows.			
Additions/Alterations to Primary Building	New roof.			
Condition of Primary Building	Good		code

G	
Observable Threats	None			
Compatibility with Adjacent Land Uses	Good			
Potential NR Eligibility	Non-Contributing		code	
			N	
Other Comments / Salient Details	Double car attached garage on left side of the house. Short wood fence around backyard. Paved driveway leading to garage.			
Photo Views				
1 Front view	2 3/4 view	3	4

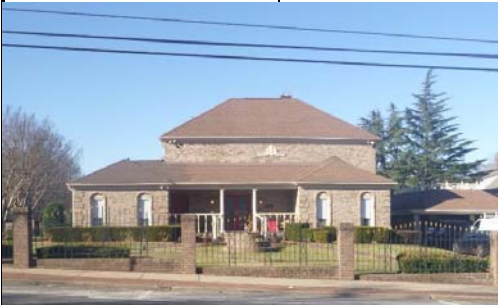
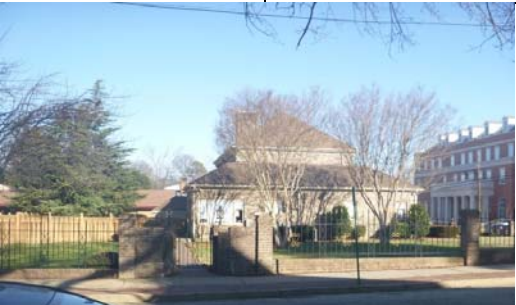
Name of Surveyors	Kimberly Packett		Survey Date	2/28/2016
ADDRESS	Street		Number	
	College	Avenue	1500	
TYPE & NUMBER OF BLGS & STRUCTURES	Type		Number	
	Single Family House		1	
Current Use of Primary Building	Single Family	Historic Use of Primary Building	Single Family	
Style of Primary Bldg	Neo-French			
Number of Stories	2	Width (bays)	5	
Foundation Material	Cinderblock	Depth (rooms)		
Year Built	1979	Wall Cladding Material	Brick	
Roof Shape	Hip	Roof Material	Composition shingle	
Decorative Details/Unique Features	Decorative brick around front windows. Decorative plaster figure on front of second floor.			
Evidence of Integrity Location/Materials	Original brick siding.			
Additions/Alterations to Primary Building	Possibly new windows, new roof.			
Condition of Primary Building	Excellent		code	
			E	
Observable Threats	Expansion of UMW			
Compatibility with Adjacent Land Uses	Good			
Potential NR Eligibility	Non-Contributing		code

N	
Other Comments / Salient Details	Wrought iron and brick gate around entire property. Iron gate with brick path leading to front door. Brick front porch with white railing and columns. Wood privacy fence around backyard. Bushes along base of house and base of fence. Chimney on back of house.			
Photo Views				
1 Front view	2 Side view	3	4

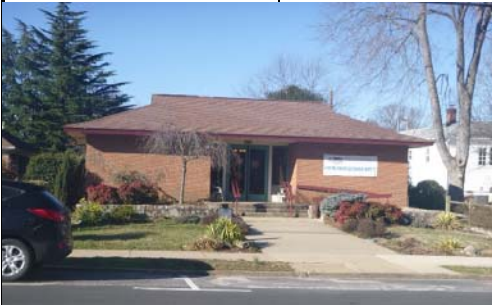
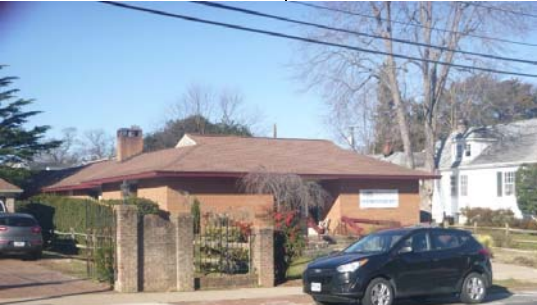
Name of Surveyors	Kimberly Packett		Survey Date	2/28/2016
ADDRESS	Street		Number	
	College	Avenue	1514	
TYPE & NUMBER OF BLGS & STRUCTURES	Type		Number	
	Commercial		1	
Current Use of Primary Building	Commercial	Historic Use of Primary Building	Commercial	
Style of Primary Bldg	Commercial style			
Number of Stories	1	Width (bays)	1	
Foundation Material	Cinderblock	Depth (rooms)	4	
Year Built	1981	Wall Cladding Material	Brick	
Roof Shape	Hip	Roof Material	Composition shingle	
Decorative Details/Unique Features	Green front double doors with side lights. Red eaves.			
Evidence of Integrity Location/Materials	Original materials on original section of house.			
Additions/Alterations to Primary Building	Multiple additions on back of house. One addition has a side gable roof.			
Condition of Primary Building	Excellent		code	
			E	
Observable Threats	Expansion of UMW			
Compatibility with Adjacent Land Uses	Good

Potential NR Eligibility	Non-Contributing		code	
			N	
Other Comments / Salient Details	Bushes and plants along path and base of building. Stone retaining wall along garden on left side of building. Cement path leading to front door with cement front porch with overhang. Stairs and ramp have red railings. Cement path from sidewalk leads to ramp that leads to right side of the porch. Interior chimney on left side of building.			
Photo Views				
1 Front view	2 3/4 view	3	4

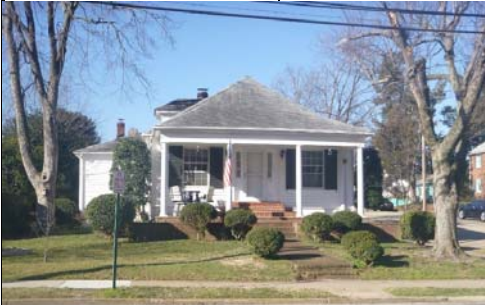
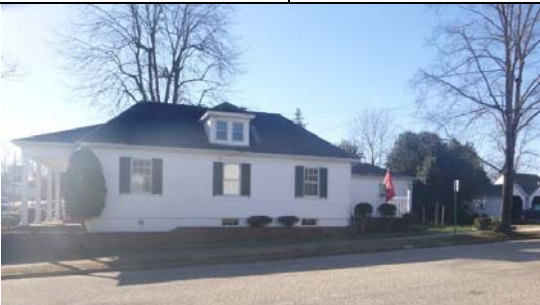
Name of Surveyors	Kimberly Packett		Survey Date	2/28/2016
ADDRESS	Street		Number	
	College	Avenue	1518	
TYPE & NUMBER OF BLGS & STRUCTURES	Type		Number	
	Single Family House		1	
Current Use of Primary Building	Single Family	Historic Use of Primary Building	Single Family	
Style of Primary Bldg	Craftsman			
Number of Stories	1	Width (bays)	3	
Foundation Material	Cinderblock	Depth (rooms)	4	
Year Built	1929	Wall Cladding Material	Vinyl siding	
Roof Shape	Hip on gable	Roof Material	Composition shingle	
Decorative Details/Unique Features	Green shutters on front and side of building. Front door has sidelights. Hip gable dormer on right side of house.			
Evidence of Integrity Location/Materials	Brick front porch possibly original.			
Additions/Alterations to Primary Building	Addition on the back. New siding, roof and windows.			
Condition of Primary Building	Good		code	
			G	
Observable Threats	Expansion of UMW

Compatibility with Adjacent Land Uses	Good			
Potential NR Eligibility	Non-Contributing		code	
			N	
Other Comments / Salient Details	Two interior chimneys on back left of Brick stairs and path leading to brick front porch with overhang and white columns. Bushes along path and front and side of house. Back porch with back door, white railings, columns, and overhang.			
Photo Views				
1 Front view	2 Side view	3	4

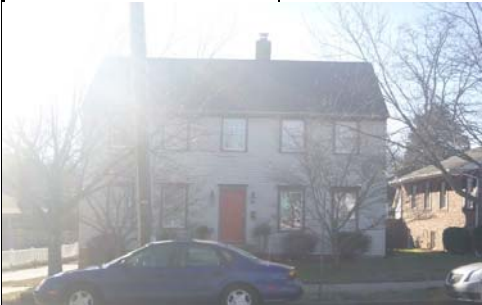
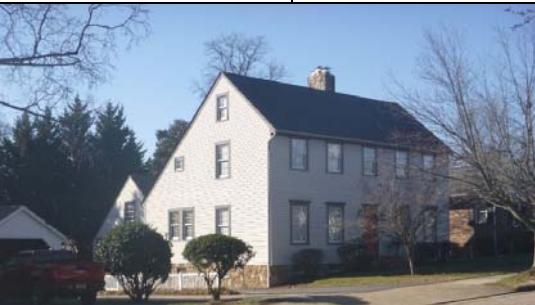
Name of Surveyors	Kimberly Packett		Survey Date	2/28/2016
ADDRESS	Street		Number	
	Parcel	Street	1212	
TYPE & NUMBER OF BLGS & STRUCTURES	Type		Number	
	Single Family House		1	
	Detatched Garage		1	
Current Use of Primary Building	Single Family	Historic Use of Primary Building	Single Family	
Style of Primary Blg	Federal			
Number of Stories	1.5	Width (bays)	5	
Foundation Material	Concrete	Depth (rooms)	3	
Year Built	1992	Wall Cladding Material	Vinyl siding	
Roof Shape	Saltbox	Roof Material	Composition shingle	
Decorative Details/Unique Features	Green surround around front windows and door. Tan surround around side windows.			
Evidence of Integrity Location/Materials	All materials are most likely original since the house was built in 1992.			
Additions/Alterations to Primary Building	Addition attached by hallway in back of house.			
Condition of Primary Building	Excellent		code	
			E	
Observable Threats	None

Compatibility with Adjacent Land Uses	Good			
Potential NR Eligibility	Non-Contributing		code	
			N	
Other Comments / Salient Details	Paved driveway on left side of the house. Paved path and brick stairs leading to front door. Bushes along front of house. Stone central chimney. Short white fence along left of property.			
Photo Views				
1 Front view	2 3/4 view	3	4

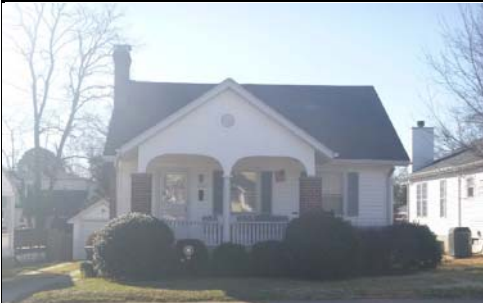
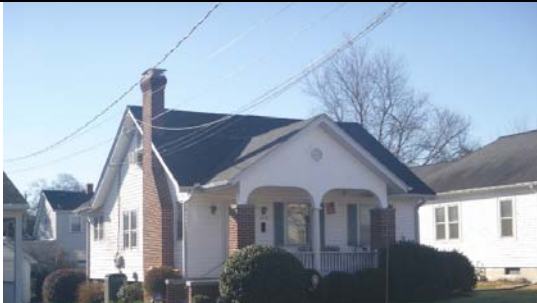
Name of Surveyors	Kimberly Packett		Survey Date	2/28/2016
ADDRESS	Street		Number	
	Parcel	Street	1220	
TYPE & NUMBER OF BLGS & STRUCTURES	Type		Number	
	Single Family House		1	
Current Use of Primary Building	Single Family	Historic Use of Primary Building	Single Family	
Style of Primary Bldg	Craftsman			
Number of Stories	1.5	Width (bays)	3	
Foundation Material	Brick	Depth (rooms)	3	
Year Built	1937	Wall Cladding Material	Vinyl siding	
Roof Shape	Side gable	Roof Material	Composition shingle	
Decorative Details/Unique Features	Front gable porch. Front gable is stucco. Blue shutters on front windows. Decorative circle on front gable.			
Evidence of Integrity Location/Materials	None.			
Additions/Alterations to Primary Building	New roof, windows, and siding.			
Condition of Primary Building	Good		code	
			G	
Observable Threats	None			
Compatibility with Adjacent Land Uses	Good			
Potential NR Eligibility	Non-Contributing		code

N	
Other Comments / Salient Details	Cement driveway on left side of house leading to detached garage. Bushes along base of house. Cement stairs with decorative brick ends leading to front porch with white railings and brick and white columns.			
Photo Views				
1 Front view	2 3/4 view	3	4

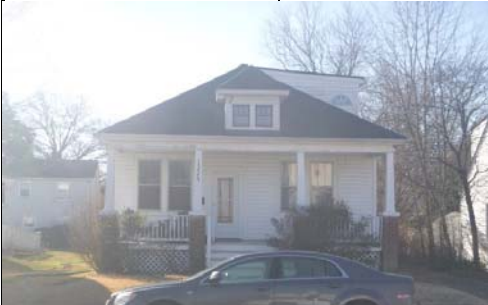
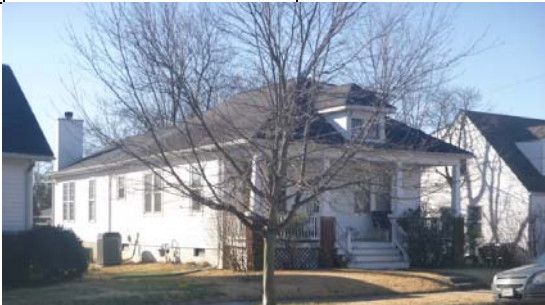
Name of Surveyors	Kimberly Packett	Survey Date	2/28/2016
ADDRESS	Street	Number	
	Parcel	Street	1224
TYPE & NUMBER OF BLGS & STRUCTURES	Type	Number	
	Single Family House	1	
Current Use of Primary Building	Single Family	Historic Use of Primary Building	Single Family
Style of Primary Bldg	Bungalow		
Number of Stories	1.5	Width (bays)	3
Foundation Material	Concrete	Depth (rooms)	5
Year Built	1937	Wall Cladding Material	Vinyl siding
Roof Shape	Hip	Roof Material	Composition shingle
Decorative Details/Unique Features	Hip domer on front of roof. Extended dormer on right side of house. Semi-circle window on side of extended dormer.		
Evidence of Integrity Location/Materials	Windows in hip dormer appear original.		
Additions/Alterations to Primary Building	Addition on the back. New siding, windows, and roof.		
Condition of Primary Building	Fair	code	
		F	
Observable Threats	None		
Compatibility with Adjacent Land Uses	Good

Potential NR Eligibility	Non-Contributing	code	
		N	
Other Comments / Salient Details	Chimney on back of the house. Cement stairs and path leading to front porch. Wood front porch with white railings and columns with brick bases. Bushes along front of house.		
Photo Views			
1 Front view	2 3/4 view	3	4

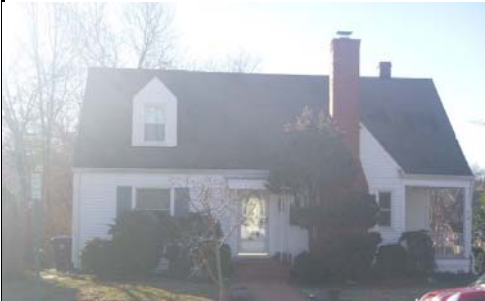
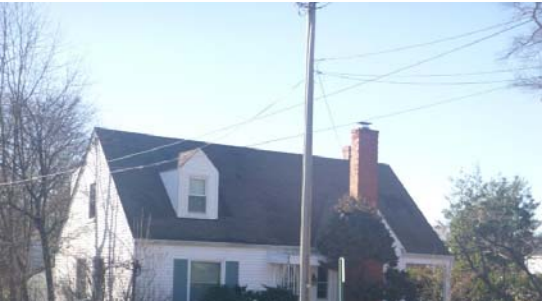
Name of Surveyors	Kimberly Packett		Survey Date	2/28/2016
ADDRESS	Street		Number	
	Parcel	Street	1226	
TYPE & NUMBER OF BLGS & STRUCTURES	Type		Number	
	Single Family House		1	
Current Use of Primary Building	Single Family	Historic Use of Primary Building	Single Family	
Style of Primary Bldg	Minimal Traditional			
Number of Stories	1.5	Width (bays)	3	
Foundation Material	Cinderblock	Depth (rooms)	2	
Year Built	1948	Wall Cladding Material	Aluminum siding	
Roof Shape	Side gable	Roof Material	Composition shingle	
Decorative Details/Unique Features	Front gable on right side of house with chimney. Light blue shutters on front left window.			
Evidence of Integrity Location/Materials	Original siding and windows.			
Additions/Alterations to Primary Building	New roof.			
Condition of Primary Building	Good		code	
			G	
Observable Threats	None			
Compatibility with Adjacent Land Uses	Good			
Potential NR Eligibility	Contributing		code

C	
Other Comments / Salient Details	Brick path and stairs to front door. Shed roof overhang above front door with metal columns. Additional chimney on back of house. Porch on front right side of house with side door and white railing and column. Cement path leading to side porch. Bushes along front of house.			
Photo Views				
1 Front view	2 3/4 view	3	4

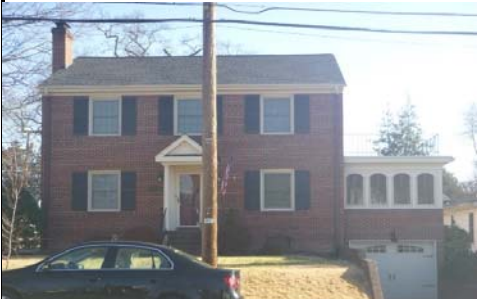
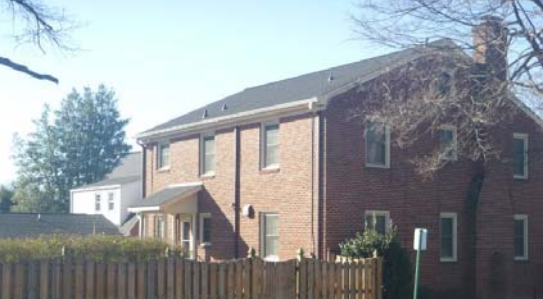
Name of Surveyors	Kimberly Packett		Survey Date	2/28/2016
ADDRESS	Street		Number	
	Augustine	Avenue	1517	
TYPE & NUMBER OF BLGS & STRUCTURES	Type		Number	
	Single Family House		1	
Current Use of Primary Building	Single Family	Historic Use of Primary Building	Single Family	
Style of Primary Bldg	Colonial Revival			
Number of Stories	2	Width (bays)	3	
Foundation Material	Cinderblock	Depth (rooms)	3	
Year Built	1957	Wall Cladding Material	Brick	
Roof Shape	Side gable	Roof Material	Composition shingle	
Decorative Details/Unique Features	Front gable entranceway with tan pilasters. Tan surround around front windows with blue shutters.			
Evidence of Integrity Location/Materials	Original brick siding and windows.			
Additions/Alterations to Primary Building	New roof.			
Condition of Primary Building	Excellent		code	
			E	
Observable Threats	None			
Compatibility with Adjacent Land Uses	Good			
Potential NR Eligibility	Contributing		code

C	
Other Comments / Salient Details	Chimney on left end of house. Wood privacy fence around backyard. Paved driveway leading to attached basement garage. Brick retaining wall along left side of driveway. Brick stairs an path with iron railing leading to front door. Sun room above attached garage with flat roof and iron railing. Back door with shed roof overhang.			
Photo Views				
1 Front view	2 3/4 view	3	4

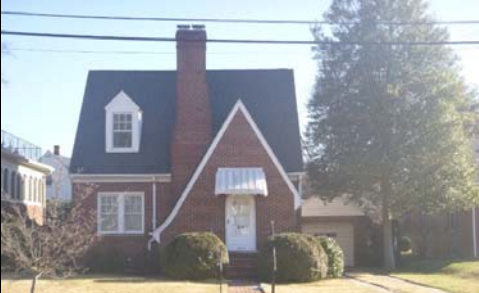
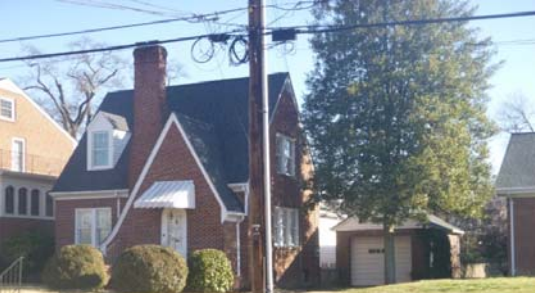
Name of Surveyors	Kimberly Packett		Survey Date	2/28/2016
ADDRESS	Street		Number	
	Augustine Avenue		1513	
TYPE & NUMBER OF BLGS & STRUCTURES	Type		Number	
	Single Family House		1	
	Detatched Garage		1	
Current Use of Primary Building	Single Family	Historic Use of Primary Building	Single Family	
Style of Primary Blg	Tudor			
Number of Stories	1.5	Width (bays)	2	
Foundation Material	Cinderblock	Depth (rooms)	1	
Year Built	1947	Wall Cladding Material	Brick	
Roof Shape	Side gable	Roof Material	Composition shingle	
Decorative Details/Unique Features	Front gable entrance way with front chimney. Front gable dormer on front of house. Metal awning above front door. Front foor has curved top.			
Evidence of Integrity Location/Materials	Original brick siding			
Additions/Alterations to Primary Building	Addition on back of building. New roof and windows.			
Condition of Primary Building	Excellent		code	
			E	
Observable Threats	None

Compatibility with Adjacent Land Uses	Good			
Potential NR Eligibility	Non-Contributing		code	
			N	
Other Comments / Salient Details	Cement driveway along right side of house leading to detached garage. Brick stairs and path with iron railing leading to front door. Bushes on either side of front door.			
Photo Views				
1 Front view	2 3/4 view	3	4

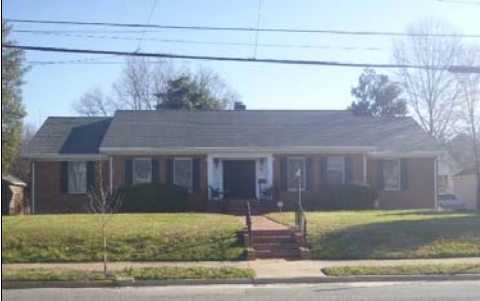
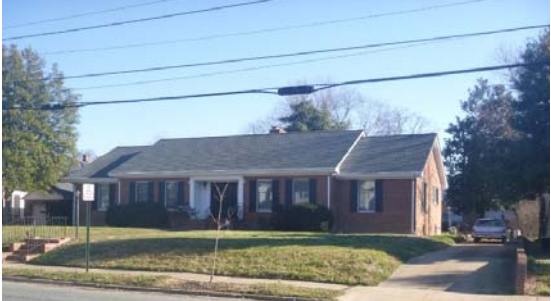
Name of Surveyors	Kimberly Packett		Survey Date	2/28/2016
ADDRESS	Street		Number	
	Augustine	Avenue	1507	
TYPE & NUMBER OF BLGS & STRUCTURES	Type		Number	
	Single Family Home		1	
Current Use of Primary Building	Single Family	Historic Use of Primary Building	Single Family	
Style of Primary Bldg	Ranch			
Number of Stories	1	Width (bays)	7	
Foundation Material	Cinderblock	Depth (rooms)	2	
Year Built	1973	Wall Cladding Material	Brick	
Roof Shape	Side gable	Roof Material	Composition shingle	
Decorative Details/Unique Features	Dark blue shutters on front windows. Dark blue double double with white sunken entrance way with a white surround.			
Evidence of Integrity Location/Materials	Original brick siding and windows.			
Additions/Alterations to Primary Building	New roof.			
Condition of Primary Building	Excellent		code	
			E	
Observable Threats	None			
Compatibility with Adjacent Land Uses	Good			
Potential NR Eligibility	Non-Contributing		code

N	
Other Comments / Salient Details	Cement driveway along right side of house. Brick stairs and path with iron railing leading to front door. Bushes along front of house. Central chimney. Short brick wall along right side of driveway.			
Photo Views				
1 Front view	2 3/4 view	3	4

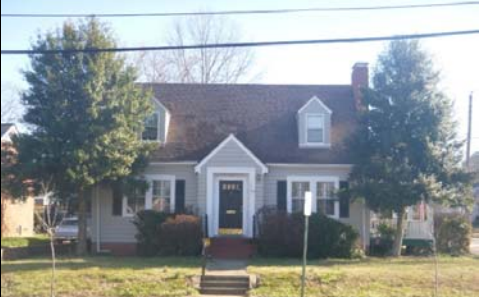
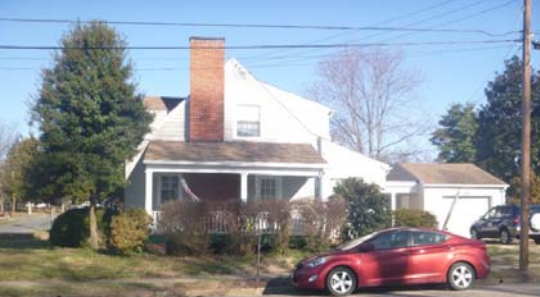
Name of Surveyors	Kimberly Packett		Survey Date	2/28/2016
ADDRESS	Street		Number	
	Augustine Avenue		1501	
TYPE & NUMBER OF BLGS & STRUCTURES	Type		Number	
	Single Family House		1	
Current Use of Primary Building	Single Family	Historic Use of Primary Building	Single Family	
Style of Primary Bldg	Cape Cod			
Number of Stories	1.5	Width (bays)	3	
Foundation Material	Brick	Depth (rooms)	3	
Year Built	1949	Wall Cladding Material	Hardboard siding	
Roof Shape	Side gable	Roof Material	Composition shingle	
Decorative Details/Unique Features	White surround around door and windows. Front gable entranceway. Two front gable dormers on front of house. Dark blue shutters on front windows.			
Evidence of Integrity Location/Materials	Possibly original windows.			
Additions/Alterations to Primary Building	New siding and roof.			
Condition of Primary Building	Excellent		code	
			E	
Observable Threats	None			
Compatibility with Adjacent Land Uses	Good

Potential NR Eligibility	Contributing		code	
			C	
Other Comments / Salient Details	Cement path and brick stairs with iron railing leading to front door. Bushes along front of house. Side porch with shed roof and white railings and columns. Driveway leading to garage in back of property. Covered path from detached garage to back door. Chimney on right side of the house.			
Photo Views				
1 Front view	2 Side view	3	4

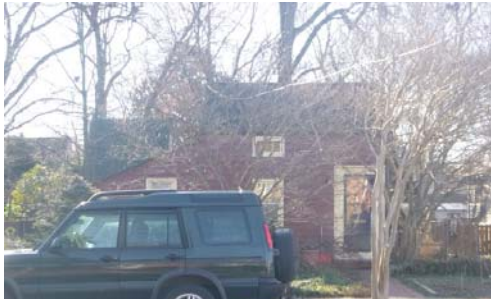
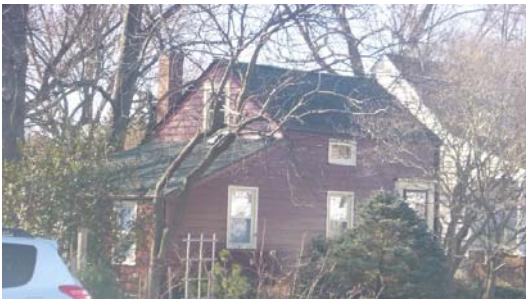
Name of Surveyors	Kimberly Packett		Survey Date	2/21/2016
ADDRESS	Street		Number	
	Payne	Street	1308	
TYPE & NUMBER OF BLGS & STRUCTURES	Type		Number	
	Single Family House		1	
	Shed		1	
Current Use of Primary Building	Single Family	Historic Use of Primary Building	Single Family	
Style of Primary Bldg	Minimal Traditional			
Number of Stories	1.5	Width (bays)	3	
Foundation Material	Cinderblock	Depth (rooms)	3	
Year Built	1948	Wall Cladding Material	Wood Siding	
Roof Shape	Side gable	Roof Material	Composition shingles	
Decorative Details/Unique Features	Red siding. Tan surround around front door and windows.			
Evidence of Integrity Location/Materials	Appears to be original windows.			
Additions/Alterations to Primary Building	New roof and siding.			
Condition of Primary Building	Fair	code		
		F		
Observable Threats	None			
Compatibility with Adjacent Land Uses	Good			
Potential NR Eligibility	Contributing	code

C		
Other Comments / Salient Details	A lot of trees and shrubbery in the front and a brick pathway to the front door. Chimney on the back of the house. Chainlink fence around backyard.			
Photo Views				
1 Front view	2 3/4 view	3	4

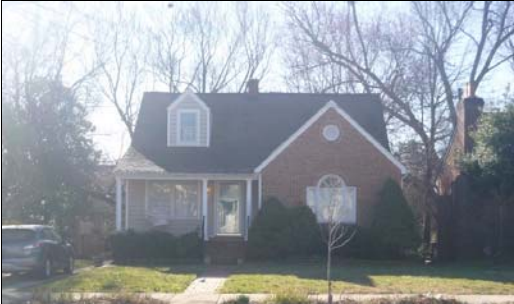
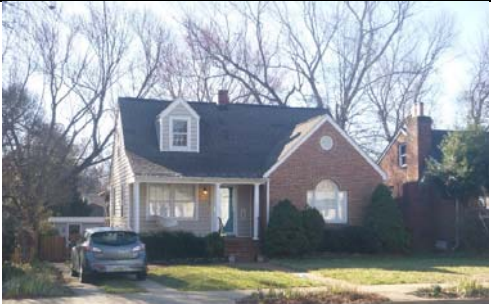
Name of Surveyors	Kimberly Packett		Survey Date	2/21/2016
ADDRESS	Street		Number	
	Payne Street		1310	
TYPE & NUMBER OF BLGS & STRUCTURES	Type		Number	
	Single Family House		1	
	Shed		1	
Current Use of Primary Building	Single Family	Historic Use of Primary Building	Single Family	
Style of Primary Bldg	Minimal Traditional			
Number of Stories	1 1/2	Width (bays)	3	
Foundation Material	Cinderblock	Depth (rooms)	5	
Year Built	1959	Wall Cladding Material	Vinyl siding	
Roof Shape	Side gable	Roof Material	Composition shingles	
Decorative Details/Unique Features	Small porch with white columns, front gable on front right side of house with palladian window, brick façade, and small circular window. One front gable dormer with vinyl siding on front of house.			
Evidence of Integrity Location/Materials	Brick façade may be original.			
Additions/Alterations to Primary Building	New windows, vinyl siding, and roof. Addition on back of house.

Condition of Primary Building	Good	code		
		G		
Observable Threats	None			
Compatibility with Adjacent Land Uses	Good			
Potential NR Eligibility	Contributing	code		
		C		
Other Comments / Salient Details	Paved driveway along left side of the house. Brick path and stairs leading to front door. Wood fence around backyard. Central chimney.			
Photo Views				
1 Front view	2 3/4 view	3	4

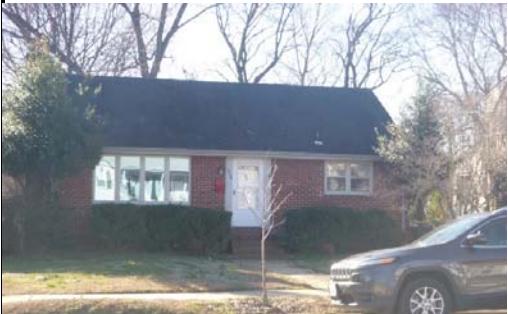
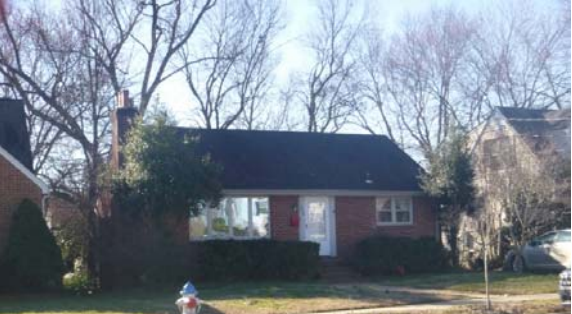
Name of Surveyors	Kimberly Packett		Survey Date	2/21/2016
ADDRESS	Street		Number	
	Payne	Street	1316	
TYPE & NUMBER OF BLGS & STRUCTURES	Type		Number	
	Single Family House		1	
Current Use of Primary Building	Single Family	Historic Use of Primary Building	Single Family	
Style of Primary Bldg	Minimal Traditional			
Number of Stories	1	Width (bays)	3	
Foundation Material	Cinderblock	Depth (rooms)	2	
Year Built	1964	Wall Cladding Material	Brick	
Roof Shape	Side gable	Roof Material	Composition shingles	
Decorative Details/Unique Features	Pilasters on either side of the front door			
Evidence of Integrity Location/Materials	Original brick siding.			
Additions/Alterations to Primary Building	New windows and roof.			
Condition of Primary Building	Good		code	
			G	
Observable Threats	None			
Compatibility with Adjacent Land Uses	Good			
Potential NR Eligibility	Contributing		code	
			C	
Other Comments / Salient Details	Brick path and stairs leading to front door. Brick driveway on right side of the house. Bushes along front of house. Chimney on left end of house.

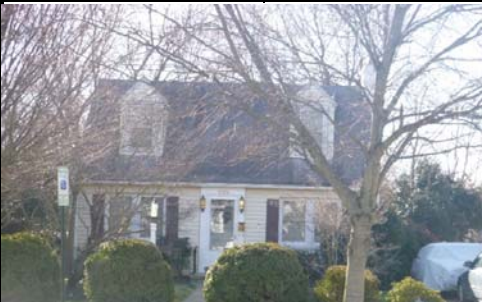
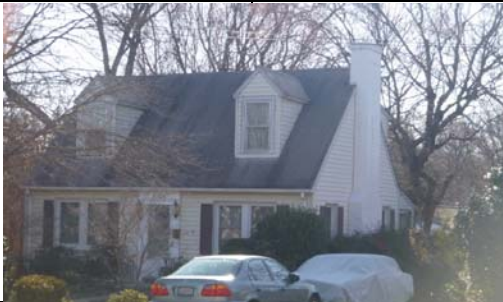
Name of Surveyors	Kimberly Packett		Survey Date	2/21/2016
ADDRESS	Street		Number	
	Payne	Street	1320	
TYPE & NUMBER OF BLGS & STRUCTURES	Type		Number	
	Single Family House		1	
Current Use of Primary Building	Single Family	Historic Use of Primary Building	Single Family	
Style of Primary Bldg	Cape Cod			
Number of Stories	1 1/2	Width (bays)	3	
Foundation Material	Cinderblock	Depth (rooms)	3	
Year Built	1948	Wall Cladding Material	Vinyl siding	
Roof Shape	Side gable	Roof Material	Composition shingle	
Decorative Details/Unique Features	Dark blue shutters on bottoms windows. White surround around front door. Two front gable dormers on front of house.			
Evidence of Integrity Location/Materials	Appears to be original windows.			
Additions/Alterations to Primary Building	Addition on the back of the house. New vinyl siding and roof.			
Condition of Primary Building	Good		code	
			G	
Observable Threats	None			
Compatibility with Adjacent Land Uses	Good

Potential NR Eligibility	Contributing		code	
			C	
Other Comments / Salient Details	Paved driveway on right side. Concrete path and steps leading to front door with iron railing. A lot of landscaping including trees and bushes all around the house. Painted brick chimney on right side of house.			
Photo Views				
1 Front view	2 3/4 view	3	4

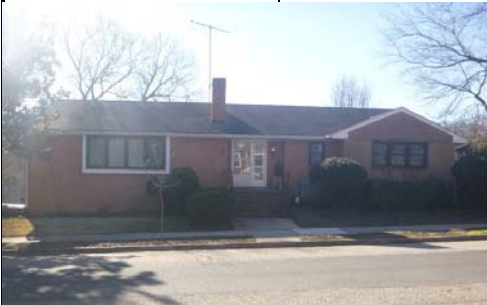
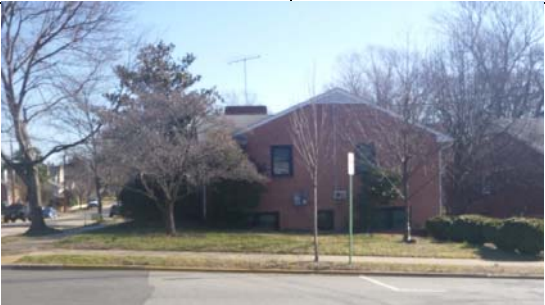
Name of Surveyors	Kimberly Packett		Survey Date	2/28/2016
ADDRESS	Street		Number	
	Payne	Street	1324	
TYPE & NUMBER OF BLGS & STRUCTURES	Type		Number	
	Single Family House		1	
Current Use of Primary Building	Single Family	Historic Use of Primary Building	Single Family	
Style of Primary Bldg	Ranch			
Number of Stories	1	Width (bays)	4	
Foundation Material	Cinderblock	Depth (rooms)	2	
Year Built	1964	Wall Cladding Material	Brick	
Roof Shape	Side gable	Roof Material	Composition shingle	
Decorative Details/Unique Features	Black windows. White surround round left windows. Front gable on right side of house. Side light on right side of door.			
Evidence of Integrity Location/Materials	Original brick siding.			
Additions/Alterations to Primary Building	New roof and possibly new windows.			
Condition of Primary Building	Fair		code	
			F	
Observable Threats	None			
Compatibility with Adjacent Land Uses	Good			
Potential NR Eligibility	Contributing		code

C	
Other Comments / Salient Details	Central chimney. Bushes along front right side of house. Cement path leading to front door with brick stairs and iron railing.			
Photo Views				
1 Front view	2 Side view	3	4

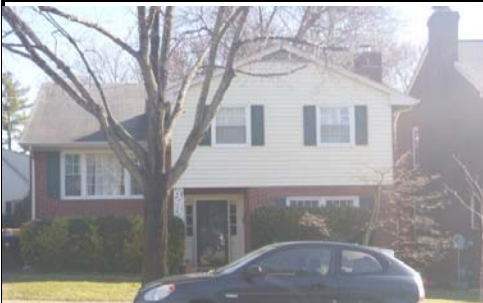
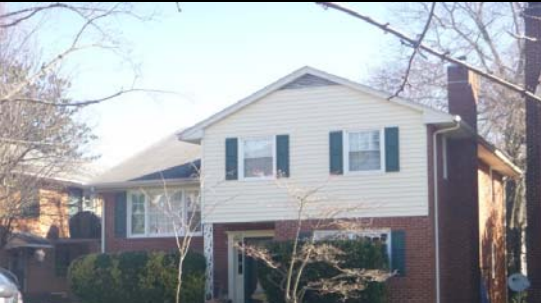
Name of Surveyors	Kimberly Packett		Survey Date	2/28/2016
ADDRESS	Street		Number	
	Stafford	Avenue	1415	
TYPE & NUMBER OF BLGS & STRUCTURES	Type		Number	
	Single Family House		1	
Current Use of Primary Building	Single Family	Historic Use of Primary Building	Single Family	
Style of Primary Bldg	Split Level			
Number of Stories	2	Width (bays)	3	
Foundation Material	Cinderblock	Depth (rooms)	2	
Year Built	1955	Wall Cladding Material	Brick	
Roof Shape	Side gable	Roof Material	Composition shingle	
Decorative Details/Unique Features	Green shutters on front windows that match front door. Tan surround around front door and windows. Front door has side lights. Front right top story has vinyl siding.			
Evidence of Integrity Location/Materials	Original brick siding.			
Additions/Alterations to Primary Building	New roof, windows and vinyl siding.			
Condition of Primary Building	Good		code	
			G	
Observable Threats	None

Compatibility with Adjacent Land Uses	Good			
Potential NR Eligibility	Contributing		code	
			C	
Other Comments / Salient Details	Cement path leading to front door. Overhang supported by metal column above front door. Bushes along front of house. Right end chimney.			
Photo Views				
1 Front view	2 3/4 view	3	4

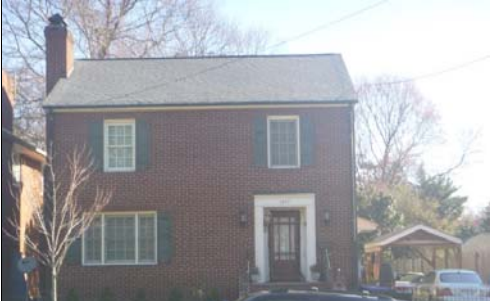
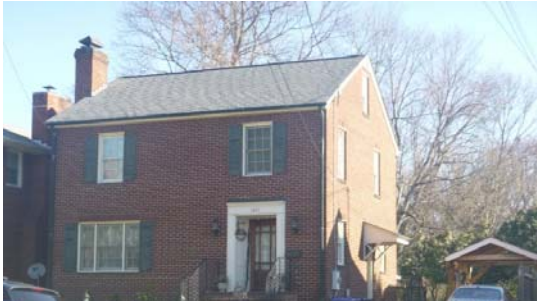
Name of Surveyors	Kimberly Packett		Survey Date	2/28/2016
ADDRESS	Street		Number	
	Stafford	Avenue	1407	
TYPE & NUMBER OF BLGS & STRUCTURES	Type		Number	
	Single Family House		1	
	Carport		1	
Current Use of Primary Building	Single Family	Historic Use of Primary Building	Single Family	
Style of Primary Bldg	Federal			
Number of Stories	2	Width (bays)	2	
Foundation Material	Cinderblock	Depth (rooms)	3	
Year Built	1958	Wall Cladding Material	Brick	
Roof Shape	Side gable	Roof Material	Composition shingle	
Decorative Details/Unique Features	Tan surround around front door and windows. Windows have blue shutters.			
Evidence of Integrity Location/Materials	Original brick siding.			
Additions/Alterations to Primary Building	New roof, appears to be new windows.			
Condition of Primary Building	Good		code	
			G	
Observable Threats	None			
Compatibility with Adjacent Land Uses	Good			
Potential NR Eligibility	Non-Contributing		code

N	
Other Comments / Salient Details	Cement driveway on right side of house. Iron railing around backyard. Brick retaining wall along sides of driveway. Brick stairs and path with brick sides leading to front door with brick stairs and iron railing. Iron lamps on either side of beginning of path leading to front door. Left end chimney. Carport in backyard. Brick steps leading to side door with shed awning on right side of house.			
Photo Views				
1 Front view	2 3/4 view	3	4

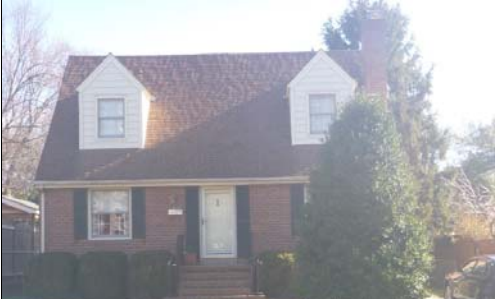
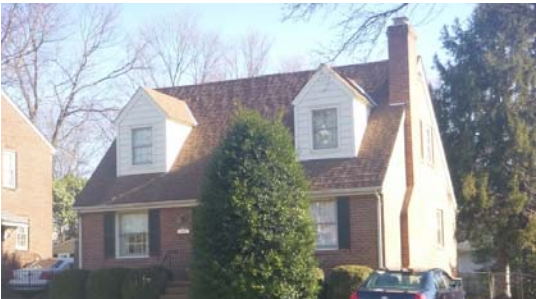
Name of Surveyors	Kimberly Packett		Survey Date	2/28/2016
ADDRESS	Street		Number	
	Stafford	Avenue	1405	
TYPE & NUMBER OF BLGS & STRUCTURES	Type		Number	
	Single Family House		1	
Current Use of Primary Building	Single Family	Historic Use of Primary Building	Single Family	
Style of Primary Bldg	Cape Cod			
Number of Stories	1.5	Width (bays)	3	
Foundation Material	Cinderblock	Depth (rooms)	1	
Year Built	1960	Wall Cladding Material	Brick	
Roof Shape	Side gable	Roof Material	Composition shingle	
Decorative Details/Unique Features	Two front dormers with vinyl siding on front of house. Dark blue shutters on front windows and door.			
Evidence of Integrity Location/Materials	Original brick siding, possibly original windows.			
Additions/Alterations to Primary Building	New roof.			
Condition of Primary Building	Good		code	
			G	
Observable Threats	None			
Compatibility with Adjacent Land Uses	Good			
Potential NR Eligibility	Contributing		code

C	
Other Comments / Salient Details	Chimney on right end of house. Brick path and stairs with iron railing leading to front door. Bushes along front of house. Chain link fence around backyard. Cement driveway on right side of house.			
Photo Views				
1 Front view	2 3/4 view	3	4

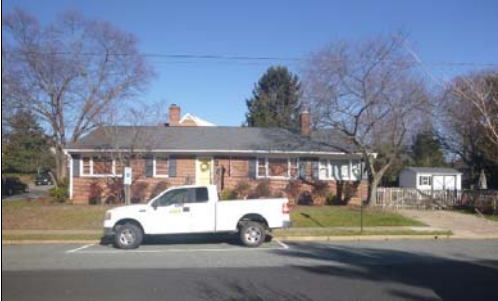
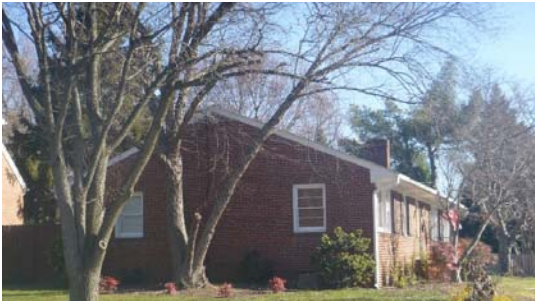
Name of Surveyors	Kimberly Packett		Survey Date	2/28/2016
ADDRESS	Street		Number	
	Dandridge	Street	1321	
TYPE & NUMBER OF BLGS & STRUCTURES	Type		Number	
	Single Family House		1	
	Shed		1	
Current Use of Primary Building	Single Family	Historic Use of Primary Building	Single Family	
Style of Primary Bldg	Ranch			
Number of Stories	1	Width (bays)	5	
Foundation Material	Concrete	Depth (rooms)	2	
Year Built	1962	Wall Cladding Material	Brick	
Roof Shape	Side gable	Roof Material	Composition shingle	
Decorative Details/Unique Features	Blue shutters on front windows. White surround around front door.			
Evidence of Integrity Location/Materials	Original brick siding and possibly windows.			
Additions/Alterations to Primary Building	New roof.			
Condition of Primary Building	Good		code	
			G	
Observable Threats	None			
Compatibility with Adjacent Land Uses	Good			
Potential NR Eligibility	Contributing		code	
			C	
Other Comments / Salient Details	Cement driveway on right side of property. Wood fence around backyard. Bushes along foot of house. Cement path and stairs with iron railing leading to the front door. Interior chimney on right side of house and central chimney.

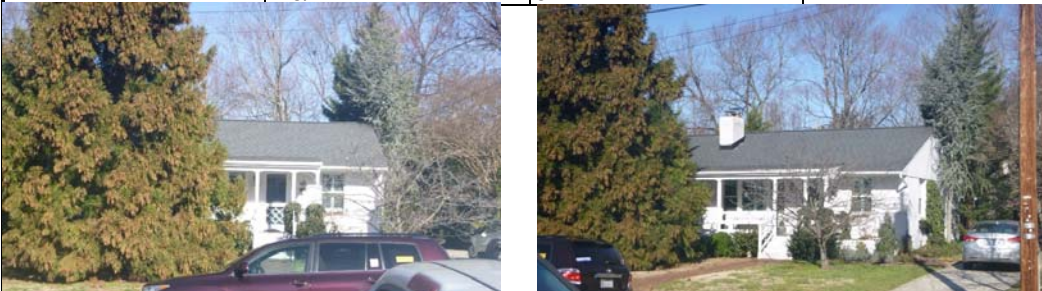
Potential NR Eligibility	Contributing	code		
		C		
Other Comments / Salient Details	Brick walk to the front entrance, white brick stairs to front entrance with wood rail, stamped brick driveway, shed roof over front porch. Large tree on left side of house. Bushes along front of property. Ivy on left side of house.			
Photo Views				
1 Front view	2 3/4 view	3	4

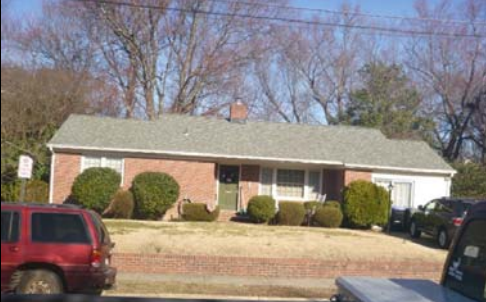
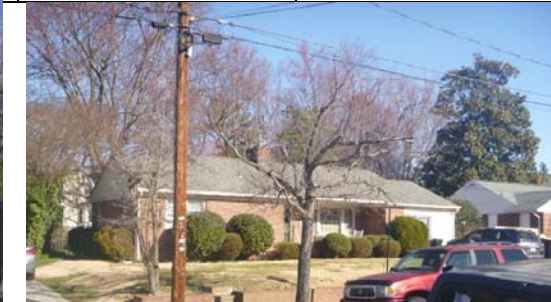
Condition of Primary Building	Good		code	
			G	
Observable Threats	None			
Compatibility with Adjacent Land Uses	Good			
Potential NR Eligibility	Contributing		code	
			C	
Other Comments / Salient Details	Brick retaining wall along front of property. Paved driveway on right side of house. Bushes along front of property. Cement path leading to front door with brick stairs and iron railing. Central chimney.			
Photo Views				
1 Front view	2 3/4 view	3	4

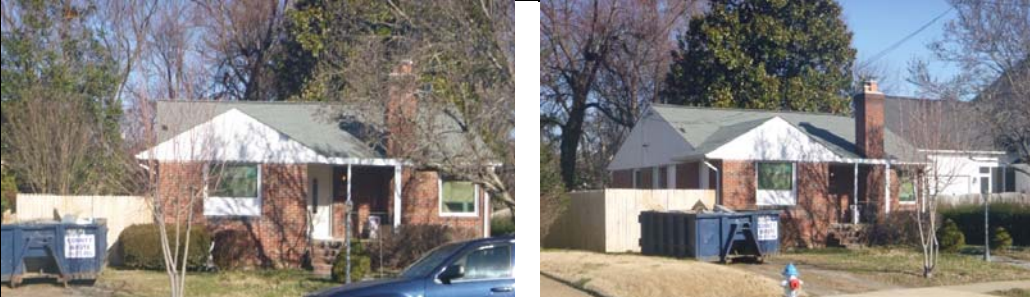
Figure 4.5 shows 1311 Dandridge Street, an example of a typical Minimal Traditional home. This building is in good condition and was deemed contributing.

Potential NR Eligibility	Contributing		code	
			C	
Other Comments / Salient Details	Dirt driveway on left side of the house. Wood privacy fence around backyard. Cement path and brick stairs and iron railing leading to front porch. Iron lamppost on front yard. Front brick chimney.			
Photo Views				
1 Front view	2 3/4 view	3	4

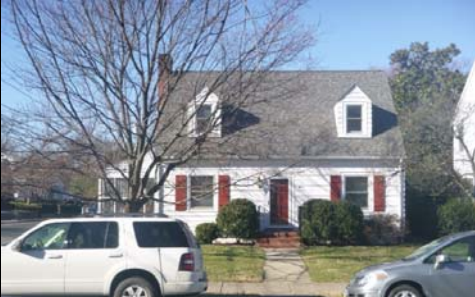
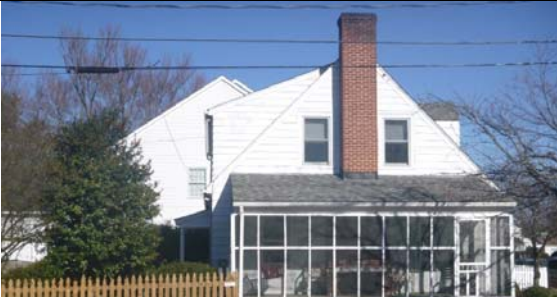
Compatibility with Adjacent Land Uses	Good			
Potential NR Eligibility	Contributing		code	
			C	
Other Comments / Salient Details	Picket fence around backyard. Screened in porch on left side of the house. Brick chimney on left end of the house. Back door with shed roof overhang. Bushes along front of house. Cement path leading to brick stairs with iron railing leading to front door.			
Photo Views				
1 Front view	2 Side view	3	4

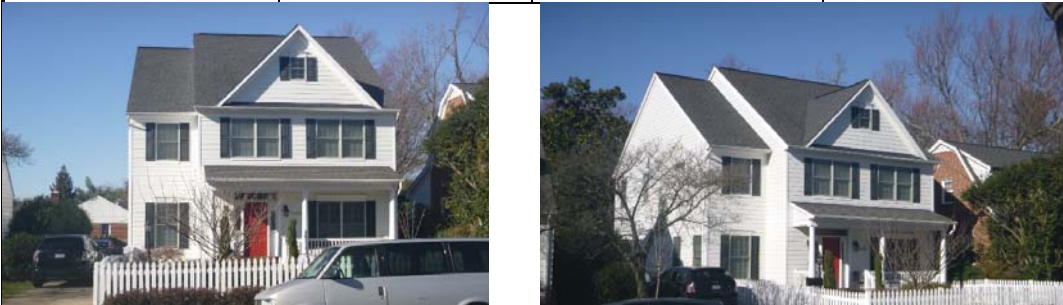
Compatibility with Adjacent Land Uses	Good			
Potential NR Eligibility	Non-Contributing			code
				N
Other Comments / Salient Details	White picket fence around frontyard. Wood privacy fence around backyard. Cement driveway on left side of house. Cement path leading from driveway to front porch. Bushes along front of white picket fence.			
Photo Views				
1 Front view	2 3/4 view	3	4

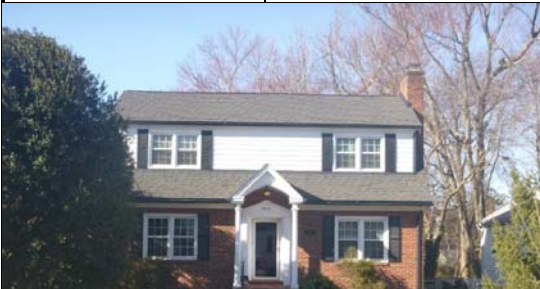
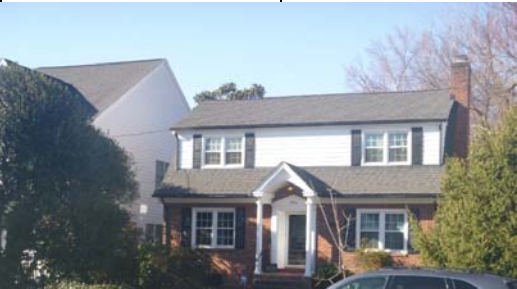
Condition of Primary Building	Excellent			code E
Observable Threats	None			
Compatibility with Adjacent Land Uses	Good			
Potential NR Eligibility	Contributing			code C
Other Comments / Salient Details	Brick walkway to front entrance, brick stairs and small landing at front entrance, black iron fence around porch, chain link fenced backyard with gate, brick walk to side entrance off the front walk. Bushes along front of house. Chimney on the right end of the house.			
Photo Views				
1 Front view	2 3/4 view	3	4

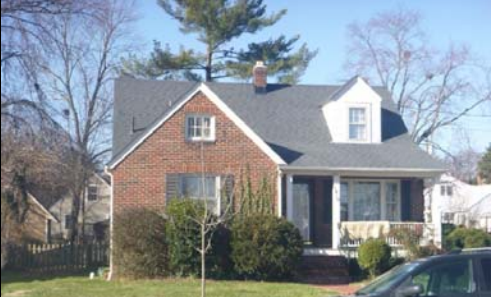
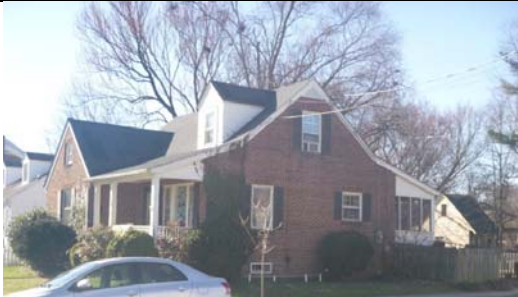
Condition of Primary Building	Good		code	
			G	
Observable Threats	None			
Compatibility with Adjacent Land Uses	Good			
Potential NR Eligibility	Contributing		code	
			C	
Other Comments / Salient Details	Brick path and stairs leading to front porch with white railings and columns. Bushes along front and side of house. Wood fence around backyard.			
Photo Views				
1 Front view	2 3/4 view	3 Side view	4
