Cultural Resource Survey of College Heights in Fredericksburg, Virginia

Master of Science

Historic Preservation

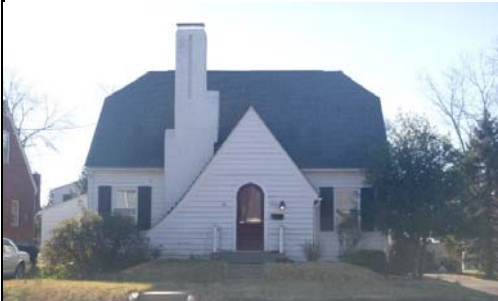
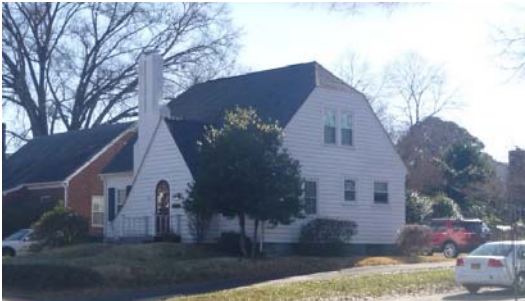
N	
Other Comments / Salient Details	Brick stairs and path with white wood railing leading to front door. Front brick chimney. Paved driveway on right side of the house. Bushes along front of house.			
Photo Views				
1 Front view	2 3/4 view	3	4

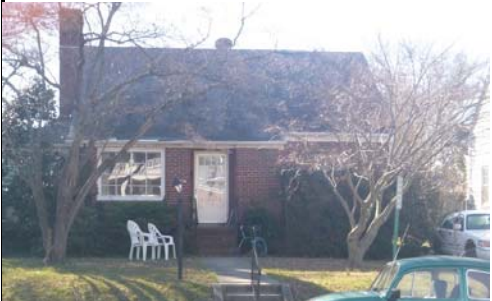
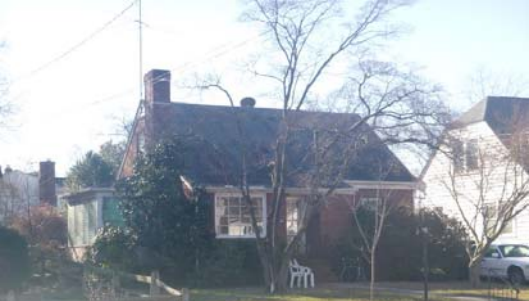
C		
Other Comments / Salient Details	Black lamppost on front lawn. Cement stairs and path with iron railing leading to front door with brick stairs and iron railing. Bushes along front of house. Paved driveway on right side of house. Chimney on left end of the house.			
Photo Views				
1 Front view	2 3/4 view	3	4

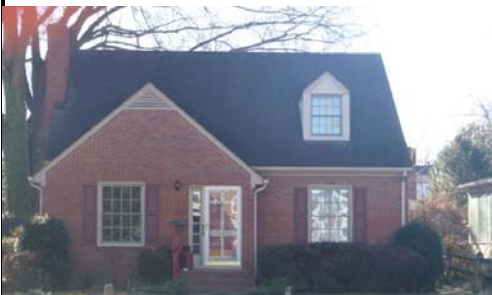
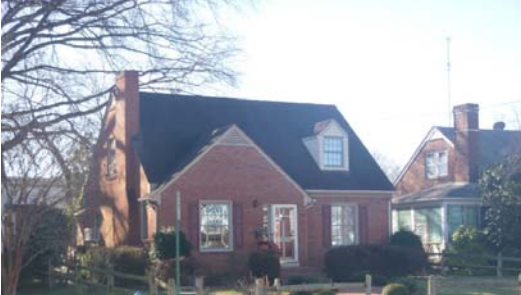
Compatibility with Adjacent Land Uses	Good			
Potential NR Eligibility	Contributing		code	
			C	
Other Comments / Salient Details	Wood farm fence around property. Bushes along front of house. Brick stairs and path leading to front door. Chimney on left end of house.			
Photo Views				
1 Front view	2 3/4 view	3	4

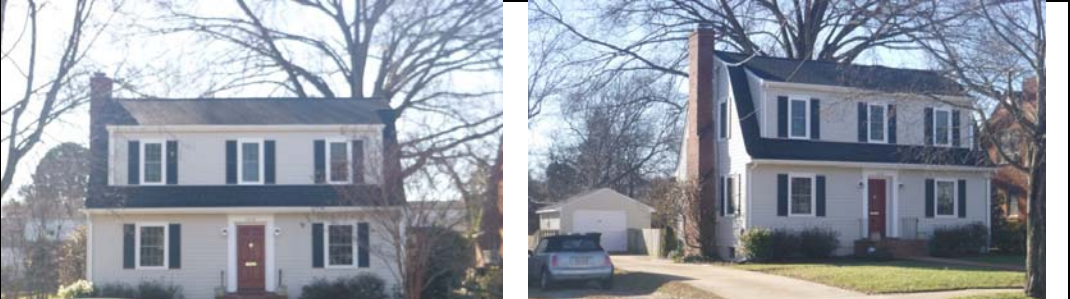
Potential NR Eligibility	Contributing		code	
			C	
Other Comments / Salient Details	Brick path and stairs with iron railing leading to front door. Cement driveway on left side of the house leading to detached garage. Bushes along front of house.			
Photo Views				
1 Front view	2 3/4 view	3	4

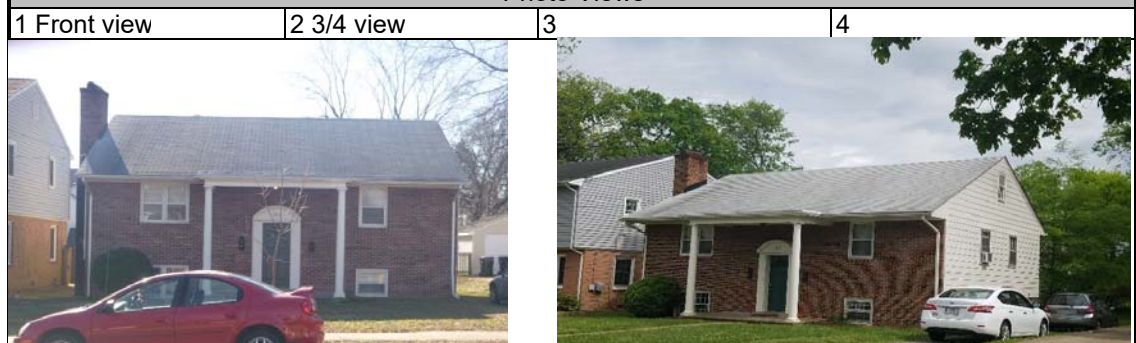
Potential NR Eligibility	Contributing			code
				C
Other Comments / Salient Details	Cement path leading to cement front porch. Chimney on left end of house.

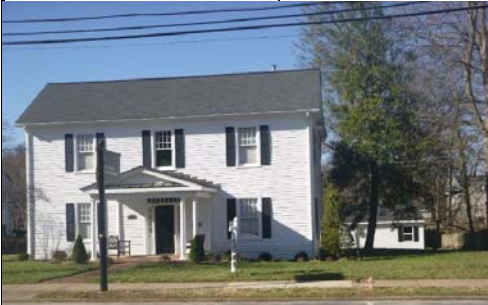
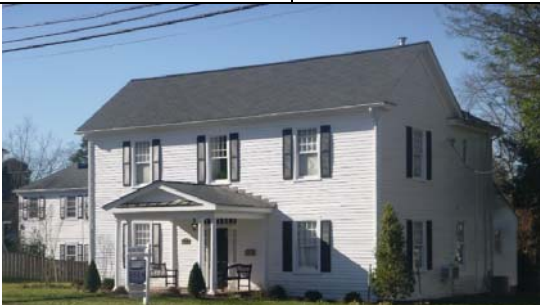
Compatibility with Adjacent Land Uses	Good			
Potential NR Eligibility	Non-Contributing		code	
			N	
Other Comments / Salient Details	Brick path leading to front door with brick porch. House is currently for sale			
Photo Views				
1 Front view	2 3/4 view	3	4

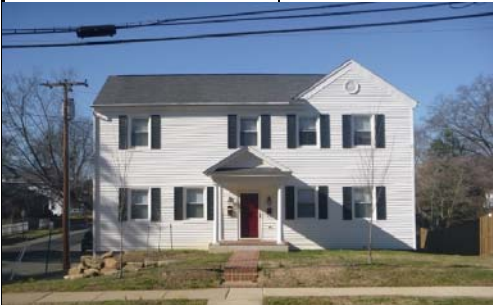
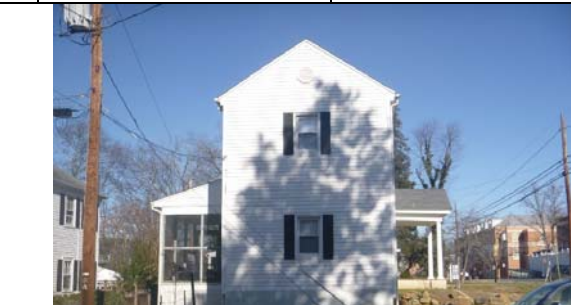
Potential NR Eligibility	Non-Contributing		code	
			N	
Other Comments / Salient Details	Brick stairs and path leading to cement front porch. Brick path behind house leading to back door. Screened in porch on back of house.			
Photo Views				
1 Front view	2 Side view	3	4

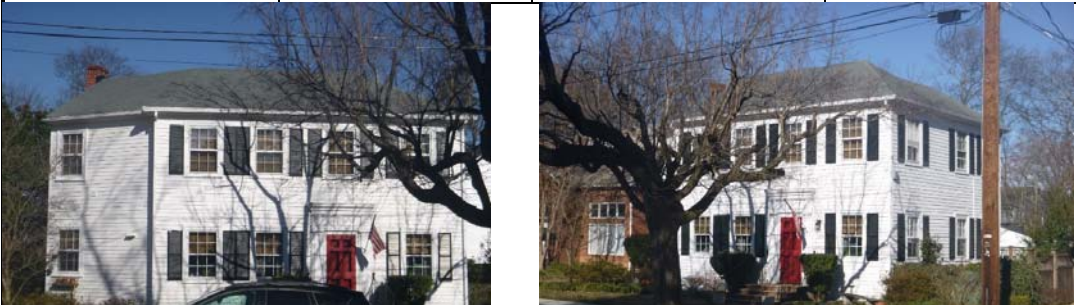
Potential NR Eligibility	Non-Contributing		code	
			N	
Other Comments / Salient Details	Brick pathway leading to backyard. Brick path and stairs with iron railing leading to front door. Bushes along front of house. Chimney on left end of house.			
Photo Views				
1 Front view	2 3/4 view	3	4

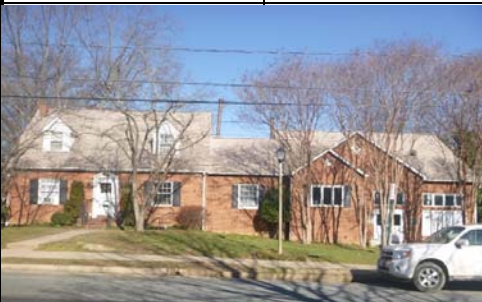
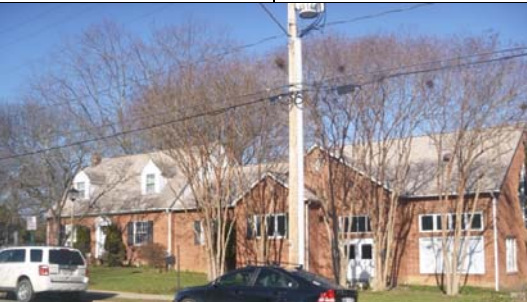
Compatibility with Adjacent Land Uses	Good			
Potential NR Eligibility	Contributing		code	
			C	
Other Comments / Salient Details	Cement path and brick stairs with iron railing leading to front door. Another door located on front right side of house. Chimney on left end of the house. Large lamppost in front yard.			
Photo Views				
1 Front view	2 3/4 view	3	4

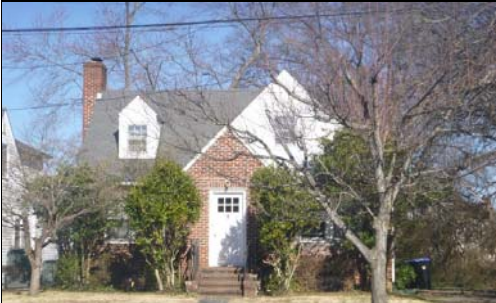
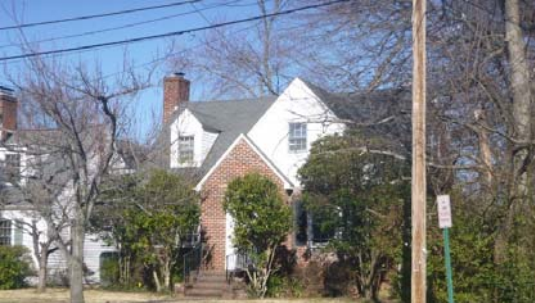
Name of Surveyors	Kimberly Packett		Survey Date	2/28/2016
ADDRESS	Street		Number	
	Dandridge	Street	1221	
TYPE & NUMBER OF BLGS & STRUCTURES	Type		Number	
	Single Famiy House		1	
Current Use of Primary Building	Single Family	Historic Use of Primary Building	Single Family	
Style of Primary Blg	Cape Cod			
Number of Stories	1.5	Width (bays)	3	
Foundation Material	Cinderblock	Depth (rooms)	2	
Year Built	1950	Wall Cladding Material	Brick	
Roof Shape	Side gable	Roof Material	Composition shingle	
Decorative Details/Unique Features	Decorative brick around front door and windows. Front gable dormer on front of house with vinyl siding. Front gable on right side of house with viny siding. Front gable entrance.			
Evidence of Integrity Location/Materials	Original brick siding. Appears to be original windows.			
Additions/Alterations to Primary Building	New roof.			
Condition of Primary Building	Good			code
				G
Observable Threats	None

Compatibility with Adjacent Land Uses	Good			
Potential NR Eligibility	Contributing			code
				C
Other Comments / Salient Details	Cement path and brick stairs with iron railing leading to front door. Bushes along front of house. Dirt driveway on right side of house.			
Photo Views				
1 Front view	2 3/4 view	3	4

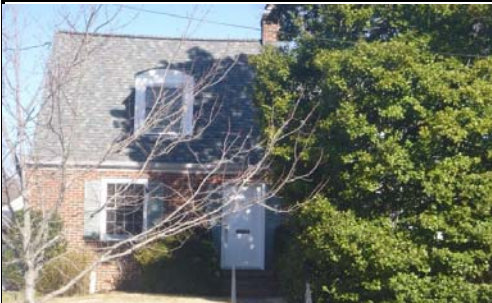
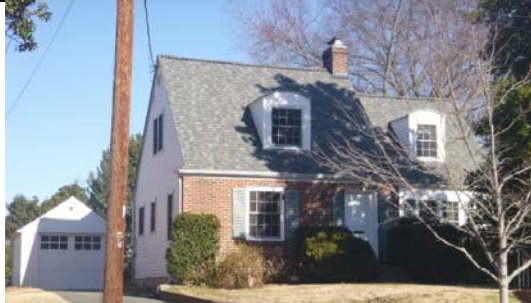
Name of Surveyors	Kimberly Packett		Survey Date	2/28/2016
ADDRESS	Street		Number	
	Dandridge	Street	1225	
TYPE & NUMBER OF BLGS & STRUCTURES	Type		Number	
	Single Family House		1	
	Detatched Garage		1	
Current Use of Primary Building	Single Family	Historic Use of Primary Building	Single Family	
Style of Primary Blg	Cape Cod			
Number of Stories	1.5	Width (bays)	3	
Foundation Material	Concrete	Depth (rooms)	3	
Year Built	1949	Wall Cladding Material	Vinyl siding	
Roof Shape	Side gable	Roof Material	Composition shingle	
Decorative Details/Unique Features	Green shutters on front windows and front door. Brick front façade on front left side of house. Two dormers with curved roofs on front of building.			
Evidence of Integrity Location/Materials	Could possibly be original windows on original section of house.			
Additions/Alterations to Primary Building	Addition on back of house. New vinyl siding and roof.

Condition of Primary Building	Good		code	
			G	
Observable Threats	None			
Compatibility with Adjacent Land Uses	Good			
Potential NR Eligibility	Contributing		code	
			C	
Other Comments / Salient Details	Brick retaining wall along front of property and right side of driveway. Paved driveway along left side of house leading to detached garage. Brick path and stairs with iron railing leading to front door. Central chimney. Bushes along front of house, large tree on front right of property.			
Photo Views				
1 Front view	2 3/4 view	3	4

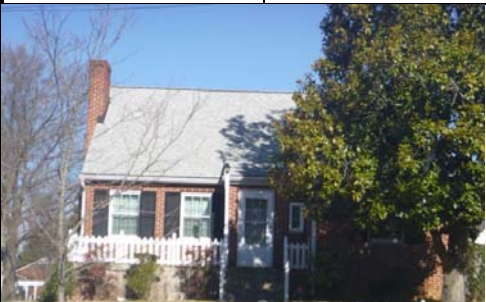
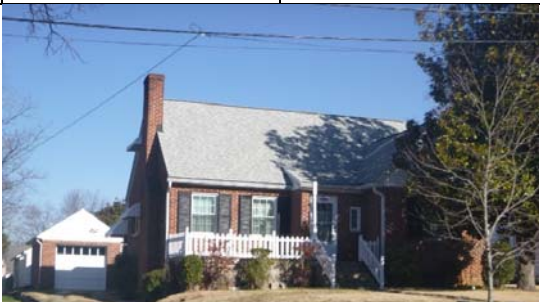
Name of Surveyors	Kimberly Packett		Survey Date	2/28/2016
ADDRESS	Street		Number	
	Dandridge	Street	1229	
TYPE & NUMBER OF BLGS & STRUCTURES	Type		Number	
	Single Family House		1	
	Detatched Garage		1	
Current Use of Primary Building	Single Family	Historic Use of Primary Building	Single Family	
Style of Primary Blg	Cape Cod			
Number of Stories	1.5	Width (bays)	4	
Foundation Material	Cinderblock	Depth (rooms)	2	
Year Built	1949	Wall Cladding Material	Brick	
Roof Shape	Side gable	Roof Material	Composition shingle	
Decorative Details/Unique Features	Front porch has white picket fence. Dark blue shutters on front windows. Front gable on front right side of house. Awnings over windows on left side of the house.			
Evidence of Integrity Location/Materials	Original brick siding, possibly original windows.			
Additions/Alterations to Primary Building	New roof.			
Condition of Primary Building	Excellent		code	
			E

Observable Threats	None			
Compatibility with Adjacent Land Uses	Good			
Potential NR Eligibility	Contributing		code	
			C	
Other Comments / Salient Details	Cement path and stairs leading to front porch. Chimne on left end of house. Cement driveway along left side of house leading to detached garage. Small bushes along front of house, large tree on front right side of property.			
Photo Views				
1 Front view	2 3/4 view	3	4

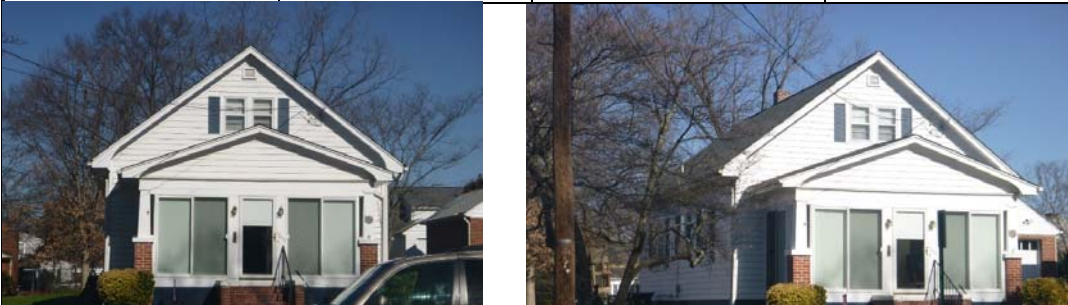
Name of Surveyors	Kimberly Packett		Survey Date	2/28/2016
ADDRESS	Street		Number	
	Dandridge	Street	1233	
TYPE & NUMBER OF BLGS & STRUCTURES	Type		Number	
	Single Family House		1	
	Detatched Garage		1	
Current Use of Primary Building	Single Family	Historic Use of Primary Building	Single Family	
Style of Primary Blg	Bungalow			
Number of Stories	1.5	Width (bays)	3	
Foundation Material	Concrete	Depth (rooms)	2	
Year Built	1940	Wall Cladding Material	Hardboard siding	
Roof Shape	Front gable	Roof Material	Composition shingle	
Decorative Details/Unique Features	Blue shutters on windows. Front gable porch has wood columns with brick bottoms.			
Evidence of Integrity Location/Materials	Possibly original windows and siding.			
Additions/Alterations to Primary Building	Front porch has been screened in. New roof.			
Condition of Primary Building	Good		code	
			G	
Observable Threats	None			
Compatibility with Adjacent Land Uses	Good

Potential NR Eligibility	Non-Contributing		code	
			N	
Other Comments / Salient Details	Cement path and brick stairs with iron railing leading to front porch. Cement driveway on right side of property leading to detatched garage. Central chimney.			
Photo Views				
1 Front view	2 3/4 view	3	4

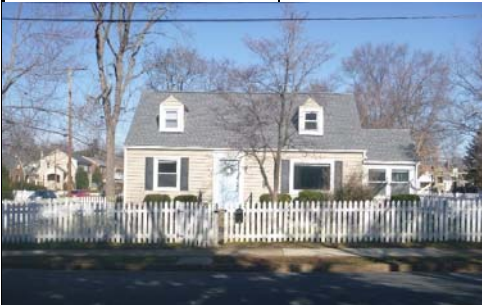
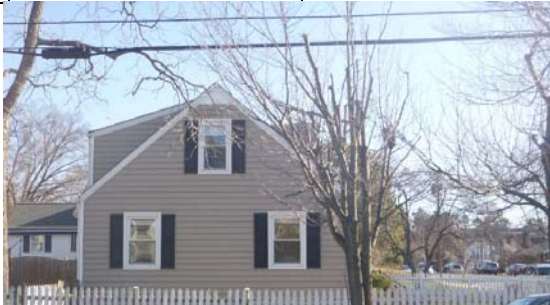
Name of Surveyors	Kimberly Packett		Survey Date	2/28/2016
ADDRESS	Street		Number	
	Dandridge	Street	1235	
TYPE & NUMBER OF BLGS & STRUCTURES	Type		Number	
	Single Family House		1	
Current Use of Primary Building	Single Family	Historic Use of Primary Building	Single family	
Style of Primary Bldg	Cape Cod			
Number of Stories	1.5	Width (bays)	3	
Foundation Material	Cinderblock	Depth (rooms)	2	
Year Built	1949	Wall Cladding Material	Vinyl siding	
Roof Shape	Side gable	Roof Material	Composition shingle	
Decorative Details/Unique Features	Two front gable dormers on front of house. Extended dormer on back of house. White surround around front door and windows. Blue shutters on windows.			
Evidence of Integrity Location/Materials	None.			
Additions/Alterations to Primary Building	New windows, roof, and siding. Screened in porch on right side.			
Condition of Primary Building	Excellent		code	
			E	
Observable Threats	None

Compatibility with Adjacent Land Uses	Good			
Potential NR Eligibility	Contributing		code	
			C	
Other Comments / Salient Details	White picket fence around property. Cement path and brick stairs with iron railing leading to front door. Bushes along front of house.			
Photo Views				
1 Front view	2 Side view	3	4

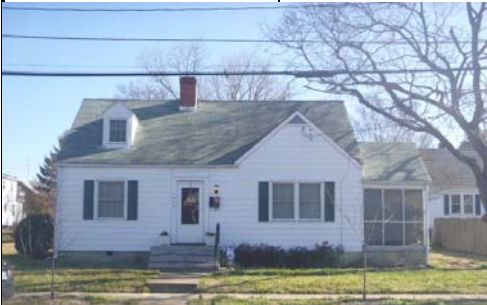
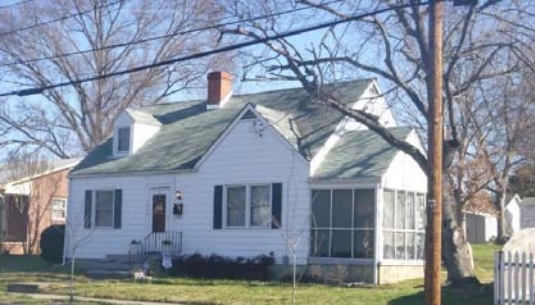
Name of Surveyors	Kimberly Packett		Survey Date	2/28/2016
ADDRESS	Street		Number	
	Augustine	Avenue	1405	
TYPE & NUMBER OF BLGS & STRUCTURES	Type		Number	
	Single Family House		1	
Current Use of Primary Building	Single Family	Historic Use of Primary Building	Single Family	
Style of Primary Bldg	Cape Cod			
Number of Stories	1.5	Width (bays)	3	
Foundation Material	Cinderblock	Depth (rooms)	2	
Year Built	1949	Wall Cladding Material	Aluminum siding	
Roof Shape	Side gable	Roof Material	Composition shingles	
Decorative Details/Unique Features	Front gable on right side of house. White surround around front door. Bottom front windows have blue shutters. Front gable dormer on front of house.			
Evidence of Integrity Location/Materials	Appears to be original siding and windows.			
Additions/Alterations to Primary Building	New roof. Screened in porch on right side.			
Condition of Primary Building	Fair		code	
			F

Observable Threats	None			
Compatibility with Adjacent Land Uses	Good			
Potential NR Eligibility	Contributing		code	
			C	
Other Comments / Salient Details	Cement path and stairs with iron railing leading to front door. Screened in porch on right side. Central chimney.			
Photo Views				
1 Front view	2 3/4 view	3	4

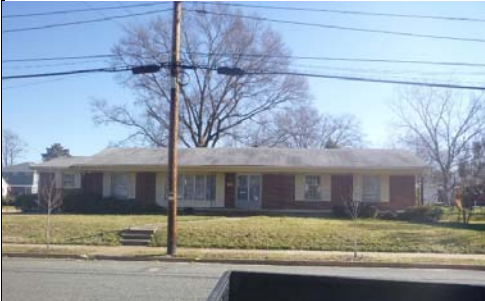
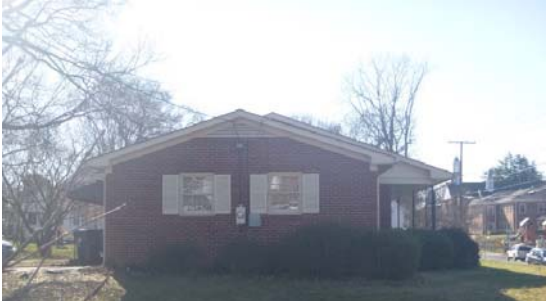
Name of Surveyors	Kimberly Packett		Survey Date	2/28/2016
ADDRESS	Street		Number	
	Augustine	Avenue	1415	
TYPE & NUMBER OF BLGS & STRUCTURES	Type		Number	
	Single Family House		1	
Current Use of Primary Building	Single Family	Historic Use of Primary Building	Single Family	
Style of Primary Bldg	Ranch			
Number of Stories	1	Width (bays)	6	
Foundation Material	Cinderblock	Depth (rooms)	2	
Year Built	1963	Wall Cladding Material	Brick	
Roof Shape	Side gable	Roof Material	Composition shingle	
Decorative Details/Unique Features	Tan shutters on windows. Double front doors.			
Evidence of Integrity Location/Materials	Original brick siding and appears to be original windows.			
Additions/Alterations to Primary Building	Attached garage on left side of house was renovated into a livable space.			
Condition of Primary Building	Fair		code	F
Observable Threats	None			
Compatibility with Adjacent Land Uses	Good			
Potential NR Eligibility	Contributing		code	C

Other Comments / Salient Details	Cement stairs and path leading to cement front porch. Roof extends over porch supported by black metal columns. Paved driveway in backyard. Back door.			
Photo Views				
1 Front view	2 Side view	3	4

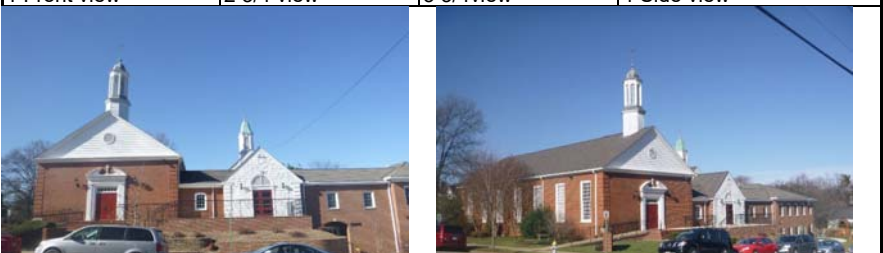
Name of Surveyors	Kimberly Packett		Survey Date	2/21/2016
ADDRESS	Street		Number	
	Augustine Avenue		1300	
TYPE & NUMBER OF BLGS & STRUCTURES	Type		Number	
	Church		1	
	Shed		1	
	Building (Office)		1	
Current Use of Primary Building	Religious	Historic Use of Primary Building	Religious	
Style of Primary Bldg	Christian Church			
Number of Stories	2	Width (bays)	1	
Foundation Material	Concrete	Depth (rooms)	6	
Year Built	1970	Wall Cladding Material	Brick	
Roof Shape	Front Gable	Roof Material	Composition shingles	
Decorative Details/Unique Features	White painted wood shingles on the front, red double door, wooden bell tower with copper roof and cross, wood shingle siding on front gable. Front door has white pilasters and broken triangle pediment.			
Evidence of Integrity Location/Materials	Original windows and doors with storm windows. Original wood siding.			
Additions/Alterations to Primary Building	Larger sanctuary constructed to the left, connects to the house on the right (now an office), additional building constructed in the back. New roof.

Condition of Primary Building	Excellent		code	
			E	
Observable Threats	None			
Compatibility with Adjacent Land Uses	Good			
Potential NR Eligibility	Non-Contributing		code	
			N	
Other Comments / Salient Details	Larger sanctuary constructed to the left; 1 story, 1 bay, 7 rooms, brick foundation, wood framed structural system, brick wall cladding, front gable roof, composite shingles, top half of the front white aluminum, broken segmental pediment with cross in the center, octagonal bell tower with copper roof and cross; original windows, large fenced in playground to right the right, asphalt parking lot behind playground. House/Office- 4 bays, 2 stories. Decoration- raised brick under second story windows, side-gable roof with composition shingles, side chimneys, concrete steps with black iron rail. Connection between House/Office and main building- archway with concrete sidewalk. Addition to main house- located in the back, brick exterior, modern pediment porch with square columns, gable roof.

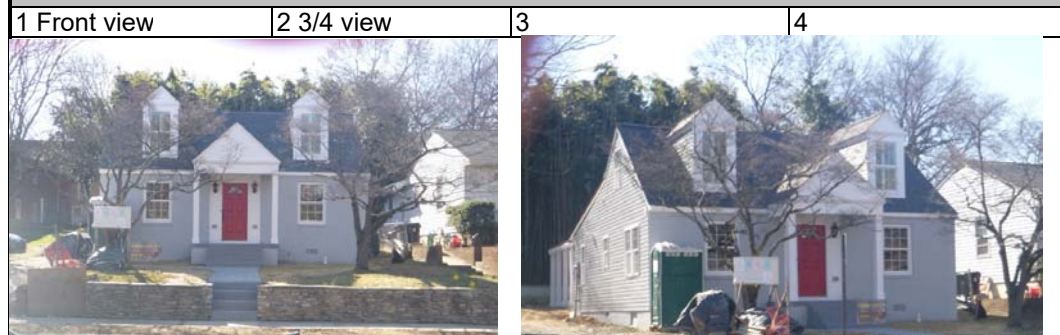
Name of Surveyors	Kimberly Packett		Survey Date	2/21/2016
ADDRESS	Street		Number	
	Dandridge	Street	1308	
TYPE & NUMBER OF BLGS & STRUCTURES	Type		Number	
	Single Family House		1	
Current Use of Primary Building	Single Family	Historic Use of Primary Building	Single Family	
Style of Primary Bldg	Cape cod			
Number of Stories	1.5	Width (bays)	3	
Foundation Material	Cinderblock	Depth (rooms)	2	
Year Built	1944	Wall Cladding Material	Vinyl siding	
Roof Shape	Side Gable	Roof Material	Composition shingles	
Decorative Details/Unique Features	Front dormer portico porch over front door with two white columns. Two front gable dormers on front of roof. White surround around front door. Front façade of house is painted brick.			
Evidence of Integrity Location/Materials	Brick façade is possibly original.			
Additions/Alterations to Primary Building	Small addition to the back left of the house. New roof, siding, and windows.

Condition of Primary Building	Excellent		code	
			E	
Observable Threats	None			
Compatibility with Adjacent Land Uses	Good			
Potential NR Eligibility	Contributing		code	
			C	
Other Comments / Salient Details	Stone retaining wall on the front of the property. House is currently undergoing renovation. Brick stairs and path leading to front porch. Gravel driveway on left side of the house.

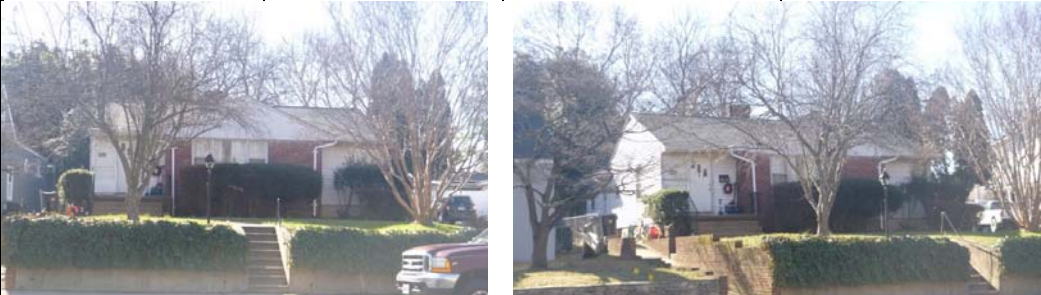
Name of Surveyors	Kimberly Packett		Survey Date	2/21/2016
ADDRESS	Street		Number	
	Dandridge	Street	1314	
TYPE & NUMBER OF BLGS & STRUCTURES	Type		Number	
	Single Family House		1	
Current Use of Primary Building	Single Family	Historic Use of Primary Building	Single Family	
Style of Primary Blg	Minimal Traditional			
Number of Stories	1	Width (bays)	3	
Foundation Material	Cinderblock	Depth (rooms)	4	
Year Built	1963	Wall Cladding Material	Aluminum siding	
Roof Shape	Cross gable	Roof Material	Composition shingle	
Decorative Details/Unique Features	Front gable with some kind of boarding. Brick front façade on the middle of the building.			
Evidence of Integrity Location/Materials	Original siding and possibly original windows.			
Additions/Alterations to Primary Building	New roof			
Condition of Primary Building	Good		code	
			G	
Observable Threats	None			
Compatibility with Adjacent Land Uses	Good			
Potential NR Eligibility	Contributing		code

C	
Other Comments / Salient Details	Concrete retaining wall in the front of the property, brick retaining wall on right side of property. Central chimney. Iron lamppost in front yard. Cement stairs and path with iron railing leading to front door. Bushes along front of house. Cement retaining wall is covered in ivy.			
Photo Views				
1 Front view	2 3/4 view	3	4

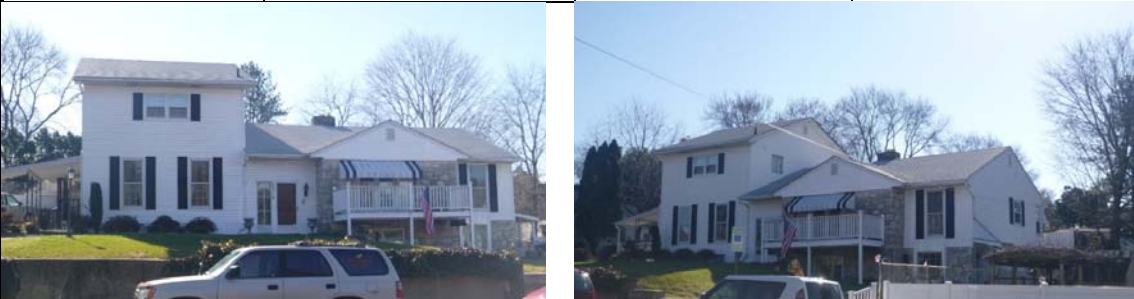
Name of Surveyors	Kimberly Packett		Survey Date	2/21/2016
ADDRESS	Street		Number	
	Dandridge	Street	1318	
TYPE & NUMBER OF BLGS & STRUCTURES	Type		Number	
	Multi-family House		1	
Current Use of Primary Building	Multi Family	Historic Use of Primary Building	Single Family	
Style of Primary Blg	Split Level			
Number of Stories	3	Width (bays)	5	
Foundation Material	Cinderblock	Depth (rooms)	3	
Year Built	1949	Wall Cladding Material	Vinyl siding	
Roof Shape	Side gable	Roof Material	Composition shingles	
Decorative Details/Unique Features	Decorative stone siding, glass screened front entrance, two side entrances at entry level, one entrance on second floor, dark blue shutters on windows, front balcony covered by awning, double doors and sidelights leading out to balcony.			
Evidence of Integrity Location/Materials	None			
Additions/Alterations to Primary Building	One huge addition to back, covered walkway connecting addition to primary. New roof, siding, and windows.

Condition of Primary Building	Good		code	
			G	
Observable Threats	None			
Compatibility with Adjacent Land Uses	Not compatible with surrounding styles.			
Potential NR Eligibility	Non-Contributing		code	
			N	
Other Comments / Salient Details	Poured concrete and decorative stone retaining wall in front, white painted cinder block wall along driveway, stairs to second story are latticed, cinder block fence with lattice and wooden gate, brick wall along poured concrete walk to right side entrance, central chimney, lamppost in yard. Ivy covering cement retaining wall.			
Photo Views				
1 Front view	2 3/4 view	3 3/4 view	4

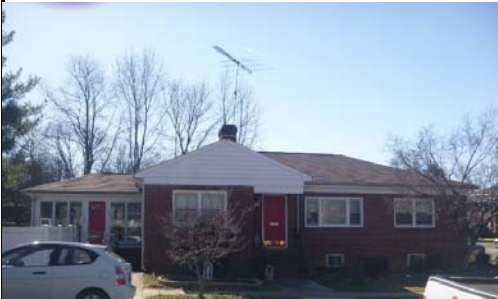
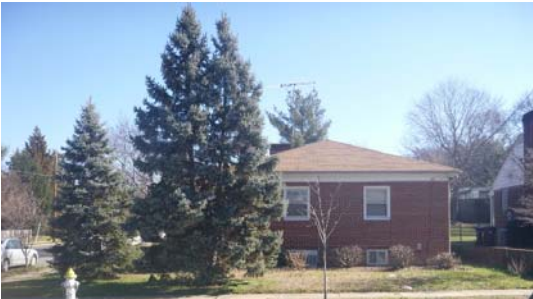
Name of Surveyors	Kimberly Packett		Survey Date	2/28/2016
ADDRESS	Street		Number	
	Dandridge	Street	1324	
TYPE & NUMBER OF BLGS & STRUCTURES	Type		Number	
	Single Family House		1	
Current Use of Primary Building	Single Family	Historic Use of Primary Building	Single Family	
Style of Primary Bldg	Minimal Traditional			
Number of Stories	1.5	Width (bays)	7	
Foundation Material	Cinderblock	Depth (rooms)	2	
Year Built	1954	Wall Cladding Material	Brick	
Roof Shape	Hip	Roof Material	Composition shingle	
Decorative Details/Unique Features	White siding on front gable on the front left side of the house. Roof hangs over porch supported by black metal column.			
Evidence of Integrity Location/Materials	Appears to be original windows, original siding.			
Additions/Alterations to Primary Building	New roof. Screened in porch on back left side of the house.			
Condition of Primary Building	Good		code	
			G	
Observable Threats	None

Compatibility with Adjacent Land Uses	Good			
Potential NR Eligibility	Contributing		code	
			C	
Other Comments / Salient Details	Cement path and brick stairs with iron railing leading to front door. White fence around backyard. Central chimney.			
Photo Views				
1 Front view	2 Side view	3	4

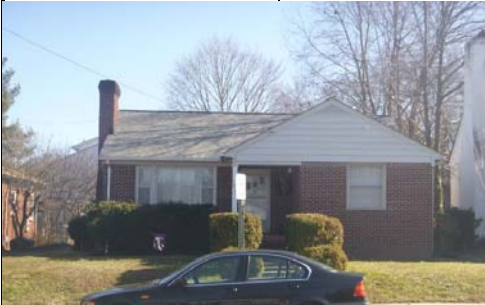
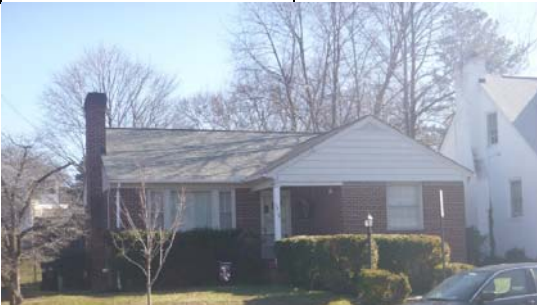
Name of Surveyors	Kimberly Packett		Survey Date	2/28/2016
ADDRESS	Street		Number	
	Stafford	Avenue	1313	
TYPE & NUMBER OF BLGS & STRUCTURES	Type		Number	
	Single Family House		1	
Current Use of Primary Building	Single Family	Historic Use of Primary Building	Single Family	
Style of Primary Bldg	Minimal Traditional			
Number of Stories	1	Width (bays)	3	
Foundation Material	Cinderblock	Depth (rooms)	2	
Year Built	1952	Wall Cladding Material	Brick	
Roof Shape	Side gable	Roof Material	Composition shingle	
Decorative Details/Unique Features	Front gable on right side of the house with white siding. Gable overhangs above landing supported by white column.			
Evidence of Integrity Location/Materials	Original siding, appears to be original windows.			
Additions/Alterations to Primary Building	New roof.			
Condition of Primary Building	Fair	code		
		F		
Observable Threats	None			
Compatibility with Adjacent Land Uses	Good

Potential NR Eligibility	Contributing	code		
		C		
Other Comments / Salient Details	Bushes along path and front of house. Lamppost in front yard. Cement path and brick stairs leading to front door landing. Chimney on left end of house.			
Photo Views				
1 Front view	2 3/4 view	3	4

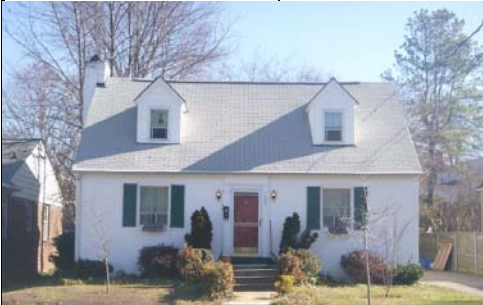
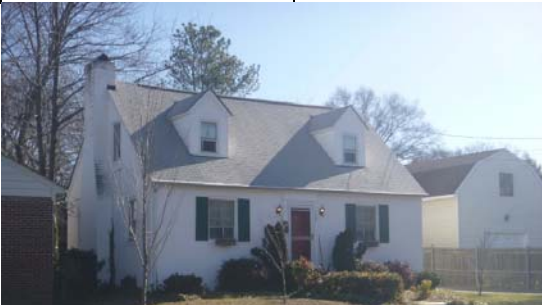
Name of Surveyors	Kimberly Packett		Survey Date	2/28/2016
ADDRESS	Street		Number	
	Stafford	Avenue	1309	
TYPE & NUMBER OF BLGS & STRUCTURES	Type		Number	
	Single Family House		1	
Current Use of Primary Building	Single Family	Historic Use of Primary Building	Single Family	
Style of Primary Bldg	Cape Cod			
Number of Stories	1.5	Width (bays)	3	
Foundation Material	Cinderblock	Depth (rooms)	2	
Year Built	1949	Wall Cladding Material	Brick	
Roof Shape	Side gable	Roof Material	Composition shingle	
Decorative Details/Unique Features	Brick siding is painted white. Two front gable dormers on front of house. Dark green shutters on first story front windows. White surround around front door.			
Evidence of Integrity Location/Materials	Original brick siding. Appears to be original windows.			
Additions/Alterations to Primary Building	New roof.			
Condition of Primary Building	Good		code	
			G	
Observable Threats	None

Compatibility with Adjacent Land Uses	Good			
Potential NR Eligibility	Contributing		code	
			C	
Other Comments / Salient Details	Cement path and brick stairs with iron railing leading to front door. Bushes line the path and front of house. Paved driveway along right side of house. Chimney on left end of house.			
Photo Views				
1 Front view	2 3/4 view	3	4

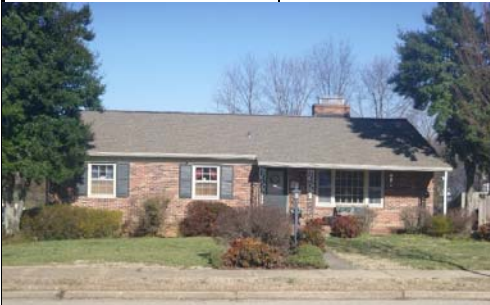
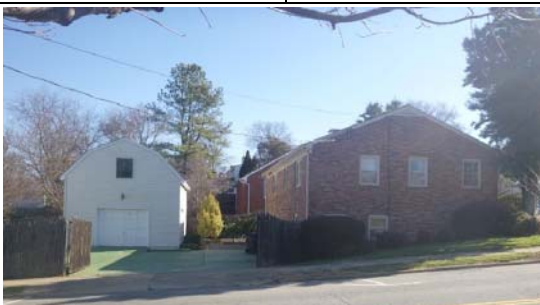
Name of Surveyors	Kimberly Packett		Survey Date	2/28/2016
ADDRESS	Street		Number	
	Brent	Street	1329	
TYPE & NUMBER OF BLGS & STRUCTURES	Type		Number	
	Single Family House		1	
	Detatched Garage		1	
Current Use of Primary Building	Single Family	Historic Use of Primary Building	Single Family	
Style of Primary Blg	Ranch			
Number of Stories	1.5	Width (bays)	3	
Foundation Material	Cinderblock	Depth (rooms)	3	
Year Built	1964	Wall Cladding Material	Brick	
Roof Shape	Side gable	Roof Material	Composition gable	
Decorative Details/Unique Features	Two story detached barn style garage. Roof overhangs right front part of house, supported by metal columns. Dark blue shutters on front left windows.			
Evidence of Integrity Location/Materials	Original brick siding. Appears to be original windows.			
Additions/Alterations to Primary Building	New roof.			
Condition of Primary Building	Excellent		code	
			E	
Observable Threats	None

Compatibility with Adjacent Land Uses	Good			
Potential NR Eligibility	Contributing		code	
			C	
Other Comments / Salient Details	Wood privacy fence around the backyard. Cement path leading to brick landing in front of front door. Bushes along path and front of house. Interior chimney on right side of house. Back door.			
Photo Views				
1 Front view	2 Side view	3	4

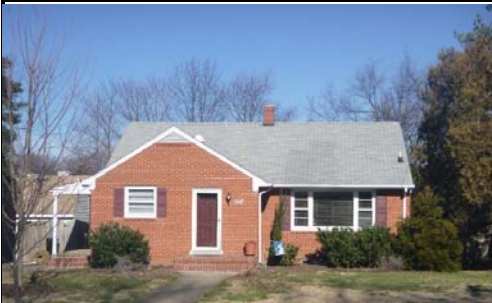
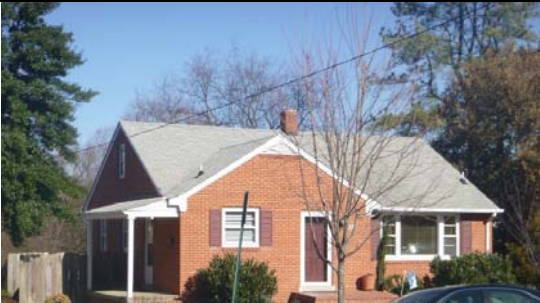
Name of Surveyors	Kimberly Packett		Survey Date	2/28/2016
ADDRESS	Street		Number	
	Brent	Street	1325	
TYPE & NUMBER OF BLGS & STRUCTURES	Type		Number	
	Single Family House		1	
Current Use of Primary Building	Single Family	Historic Use of Primary Building	Single Family	
Style of Primary Bldg	Minimal Traditional			
Number of Stories	1	Width (bays)	3	
Foundation Material	Cinderblock	Depth (rooms)	3	
Year Built	1964	Wall Cladding Material	Brick	
Roof Shape	Side gable	Roof Material	Composition shingle	
Decorative Details/Unique Features	White surround around front door and windows. Maroon shutters on front windows that match front door.			
Evidence of Integrity Location/Materials	Original brick siding.			
Additions/Alterations to Primary Building	New roof and windows.			
Condition of Primary Building	Good	code		
		G		
Observable Threats	None			
Compatibility with Adjacent Land Uses	Good			
Potential NR Eligibility	Contributing	code

C		
Other Comments / Salient Details	Central chimney. Cement path and brick stairs leading to front door. Cement path and brick steps leading to brick landing at side door. Shed roof overhang over side door with white columns. Bushes along front of house. Wood privacy fence around backyard.			
Photo Views				
1 Front view	2 3/4 view	3	4

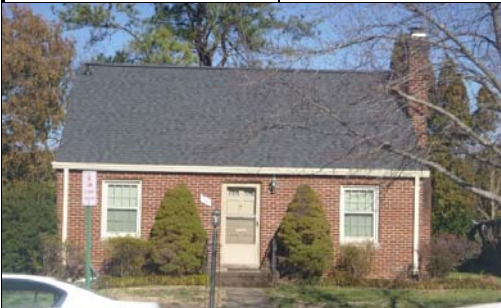
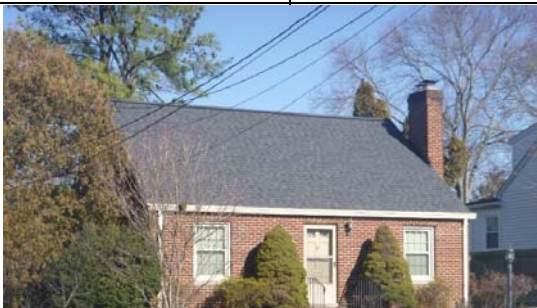
Name of Surveyors	Kimberly Packett		Survey Date	2/21/2016
ADDRESS	Street		Number	
	Brent	Street	1321	
TYPE & NUMBER OF BLGS & STRUCTURES	Type		Number	
	Single Family House		1	
	Shed		1	
Current Use of Primary Building	Single Family	Historic Use of Primary Building	Single Family	
Style of Primary Bldg	Cape Cod			
Number of Stories	1.5	Width (bays)	3	
Foundation Material	Concrete	Depth (rooms)	2	
Year Built	1953	Wall Cladding Material	Brick	
Roof Shape	Side Gable	Roof Material	Composition shingles	
Decorative Details/Unique Features	Tan front door and windows.			
Evidence of Integrity Location/Materials	Original brick siding.			
Additions/Alterations to Primary Building	New windows and roof.			
Condition of Primary Building	Good		code	
			G	
Observable Threats	None			
Compatibility with Adjacent Land Uses	Good			
Potential NR Eligibility	Contributing		code	
			C	
Other Comments / Salient Details	Chimney on right end of house. Bushes and trees along front of house. Cement path and brick stairs leading to front door. Lamppost in front yard.

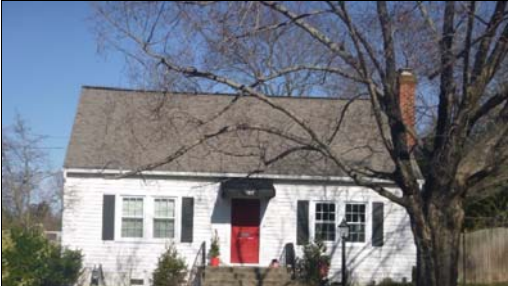
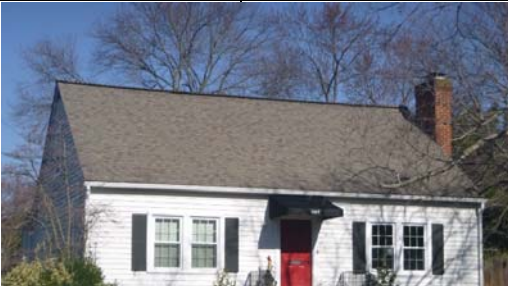
Name of Surveyors	Kimberly Packett		Survey Date	2/21/2016
ADDRESS	Street		Number	
	Brent	Street	1317	
TYPE & NUMBER OF BLGS & STRUCTURES	Type		Number	
	Single Family House		1	
	Gazebo		1	
	Shed		1	
Current Use of Primary Building	Single Family	Historic Use of Primary Building	Single Family	
Style of Primary Bldg	Cape Cod			
Number of Stories	1 1/2	Width (bays)	3	
Foundation Material	Cinderblock	Depth (rooms)	3	
Year Built	1951	Wall Cladding Material	Vinyl Siding	
Roof Shape	Side gable	Roof Material	Composition shingles	
Decorative Details/Unique Features	Black awning over front entrance. Black shutters on front windows. White surround around door and windows.			
Evidence of Integrity Location/Materials	None			
Additions/Alterations to Primary Building	Addition on the back of the house. New siding, windows, and roof.			
Condition of Primary Building	Good	code		
		G		
Observable Threats	None			
Compatibility with Adjacent Land Uses	Good

Potential NR Eligibility	Contributing	code		
		C		
Other Comments / Salient Details	Chimney on right side of the house. Paved driveway on left side of the house. Wood privacy fence around backyard. Cement path and stairs with iron railing leading to front door. Lamppost in front yard.			
Photo Views				
1 Front view	2 3/4 view	3	4

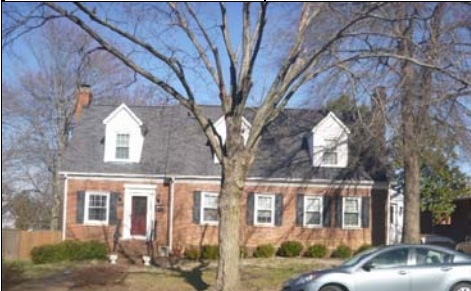
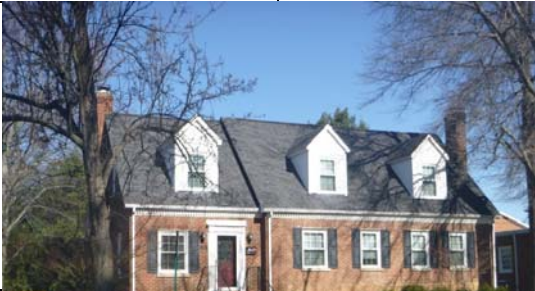
Name of Surveyors	Kimberly Packett		Survey Date	2/21/2016
ADDRESS	Street		Number	
	Brent	Street	1309	
TYPE & NUMBER OF BLGS & STRUCTURES	Type		Number	
	Single Family House		1	
Current Use of Primary Building	Single Family	Historic Use of Primary Building	Single Family	
Style of Primary Bldg	Neo-colonial			
Number of Stories	1.5	Width (bays)	6	
Foundation Material	Concrete	Depth (rooms)	3	
Year Built	1959	Wall Cladding Material	Brick	
Roof Shape	Side Gable	Roof Material	Composition shingles	
Decorative Details/Unique Features	Three front gable dormers on front of house. Cornice with dentils along front of house. White surround around door and windows. Pilasters and crosshead around front door. Black shutters on front windows.			
Evidence of Integrity Location/Materials	Original brick siding.			
Additions/Alterations to Primary Building	Addition on the back of the house, new windows, and roof.			
Condition of Primary Building	Excellent		code

E	
Observable Threats	None			
Compatibility with Adjacent Land Uses	Good			
Potential NR Eligibility	Contributing		code	
			C	
Other Comments / Salient Details	Wood privacy fence around backyard. Brick path and stairs with iron railing leading to front door. Bushes along front of house. Chimneys on either ends of house.			
Photo Views				
1 Front view	2 3/4 view	3	4

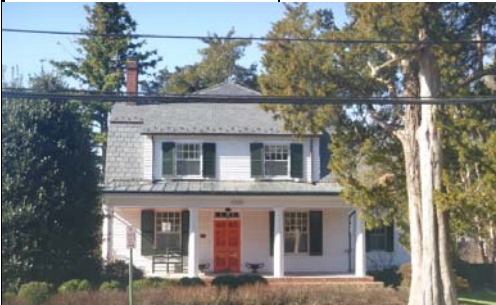
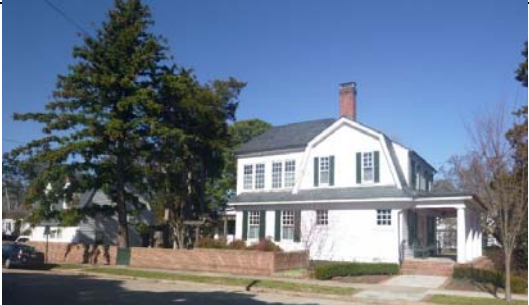
Name of Surveyors	Kimberly Packett		Survey Date	2/28/2016
ADDRESS	Street		Number	
	College	Avenue	1300	
TYPE & NUMBER OF BLGS & STRUCTURES	Type		Number	
	Single Family House		1	
	Detatched Garage		1	
Current Use of Primary Building	Single Family	Historic Use of Primary Building	Single Family	
Style of Primary Blg	Dutch Colonial			
Number of Stories	2	Width (bays)	4	
Foundation Material	Concrete	Depth (rooms)	4	
Year Built	1915	Wall Cladding Material	Hardboard siding	
Roof Shape	Gambrel	Roof Material	Slate	
Decorative Details/Unique Features	Black shutters on some of the windows. Red front door with transom. Meta hip roof overhang above front porch with white columns.			
Evidence of Integrity Location/Materials	Possibly original windows on main section of house.			
Additions/Alterations to Primary Building	Addition on back of house. New roof and siding.			
Condition of Primary Building	Excellent		code	
			E

Observable Threats	Growth of UMW			
Compatibility with Adjacent Land Uses	Good			
Potential NR Eligibility	Non-Contributing		code	
			N	
Other Comments / Salient Details	Cement path lined with bushes leading to front porch. Chimney on left end of main house and back end of addition. Short brick wall around backyard. Paved driveway in backyard. Hallway connection main house to addition. Addition has gambrel roof and two front gable dormers. Addition has exterior door near driveway.			
Photo Views				
1 Front view	2 3/4 view	3 Side view	4

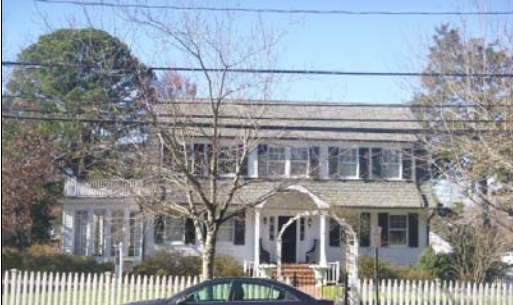
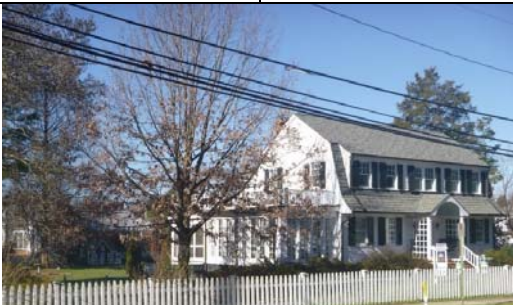
Name of Surveyors	Kimberly Packett		Survey Date	2/28/2016
ADDRESS	Street		Number	
	College	Avenue	1314	
TYPE & NUMBER OF BLGS & STRUCTURES	Type		Number	
	Single Family House		1	
	Shed		1	
	Guest House?		1	
Current Use of Primary Building	Single Family	Historic Use of Primary Building	Single Family	
Style of Primary Bldg	Dutch colonial			
Number of Stories	2	Width (bays)	5	
Foundation Material	Concrete	Depth (rooms)	4	
Year Built	1904	Wall Cladding Material	Hardboard siding	
Roof Shape	Gambrel	Roof Material	Composition shingle	
Decorative Details/Unique Features	Front gable poritco over front door with checkered pattern walls. Front door has sidelights. Black shutters on windows.			
Evidence of Integrity Location/Materials	None			
Additions/Alterations to Primary Building	Addition on back of house. New roof, siding, and windows.			
Condition of Primary Building	Excellent		code	
			E	
Observable Threats	Growth of UMW

Compatibility with Adjacent Land Uses	Good			
Potential NR Eligibility	Non-Contributing		code	
			N	
Other Comments / Salient Details	White picket fence around property. White archway above brick path and stairs leading to brick front porch. Sunroom on left side of house with flat roof and white iron railing. Driveway on back right side of property leading to possible guest house. Back door and garden. Bushes along base of house			
Photo Views				
1 Front view	2 3/4 view	3 Side view	4 Rear 3/4 view

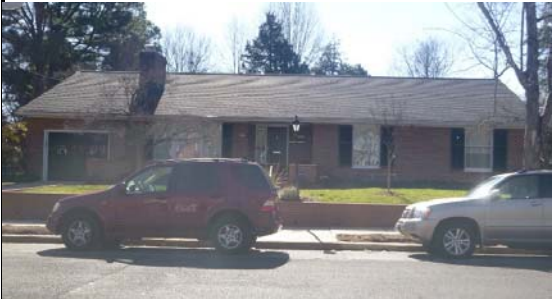
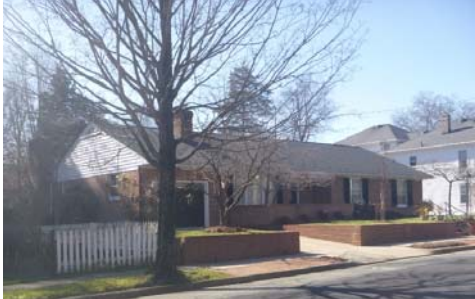
Name of Surveyors	Kimberly Packett		Survey Date	2/28/2016
ADDRESS	Street		Number	
	Dandridge	Street	1212	
TYPE & NUMBER OF BLGS & STRUCTURES	Type		Number	
	Single Family House		1	
Current Use of Primary Building	Single Family	Historic Use of Primary Building	Single Family	
Style of Primary Bldg	Ranch			
Number of Stories	1	Width (bays)	5	
Foundation Material	Concrete	Depth (rooms)	2	
Year Built	1958	Wall Cladding Material	Brick	
Roof Shape	Side gable	Roof Material	Asbestos shingle	
Decorative Details/Unique Features	Blue shutters on front windows. Sidelight on left side of the front door. White siding on gable ends.			
Evidence of Integrity Location/Materials	Original brick siding, roof, and windows.			
Additions/Alterations to Primary Building	Deck on back of house.			
Condition of Primary Building	Good		code	
			G	
Observable Threats	None			
Compatibility with Adjacent Land Uses	Good			
Potential NR Eligibility	Contributing		code

C	
Other Comments / Salient Details	Attached garage on left side of house. Brick retaining wall along property line. Cement driveway leading to attached garage. Cement path and stairs with iron railing leading to front door. Short brick wall along path leading from driveway to front door. Interior chimney on left side of the house. Lamppost on front lawn.			
Photo Views				
1 Front view	2 3/4 view	3	4

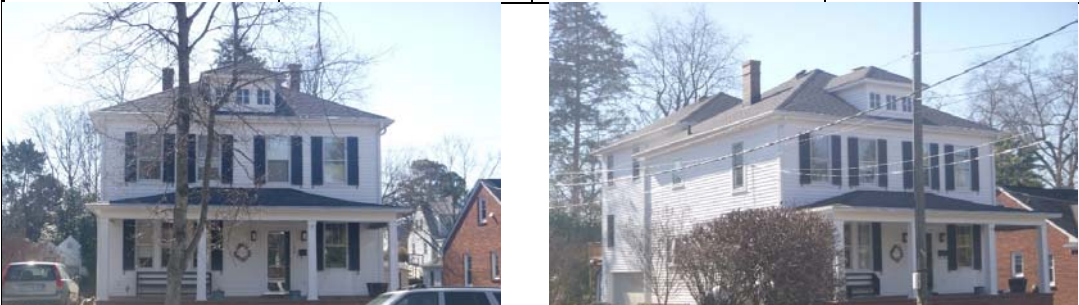
Name of Surveyors	Kimberly Packett		Survey Date	2/28/2016
ADDRESS	Street		Number	
	Dandridge	Street	1220	
TYPE & NUMBER OF BLGS & STRUCTURES	Type		Number	
	Single Family House		1	
Current Use of Primary Building	Single Family	Historic Use of Primary Building	Single Family	
Style of Primary Bldg	Craftsman			
Number of Stories	2	Width (bays)	4	
Foundation Material	Concrete	Depth (rooms)	3	
Year Built	1929	Wall Cladding Material	Hardboard siding	
Roof Shape	Hip	Roof Material	Composition Shingle	
Decorative Details/Unique Features	Dark blue shutters on front windows. Hip gable dormer with three small windows at top of front of house. Hip roof over front porch with white columns. White surround around front door.			
Evidence of Integrity Location/Materials	None			
Additions/Alterations to Primary Building	Addition on back of house. New roof, siding, and windows.			
Condition of Primary Building	Excellent			code

E
Observable Threats	None			
Compatibility with Adjacent Land Uses	Good			
Potential NR Eligibility	Non-Contributing			code
				N
Other Comments / Salient Details	Two interior chimneys. Cement driveway on left side of house. Cement path leading to brick steps and brick front porch. Attached garage at back of house.			
Photo Views				
1 Front view	2 3/4 view	3	4

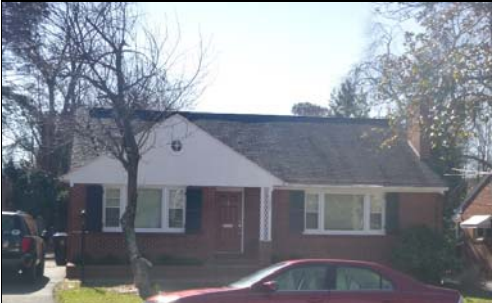
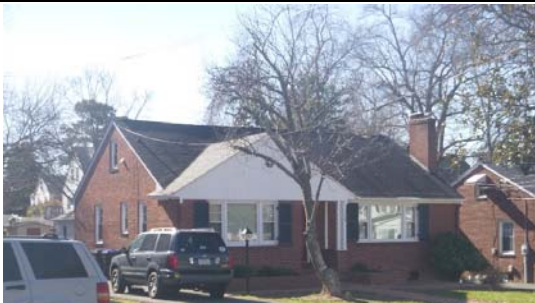
Name of Surveyors	Kimberly Packett		Survey Date	2/28/2016
ADDRESS	Street		Number	
	Dandridge	Street	1224	
TYPE & NUMBER OF BLGS & STRUCTURES	Type		Number	
	Single Family House		1	
Current Use of Primary Building	Single Family	Historic Use of Primary Building	Single Family	
Style of Primary Bldg	Minimal Traditional			
Number of Stories	1	Width (bays)	3	
Foundation Material	Cinderblock	Depth (rooms)	3	
Year Built	1949	Wall Cladding Material	Brick	
Roof Shape	Side gable	Roof Material	Composition shingle	
Decorative Details/Unique Features	Front gable on left side of house with white wood siding has small circular window. Gable overhangs above front door with brick and white column. Dark blue shutters on front windows.			
Evidence of Integrity Location/Materials	Original brick siding.			
Additions/Alterations to Primary Building	New roof and windows.			
Condition of Primary Building	Good		code	
			G	
Observable Threats	None

Compatibility with Adjacent Land Uses	Good			
Potential NR Eligibility	Contributing		code	
			C	
Other Comments / Salient Details	Chimney on right end of house. Paved driveway on left side of house. Lamppost in front yard. Brick planters along front of house. Cement path from driveway to front door.			
Photo Views				
1 Front view	2 3/4 view	3	4

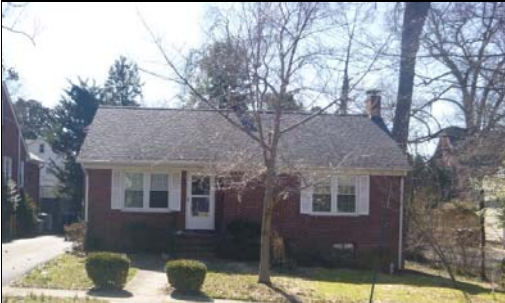
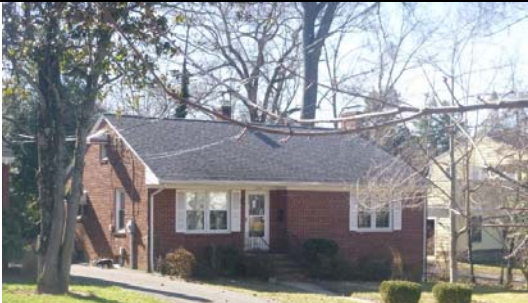
Name of Surveyors	Kimberly Packett		Survey Date	2/28/2016
ADDRESS	Street		Number	
	Dandridge	Street	1228	
TYPE & NUMBER OF BLGS & STRUCTURES	Type		Number	
	Single Family House		1	
Current Use of Primary Building	Single Family	Historic Use of Primary Building	Single Family	
Style of Primary Bldg	Minimal Traditional			
Number of Stories	1.5	Width (bays)	3	
Foundation Material	Cinderblock	Depth (rooms)	2	
Year Built	1958	Wall Cladding Material	Brick	
Roof Shape	Side gable	Roof Material	Composition shingle	
Decorative Details/Unique Features	White shutters on front windows. Roof hangs over front door.			
Evidence of Integrity Location/Materials	Original brick siding and possibly original windows.			
Additions/Alterations to Primary Building	New roof.			
Condition of Primary Building	Good		code	
			G	
Observable Threats	None			
Compatibility with Adjacent Land Uses	Good			
Potential NR Eligibility	Contributing		code

C	
Other Comments / Salient Details	Chimney on right end of house. Bushes along front of house. Paved driveway along left side of house. Cement path and brick stairs with iron railing leading to front door. Wood fence around backyard.			
Photo Views				
1 Front view	2 3/4 view	3	4

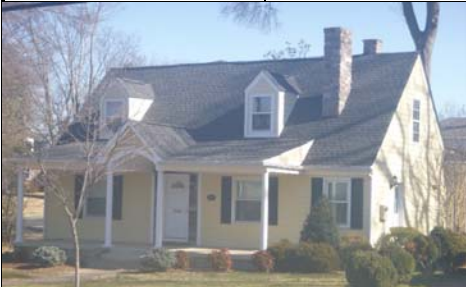
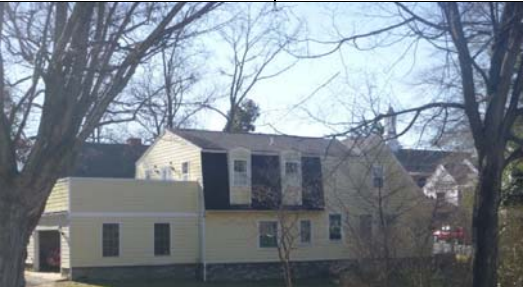
Name of Surveyors	Kimberly Packett		Survey Date	2/28/2016
ADDRESS	Street		Number	
	Augustine Avenue		1319	
TYPE & NUMBER OF BLGS & STRUCTURES	Type		Number	
	Single Family House		1	
Current Use of Primary Building	Single Family	Historic Use of Primary Building	Single Family	
Style of Primary Bldg	Cape Cod			
Number of Stories	2	Width (bays)	4	
Foundation Material	Cinderblock	Depth (rooms)	7	
Year Built	1939	Wall Cladding Material	Hardboard siding	
Roof Shape	Cross gable	Roof Material	Composition shingle	
Decorative Details/Unique Features	Black shutters on front windows. Two front gable dormers on the front of the house. Yellow siding. Decorative stone around front door. Front gable portico over front door that extends with the roof that covers the front porch.			
Evidence of Integrity Location/Materials	None			
Additions/Alterations to Primary Building	Large addition on back of house with front gable roof. Attached garage on back of house with flat roof New roof, siding, and windows.

Condition of Primary Building	Excellent		code	
			E	
Observable Threats	None			
Compatibility with Adjacent Land Uses	Good			
Potential NR Eligibility	Non-Contributing		code	
			N	
Other Comments / Salient Details	Two interior chimneys on right side of original part of house. Brick path leading to cement stairs and front porch. Two dormers on left side of the house with low pitch gable roofs. Gravel driveway leading to attached garage. Side door on right side of house.			
Photo Views				
1 3/4 vie	2 Side view	3	4

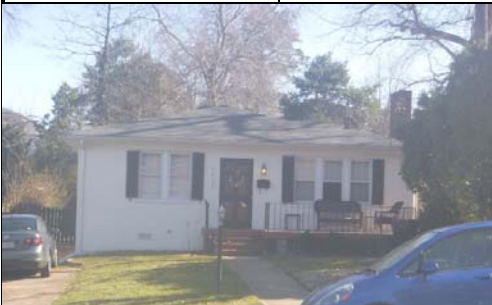
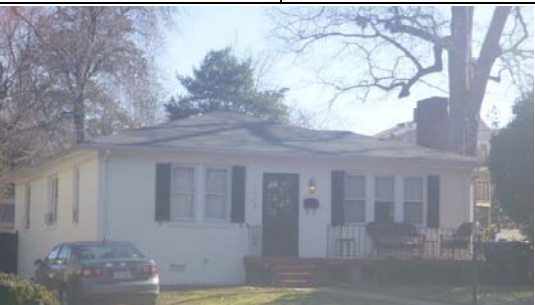
Name of Surveyors	Kimberly Packett		Survey Date	2/28/2016
ADDRESS	Street		Number	
	Augustine	Avenue	1317	
TYPE & NUMBER OF BLGS & STRUCTURES	Type		Number	
	Single Family House		1	
Current Use of Primary Building	Single Family	Historic Use of Primary Building	Single Family	
Style of Primary Bldg	Minimal Traditional			
Number of Stories	1	Width (bays)	3	
Foundation Material	Cinderblock	Depth (rooms)	3	
Year Built	1951	Wall Cladding Material	Brick	
Roof Shape	Hip	Roof Material	Composition shingle	
Decorative Details/Unique Features	Black shutters on windows. Black storm door over front door. Siding is painted white brick.			
Evidence of Integrity Location/Materials	Original brick siding and windows.			
Additions/Alterations to Primary Building	New roof.			
Condition of Primary Building	Fair		code	
			F	
Observable Threats	None			
Compatibility with Adjacent Land Uses	Good			
Potential NR Eligibility	Contributing		code

C	
Other Comments / Salient Details	Chimney on right end of house. Cement path leading to brick stairs and porch with iron railing. Lamppost on front lawn. Brick driveway on left side of the house. Wood fence around backyard.			
Photo Views				
1 Front view	2 3/4 view	3	4
