Cultural Resource Survey of College Heights in Fredericksburg, Virginia

Master of Science

Historic Preservation

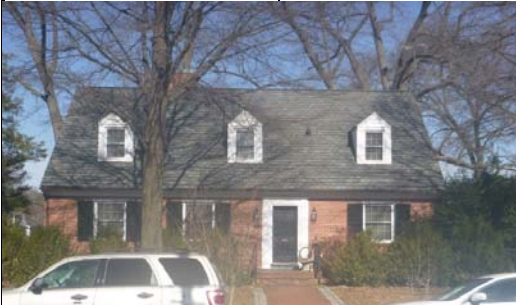
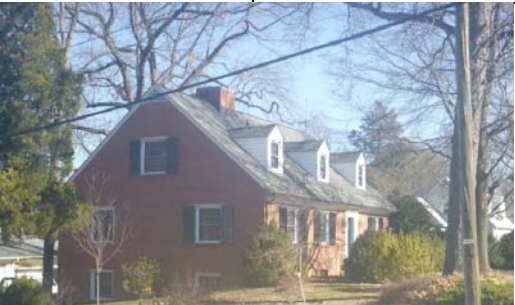
Name of Surveyors	Kimberly Packett		Survey Date	2/28/2016
ADDRESS	Street		Number	
	Brent	Street	1233	
TYPE & NUMBER OF BLGS & STRUCTURES	Type		Number	
	Single Family House		1	
Current Use of Primary Building	Single Family	Historic Use of Primary Building	Single Family	
Style of Primary Bldg	Neo-Colonial			
Number of Stories	2.5	Width (bays)	4	
Foundation Material	Cinderblock	Depth (rooms)	2	
Year Built	1954	Wall Cladding Material	Brick	
Roof Shape	Side gable	Roof Material	Composition shingle	
Decorative Details/Unique Features	Three front gable dormers on front of house with white siding. Dark blue shutters on windows. White surround around front door.			
Evidence of Integrity Location/Materials	Original brick siding and windows.			
Additions/Alterations to Primary Building	New roof.			
Condition of Primary Building	Excellent		code	
			E	
Observable Threats	None			
Compatibility with Adjacent Land Uses	Good

Potential NR Eligibility	Contributing		code	
			C	
Other Comments / Salient Details	Brick path and stairs with iron railing leading to front door. Bushes along front of house. Interior chimney on left side of house.			
Photo Views				
1 Front view	2 3/4 view	3 Side view	4

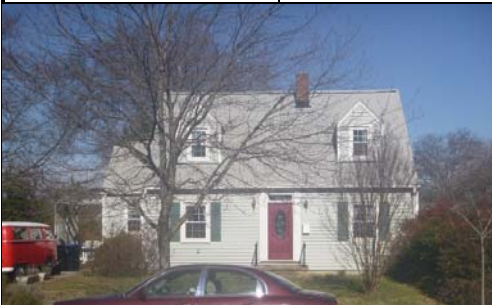
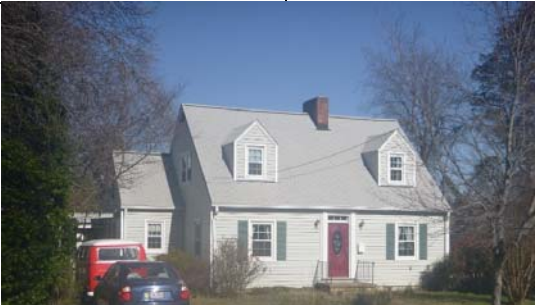
Name of Surveyors	Kimberly Packett		Survey Date	2/28/2016
ADDRESS	Street		Number	
	Brent	Street	1229	
TYPE & NUMBER OF BLGS & STRUCTURES	Type		Number	
	Single Family House		1	
Current Use of Primary Building	Single Family	Historic Use of Primary Building	Single Family	
Style of Primary Bldg	Cape Cod			
Number of Stories	1.5	Width (bays)	4	
Foundation Material	Cinderblock	Depth (rooms)	4	
Year Built	1953	Wall Cladding Material	Vinyl siding	
Roof Shape	Side gable	Roof Material	Composition shingle	
Decorative Details/Unique Features	Two front gable dormers on front of house. Dark green shutters on first story front windows. White surround around windows. Sidelights and transom around front door.			
Evidence of Integrity Location/Materials	Possibly original windows.			
Additions/Alterations to Primary Building	Addition on back left side of house. New siding and roof.			
Condition of Primary Building	Good		code

G	
Observable Threats	None			
Compatibility with Adjacent Land Uses	Good			
Potential NR Eligibility	Contributing		code	
			C	
Other Comments / Salient Details	Central chimney. Carport attached to left side of house. Cement driveway on left side of house leading to carport. Cement path and stairs with iron railing leading to front door.			
Photo Views				
1 Front view	2 3/4 view	3	4

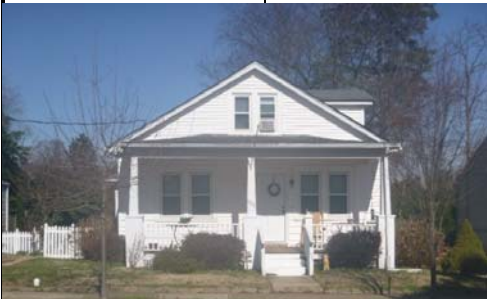
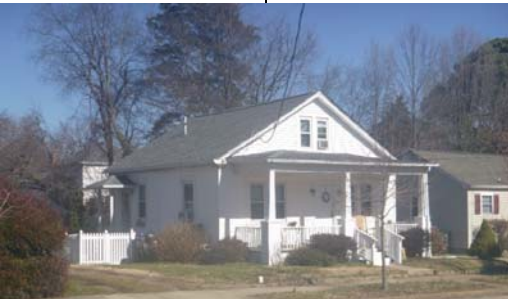
Name of Surveyors	Kimberly Packett		Survey Date	2/28/2016
ADDRESS	Street		Number	
	Brent	Street	1225	
TYPE & NUMBER OF BLGS & STRUCTURES	Type		Number	
	Single Family House		1	
Current Use of Primary Building	Single Family	Historic Use of Primary Building	Single Family	
Style of Primary Blg	Bungalow			
Number of Stories	1.5	Width (bays)	3	
Foundation Material	Concrete	Depth (rooms)	3	
Year Built	1954	Wall Cladding Material	Vinyl siding	
Roof Shape	Side gable	Roof Material	Composition shingle	
Decorative Details/Unique Features	Front gable dormer on right side of the house. White surround around front door and windows. Wood front porch with hip roof. Columns have painted white brick on bottom.			
Evidence of Integrity Location/Materials	Original windows.			
Additions/Alterations to Primary Building	New roof and possibly new siding.			
Condition of Primary Building	Fair		code	
			F	
Observable Threats	None

Compatibility with Adjacent Land Uses	Good			
Potential NR Eligibility	Contributing		code	
			C	
Other Comments / Salient Details	Bushes along front and side of house. White picket fence around backyard. Paved driveway on left side of the house. Side door on left side of the house with hip roof.			
Photo Views				
1 Front view	2 3/4 view	3	4

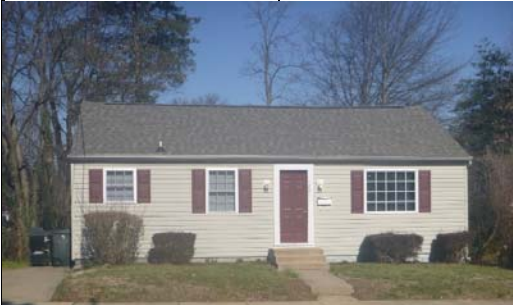
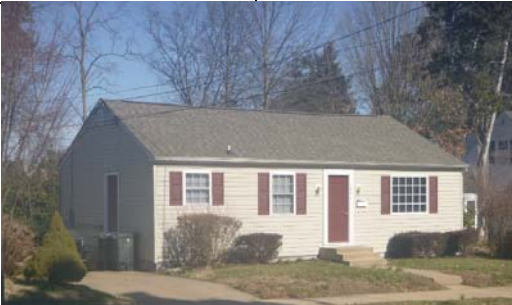
Name of Surveyors	Kimberly Packett		Survey Date	2/28/2016
ADDRESS	Street		Number	
	Brent	Street	1221	
TYPE & NUMBER OF BLGS & STRUCTURES	Type		Number	
	Single Family House		1	
Current Use of Primary Building	Single Family	Historic Use of Primary Building	Single Family	
Style of Primary Bldg	Minimal Traditional			
Number of Stories	1	Width (bays)	4	
Foundation Material	Cinderblock	Depth (rooms)	1	
Year Built	1964	Wall Cladding Material	Vinyl siding	
Roof Shape	Side gable	Roof Material	Composition shingle	
Decorative Details/Unique Features	Red shutters on front windows that match front door and side door. White surround around front door and windows.			
Evidence of Integrity Location/Materials	None.			
Additions/Alterations to Primary Building	New siding, roof, and windows.			
Condition of Primary Building	Excellent		code	
			E	
Observable Threats	None			
Compatibility with Adjacent Land Uses	Good			
Potential NR Eligibility	Contributing		code

C	
Other Comments / Salient Details	Cement path and stairs leading to front door. Cement driveway on left side of the house. Side door on left side of the house. Bushes along front of the house.			
Photo Views				
1 Front view	2 3/4 view	3	4

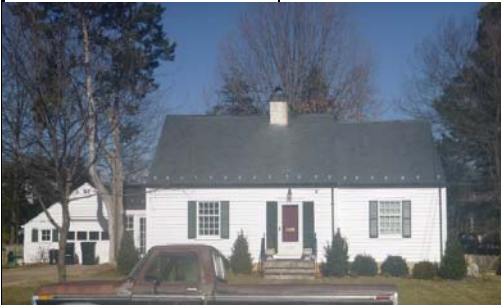
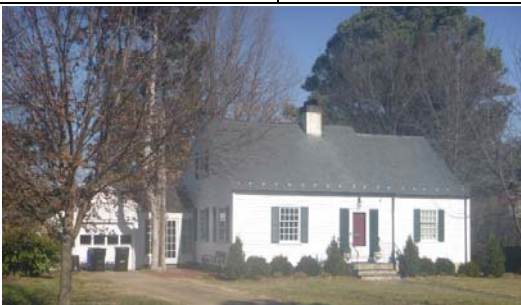
Name of Surveyors	Kimberly Packett		Survey Date	2/28/2016
ADDRESS	Street		Number	
	Brent	Street	1217	
TYPE & NUMBER OF BLGS & STRUCTURES	Type		Number	
	Single Family House		1	
Current Use of Primary Building	Single Family	Historic Use of Primary Building	Single Family	
Style of Primary Bldg	Cape Cod			
Number of Stories	1.5	Width (bays)	3	
Foundation Material	Concrete	Depth (rooms)	3	
Year Built	1933	Wall Cladding Material	Hardboard siding	
Roof Shape	Side gable	Roof Material	Slate	
Decorative Details/Unique Features	Snowbreakers on front of roof. Dark blue shutters on front door and windows. White surround around front door and windows.			
Evidence of Integrity Location/Materials	None			
Additions/Alterations to Primary Building	Addition on back, attached garage on left. New roof, siding, and windows.			
Condition of Primary Building	Excellent		code	
			E	
Observable Threats	None			
Compatibility with Adjacent Land Uses	Good

Potential NR Eligibility	Non-Contributing		code	
			N	
Other Comments / Salient Details	Central chimney. Cement path and brick stairs with iron railing leading to front door. Bushes along front of house. Paved driveway on left side of house leading to garage attached to main house by hallway.			
Photo Views				
1 Front view	2 3/4 view	3	4

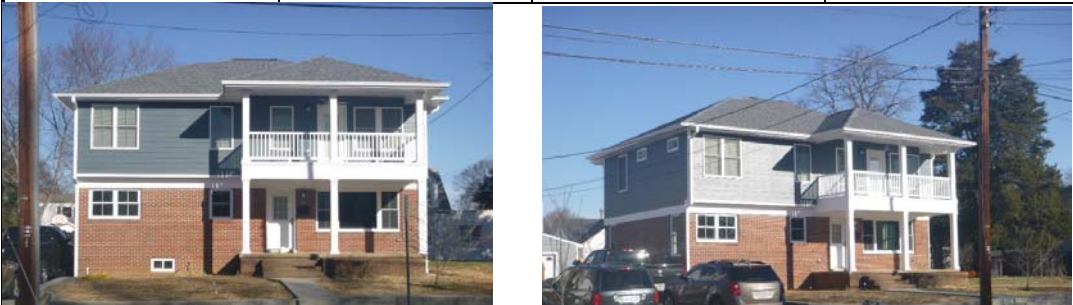
Name of Surveyors	Kimberly Packett		Survey Date	2/28/2016
ADDRESS	Street		Number	
	Payne	Street	1225	
TYPE & NUMBER OF BLGS & STRUCTURES	Type		Number	
	Single Family House		1	
Current Use of Primary Building	Single Family	Historic Use of Primary Building	Single Family	
Style of Primary Bldg	Mixed Style			
Number of Stories	2	Width (bays)	4	
Foundation Material	Cinderblock	Depth (rooms)	3	
Year Built	1961	Wall Cladding Material	Brick	
Roof Shape	Side gable	Roof Material	Composition shingle	
Decorative Details/Unique Features	Double porch with hip roof and white columns and railings. Appears to have been recently renovated.			
Evidence of Integrity Location/Materials	Brick siding on first floor may be original.			
Additions/Alterations to Primary Building	New roof, windows, and vinyl siding.			
Condition of Primary Building	Excellent		code	
			E	
Observable Threats	None			
Compatibility with Adjacent Land Uses	Good

Potential NR Eligibility	Non-Contributing		code	
			N	
Other Comments / Salient Details	Paved driveway on left side of house. Cement retaining wall along front and left side of property. Cement path leading to brick double porch with white columns and white railing on the second story. Porch has hip roof.			
Photo Views				
1 Front view	2 3/4 view	3	4

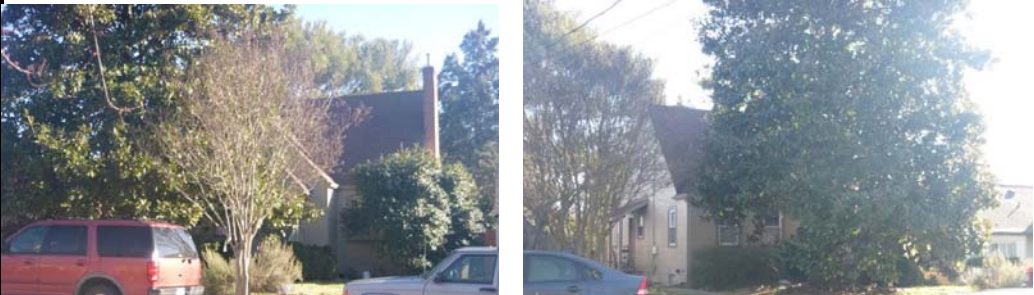
Name of Surveyors	Kimberly Packett		Survey Date	2/21/2016
ADDRESS	Street		Number	
	Stafford Ave		1509	
TYPE & NUMBER OF BLGS & STRUCTURES	Type		Number	
	Multi-family House		1	
Current Use of Primary Building	Multi-family	Historic Use of Primary Building	Single family	
Style of Primary Bldg	Colonial Revival			
Number of Stories	1.5	Width (bays)	4	
Foundation Material	Concrete	Depth (rooms)	3	
Year Built	1950	Wall Cladding Material	Asbestos shingles	
Roof Shape	Gable	Roof Material	Composition shingles	
Decorative Details/Unique Features	Red surround around windows and front door.			
Evidence of Integrity Location/Materials	Original siding and appears to be original windows.			
Additions/Alterations to Primary Building	New roof.			
Condition of Primary Building	Good	code		
		G		
Observable Threats	None			
Compatibility with Adjacent Land Uses	Good			
Potential NR Eligibility	Contributing	code		
		C		
Other Comments / Salient Details	Brick walkway to the front door, concrete driveway to the left. Side entrance has a shed overhang. Chimney on right end of house. Large trees and shrubs block view of the house.

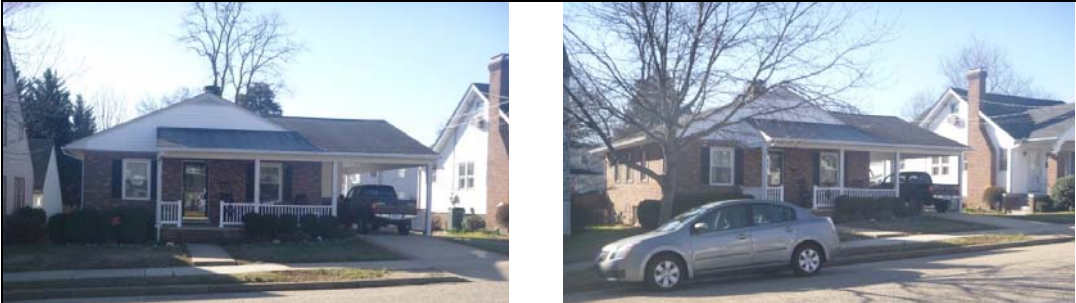
Name of Surveyors	Kimberly Packett		Survey Date	2/28/2016
ADDRESS	Street		Number	
	Parcel	Street	1216	
TYPE & NUMBER OF BLGS & STRUCTURES	Type		Number	
	Single Family House		1	
Current Use of Primary Building	Single Family	Historic Use of Primary Building	Single Family	
Style of Primary Bldg	Mixed Style			
Number of Stories	1	Width (bays)	3	
Foundation Material	Cinderblock	Depth (rooms)	3	
Year Built	1963	Wall Cladding Material	Brick	
Roof Shape	Cross gable	Roof Material	Composition shingle	
Decorative Details/Unique Features	Side gable porch extends to attached carport. Dark blue shutters on front windows. White vinyl siding on front gable.			
Evidence of Integrity Location/Materials	Original siding.			
Additions/Alterations to Primary Building	New roof and windows.			
Condition of Primary Building	Good			code
				G
Observable Threats	None			
Compatibility with Adjacent Land Uses	Good			
Potential NR Eligibility	Non-Contributing			code

N
Other Comments / Salient Details	Cement driveway on right side of house leading to carport. Bushes along front of house. Cement path leading to front porch with white railings and columns. Central chimney.			
Photo Views				
1 Front view	2 3/4 view	3	4

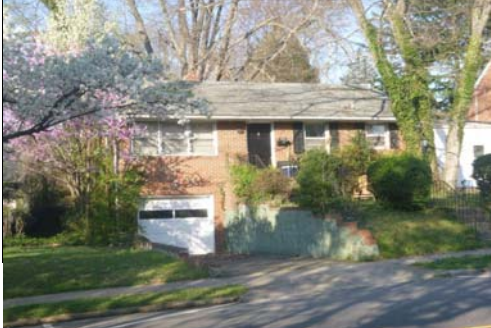
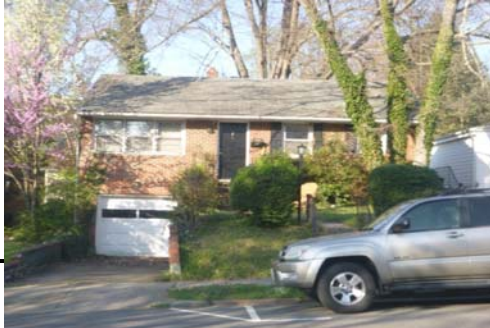
Name of Surveyors	Kimberly Packett		Survey Date	3/12/2016
ADDRESS	Street		Number	
	Stafford	Avenue	1404	
TYPE & NUMBER OF BLGS & STRUCTURES	Type		Number	
	Single Family House		1	
Current Use of Primary Building	Single Family	Historic Use of Primary Building	Single Family	
Style of Primary Bldg	Minimal Traditional			
Number of Stories	1	Width (bays)	2	
Foundation Material	Cinderblock	Depth (rooms)	4	
Year Built	1952	Wall Cladding Material	Brick	
Roof Shape	Side Gable	Roof Material	Composition Shingle	
Decorative Details/Unique Features	Black shutters on front windows to the right of the front door. Attached basement garage on left side of house.			
Evidence of Integrity Location/Materials	Original brick siding and possibly original windows.			
Additions/Alterations to Primary Building	New roof.			
Condition of Primary Building	Good		code	
			G	
Observable Threats	None			
Compatibility with Adjacent Land Uses	Good

Potential NR Eligibility	Contributing		code	
			C	
Other Comments / Salient Details	Paved driveway on left side of the house leading to basement attached garage. Cinderblock and brick retaining wall along either side of the driveway. Cement stairs and path with iron railing leading to front door. Bushes along path, driveway, and front of house. Lamp post in front yard. Central chimney.			
Photo Views				
1 3/4 View	2 Front View	3	4

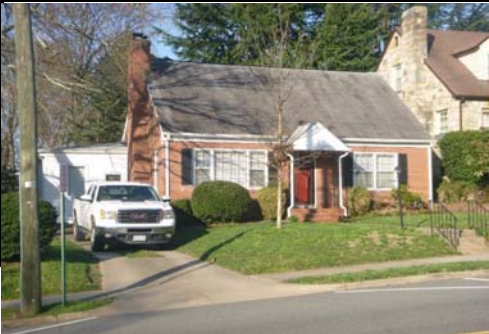
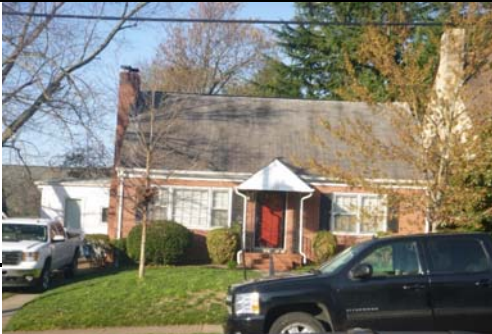
Name of Surveyors	Kimberly Packett		Survey Date	3/12/2016
ADDRESS	Street		Number	
	Stafford	Avenue	1408	
TYPE & NUMBER OF BLGS & STRUCTURES	Type		Number	
	Single Family House		1	
	Shed		1	
Current Use of Primary Building	Single Family	Historic Use of Primary Building	Single Family	
Style of Primary Bldg	Cape Cod			
Number of Stories	1 1/2	Width (bays)	3	
Foundation Material	Cinderblock	Depth (rooms)	2	
Year Built	1960	Wall Cladding Material	Brick	
Roof Shape	Side Gable	Roof Material	Composition shingle	
Decorative Details/Unique Features	Black shutters on front windows. Front gable portico with wood siding and white columns over front landing.			
Evidence of Integrity Location/Materials	Original brick siding.			
Additions/Alterations to Primary Building	New roof and windows.			
Condition of Primary Building	Good	code		
		G		
Observable Threats	None			
Compatibility with Adjacent Land Uses	Good			
Potential NR Eligibility	Contributing	code

C		
Other Comments / Salient Details	Cement driveway along left side of house. Cement stairs with iron railing and path leading to bricks stairs and landing in front of front door. Bushes along front of house. Lamp post in front yard. Chimney on left end of the house.			
Photo Views				
1 3/4 View	2 Front View	3	4

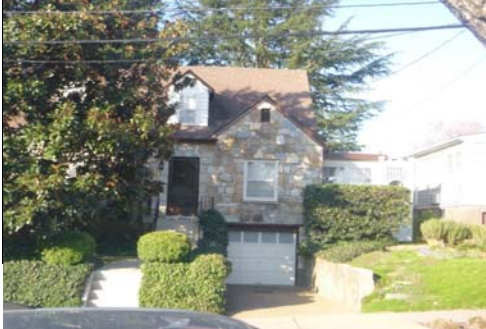
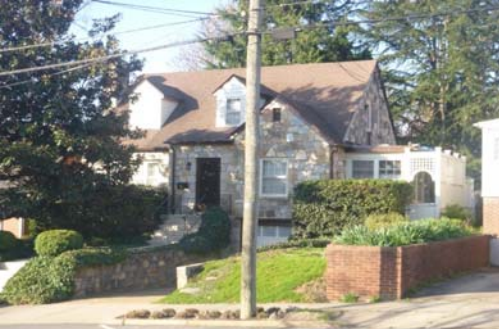
Name of Surveyors	Kimberly Packett		Survey Date	3/12/2016
ADDRESS	Street		Number	
	Srafford Avenue		1414?	
TYPE & NUMBER OF BLGS & STRUCTURES	Type		Number	
	Single Family House		1	
Current Use of Primary Building	Single Family	Historic Use of Primary Building	Single Family	
Style of Primary Bldg	Cape Cod			
Number of Stories	1 1/2	Width (bays)	3	
Foundation Material	Concrete	Depth (rooms)	2	
Year Built	1950	Wall Cladding Material	Stone	
Roof Shape	Side Gable	Roof Material	Composition shingle	
Decorative Details/Unique Features	Two front gable dormers with vinyl siding on front of the house. Front gable on right side of the house. Large shrubs, trees, and a lot of ivy cover the front yard.			
Evidence of Integrity Location/Materials	Original stone siding.			
Additions/Alterations to Primary Building	New windows and roof.			
Condition of Primary Building	Good		code	G
Observable Threats	None			
Compatibility with Adjacent Land Uses	Good

Potential NR Eligibility	Contributing		code	C
Other Comments / Salient Details	<p>Stone and cement retaining walls on either side of the driveway.</p> <p>Paved driveway on right side of the house leads to basement attached garage. Cement stairs and path with iron railing leading to front door. Large shrubs and trees block the left side of the house.</p> <p>Sun room on right side of the house. White privacy fence around backyard.</p>			
Photo Views				
1 Front View	2 3/4 View	3	4

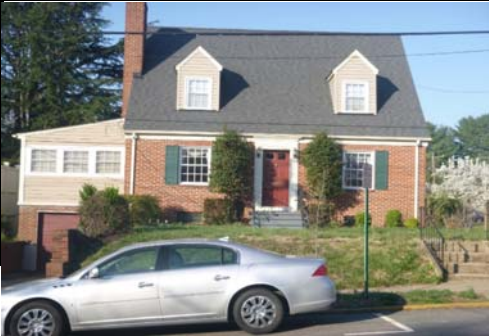
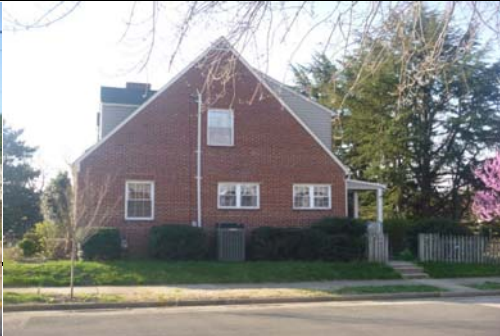
Name of Surveyors	Kimberly Packett		Survey Date	3/12/2016
ADDRESS	Street		Number	
	Stafford Avenue		1416	
TYPE & NUMBER OF BLGS & STRUCTURES	Type		Number	
	Single Family House		1	
Current Use of Primary Building	Single Family	Historic Use of Primary Building	Single Family	
Style of Primary Bldg	Cape Cod			
Number of Stories	1 1/2	Width (bays)	4	
Foundation Material	Concrete	Depth (rooms)	3	
Year Built	1946	Wall Cladding Material	Brick	
Roof Shape	Side Gable	Roof Material	Composition shingle	
Decorative Details/Unique Features	Two front gable dormers on the front of the house with vinyl siding. Green shutters on windows on front of the house. Extended dormer with vinyl siding on rear of house. White pilasters and crown around front door. Decoartive brick lintel above windows.			
Evidence of Integrity Location/Materials	Original brick siding and possibly original windows.			
Additions/Alterations to Primary Building	Addition with vinyl siding on left side of the house with a shed roof. New roof.

Condition of Primary Building	Good		code	
			G	
Observable Threats	None			
Compatibility with Adjacent Land Uses	Good			
Potential NR Eligibility	Contributing		code	
			C	
Other Comments / Salient Details	Chimney on left end of the house. Paved driveway on left side of the house leads to basement attached garage. Brick retaining wall along each side of the driveway. Cement steps and path with iron railing leading to front door. Wood picket fence around backyard. Cement stairs and path leading to back door. Bushes along front and side of house.			
Photo Views				
1 Front View	2 Side View	3	4

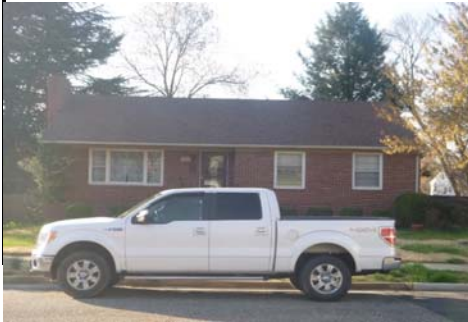
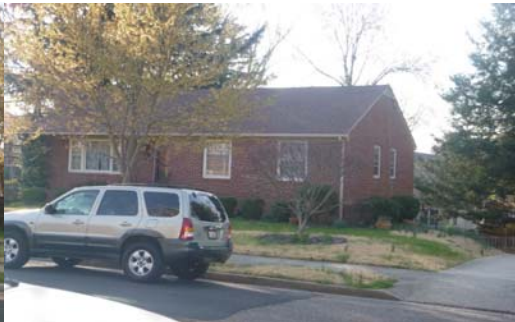
Name of Surveyors	Kimberly Packett		Survey Date	3/12/2016
ADDRESS	Street		Number	
	Payne	Street	1408	
TYPE & NUMBER OF BLGS & STRUCTURES	Type		Number	
	Single Family House		1	
Current Use of Primary Building	Single Family	Historic Use of Primary Building	Single Family	
Style of Primary Bldg	Ranch			
Number of Stories	1	Width (bays)	4	
Foundation Material	Cinderblock	Depth (rooms)	2	
Year Built	1961	Wall Cladding Material	Brick	
Roof Shape	Side Gable	Roof Material	Composition shingle	
Decorative Details/Unique Features	Sunken in front door.			
Evidence of Integrity Location/Materials	Original brick siding and windows.			
Additions/Alterations to Primary Building	New roof.			
Condition of Primary Building	Good			code G
Observable Threats	None			
Compatibility with Adjacent Land Uses	Good			
Potential NR Eligibility	Contributing			code C
Other Comments / Salient Details	Brick path and stairs with iron railing leading to front door. Bushes along front and side of house. Chimney on the left end of the house.

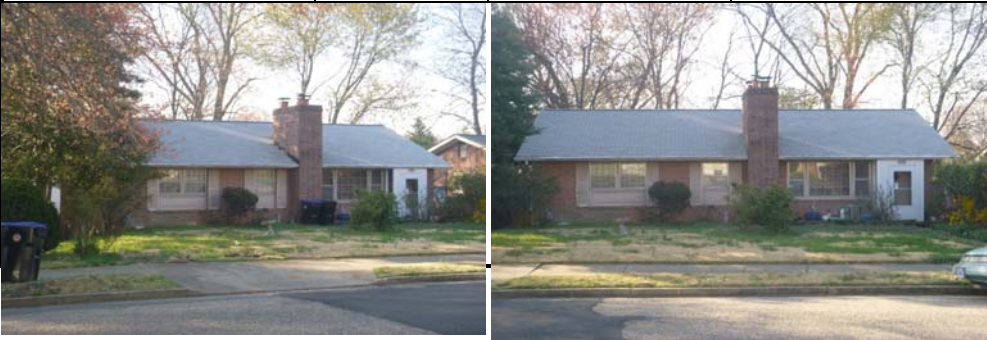
Name of Surveyors	Kimberly Packett		Survey Date	3/12/2016
ADDRESS	Street		Number	
	Payne	Street	1416	
TYPE & NUMBER OF BLGS & STRUCTURES	Type		Number	
	Single Family House		1	
Current Use of Primary Building	Single Family	Historic Use of Primary Building	Single Family	
Style of Primary Bldg	Ranch			
Number of Stories	1	Width (bays)	4	
Foundation Material	Cinderblock	Depth (rooms)	1	
Year Built	1966	Wall Cladding Material	Brick	
Roof Shape	Side Gable	Roof Material	Composition shingle	
Decorative Details/Unique Features	White siding around front door. Tan shutters on front left windows. Tan paneling underneath front left windows.			
Evidence of Integrity Location/Materials	Original brick siding and possibly original windows.			
Additions/Alterations to Primary Building	New roof.			
Condition of Primary Building	Fair		code	F
Observable Threats	None			
Compatibility with Adjacent Land Uses	Good			
Potential NR Eligibility	Contributing		code	C

Other Comments / Salient Details	Chimney on front middle of the house. Cement path leading to front door.			
Photo Views				
1 3/4 View	2 Front View	3	4

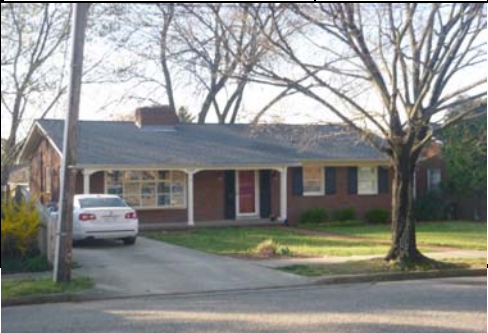
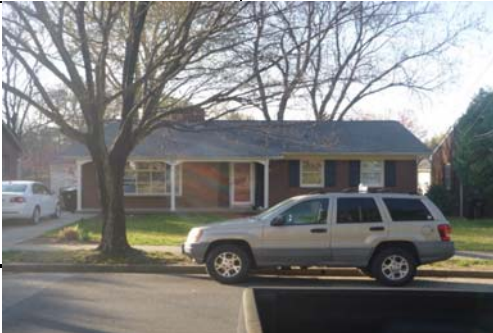
Name of Surveyors	Kimberly Packett		Survey Date	3/12/2016
ADDRESS	Street		Number	
	Payne	Street	1414	
TYPE & NUMBER OF BLGS & STRUCTURES	Type		Number	
	Single Family House		1	
Current Use of Primary Building	Single Family	Historic Use of Primary Building	Single Family	
Style of Primary Bldg	Ranch			
Number of Stories	1	Width (bays)	4	
Foundation Material	Cinderblock	Depth (rooms)	2	
Year Built	1959	Wall Cladding Material	Brick	
Roof Shape	Side Gable	Roof Material	Composition Shingle	
Decorative Details/Unique Features	Overhang above front porch with white columns and decorative white archways. Dark blue shutters on front door and right front windows.			
Evidence of Integrity Location/Materials	Original brick siding and windows.			
Additions/Alterations to Primary Building	New roof			
Condition of Primary Building	Good		code	
			G	
Observable Threats	None			
Compatibility with Adjacent Land Uses	Good			
Potential NR Eligibility	Contributing		code

C	
Other Comments / Salient Details	Interior chimney on left side of house. Cement driveway on left side of the house. Brick path leading to cement front porch. Bushes along front and side of the house.			
Photo Views				
1 3/4 View	2 Front View	3	4

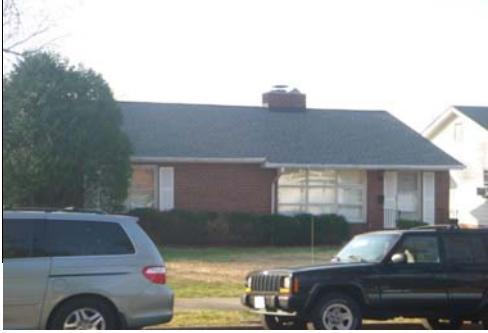
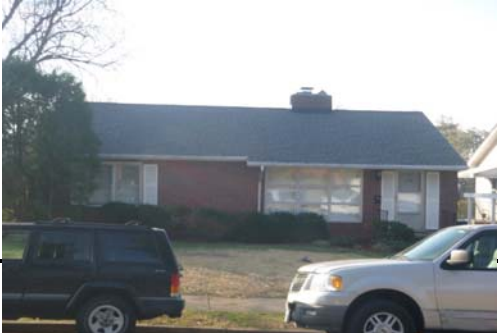
Name of Surveyors	Kimberly Packett		Survey Date	3/12/2016
ADDRESS	Street		Number	
	Payne	Street	1424	
TYPE & NUMBER OF BLGS & STRUCTURES	Type		Number	
	Single Family House		1	
Current Use of Primary Building	Single Family	Historic Use of Primary Building	Single Family	
Style of Primary Bldg	Ranch			
Number of Stories	1	Width (bays)	3	
Foundation Material	Cinderblock	Depth (rooms)	2	
Year Built	1961	Wall Cladding Material	Brick	
Roof Shape	Side Gable	Roof Material	Composition shingle	
Decorative Details/Unique Features	White shutters on front door and left front window.			
Evidence of Integrity Location/Materials	Original brick siding and windows.			
Additions/Alterations to Primary Building	New roof.			
Condition of Primary Building	Good		code	
			G	
Observable Threats	None			
Compatibility with Adjacent Land Uses	Good			
Potential NR Eligibility	Contributing		code	
			C	
Other Comments / Salient Details	Bushes along front of house and path. Cement path and brick stairs with iron railing leading to front door. Interior chimney on right side of the house.

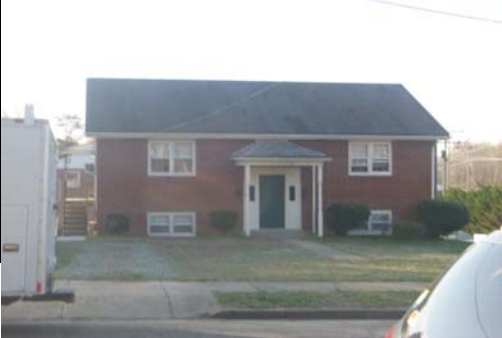
Name of Surveyors	Kimberly Packett		Survey Date	3/12/2016
ADDRESS	Street		Number	
	Payne	Street	1428	
TYPE & NUMBER OF BLGS & STRUCTURES	Type		Number	
	Single Family House		1	
Current Use of Primary Building	Single Family	Historic Use of Primary Building	Single Family	
Style of Primary Bldg	Split Level			
Number of Stories	2	Width (bays)	3	
Foundation Material	Cinderblock	Depth (rooms)	2	
Year Built	1959	Wall Cladding Material	Brick	
Roof Shape	Side Gable	Roof Material	Composition shingle	
Decorative Details/Unique Features	White crown and pilasters around front door. Sidelights on either side of the front door. Hip roof portico with white supports above front door.			
Evidence of Integrity Location/Materials	Original brick siding and windows.			
Additions/Alterations to Primary Building	New roof.			
Condition of Primary Building	Fair		code	F
Observable Threats	None			
Compatibility with Adjacent Land Uses	Good

Potential NR Eligibility	Contributing		code	C
Other Comments / Salient Details	Gravel driveway on left side of the house. Cement path starting half way through the front yard leading to cement steps leading to front door. Bushes along front of house. Wood stairs and railing leading to second story entrance on left side of the house.			
Photo Views				
1 Front View	2	3	4

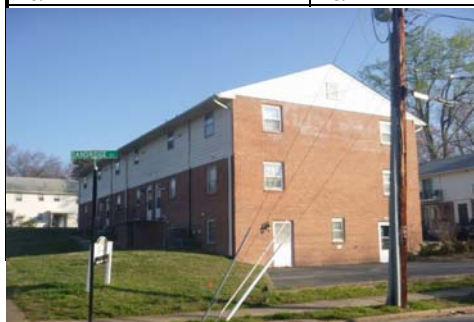
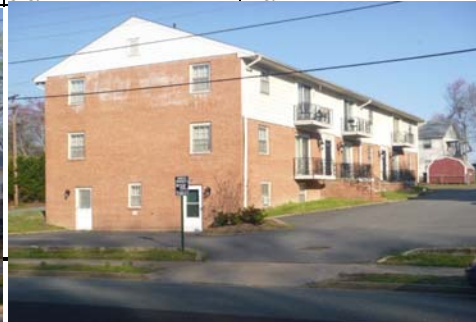
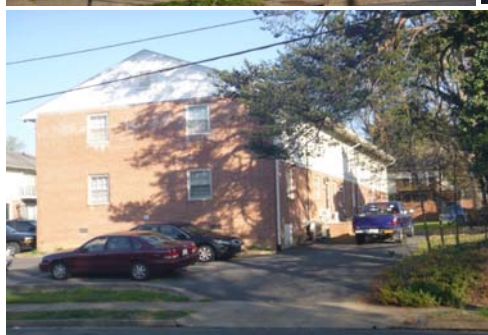
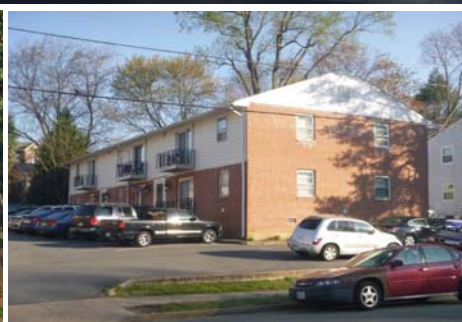
Name of Surveyors	Kimberly Packett	Survey Date	3/12/2016
ADDRESS	Street	Number	
	Dandridge Street	1417-1427	
TYPE & NUMBER OF BLGS & STRUCTURES	Type	Number	
	Apartment Complex	1	
Current Use of Primary Building	Apartment Complex	Historic Use of Primary Building	Apartment Complex
Style of Primary Bldg	Apartment Complex		
Number of Stories	3	Width (bays)	4
Foundation Material	Cinderblock	Depth (rooms)	8
Year Built	1969	Wall Cladding Material	Brick
Roof Shape	Side Gable	Roof Material	Composition shingle
Decorative Details/Unique Features	Vinyl siding on second story and gable ends. Brick siding on first story and ends of structures. Apartments facing towards the parking lot on second story have cement balconies with iron railings. Main doors have white crown and pilasters.		
Evidence of Integrity Location/Materials	Original siding and windows.		
Additions/Alterations to Primary Building	Most likely a new roof.

Condition of Primary Building	Fair	code F	
Observable Threats	Poor, surrounding buildings are predominantly single family homes.		
Compatibility with Adjacent Land Uses	Good		
Potential NR Eligibility	Non-Contributing	code N	
Other Comments / Salient Details	Paved driveway in between buildings. Brick stairs with iron railing lead to main entrance doors in the center of each building. First story apartments have rear entrances with brick stairs and iron railings.

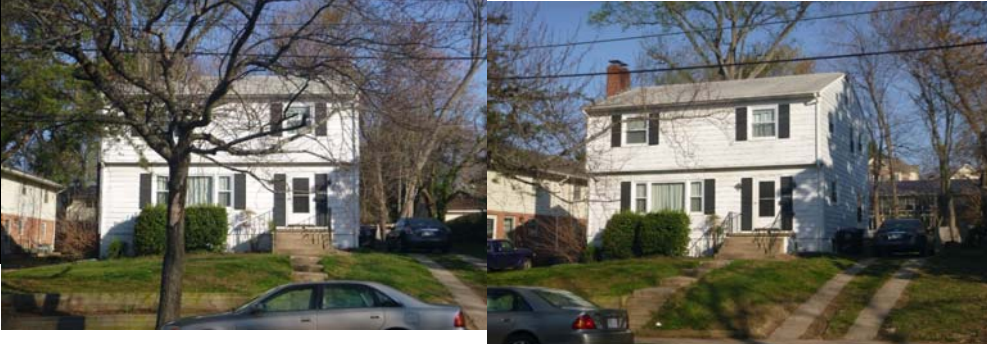
Name of Surveyors	Kimberly Packett		Survey Date	3/12/2016
ADDRESS	Street		Number	
	Dandridge	Street	1411	
TYPE & NUMBER OF BLGS & STRUCTURES	Type		Number	
	Single Family House		1	
	Shed		1	
Current Use of Primary Building	Single Family	Historic Use of Primary Building	Single Family	
Style of Primary Bldg	Neocolonial			
Number of Stories	2	Width (bays)	2	
Foundation Material	Cinderblock	Depth (rooms)	2	
Year Built	1959	Wall Cladding Material	Aluminum Siding	
Roof Shape	Side Gable	Roof Material	Composition shingle	
Decorative Details/Unique Features	Dark green shutters on front windows and front door. Second story juts out further than first story in the front of the house.			
Evidence of Integrity Location/Materials	Possibly original siding. Original windows.			
Additions/Alterations to Primary Building	New roof.			
Condition of Primary Building	Good			code
				G
Observable Threats	None			
Compatibility with Adjacent Land Uses	Good

Potential NR Eligibility	Contributing			code
				C
Other Comments / Salient Details	Cement driveway on right side of the house. Cement stairs and path with iron railing leading to front door. Bushes along front and side of house. Chimney on left end of the house. Shed in the backyard.			
Photo Views				
1 Front View	2 3/4 View	3	4

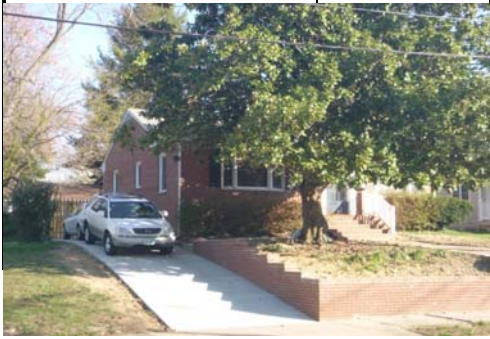
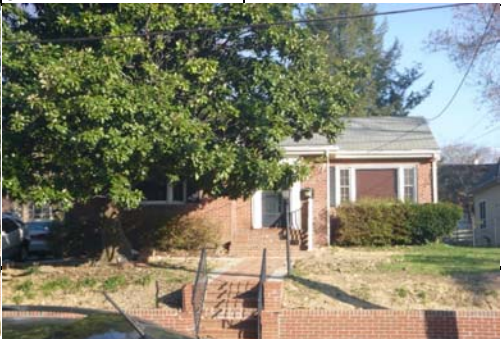
Name of Surveyors	Kimberly Packett		Survey Date	3/12/2016
ADDRESS	Street		Number	
	Dandridge	Street	1409	
TYPE & NUMBER OF BLGS & STRUCTURES	Type		Number	
	Single Family House		1	
Current Use of Primary Building	Single Family	Historic Use of Primary Building	Single Family	
Style of Primary Bldg	Minimal Traditional			
Number of Stories	1	Width (bays)	3	
Foundation Material	Cinderblock	Depth (rooms)	3	
Year Built	1954	Wall Cladding Material	Brick	
Roof Shape	Side gable	Roof Material	Composition shingle	
Decorative Details/Unique Features	White crown and pilasters around front door. Black shutters on front windows. Large tree blocks the left side of the house.			
Evidence of Integrity Location/Materials	Original brick siding.			
Additions/Alterations to Primary Building	New roof and windows.			
Condition of Primary Building	Fair	code		
		F		
Observable Threats	None			
Compatibility with Adjacent Land Uses	Good

Potential NR Eligibility	Contributing	code		
		C		
Other Comments / Salient Details	Brick retaining wall along front of the property and driveway. Cement driveway on left side of the house. Wood privacy fence around backyard. Brick stairs with iron railing and path leading to front door. Brick stairs leading to front door has white railing. Cement and brick path from the driveway to the front door. Lamp post in front yard.			
Photo Views				
1 3/4 View	2 Front View	3	4

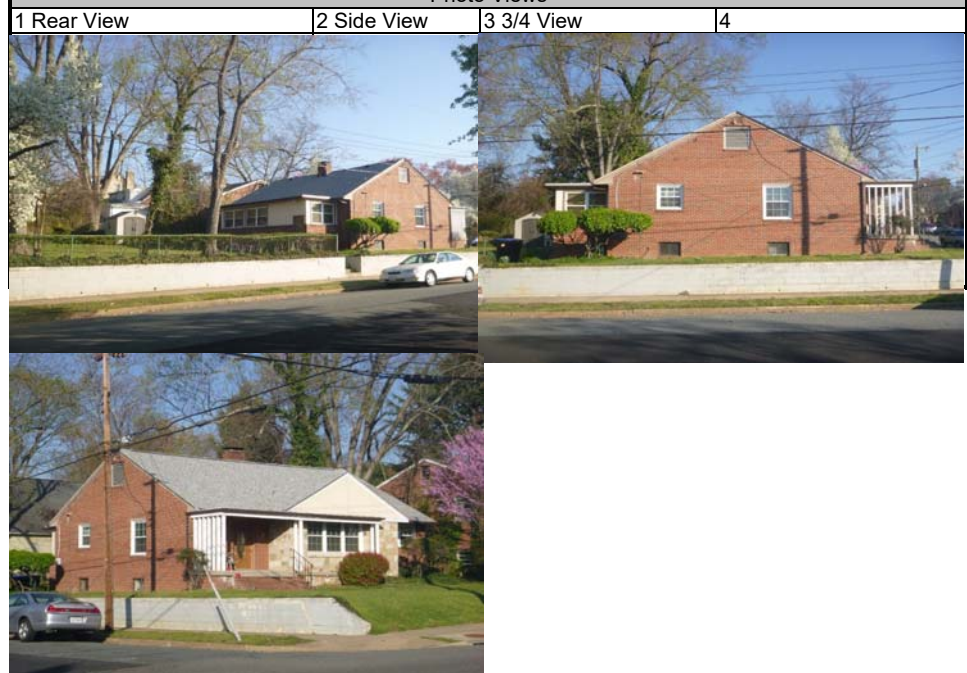
Name of Surveyors	Kimberly Packett	Survey Date	3/12/2016
ADDRESS	Street	Number	
	Stafford Avenue	1400	
TYPE & NUMBER OF BLGS & STRUCTURES	Type	Number	
	Single Family House	1	
	Shed	1	
Current Use of Primary Building	Single Family	Historic Use of Primary Building	Single Family
Style of Primary Bldg	Minimal Traditional		
Number of Stories	1	Width (bays)	3
Foundation Material	Cinderblock	Depth (rooms)	2
Year Built	1955	Wall Cladding Material	Brick
Roof Shape	Side gable	Roof Material	Composition shingle
Decorative Details/Unique Features	Front gable in center of house has vertical tan wood and stone siding. Tan surround around front door.		
Evidence of Integrity Location/Materials	Original brick siding.		
Additions/Alterations to Primary Building	Addition on rear of house has vinyl and brick siding. New windows and roof.		
Condition of Primary Building	Good	code G	
Observable Threats	None		
Compatibility with Adjacent Land Uses	Good

Potential NR Eligibility	Contributing	code C	
Other Comments / Salient Details	Cinderblock retaining wall along side of property. Cement stairs leading to backyard on left side of the property. Brick path and stairs leading to front door with iron railing. Central chimney. Hedges along back of house. Shed in the backyard. Chain link fence around backyard.

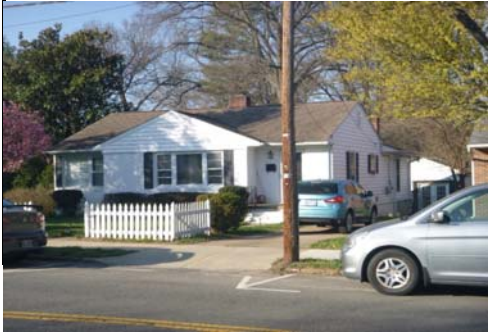
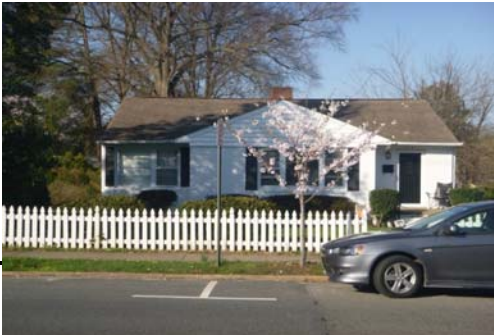
Name of Surveyors	Kimberly Packett		Survey Date	3/12/2016
ADDRESS	Street		Number	
	Stafford	Avenue	1312	
TYPE & NUMBER OF BLGS & STRUCTURES	Type		Number	
	Single Family House		1	
	Shed		1	
Current Use of Primary Building	Single Family	Historic Use of Primary Building	Single Family	
Style of Primary Bldg	Minimal Traditional			
Number of Stories	1	Width (bays)	3	
Foundation Material	Cinderblock	Depth (rooms)	3	
Year Built	1959	Wall Cladding Material	Vinyl Siding	
Roof Shape	Side gable	Roof Material	Composition Shingle	
Decorative Details/Unique Features	White painted brick on front of house. Vinyl siding on front gable and other sides of the house. Black shutters on windows.			
Evidence of Integrity Location/Materials	Original windows and brick siding.			
Additions/Alterations to Primary Building	Addition on rear of house. New vinyl siding and roof.			
Condition of Primary Building	Good		code	
			G	
Observable Threats	None

Compatibility with Adjacent Land Uses	Good			
Potential NR Eligibility	Contributing		code	
			C	
Other Comments / Salient Details	White picket fence around front yard. Central chimney. Cement driveway on right side of the house. Cement path and stairs with iron railing leading to front door from the sidewalk. Bushes along base of house and white picket fence. Interior chimney on rear addition.			
Photo Views				
1 3/4 View	2 Front View	3	4

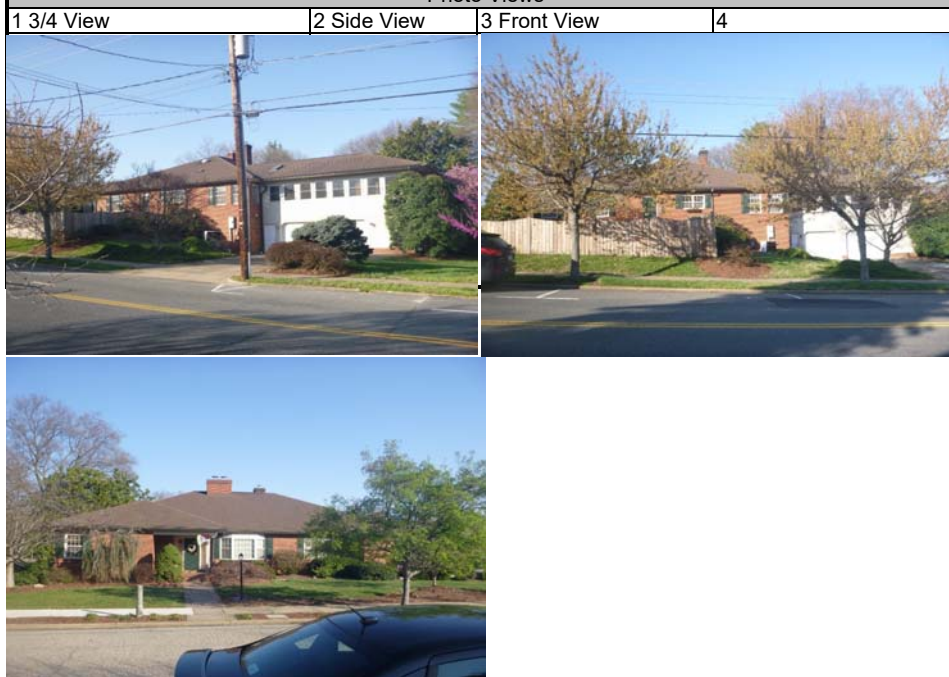
Name of Surveyors	Kimberly Packett	Survey Date	3/12/2016
ADDRESS	Street	Number	
	Brent Street	1401	
TYPE & NUMBER OF BLGS & STRUCTURES	Type	Number	
	Single Family House	1	
Current Use of Primary Building	Single Family	Historic Use of Primary Building	Single Family
Style of Primary Bldg	Minimal Traditional		
Number of Stories	2	Width (bays)	4
Foundation Material	Cinderblock	Depth (rooms)	6
Year Built	1954	Wall Cladding Material	Brick
Roof Shape	Hip	Roof Material	Composition shingle
Decorative Details/Unique Features	Green shutters on windows. Roof overhangs above front porch supported by white column. Skylight on addition on rear of house.		
Evidence of Integrity Location/Materials	Original brick siding and possibly original windows on original part of building.		
Additions/Alterations to Primary Building	Large addition on rear of structure with vinyl siding. New roof.		
Condition of Primary Building	Excellent	code E

Observable Threats	None		
Compatibility with Adjacent Land Uses	Fair, large addition doesn't fit with surrounding structures.		
Potential NR Eligibility	Non-Contributing	code N	
Other Comments / Salient Details	Wooden privacy fence around backyard and half of front yard. Cement driveway leading to basement attached garage on right side of the house. Two interior chimneys. Cement path and bricks stairs leading to front door. Bushes along front of house. Lamp post in front yard.

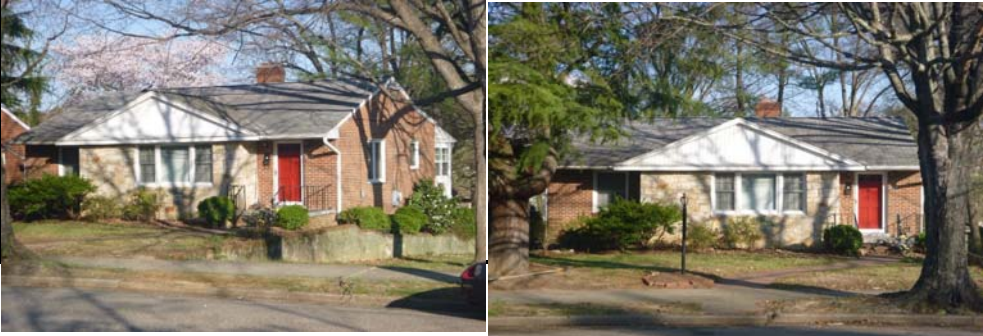
Name of Surveyors	Kimberly Packett		Survey Date	3/12/2016
ADDRESS	Street		Number	
	Brent	Street	1413	
TYPE & NUMBER OF BLGS & STRUCTURES	Type		Number	
	Single Family House		1	
Current Use of Primary Building	Single Family	Historic Use of Primary Building	Single Family	
Style of Primary Bldg	Minimal Traditional			
Number of Stories	1	Width (bays)	3	
Foundation Material	Cinderblock	Depth (rooms)	3	
Year Built	1959	Wall Cladding Material	Brick	
Roof Shape	Side Gable	Roof Material	Composition shingle	
Decorative Details/Unique Features	Vertical wood siding on front gable. Stone siding on front center of house. Red front door.			
Evidence of Integrity Location/Materials	Original brick siding.			
Additions/Alterations to Primary Building	New roof and windows.			
Condition of Primary Building	Good		code	
			G	
Observable Threats	None			
Compatibility with Adjacent Land Uses	Good			
Potential NR Eligibility	Contributing		code

C	
Other Comments / Salient Details	Central chimney. Sunroom on rear of house. Cement retaining wall along right side of the property. Cement path and brick stairs and porch with iron railing leading to front door. Lamp post in front yard. Bushes along front and side of house.			
Photo Views				
1 3/4 View	2 Front View	3	4

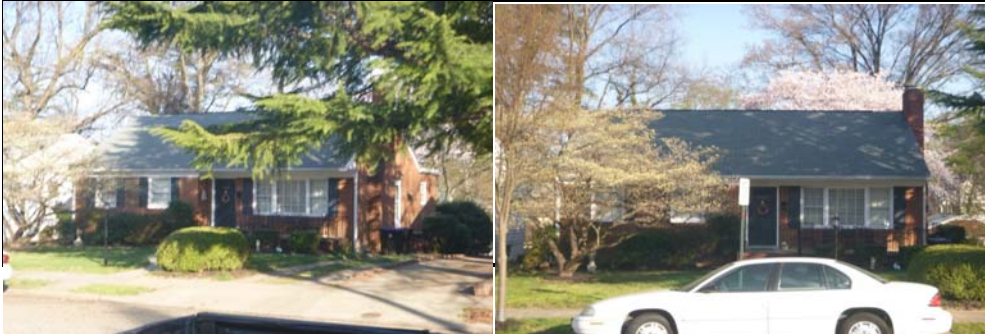
Name of Surveyors	Kimberly Packett		Survey Date	3/12/2016
ADDRESS	Street		Number	
	Brent	Street	1417	
TYPE & NUMBER OF BLGS & STRUCTURES	Type		Number	
	Single Family House		1	
Current Use of Primary Building	Single Family	Historic Use of Primary Building	Single Family	
Style of Primary Bldg	Cape Cod			
Number of Stories	1	Width (bays)	4	
Foundation Material	Cinderblock	Depth (rooms)	2	
Year Built	1958	Wall Cladding Material	Brick	
Roof Shape	Side Gable	Roof Material	Composition shingle	
Decorative Details/Unique Features	Blue shutters on front windows. Side door on right side of house with brick stairs.			
Evidence of Integrity Location/Materials	Original brick siding			
Additions/Alterations to Primary Building	New roof and windows.			
Condition of Primary Building	Good		code	
			G	
Observable Threats	None			
Compatibility with Adjacent Land Uses	Good			
Potential NR Eligibility	Contributing		code	
			C	
Other Comments / Salient Details	Cement driveway on right side of house. Lamp post on front yard. Cement path leading from sidewalk and brick steps with iron railing leading to front door. Bushes along front and side of house. Chimney on right end of house.

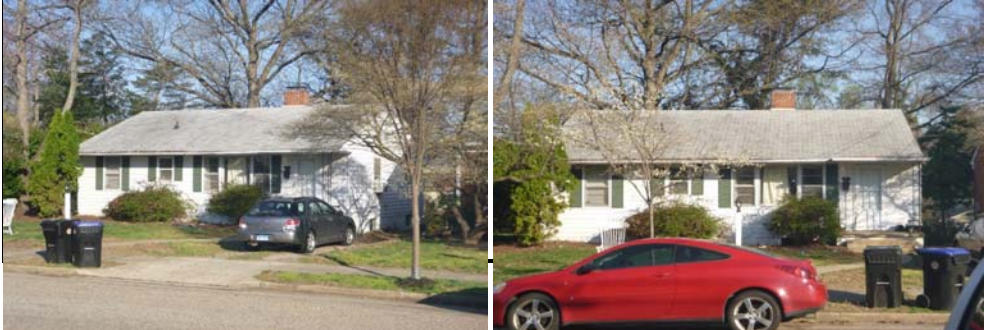
Name of Surveyors	Kimberly Packett		Survey Date	3/12/2016
ADDRESS	Street		Number	
	Brent	Street	1423	
TYPE & NUMBER OF BLGS & STRUCTURES	Type		Number	
	Single Family House		1	
Current Use of Primary Building	Single Family	Historic Use of Primary Building	Single Family	
Style of Primary Bldg	Minimal Traditional			
Number of Stories	1	Width (bays)	4	
Foundation Material	Cinderblock	Depth (rooms)	2	
Year Built	1959	Wall Cladding Material	Hardboard siding	
Roof Shape	Side Gable	Roof Material	Composition shingle	
Decorative Details/Unique Features	Green shutters on front windows. White surround around front door. Roof hangs over front door landing supported by decorative metal iron support.			
Evidence of Integrity Location/Materials	Appears to be original windows.			
Additions/Alterations to Primary Building	New siding and roof.			
Condition of Primary Building	Fair		code	F
Observable Threats	None			
Compatibility with Adjacent Land Uses	Good

Potential NR Eligibility	Contributing		code	C
Other Comments / Salient Details	Dirt and gravel driveway on right side of the house. Cement path leading from sidewalk to cement stairs leading to front door. Central chimney.			
Photo Views				
1 3/4 View	2 Front View	3	4

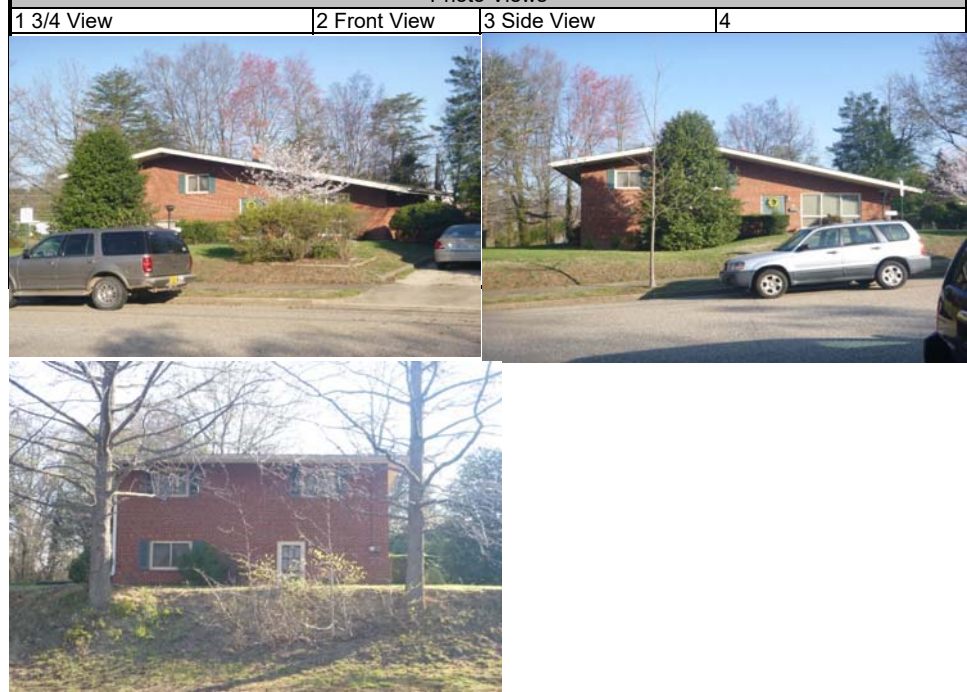
Name of Surveyors	Kimberly Packett	Survey Date	3/12/2016
ADDRESS	Street	Number	
	Brent Street	1425	
TYPE & NUMBER OF BLGS & STRUCTURES	Type	Number	
	Single Family House	1	
Current Use of Primary Building	Single Family	Historic Use of Primary Building	Single Family
Style of Primary Bldg	Split Level		
Number of Stories	1	Width (bays)	4
Foundation Material	Cinderblock	Depth (rooms)	2
Year Built	1957	Wall Cladding Material	Brick
Roof Shape	Shed	Roof Material	Composition shingle
Decorative Details/Unique Features	Green shutters on front second story windows and side windows. Side door on left side of house.		
Evidence of Integrity Location/Materials	Original brick siding and windows.		
Additions/Alterations to Primary Building	New roof.		
Condition of Primary Building	Good	code G	
Observable Threats	None		
Compatibility with Adjacent Land Uses	Fair, more modern style than surrounding houses.		
Potential NR Eligibility	Non-Contributing	code N

Other Comments / Salient Details	Dirt and gravel driveway on right side of the house. Cement path leading from driveway to front door. Bushes and trees along front of house.

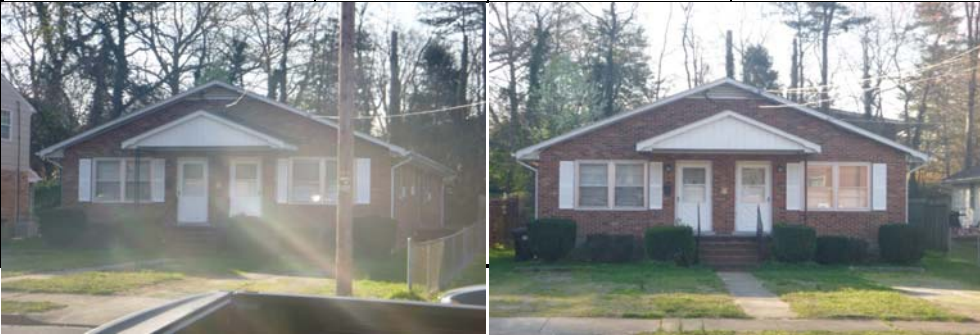
Name of Surveyors	Kimberly Packett		Survey Date	3/12/2016
ADDRESS	Street		Number	
	Dandridge	Street	1426/1428	
TYPE & NUMBER OF BLGS & STRUCTURES	Type		Number	
	Multi-Family House		1	
Current Use of Primary Building	Multi-Family	Historic Use of Primary Building	Single Family	
Style of Primary Bldg	Ranch			
Number of Stories	1	Width (bays)	4	
Foundation Material	Cinderblock	Depth (rooms)	5	
Year Built	1959	Wall Cladding Material	Brick	
Roof Shape	Front Gable	Roof Material	Composition shingle	
Decorative Details/Unique Features	Front gable portico with vertical wood siding over front landing supported by iron posts. White shutters on front windows.			
Evidence of Integrity Location/Materials	Original brick siding and windows.			
Additions/Alterations to Primary Building	New roof.			
Condition of Primary Building	Fair		code	F
Observable Threats	None			
Compatibility with Adjacent Land Uses	Fair, most surrounding houses are single family homes.

Potential NR Eligibility	Contributing		code	C
Other Comments / Salient Details	Cement path from sidewalk to brick stairs with iron railing leading to front door. Bushes along front of house. Dirt driveway on right side of house. Chain link fence and wood privacy fence around backyard. Side door on right side of house, appears to be original door and entranceway.			
Photo Views				
1 3/4 View	2 Front View	3	4

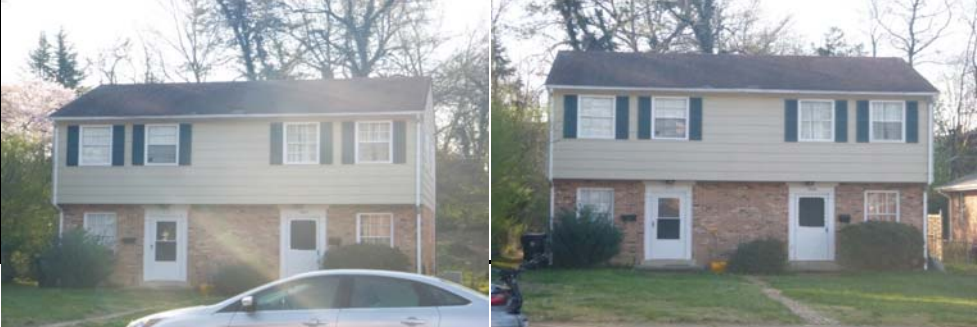
Name of Surveyors	Kimberly Packett		Survey Date	3/12/2016
ADDRESS	Street		Number	
	Dandridge	Street	1424.1422	
TYPE & NUMBER OF BLGS & STRUCTURES	Type		Number	
	Multi-Family House		1	
Current Use of Primary Building	Multi-Family	Historic Use of Primary Building	Single Family	
Style of Primary Bldg	Neocolonial			
Number of Stories	2	Width (bays)	4	
Foundation Material	Cinderblock	Depth (rooms)	2	
Year Built	1959	Wall Cladding Material	Brick/Hardboard siding	
Roof Shape	Side Gable	Roof Material	Composition shingle	
Decorative Details/Unique Features	Green shutters on front second story windows. Hardboard siding on second story, brick siding on first story. White pilasters and crowns with dentils around front doors. Second story hangs over first story slightly.			
Evidence of Integrity Location/Materials	Original brick siding.			
Additions/Alterations to Primary Building	New roof and windows.			
Condition of Primary Building	Good		code	G

Observable Threats	None			
Compatibility with Adjacent Land Uses	Fair, most surrounding houses are single family homes.			
Potential NR Eligibility	Contributing		code	C
Other Comments / Salient Details	Bushes along front of the house. Skinny brick path leading from sidewalk to both front doors. Chainlink fence around backyard.			
Photo Views				
1 3/4 View	2 Front View	3	4

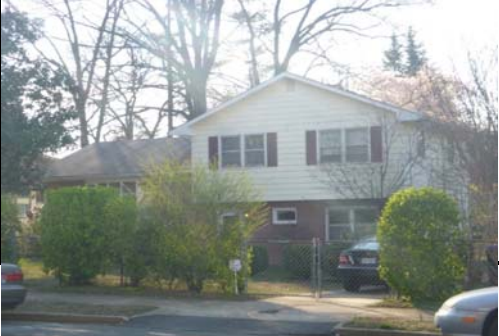
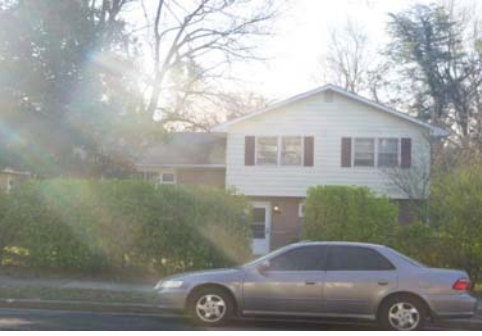
Name of Surveyors	Kimberly Packett		Survey Date	3/12/2016
ADDRESS	Street		Number	
	Dandridge	Street	1418	
TYPE & NUMBER OF BLGS & STRUCTURES	Type		Number	
	Single Family House		1	
Current Use of Primary Building	Single Family	Historic Use of Primary Building	Single Family	
Style of Primary Bldg	Split Level			
Number of Stories	2 1/2	Width (bays)	4	
Foundation Material	Cinderblock	Depth (rooms)	2	
Year Built	1959	Wall Cladding Material	Aluminum siding	
Roof Shape	Cross Gable	Roof Material	Composition shingle	
Decorative Details/Unique Features	Red shutters on front second story windows. Aluminum siding on top most story. Brick siding on bottom and middle story. Front gable on right side of the house.			
Evidence of Integrity Location/Materials	Original siding and windows.			
Additions/Alterations to Primary Building	New roof.			
Condition of Primary Building	Good			code G
Observable Threats	None			
Compatibility with Adjacent Land Uses	Good

Potential NR Eligibility	Contributing			code C
Other Comments / Salient Details	Chainlink fence around property. Cement driveway on right side of the house. Bushes along front of chainlink fence in front of house. Cement path leading from driveway to front door.			
Photo Views				
1 3/4 View	2 Front View	3	4
