Cultural Resource Survey of College Heights in Fredericksburg, Virginia

Master of Science

Historic Preservation

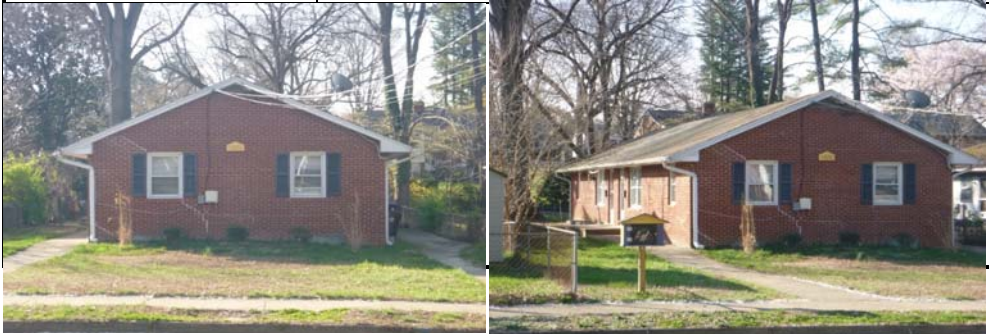
Name of Surveyors	Kimberly Packett		Survey Date	3/12/2016
ADDRESS	Street		Number	
	Dandridge	Street	1408a and 1408b	
TYPE & NUMBER OF BLGS & STRUCTURES	Type		Number	
	Multi-Family House		1	
Current Use of Primary Building	Multi-Family	Historic Use of Primary Building	Single Family	
Style of Primary Bldg	Ranch			
Number of Stories	1	Width (bays)	2	
Foundation Material	Cinderblock	Depth (rooms)	6	
Year Built	1959	Wall Cladding Material	Brick	
Roof Shape	Side Gable	Roof Material	Composition shingle	
Decorative Details/Unique Features	Blue shutters on front windows.			
Evidence of Integrity Location/Materials	Original brick siding and windows.			
Additions/Alterations to Primary Building	New roof			
Condition of Primary Building	Fair			code F
Observable Threats	None			
Compatibility with Adjacent Land Uses	Fair, most surrounding houses are single family homes.			
Potential NR Eligibility	Contributing			code C

Other Comments / Salient Details	Chainlink fence around back and side of property. Cement path and stairs from sidewalk to front doors on left side of the house. Small bushes along front of house. Cement path leading from sidewalk to back door.			
Photo Views				
1 Front View	2 3/4 View	3	4

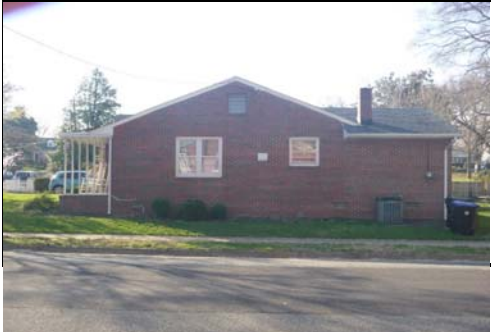
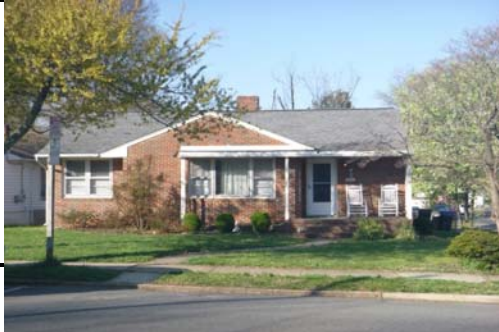
Name of Surveyors	Kimberly Packett		Survey Date	3/12/2016
ADDRESS	Street		Number	
	Stafford	Avenue	1316	
TYPE & NUMBER OF BLGS & STRUCTURES	Type		Number	
	Single Family House		1	
Current Use of Primary Building	Single Family	Historic Use of Primary Building	Single Family	
Style of Primary Bldg	Minimal Traditional			
Number of Stories	1	Width (bays)	3	
Foundation Material	Cinderblock	Depth (rooms)	2	
Year Built	1958	Wall Cladding Material	Brick	
Roof Shape	Cross Gable	Roof Material	Composition shingle	
Decorative Details/Unique Features	Roof extends over front porch with multiple white columns. Front gable in front center of house.			
Evidence of Integrity Location/Materials	Original brick siding and windows.			
Additions/Alterations to Primary Building	New roof. Addition on back of house.			
Condition of Primary Building	Good			code G
Observable Threats	None			
Compatibility with Adjacent Land Uses	Good

Potential NR Eligibility	Contributing			code C
Other Comments / Salient Details	Cement path leading from sidewalk to brick stairs and front porch. Central chimney and interior chimney on addition. Garden and small bushes along front of the house.			
Photo Views				
1 Side View	2 Front View	3	4

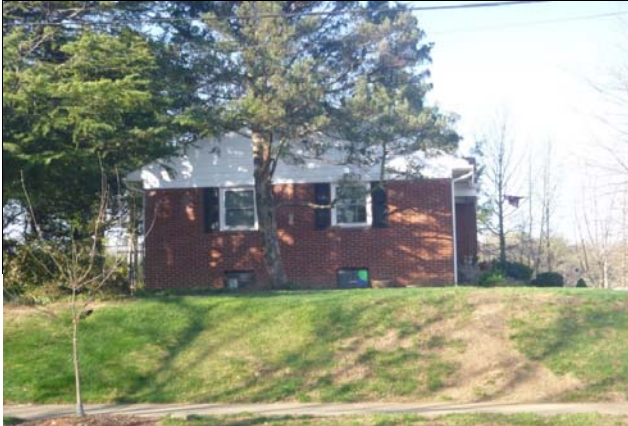
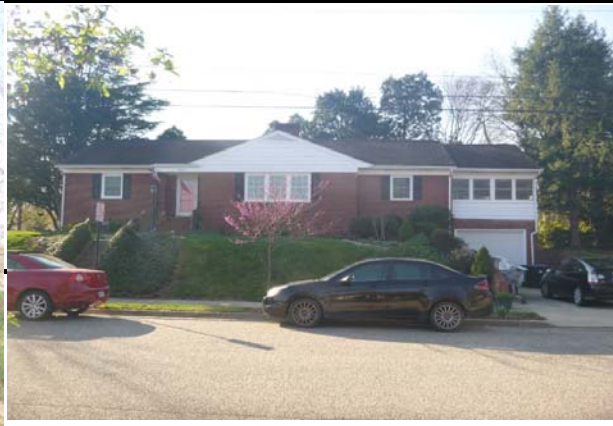
Name of Surveyors	Kimberly Packett		Survey Date	3/12/2016
ADDRESS	Street		Number	
	Brent	Street	1400	
TYPE & NUMBER OF BLGS & STRUCTURES	Type		Number	
	Single Family House		1	
Current Use of Primary Building	Single Family	Historic Use of Primary Building	Single Family	
Style of Primary Bldg	Minimal Traditional			
Number of Stories	1	Width (bays)	5	
Foundation Material	Cinderblock	Depth (rooms)	2	
Year Built	1955	Wall Cladding Material	Brick	
Roof Shape	Side Gable	Roof Material	Composition shingles	
Decorative Details/Unique Features	Black shutters on front and side windows. Horizontal siding on gable end, front gable, and addition on right side of house.			
Evidence of Integrity Location/Materials	Original brick siding			
Additions/Alterations to Primary Building	New windows and roof. Vinyl siding on front gable, side gable, and below windows on right side of the house.			
Condition of Primary Building	Good			code G

Observable Threats	None			
Compatibility with Adjacent Land Uses	Good			
Potential NR Eligibility	Contributing			code C
Other Comments / Salient Details	Cement driveway leads to basement attached garage on front right side of the house. Brick retaining wall along left side of the driveway. Cement stairs and path with iron railing leading to front door from sidewalk. Lamp post in front yard. Ivy on either side of path.			
Photo Views				
1 Side View	2 Front View	3	4

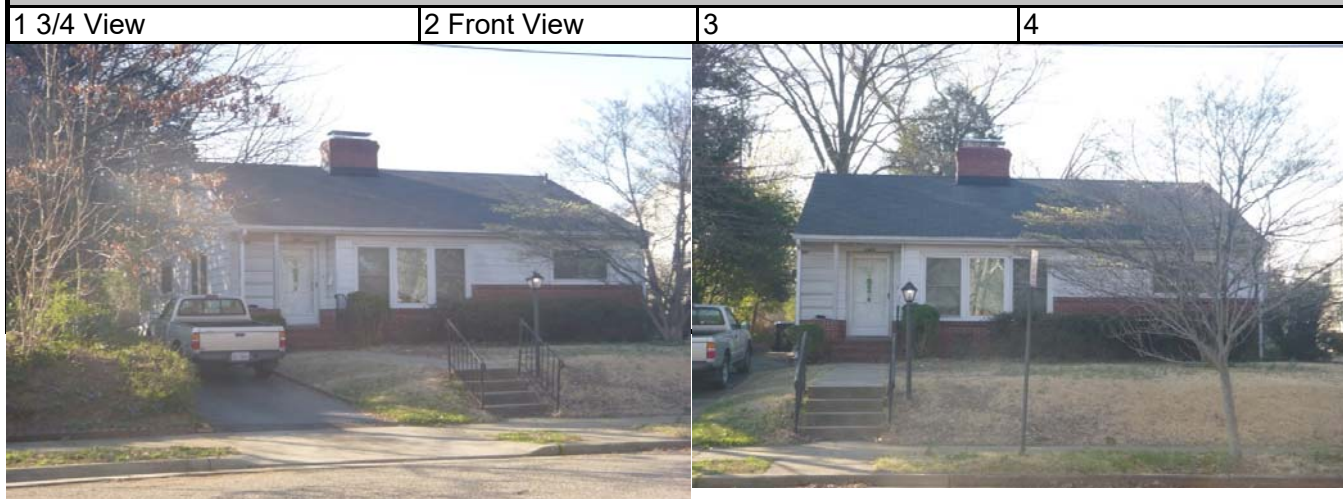
Name of Surveyors	Kimberly Packett		Survey Date	3/12/2016
ADDRESS	Street		Number	
	Brent	Street	1408	
TYPE & NUMBER OF BLGS & STRUCTURES	Type		Number	
	Single Family House		1	
Current Use of Primary Building	Single Family	Historic Use of Primary Building	Single Family	
Style of Primary Blg	Minimal Traditional			
Number of Stories	1	Width (bays)	3	
Foundation Material	Cinderblock	Depth (rooms)	2	
Year Built	1955	Wall Cladding Material	Aluminum siding & Brick	
Roof Shape	Gable	Roof Material	Composition shingles	
Decorative Details/Unique Features	Brick siding on bottom half of front of house and aluminum siding on top half of house and other sides. Roof hangs over front door landing supported by white support.			
Evidence of Integrity Location/Materials	Original siding and windows			
Additions/Alterations to Primary Building	New roof			
Condition of Primary Building	Good			code G
Observable Threats	None

Compatibility with Adjacent Land Uses	Good			
Potential NR Eligibility	Contributing			code C
Other Comments / Salient Details	Paved driveway on left side of the house. Cement stairs and path with iron railing leading to front door. Brick steps with iron railing leading to front door. Lamp post in front yard. Bushes along front of house. Central chimney.

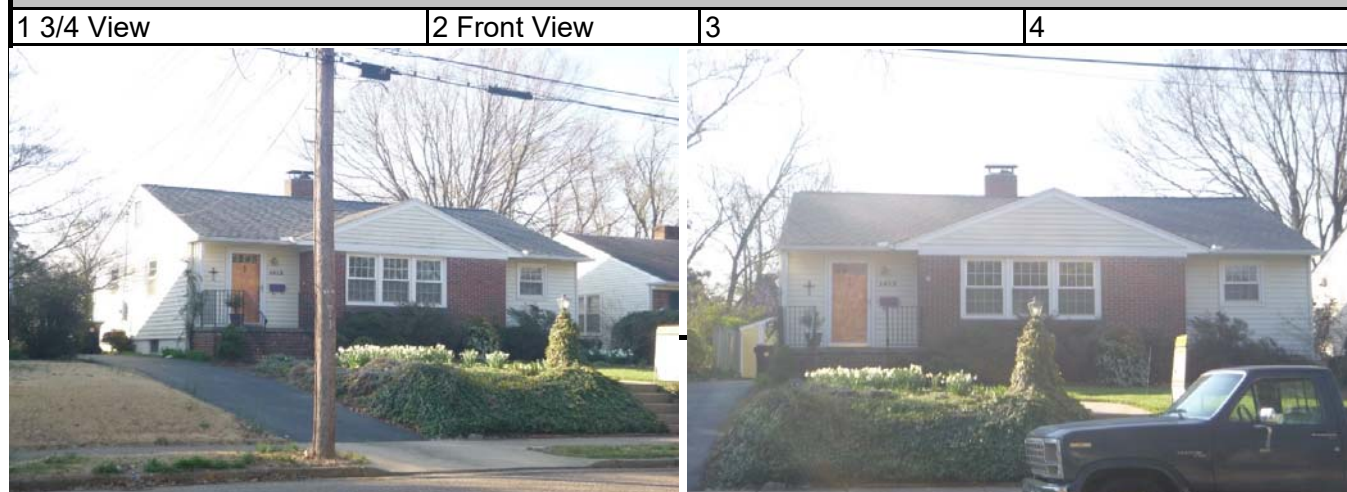
Name of Surveyors	Kimberly Packett		Survey Date	3/12/2016
ADDRESS	Street		Number	
	Brent	Street	1412	
TYPE & NUMBER OF BLGS & STRUCTURES	Type		Number	
	Single Family House		1	
	Shed		1	
Current Use of Primary Building	Single Family	Historic Use of Primary Building	Single Family	
Style of Primary Blg	Minimal Traditional			
Number of Stories	1	Width (bays)	5	
Foundation Material	Cinderblock	Depth (rooms)	2	
Year Built	1959	Wall Cladding Material	Vinyl siding	
Roof Shape	Side Gable	Roof Material	Composition shingles	
Decorative Details/Unique Features	Middle, front of house protrudes and has brick siding. Front gable has vinyl siding.			
Evidence of Integrity Location/Materials	Original brick siding.			
Additions/Alterations to Primary Building	New windows, new vinyl siding, and new roof.			
Condition of Primary Building	Good			code
				G
Observable Threats	None			
Compatibility with Adjacent Land Uses	Good

Potential NR Eligibility	Contributing			code
				C
Other Comments / Salient Details	Paved driveway on the left side of the house leading to shed, cement stairs up hill on right side of the property. Cement pathway to brick stairs leading up to small cement porch in front of front door. Porch surrounded by iron railings. Lamppost on front lawn covered in ivy, lawn covered in ivy. Bushes along front of house. Central chimney.

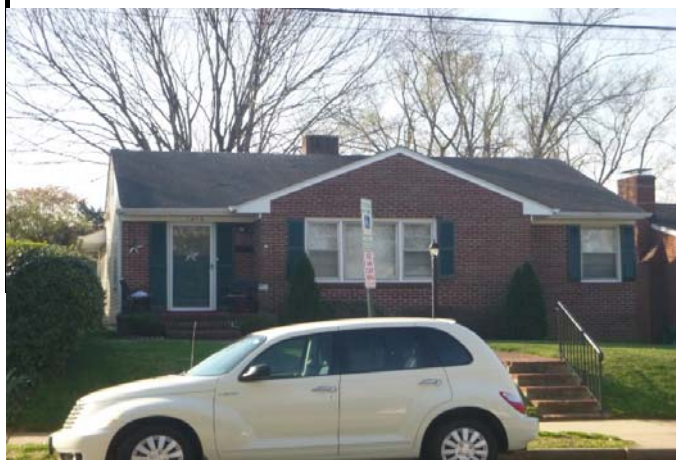
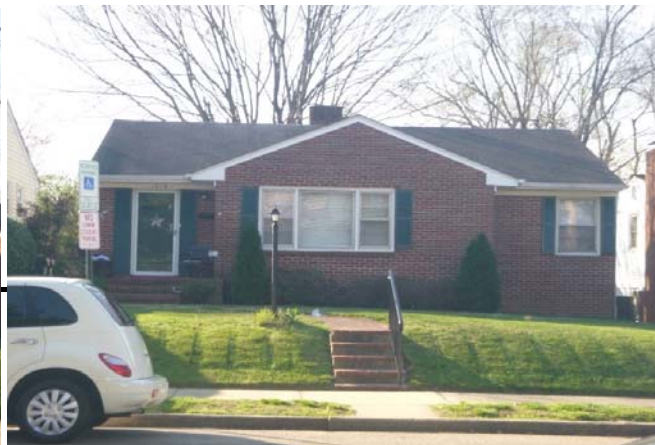
Name of Surveyors	Kimberly Packett		Survey Date	3/12/2016
ADDRESS	Street		Number	
	Brent	Street	1416	
TYPE & NUMBER OF BLGS & STRUCTURES	Type		Number	
	Single Family House		1	
	Shed		1	
Current Use of Primary Building	Single Family	Historic Use of Primary Building	Single Family	
Style of Primary Blg	Minimal Traditional			
Number of Stories	1	Width (bays)	3	
Foundation Material	Cinderblock	Depth (rooms)	2	
Year Built	1957	Wall Cladding Material	Brick	
Roof Shape	Side Gable	Roof Material	Composition shingles	
Decorative Details/Unique Features	Front gable in middle of house. Blue shutters on front door and front windows.			
Evidence of Integrity Location/Materials	Original brick siding, windows.			
Additions/Alterations to Primary Building	New roof.			
Condition of Primary Building	Good			code G
Observable Threats	None			
Compatibility with Adjacent Land Uses	Good			
Potential NR Eligibility	Contributing			code C

Other Comments / Salient Details	Brick stairs and path with iron railing leading from sidewalk to front door. Lamp post on front law. Bushes along front of house. Central chimney.			
Photo Views				
1 3/4 View	2 Front View	3	4

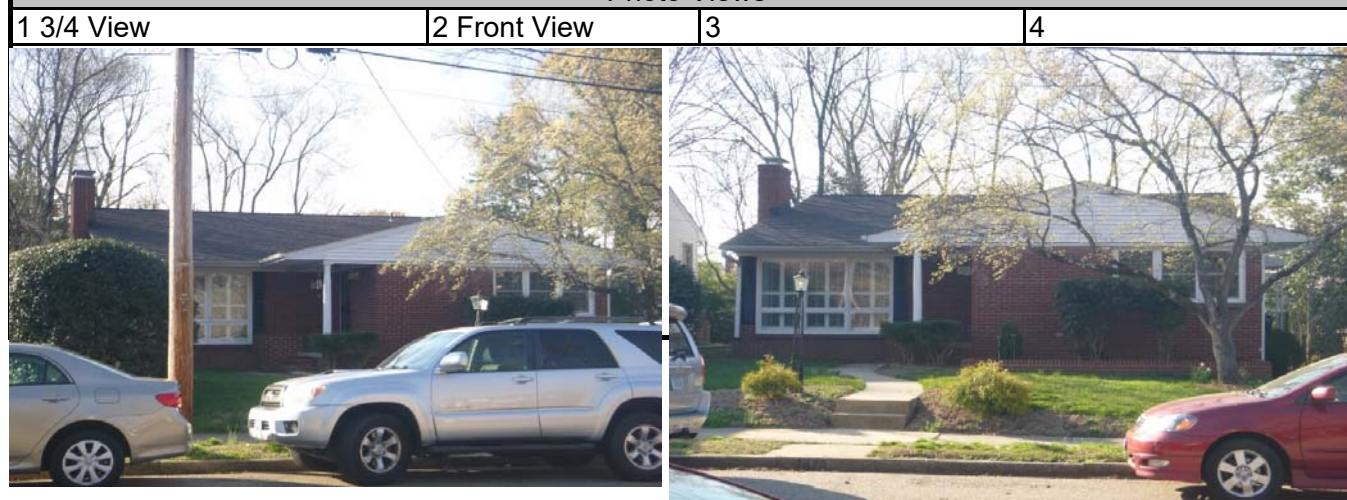
Name of Surveyors	Kimberly Packett		Survey Date	3/12/2016
ADDRESS	Street		Number	
	Brent	Street	1420	
TYPE & NUMBER OF BLGS & STRUCTURES	Type		Number	
	Single Family House		1	
	Shed		1	
Current Use of Primary Building	Single Family	Historic Use of Primary Building	Single Family	
Style of Primary Blg	Minimal Traditional			
Number of Stories	1	Width (bays)	2	
Foundation Material	Cinderblock	Depth (rooms)	3	
Year Built	1960	Wall Cladding Material	Brick	
Roof Shape	Gable	Roof Material	Composition shingles	
Decorative Details/Unique Features	Roof hands over front landing supported by white column. Front gable with vinyl siding.			
Evidence of Integrity Location/Materials	Original windows and brick siding			
Additions/Alterations to Primary Building	New roof.			
Condition of Primary Building	Good			code G
Observable Threats	None			
Compatibility with Adjacent Land Uses	Good			
Potential NR Eligibility	Contributing			code C

Other Comments / Salient Details	Cement steps and path leading from sidewalk to front door. Lamp post in front lawn. Brick planter along front right of house. Chimney on left end of house. Bushes along front of house.

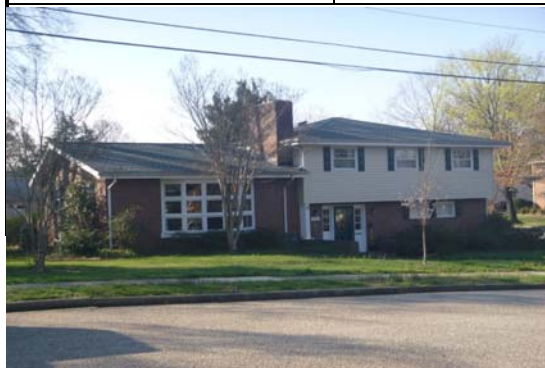
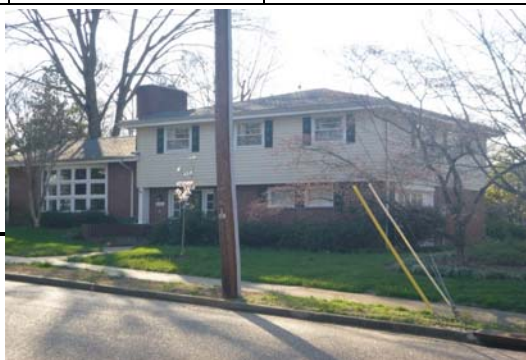
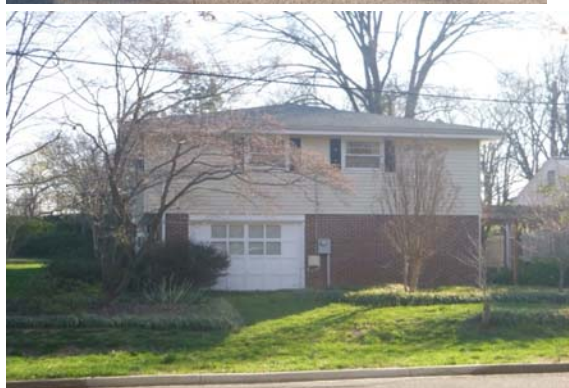
Name of Surveyors	Kimberly Packett		Survey Date	3/12/2016
ADDRESS	Street		Number	
	Brent	Street	1424	
TYPE & NUMBER OF BLGS & STRUCTURES	Type		Number	
	Single Family House		1	
	Shed		1	
Current Use of Primary Building	Single Family	Historic Use of Primary Building	Single Family	
Style of Primary Bldg	Split level			
Number of Stories	2	Width (bays)	4	
Foundation Material	Cinderblock	Depth (rooms)	2	
Year Built	1959	Wall Cladding Material	Brick	
Roof Shape	Side Gable	Roof Material	Composition shingles	
Decorative Details/Unique Features	Vinyl siding on second floor. Black shutters on windows. Sidelights on either side of front door. Side gable roof on left side of house, hip roof on right side of house.			
Evidence of Integrity Location/Materials	Original windows and brick siding			
Additions/Alterations to Primary Building	Attached garage on right converted into a living space. New vinyl siding and roof.

Condition of Primary Building	Good		code	G
Observable Threats	None			
Compatibility with Adjacent Land Uses	Good			
Potential NR Eligibility	Contributing		code	C
Other Comments / Salient Details	Brick retaining wall along left side of front door, cement pathway from sidewalk to front door, bushes along front of house. Central chimney.

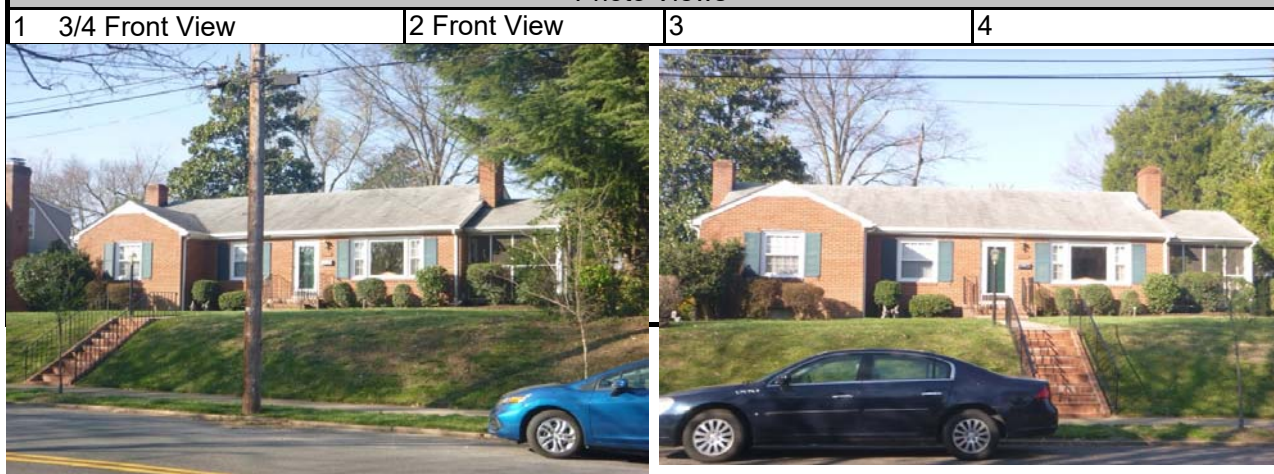
Name of Surveyors	Kimberly Packett		Survey Date	3/12/2016
ADDRESS	Street		Number	
	Stafford	Avenue	1208	
TYPE & NUMBER OF BLGS & STRUCTURES	Type		Number	
	Single Family House		1	
Current Use of Primary Building	Single Family	Historic Use of Primary Building	Single Family	
Style of Primary Blg	Minimal Traditional			
Number of Stories	1	Width (bays)	5	
Foundation Material	Cinderblock	Depth (rooms)	3	
Year Built	1954	Wall Cladding Material	Brick	
Roof Shape	Gable	Roof Material	Composition shingles	
Decorative Details/Unique Features	Front gable on left side of the house. White pilasters and crown around front door. Green shutters on front windows.			
Evidence of Integrity Location/Materials	Original brick siding.			
Additions/Alterations to Primary Building	New windows and roof.			
Condition of Primary Building	Good			code
				G
Observable Threats	None			
Compatibility with Adjacent Land Uses	Good			
Potential NR Eligibility	Contributing			code

C
Other Comments / Salient Details	Brick stairs and path with iron railing leading to front door. Chimneys on either end of the house. Sun room on right side of the house. Bushes along front of the house.

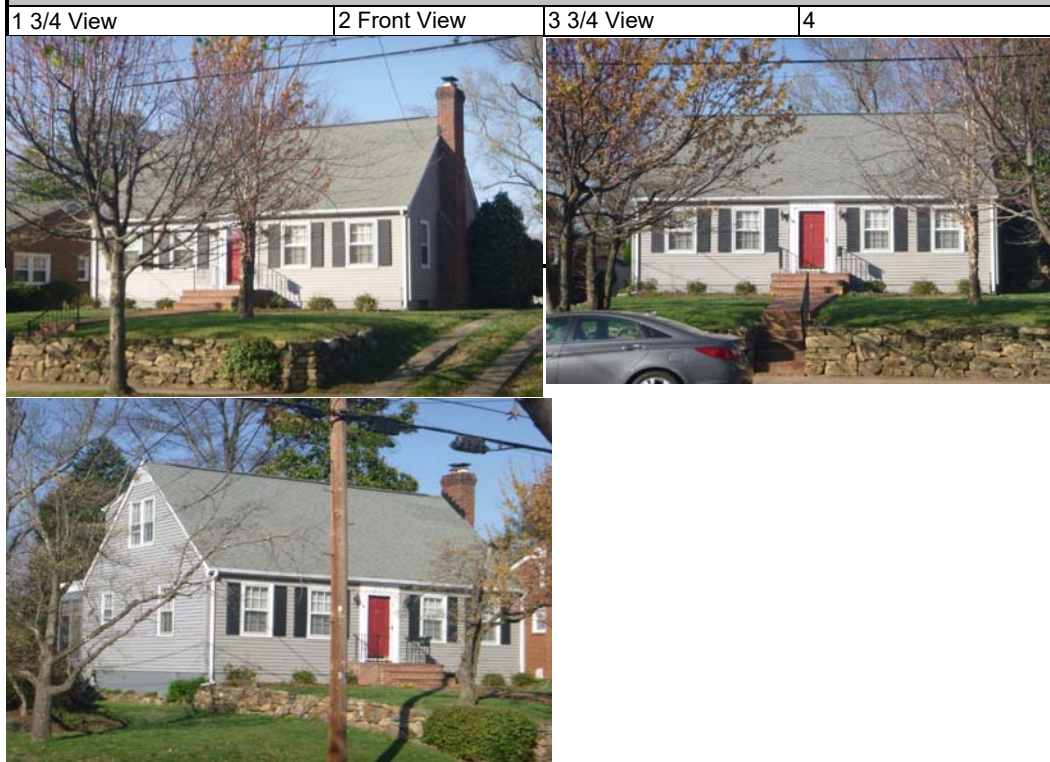
Name of Surveyors	Kimberly Packett		Survey Date	3/12/2016
ADDRESS	Street		Number	
	Stafford Avenue		1204	
TYPE & NUMBER OF BLGS & STRUCTURES	Type		Number	
	Single Family House		1	
	Shed		1	
Current Use of Primary Building	Single Family	Historic Use of Primary Building	Single Family	
Style of Primary Bldg	Cape Cod			
Number of Stories	1 1/2	Width (bays)	5	
Foundation Material	Cinderblock	Depth (rooms)	3	
Year Built	1954	Wall Cladding Material	Vinyl siding	
Roof Shape	Side Gable	Roof Material	Composition shingles	
Decorative Details/Unique Features	Black shutters on front windows. White pilasters and crown around front door.			
Evidence of Integrity Location/Materials	None			
Additions/Alterations to Primary Building	New vinyl siding, roof, and windows.			
Condition of Primary Building	Good			code G
Observable Threats	None			
Compatibility with Adjacent Land Uses	Good			
Potential NR Eligibility	Contributing			code C

Other Comments / Salient Details	Stone retaining wall along front and left of property and left side of driveway. Cement driveway on right side of the house. Brick stairs and path with iron railing leading to front door. Chimney on right end of house. Sunroom on the rear of the house. Small bushes along front of the house.

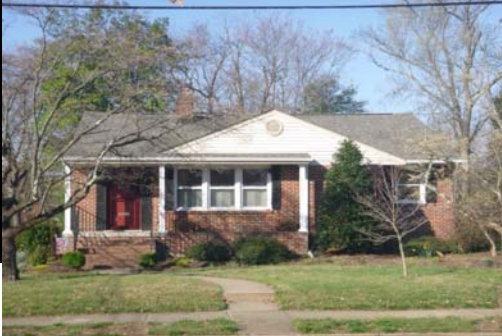
Name of Surveyors	Kimberly Packett		Survey Date	3/12/2016
ADDRESS	Street		Number	
	Stafford	Avenue	1200	
TYPE & NUMBER OF BLGS & STRUCTURES	Type		Number	
	Single Family House		1	
Current Use of Primary Building	Single Family	Historic Use of Primary Building	Single Family	
Style of Primary Bldg	Minimal Traditional			
Number of Stories	1	Width (bays)	3	
Foundation Material	Cinderblock	Depth (rooms)	5	
Year Built	1950	Wall Cladding Material	Brick	
Roof Shape	Cross Gable	Roof Material	Composition shingle	
Decorative Details/Unique Features	Black shutters on front windows and front door. Front center gable with horizontal siding and decoartive white circular vent. Brick front porch with roof overhang supported by white supports.			
Evidence of Integrity Location/Materials	Original brick siding and possibly original windows.			
Additions/Alterations to Primary Building	New roof.			
Condition of Primary Building	Good		code

G	
Observable Threats	None			
Compatibility with Adjacent Land Uses	Good			
Potential NR Eligibility	Contributing		code	
			C	
Other Comments / Salient Details	Cement path leading from sidewalk to brick stairs and landing with iron railing leading to front door. Bushes along front of house. Interior chimney.			
Photo Views				
1 Front View	2	3	4

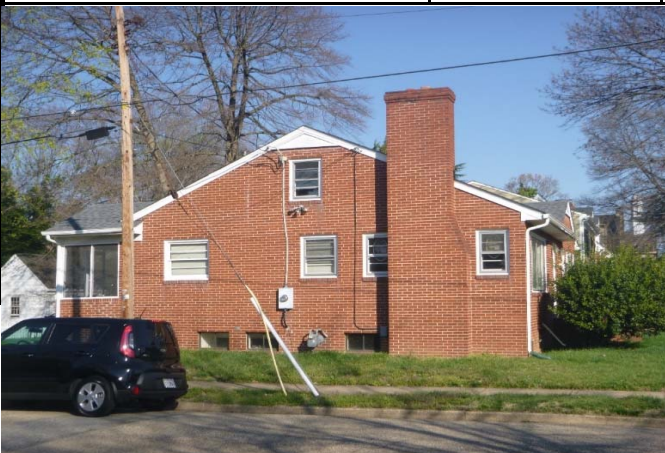
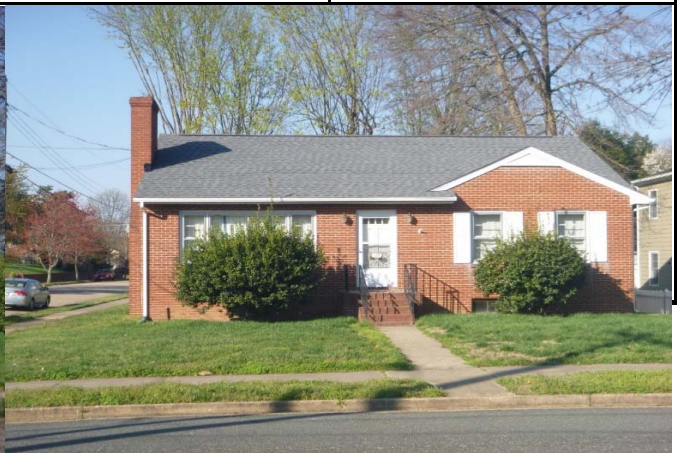
Name of Surveyors	Kimberly Packett		Survey Date	3/12/2016
ADDRESS	Street		Number	
	Augustine Avenue		1200	
TYPE & NUMBER OF BLGS & STRUCTURES	Type		Number	
	Single Family House		1	
Current Use of Primary Building	Single Family	Historic Use of Primary Building	Single Family	
Style of Primary Blg	Cape Cod			
Number of Stories	1	Width (bays)	4	
Foundation Material	Concrete	Depth (rooms)	2	
Year Built	1956	Wall Cladding Material	Brick	
Roof Shape	Gable	Roof Material	Composition shingles	
Decorative Details/Unique Features	White shutters on front white windows. Front gable on right front of house.			
Evidence of Integrity Location/Materials	Original brick siding and possibly original windows.			
Additions/Alterations to Primary Building	New roof			
Condition of Primary Building	Good			code G
Observable Threats	None			
Compatibility with Adjacent Land Uses	Good			
Potential NR Eligibility	Contributing			code C
Other Comments / Salient Details	Bushes along the front of the house. Cement path leading from sidewalk to brick stairs with iron railing leading to front door. Sunroom on rear of the house. Chimney on left end of the house.

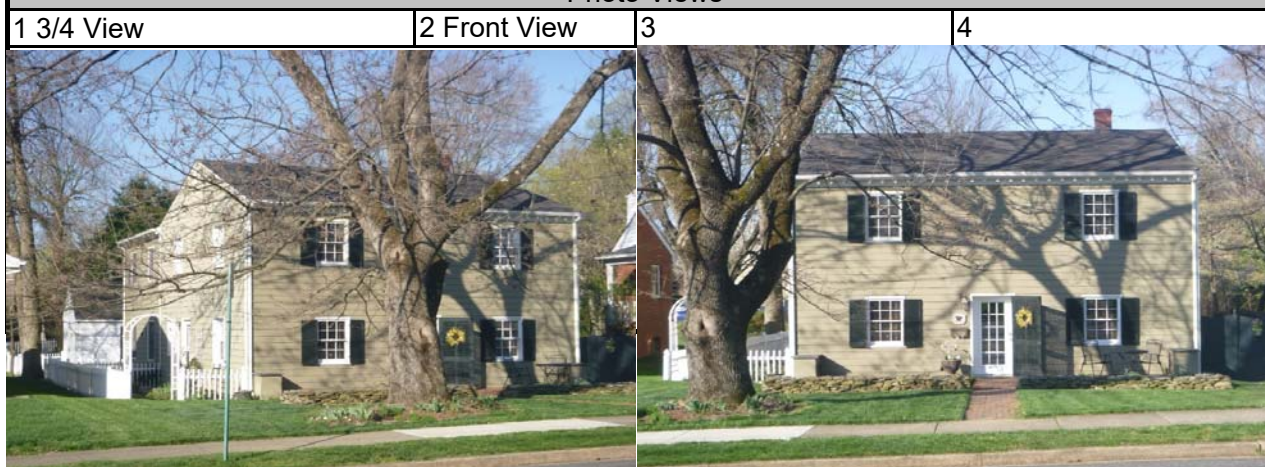
Name of Surveyors	Kimberly Packett		Survey Date	3/12/2016
ADDRESS	Street		Number	
	Augustine Avenue		1204	
TYPE & NUMBER OF BLGS & STRUCTURES	Type		Number	
	Single Family House		1	
	Shed		1	
Current Use of Primary Building	Single Family	Historic Use of Primary Building	Single Family	
Style of Primary Blg	Colonial Revival			
Number of Stories	2	Width (bays)	3	
Foundation Material	Cinderblock	Depth (rooms)	4	
Year Built	1948	Wall Cladding Material	Vinyl siding	
Roof Shape	Gable	Roof Material	Composition shingles	
Decorative Details/Unique Features	Dentils along front of house. Black shutters on front windows and front door. White surround around front door.			
Evidence of Integrity Location/Materials	Dentils appear to be original.			
Additions/Alterations to Primary Building	Two story addition on back of house, new vinyl siding, new windows, and new roof.			
Condition of Primary Building	Good			code G
Observable Threats	None

Compatibility with Adjacent Land Uses	Good			
Potential NR Eligibility	Contributing			code C
Other Comments / Salient Details	Brick path leading from sidewalk to front door. White picket fence around left side of property. Green privacy fence around backyard. White shed in backyard. Interior chimney on back of the house. Short stone wall along front of the house. Side door on left side of the house.

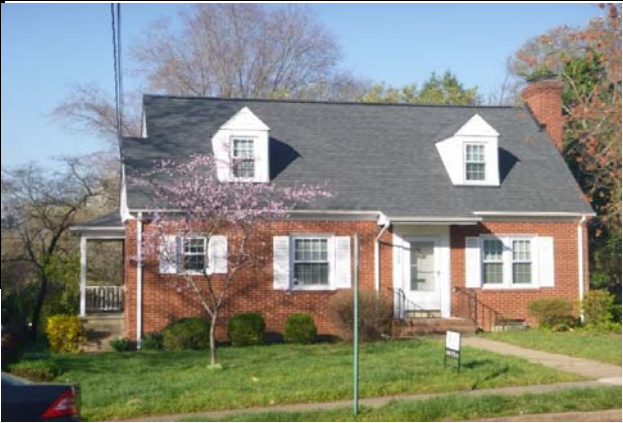
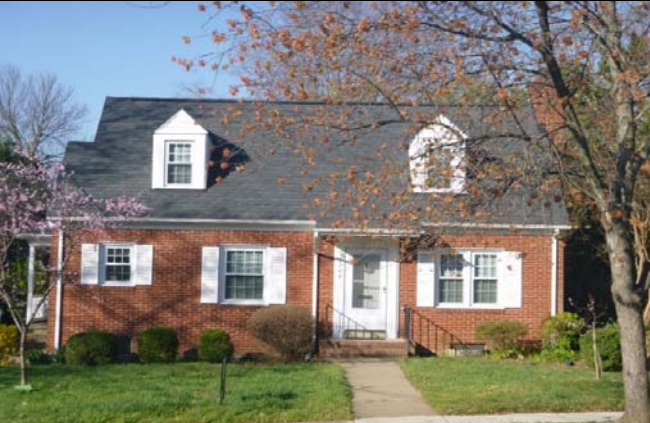
Name of Surveyors	Kimberly Packett		Survey Date	3/12/2016
ADDRESS	Street		Number	
	Augustine Avenue		1208	
TYPE & NUMBER OF BLGS & STRUCTURES	Type		Number	
	Single Family House		1	
Current Use of Primary Building	Single Family	Historic Use of Primary Building	Single Family	
Style of Primary Blg	Cape Cod			
Number of Stories	1 1/2	Width (bays)	4	
Foundation Material	Cinderblock	Depth (rooms)	3	
Year Built	1960	Wall Cladding Material	Brick	
Roof Shape	Gable	Roof Material	Composition shingles	
Decorative Details/Unique Features	Two front gable dormers on front of house with wood siding. White shutters on front first story windows. White pilasters and crown around front door. Roof hands over front door slightly.			
Evidence of Integrity Location/Materials	Original brick siding.			
Additions/Alterations to Primary Building	New windows and roof. New vinyl siding on gable ends.			
Condition of Primary Building	Good			code G

Observable Threats	None			
Compatibility with Adjacent Land Uses	Good			
Potential NR Eligibility	Contributing			code C
Other Comments / Salient Details	Cement path leading from sidewalk to brick stairs with iron railing leading to front door. Small bushes along front of house. Cement steps leads to side door on left side of house with roof overhang and white railing. Chimney on right end of house.			
Photo Views				
1 3/4 View	2 Front View	3	4

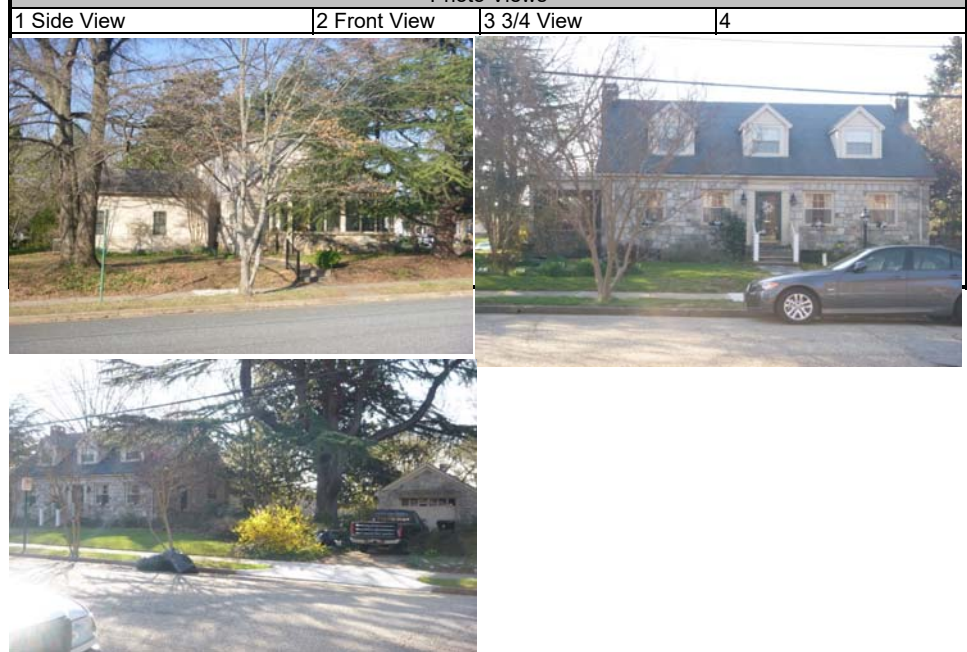
Name of Surveyors	Kimberly Packett		Survey Date	3/12/2016
ADDRESS	Street		Number	
	Brent	Street	1302	
TYPE & NUMBER OF BLGS & STRUCTURES	Augustine		Number	
	Single Family House		1	
	Detatched Garage		1	
Current Use of Primary Building	Single Family	Historic Use of Primary Building	Single Family	
Style of Primary Blg	Cape Cod			
Number of Stories	1 1/2	Width (bays)	6	
Foundation Material	Cinderblock	Depth (rooms)	3	
Year Built	1950	Wall Cladding Material	Stone	
Roof Shape	Side gable	Roof Material	Slate	
Decorative Details/Unique Features	Three front gable dormers on front of house with vinyl siding. Tan crown and pilasters around front door.			
Evidence of Integrity Location/Materials	Original stone siding and possibly original windows and roof.			
Additions/Alterations to Primary Building	Rear addition with vinyl siding.			
Condition of Primary Building	Good			code G
Observable Threats	None			
Compatibility with Adjacent Land Uses	Good

Potential NR Eligibility	Contributing			code C
Other Comments / Salient Details	Chimneys on either end of the house. Dirt and gravel driveway leading to detached garage in back of the property. Cement path leading from sidewalk to brick stairs with white railing leading to front door. Sun room on left side of the house.

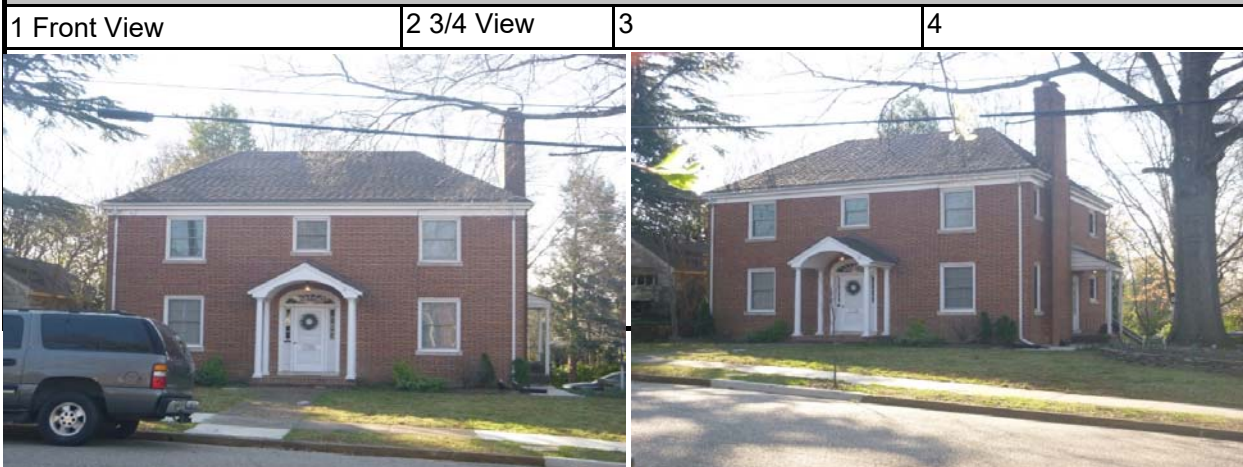
Name of Surveyors	Kimberly Packett		Survey Date	3/12/2016
ADDRESS	Street		Number	
	Brent	Street	1308	
TYPE & NUMBER OF BLGS & STRUCTURES	Type		Number	
	Single Family House		1	
Current Use of Primary Building	Single Family	Historic Use of Primary Building	Single Family	
Style of Primary Blg	Colonial Revival			
Number of Stories	2	Width (bays)	3	
Foundation Material	Concrete	Depth (rooms)	3	
Year Built	1952	Wall Cladding Material	Brick	
Roof Shape	Hip	Roof Material	Composition shingle	
Decorative Details/Unique Features	Front gable portico with four columns above front door. Front door has sidelights on either side of the front door and semi-circular transom above the front door.			
Evidence of Integrity Location/Materials	Original brick siding and windows.			
Additions/Alterations to Primary Building	New roof.			
Condition of Primary Building	Good			code G
Observable Threats	None			
Compatibility with Adjacent Land Uses	Good

Potential NR Eligibility	Contributing			code C
Other Comments / Salient Details	Brick path and stairs leading to front door from the sidewalk. Paved driveway on right side of the house. Cement path from driveway to side door on right side of the house with brick stairs and iron railing. Overhang above side door entrance. Small bushes and garden along front of house. Chimney on right end of house.

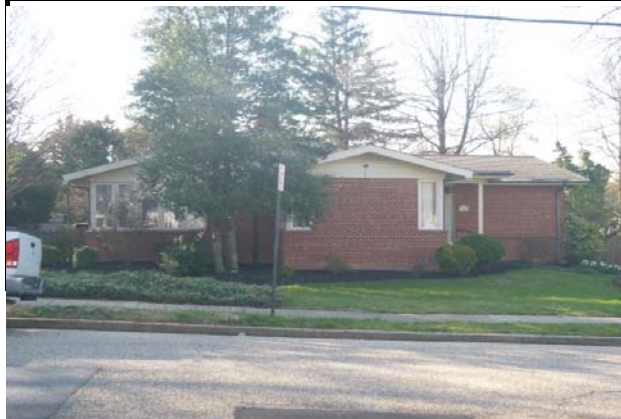
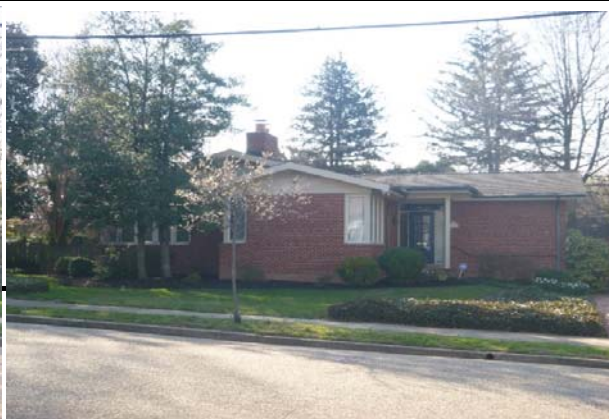
Name of Surveyors	Kimberly Packett		Survey Date	3/12/2016
ADDRESS	Street		Number	
	Brent	Street	1316	
TYPE & NUMBER OF BLGS & STRUCTURES	Type		Number	
	Single Family House		1	
Current Use of Primary Building	Single Family	Historic Use of Primary Building	Single Family	
Style of Primary Bldg	Minimal traditional			
Number of Stories	1	Width (bays)	4	
Foundation Material	Cinderblock	Depth (rooms)	3	
Year Built	1963	Wall Cladding Material	Brick	
Roof Shape	Cross Gable	Roof Material	Composition shingle	
Decorative Details/Unique Features	Sidelights and transom around front door. Roof hangs over front door landing with white support. Wood siding on gable ends.			
Evidence of Integrity Location/Materials	Original brick siding.			
Additions/Alterations to Primary Building	New windows and roof.			
Condition of Primary Building	Good	code		
		G		
Observable Threats	None			
Compatibility with Adjacent Land Uses	Good

Potential NR Eligibility	Contributing	code		
		C		
Other Comments / Salient Details	Gravel driveway on right side of house. Cement path leading from driveway to front door. Ivy along left side of driveway and left side of property. Garden with bushes along front of the house. Interior chimney.			
Photo Views				
1 Front View	2 3/4 View	3	4

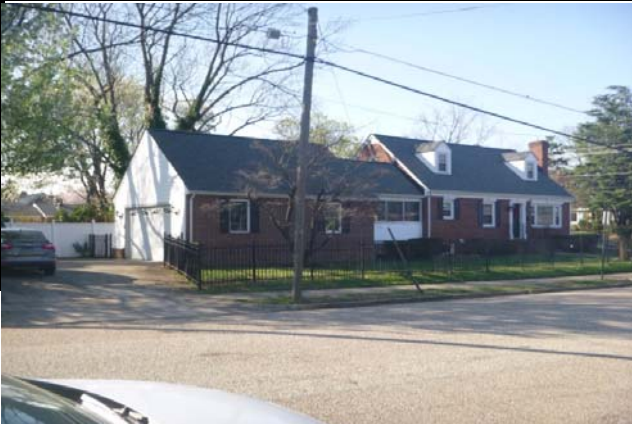
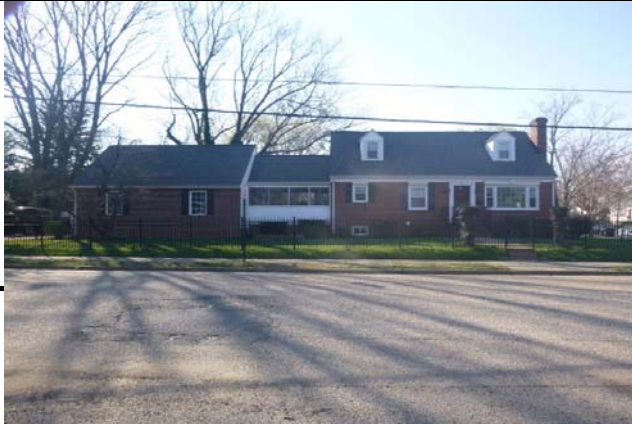
Name of Surveyors	Kimberly Packett		Survey Date	3/12/2016
ADDRESS	Street		Number	
	Stafford Avenue		1217	
TYPE & NUMBER OF BLGS & STRUCTURES	Type		Number	
	Single Family House		1	
Current Use of Primary Building	Single Family	Historic Use of Primary Building	Single Family	
Style of Primary Blg	Cape Cod			
Number of Stories	2	Width (bays)	4	
Foundation Material	Brick	Depth (rooms)	2	
Year Built	1948	Wall Cladding Material	Brick	
Roof Shape	Side Gable	Roof Material	Composition shingle	
Decorative Details/Unique Features	White lintel with keystone on main house first story windows. White pilasters and crown around front door. Two front gable dormers with white vinyl siding. Blue shutters on first story front windows.			
Evidence of Integrity Location/Materials	Original brick siding. Original windows on main house.			
Additions/Alterations to Primary Building	New roof. Attached garage is addition along with hallway attaching garage to main house.

Condition of Primary Building	Excellent		code	
			E	
Observable Threats	None			
Compatibility with Adjacent Land Uses	Good			
Potential NR Eligibility	Contributing		code	
			C	
Other Comments / Salient Details	Black iron fence around yard. Brick path leading from sidewalk to brick stairs with iron railing leading to front door. Chimney on right end of house. Attached garage is attached by a section with vinyl siding. Bushes along front of house.			
Photo Views				
1 3/4 View	2 Front View	3	4

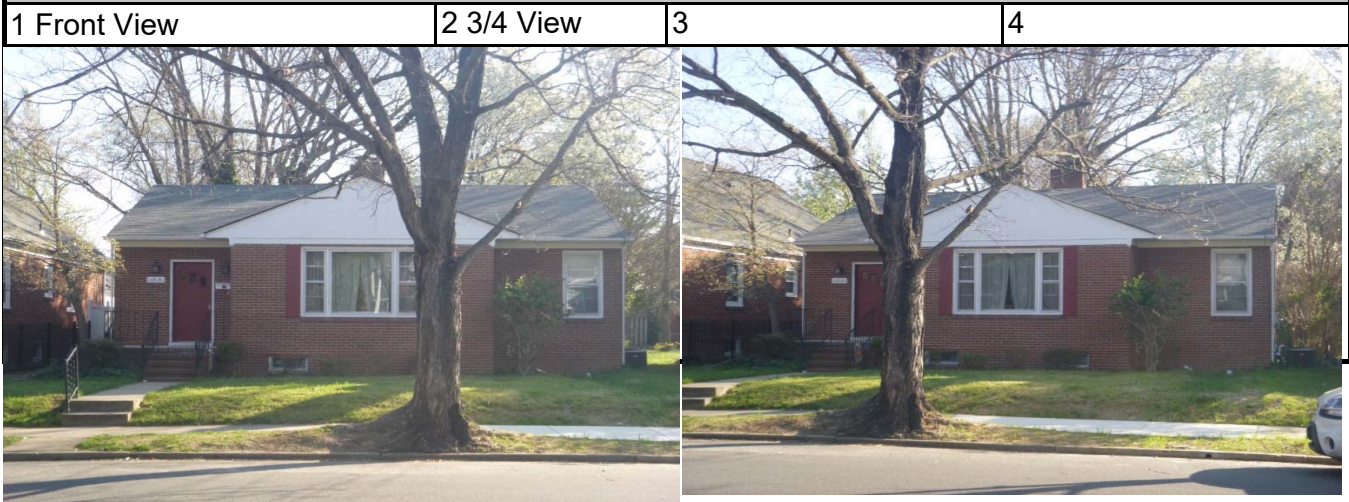
Name of Surveyors	Kimberly Packett		Survey Date	3/12/2016
ADDRESS	Street		Number	
	Stafford	Avenue	1213	
TYPE & NUMBER OF BLGS & STRUCTURES	Type		Number	
	Single Family House		1	
Current Use of Primary Building	Single Family	Historic Use of Primary Building	Single Family	
Style of Primary Blg	Minimal Traditional			
Number of Stories	1	Width (bays)	3	
Foundation Material	Cinderblock	Depth (rooms)	2	
Year Built	1954	Wall Cladding Material	Brick	
Roof Shape	Side gable	Roof Material	Composition shingles	
Decorative Details/Unique Features	Red shutters on center front window. Front gable on center front of house. Vertical white siding on front center gable.			
Evidence of Integrity Location/Materials	Original brick siding and windows.			
Additions/Alterations to Primary Building	New roof			
Condition of Primary Building	Good			code
				G
Observable Threats	None			
Compatibility with Adjacent Land Uses	Good			
Potential NR Eligibility	Contributing			code

C
Other Comments / Salient Details	Central chimney. Brick and cement stairs and path leading from sidewalk to front door with iron railings.

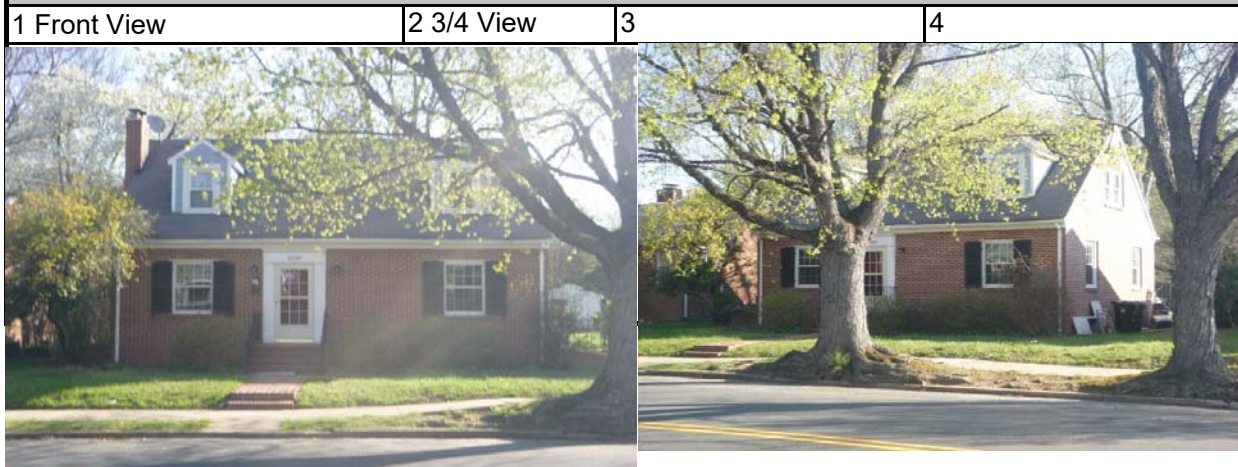
Name of Surveyors	Kimberly Packett		Survey Date	3/12/2016
ADDRESS	Street		Number	
	Stafford	Avenue	1209	
TYPE & NUMBER OF BLGS & STRUCTURES	Type		Number	
	Single Family House		1	
Current Use of Primary Building	Single Family	Historic Use of Primary Building	Single Family	
Style of Primary Blg	Cape Cod			
Number of Stories	1.5	Width (bays)	3	
Foundation Material	Cinderblock	Depth (rooms)	2	
Year Built	1951	Wall Cladding Material	Brick	
Roof Shape	Side Gable	Roof Material	Composition shingle	
Decorative Details/Unique Features	Two front gable dormers on the front of the house with blue vinyl siding. White pilasters and crown around front door. Black shutters on first story front windows.			
Evidence of Integrity Location/Materials	Original brick siding.			
Additions/Alterations to Primary Building	New windows and roof.			
Condition of Primary Building	Good			code
				G
Observable Threats	None			
Compatibility with Adjacent Land Uses	Good

Potential NR Eligibility	Contributing			code
				C
Other Comments / Salient Details	Brick stairs and path with iron railings leading to front door. Bushes along front of house. Chimney on left end of the house.

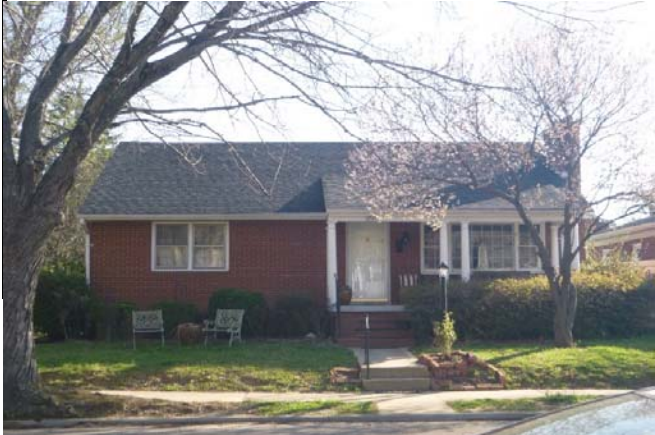
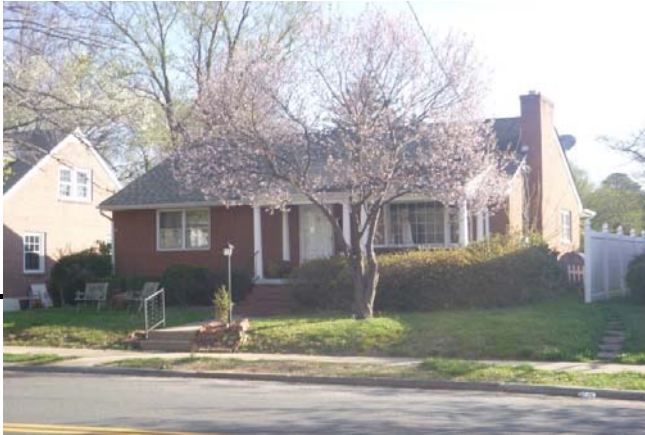
Name of Surveyors	Kimberly Packett	Survey Date	3/12/2016
ADDRESS	Street	Number	
	Stafford Avenue	1205	
TYPE & NUMBER OF BLGS & STRUCTURES	Type	Number	
	Single Family House	1	
	Shed	1	
Current Use of Primary Building	Single Family	Historic Use of Primary Building	Single Family
Style of Primary Blg	Minimal Traditional		
Number of Stories	1	Width (bays)	3
Foundation Material	Cinderblock	Depth (rooms)	2
Year Built	1962	Wall Cladding Material	Brick
Roof Shape	Side Gable	Roof Material	Composition shingle
Decorative Details/Unique Features	Roof hangs over front porch with 5 white columns.		
Evidence of Integrity Location/Materials	Original brick siding and windows.		
Additions/Alterations to Primary Building	New roof.		
Condition of Primary Building	Good	code	
		G	
Observable Threats	None		
Compatibility with Adjacent Land Uses	Good		
Potential NR Eligibility	Contributing	code	
		C	
Other Comments / Salient Details	Cement steps and path with iron railing leading from sidewalk to brick stairs with iron railing and front porch in front of front door. Bushes along front of house. Chimney on right end of house. Lamp post in front yard.

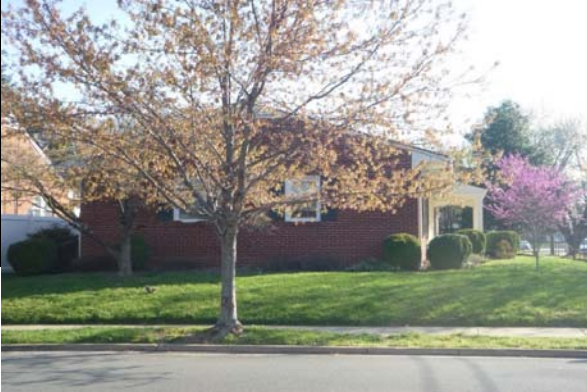
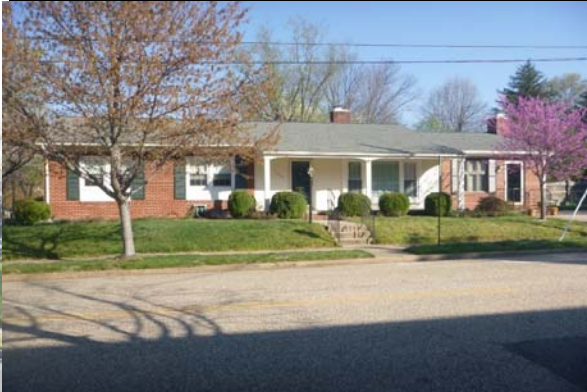
Name of Surveyors	Kimberly Packett		Survey Date	3/12/2016
ADDRESS	Street		Number	
	Royston	Street	1325	
TYPE & NUMBER OF BLGS & STRUCTURES	Type		Number	
	Single Family House		1	
	Shed		1	
Current Use of Primary Building	Single Family	Historic Use of Primary Building	Single Family	
Style of Primary Blg	Ranch			
Number of Stories	1	Width (bays)	6	
Foundation Material	Cinderblock	Depth (rooms)	3	
Year Built	1962	Wall Cladding Material	Brick, wood siding	
Roof Shape	Gable	Roof Material	Composition shingles	
Decorative Details/Unique Features	White wood paneling underneath front left windows. Left side window and front windows on left side of the house have green shutters. Window on the front right side of the house has green and white shutters. White wood paneling on center section of the house where the front porch is. Roof hangs over front porch with white supports. Two front doors.			
Evidence of Integrity Location/Materials	Original siding on original portion of house.

Additions/Alterations to Primary Building	Addition on the right side of the house, new windows, new roof.			
Condition of Primary Building	Good		code	
			G	
Observable Threats	None			
Compatibility with Adjacent Land Uses	Good			
Potential NR Eligibility	Contributing		code	
			C	
Other Comments / Salient Details	Cement driveway on left side of the house. Cement stairs and path with iron railing leading to central front door. Small bushes along front and side of house. Chimney on right end of house and central chimney. Brick stairs with iron railing leading to door on the front right side of the house.			
Photo Views				
1 Side View	2 Front View	3	4

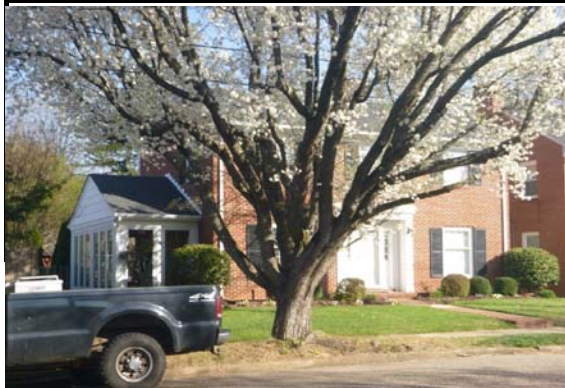
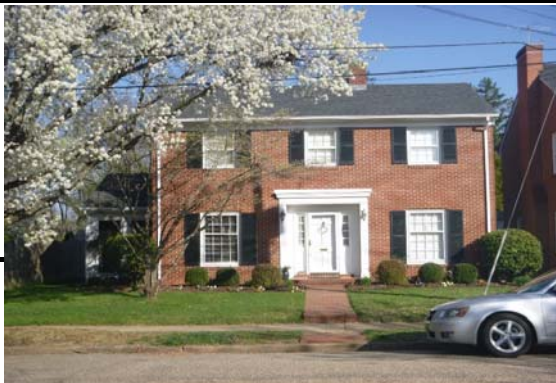
Name of Surveyors	Kimberly Packett		Survey Date	3/12/2016
ADDRESS	Street	Number		
	Royston Street	1321		
TYPE & NUMBER OF BLGS & STRUCTURES	Type	Number		
	Single Family House	1		
	Shed	1		
Current Use of Primary Building	Single Family	Historic Use of Primary Building	Single Family	
Style of Primary Bldg	Colonial Revival			
Number of Stories	2	Width (bays)	3	
Foundation Material	Concrete	Depth (rooms)	2	
Year Built	1964	Wall Cladding Material	Brick	
Roof Shape	Side gable	Roof Material	Composition shingle	
Decorative Details/Unique Features	Front door has sidelights on either side. Whole doorway has white pilasters and crown around it. Black shutters on front windows.			
Evidence of Integrity Location/Materials	Original brick siding			
Additions/Alterations to Primary Building	New roof and windows. Sun porch addition on left side of house.			
Condition of Primary Building	Excellent		code	
			E	
Observable Threats	None

Compatibility with Adjacent Land Uses	Good			
Potential NR Eligibility	Contributing		code	
			C	
Other Comments / Salient Details	Small bushes and garden along front of house. Sunroom on left side of the house. Central chimney. Brick stairs and path leading from sidewalk to front door.			
Photo Views				
1 3/4 View	2 Front View	3	4

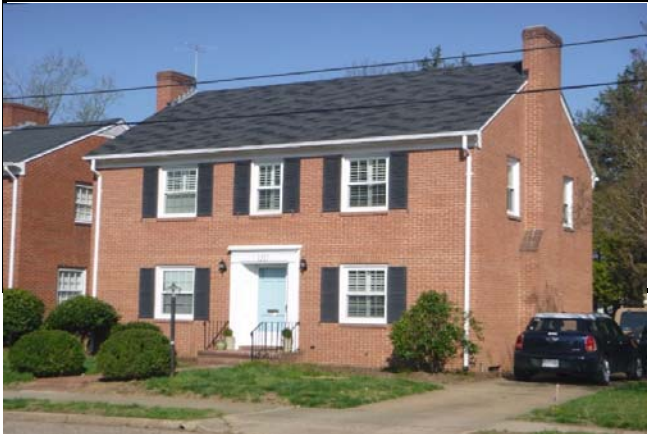
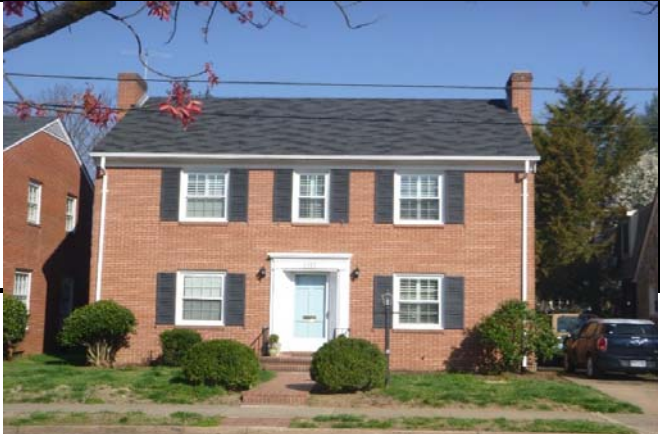
Name of Surveyors	Kimberly Packett		Survey Date	3/12/2016
ADDRESS	Street		Number	
	Royston	Street	1317	
TYPE & NUMBER OF BLGS & STRUCTURES	Type		Number	
	Single Family House		1	
	Shed		1	
Current Use of Primary Building	Single Family	Historic Use of Primary Building	Single Family	
Style of Primary Blg	Colonial Revival			
Number of Stories	2	Width (bays)	3	
Foundation Material	Concrete	Depth (rooms)	2	
Year Built	1956	Wall Cladding Material	Brick	
Roof Shape	Gable	Roof Material	Composition shingles	
Decorative Details/Unique Features	White pilasters and crown around front door. Black shutters on front window. Decorative brick lintel on first story front windows.			
Evidence of Integrity Location/Materials	Original brick siding			
Additions/Alterations to Primary Building	New windows and roof.			
Condition of Primary Building	Good			code
				G
Observable Threats	None			
Compatibility with Adjacent Land Uses	Good

Potential NR Eligibility	Contributing			code
				C
Other Comments / Salient Details	Wood privacy fence on right side of the property. Concrete driveway on right side of house. Bushes along front of house and walkway. Lamp post in front yard. Brick stairs with iron railing and path leading from sidewalk to front door. Chimneys on either end of the house.			
Photo Views				
1 3/4 View	2 Front View	3	4
