Cultural Resource Survey of College Heights in Fredericksburg, Virginia

Master of Science

Historic Preservation

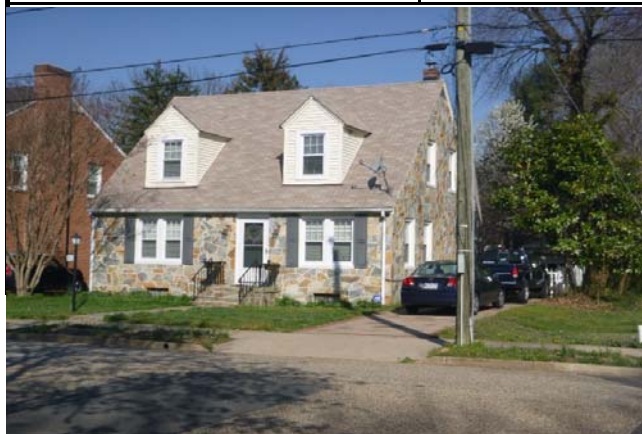
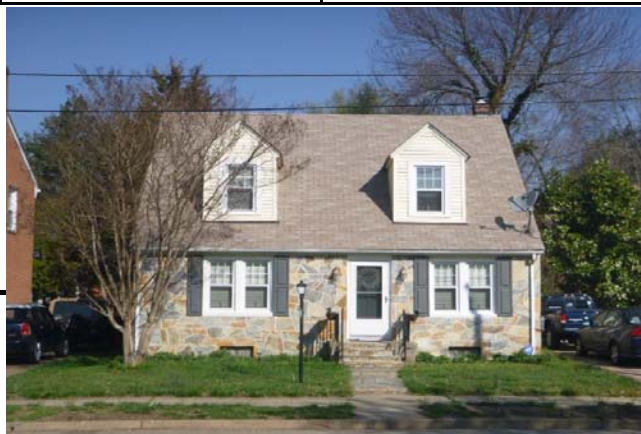
Name of Surveyors	Kimberly Packett		Survey Date	3/12/2016
ADDRESS	Street		Number	
	Royston	Street	1313	
TYPE & NUMBER OF BLGS & STRUCTURES	Type		Number	
	Single Family House		1	
	Detached garage		1	
Current Use of Primary Building	Single Family	Historic Use of Primary Building	Single Family	
Style of Primary Blg	Cape Cod			
Number of Stories	1.5	Width (bays)	3	
Foundation Material	Cinderblock	Depth (rooms)	3	
Year Built	150	Wall Cladding Material	Stone	
Roof Shape	Gable	Roof Material	Composition shingle	
Decorative Details/Unique Features	Green shutters on first story front windows. Two front gable dormers with vinyl siding on front of house.			
Evidence of Integrity Location/Materials	Possibly original stone siding.			
Additions/Alterations to Primary Building	New windows and roof.			
Condition of Primary Building	Good			code G
Observable Threats	None			
Compatibility with Adjacent Land Uses	Good			
Potential NR Eligibility	Contributing			code C

Other Comments / Salient Details	Cement driveway on right side of the house leads to detached garage in backyard. Stone path and steps with iron railing leading from sidewalk to front door. Chimney on right side of house.

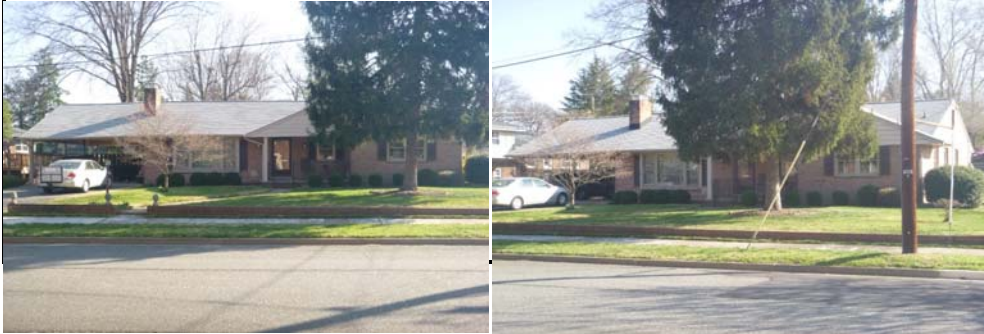
Name of Surveyors	Kimberly Packett		Survey Date	3/12/2016
ADDRESS	Street		Number	
	Rappahannock Avenue		1209	
TYPE & NUMBER OF BLGS & STRUCTURES	Type		Number	
	Single Family House		1	
Current Use of Primary Building	Single Family	Historic Use of Primary Building	Single Family	
Style of Primary Bldg	Ranch			
Number of Stories	1	Width (bays)	4	
Foundation Material	Cinderblock	Depth (rooms)	3	
Year Built	1965	Wall Cladding Material	Brick	
Roof Shape	Side gable	Roof Material	Composition shingle	
Decorative Details/Unique Features	Black shutters on front windows. Roof hangs over front door landing supported by white column. Front gable on front right side of house. Horizontal aluminum siding on front gable.			
Evidence of Integrity Location/Materials	Original brick siding. Possibly original windows.			
Additions/Alterations to Primary Building	Carport addition on left side of house. New roof.			
Condition of Primary Building	Good		code	G

Observable Threats	None			
Compatibility with Adjacent Land Uses	Good			
Potential NR Eligibility	Contributing		code	C
Other Comments / Salient Details	Cement driveway on the left side of the house leading to attached carport. Small bushes along front of house. Cement steps and path leading to front door with iron railing. Chimney on left end of house. Decorative pineapples on small brick wall around property.			
Photo Views				
1 Front View	2 3/4 View	3	4

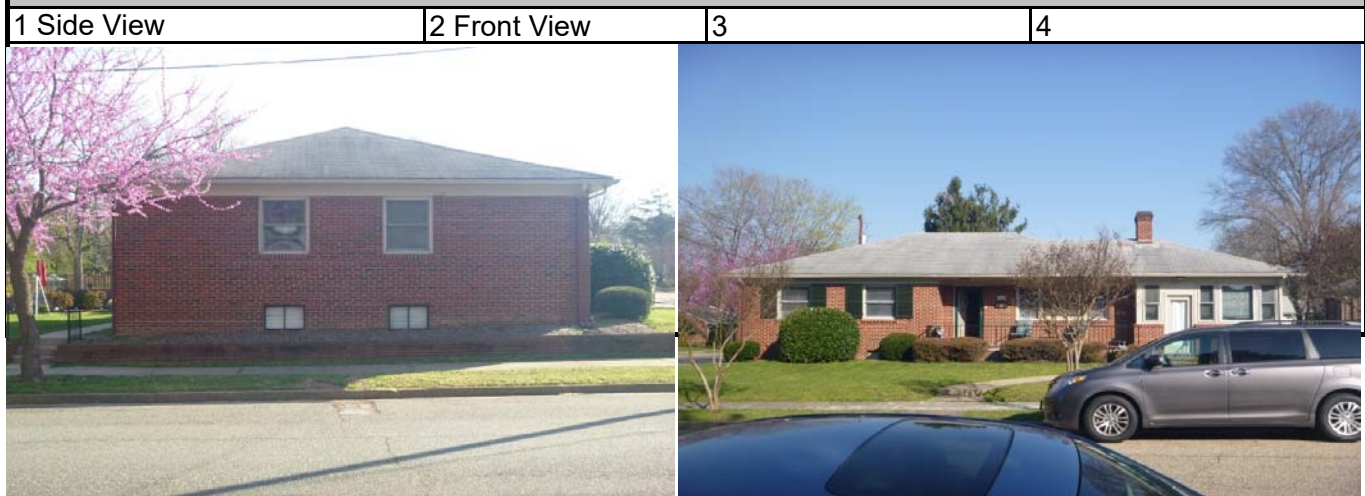
Name of Surveyors	Kimberly Packett		Survey Date	3/12/2016
ADDRESS	Street		Number	
	Royston	Street	1429	
TYPE & NUMBER OF BLGS & STRUCTURES	Type		Number	
	Single Family House		1	
	Shed		1	
Current Use of Primary Building	Single Family	Historic Use of Primary Building	Single Family	
Style of Primary Bldg	Ranch			
Number of Stories	1	Width (bays)	6	
Foundation Material	Cinderblock	Depth (rooms)	2	
Year Built	1963	Wall Cladding Material	Brick	
Roof Shape	Side gable	Roof Material	Composition shingles	
Decorative Details/Unique Features	Dark green shutters on front left side of the house. Two front doors. Tan siding on former attached garage.			
Evidence of Integrity Location/Materials	Original brick siding and original windows on original part of the house.			
Additions/Alterations to Primary Building	Attached garage on the right side of the house was converted into a livable space. New roof.			
Condition of Primary Building	Good			code G

Observable Threats	None			
Compatibility with Adjacent Land Uses	Good			
Potential NR Eligibility	Contributing			code C
Other Comments / Salient Details	Bushes along front of house. Chimney on right side of the house. Cement path and steps leading to door on the right side and front porch with iron railing.

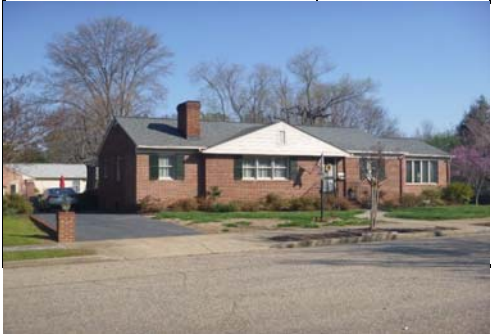
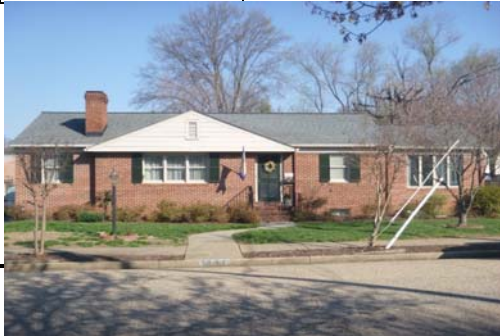
Name of Surveyors	Kimberly Packett		Survey Date	3/12/2016
ADDRESS	Street		Number	
	Royston	Street	1427	
TYPE & NUMBER OF BLGS & STRUCTURES	Type		Number	
	Single Family House		1	
Current Use of Primary Building	Single Family	Historic Use of Primary Building	Single Family	
Style of Primary Bldg	Ranch			
Number of Stories	1	Width (bays)	5	
Foundation Material	Cinderblock	Depth (rooms)	3	
Year Built	1957	Wall Cladding Material	Brick	
Roof Shape	Side Gable	Roof Material	Composition shingle	
Decorative Details/Unique Features	Front gable with horizontal siding on center front of the house. Green shutters on front of the house.			
Evidence of Integrity Location/Materials	Original brick siding and windows.			
Additions/Alterations to Primary Building	New roof.			
Condition of Primary Building	Good			code G
Observable Threats	None			
Compatibility with Adjacent Land Uses	Good			
Potential NR Eligibility	Contributing			code C

Other Comments / Salient Details	Paved driveway on left side of the house. Cement path from leading from sidewalk to brick stairs with iron railing leading to front door. Small bushes and garden along the front of the house. Chimney on left side of the house. Lamp post in front yard.			
Photo Views				
1 3/4 View	2 Front View	3	4

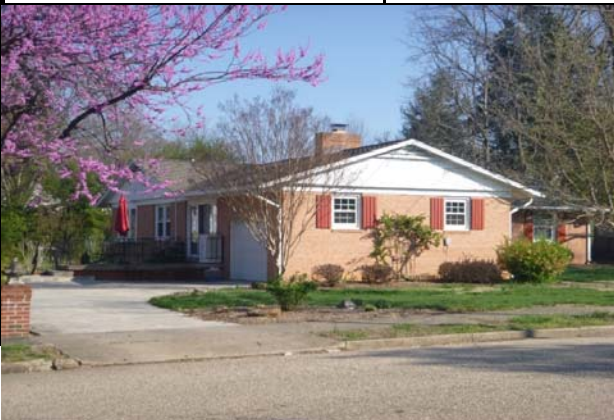
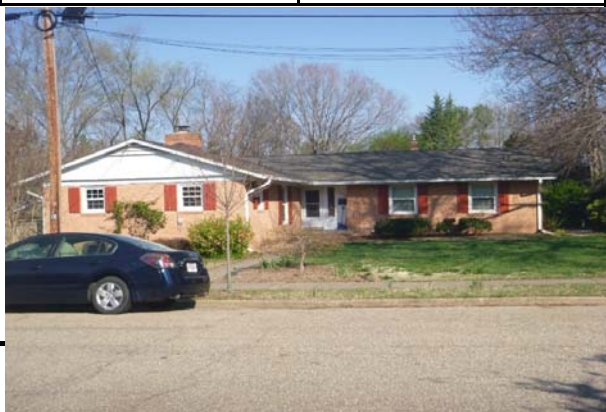
Name of Surveyors	Kimberly Packett		Survey Date	3/12/2016
ADDRESS	Street		Number	
	Royston	Street	1415	
TYPE & NUMBER OF BLGS & STRUCTURES	Type		Number	
	Single Family House		1	
Current Use of Primary Building	Single Family	Historic Use of Primary Building	Single Family	
Style of Primary Bldg	Ranch			
Number of Stories	1	Width (bays)	5	
Foundation Material	Cinderblock	Depth (rooms)	4	
Year Built	1963	Wall Cladding Material	Brick	
Roof Shape	Cross gable	Roof Material	Composition shingle	
Decorative Details/Unique Features	Red picket fence shutters on front windows. Sidelight on right side of front door with white paneling. White siding on front gable.			
Evidence of Integrity Location/Materials	Original brick siding.			
Additions/Alterations to Primary Building	New windows and roof.			
Condition of Primary Building	Good		code	G
Observable Threats	None			
Compatibility with Adjacent Land Uses	Good			
Potential NR Eligibility	Contributing		code	C

Other Comments / Salient Details	Paved driveway on left side of the house leading to attached garage. Cement path leading to front door. Cement path and steps with iron railing leading from driveway to back door. Central chimney. Bushes and garten along base of house.

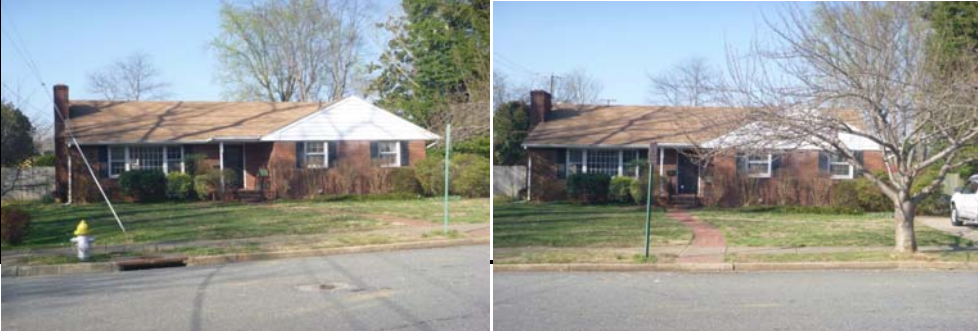
Name of Surveyors	Kimberly Packett		Survey Date	3/12/2016
ADDRESS	Street		Number	
	Colony	Road	1200	
TYPE & NUMBER OF BLGS & STRUCTURES	Type		Number	
	Single Family House		1	
Current Use of Primary Building	Single Family	Historic Use of Primary Building	Single Family	
Style of Primary Bldg	Minimal Traditional			
Number of Stories	1	Width (bays)	4	
Foundation Material	Cinderblock	Depth (rooms)	2	
Year Built	1963	Wall Cladding Material	Brick	
Roof Shape	Side Gable	Roof Material	Composition shingle	
Decorative Details/Unique Features	Front gable on right side of house with wood siding. Black shutters on front windows. Roof hangs over front porch supported by white support.			
Evidence of Integrity Location/Materials	Original brick siding.			
Additions/Alterations to Primary Building	New roof and windows.			
Condition of Primary Building	Good		code	
			G	
Observable Threats	None			
Compatibility with Adjacent Land Uses	Good

Potential NR Eligibility	Contributing		code	
			C	
Other Comments / Salient Details	Cement driveway on right side of house. Brick path and stairs with iron railing leading from the sidewalk to the front door. Chimney on left end of the house. Bushes along the front of the house. Wood privacy fence around backyard. Cement path from driveway to brick path.			
Photo Views				
1 3/4 View	2 Front View	3	4

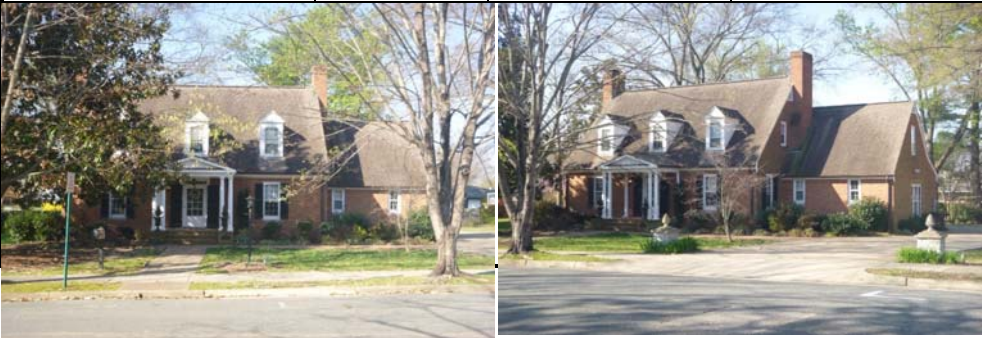
Name of Surveyors	Kimberly Packett		Survey Date	3/12/2016
ADDRESS	Street		Number	
	Colony	Road	1202	
TYPE & NUMBER OF BLGS & STRUCTURES	Type		Number	
	Single Family House		1	
Current Use of Primary Building	Single Family	Historic Use of Primary Building	Single Family	
Style of Primary Bldg	Cape Cod			
Number of Stories	1 1/2	Width (bays)	5	
Foundation Material	Cinderblock	Depth (rooms)	2	
Year Built	1960	Wall Cladding Material	Brick	
Roof Shape	Side Gable	Roof Material	Composition shingle	
Decorative Details/Unique Features	Three front gable dormers on front of house with wood siding. Black shutters on first story windows on main building. Transom above front door. Front gable portico with white columns over front landing.			
Evidence of Integrity Location/Materials	Original brick siding.			
Additions/Alterations to Primary Building	New windows and roof. Addition on back right side of the house.			
Condition of Primary Building	Good		code	G

Observable Threats	None			
Compatibility with Adjacent Land Uses	Good			
Potential NR Eligibility	Contributing		code	C
Other Comments / Salient Details	Cement driveway on right side of the house flanked by two decorative pineapples. Brick path and stairs leading from sidewalk to front door. Brick path leading from driveway to main brick path. Small bushes along front of house. Chimneys on either end of original house.			
Photo Views				
1 Front View	2 3/4 View	3	4

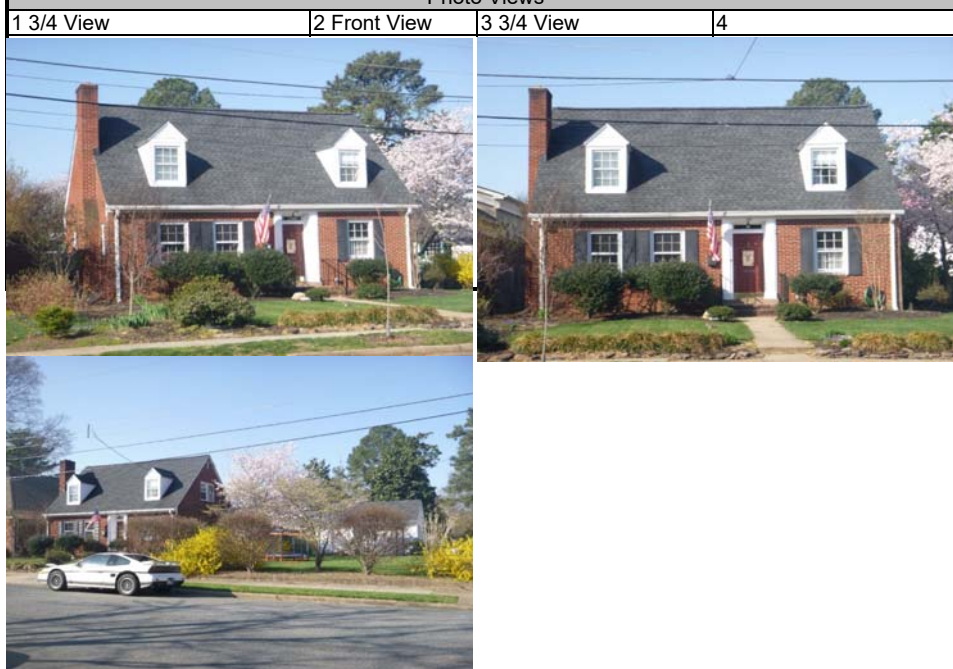
Name of Surveyors	Kimberly Packett		Survey Date	3/12/2016
ADDRESS	Street		Number	
	Colony	Road	1208	
TYPE & NUMBER OF BLGS & STRUCTURES	Type		Number	
	Single Family House		1	
	Shed		1	
Current Use of Primary Building	Single Family	Historic Use of Primary Building	Single Family	
Style of Primary Bldg	Cape Cod			
Number of Stories	1 1/2	Width (bays)	4	
Foundation Material	Cinderblock	Depth (rooms)	2	
Year Built	1949	Wall Cladding Material	Brick	
Roof Shape	Side Gable	Roof Material	Asbestos shingle	
Decorative Details/Unique Features	Transom above front door. White pilasters on either side of front door. Blue shutters on first story front windows. Two front gable dormers on front of house with wood siding.			
Evidence of Integrity Location/Materials	Original brick siding. Possibly original windows.			
Additions/Alterations to Primary Building	New roof.			
Condition of Primary Building	Good			code G
Observable Threats	None

Compatibility with Adjacent Land Uses	Good			
Potential NR Eligibility	Contributing			code C
Other Comments / Salient Details	Bushes and gardens along front of house and front of property. Chimney on left end of the house. Cement path and brick stairs with iron railing leading from sidewalk to the front door.

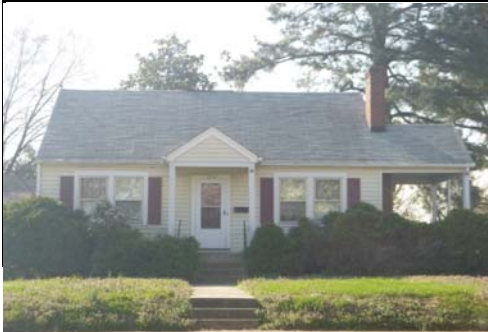
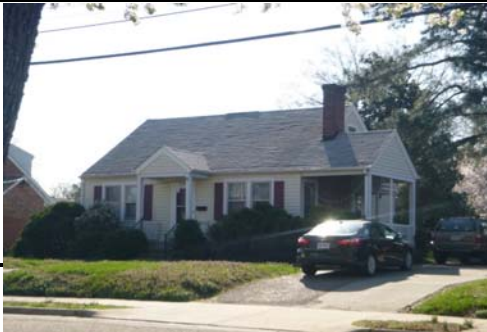
Name of Surveyors	Kimberly Packett		Survey Date	3/12/2016
ADDRESS	Street		Number	
	Brent	Street	1230	
TYPE & NUMBER OF BLGS & STRUCTURES	Type		Number	
	Single Family House		1	
Current Use of Primary Building	Single Family	Historic Use of Primary Building	Single Family	
Style of Primary Bldg	Cape Cod			
Number of Stories	1 1/2	Width (bays)	3	
Foundation Material	Cinderblock	Depth (rooms)	3	
Year Built	1949	Wall Cladding Material	Vinyl Siding	
Roof Shape	Side Gable	Roof Material	Composition shingle	
Decorative Details/Unique Features	Red shutters on the front windows. White surround around front windows and front door. Front gable portico above front porch with white beams. Front gable portico with white beams over side door.			
Evidence of Integrity Location/Materials	Possibly the brick chimney and windows.			
Additions/Alterations to Primary Building	New vinyl siding and roof.			
Condition of Primary Building	Good		code

G	
Observable Threats	None			
Compatibility with Adjacent Land Uses	Good			
Potential NR Eligibility	Contributing		code	
			C	
Other Comments / Salient Details	Chimney on right end of the house. Cement driveway on right side of the house. Cement stairs and path with iron railing leading to front door. Bushes along the front of the house. Side door on the right side of the house with front porch with white beams and railing and front gable portico.			
Photo Views				
1 Front View	2 3/4 View	3	4

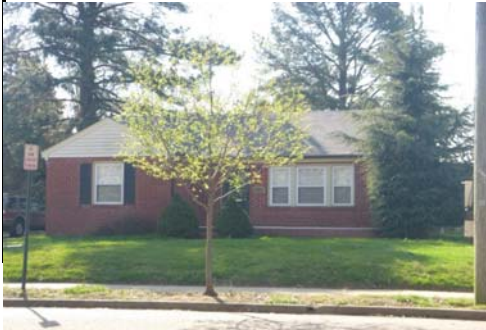
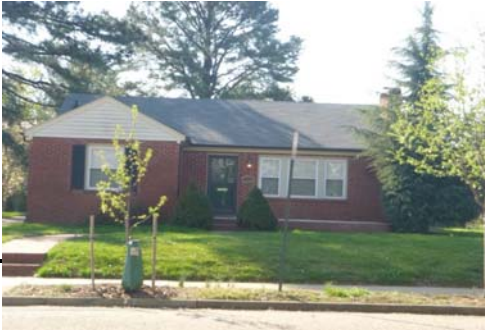
Name of Surveyors	Kimberly Packett		Survey Date	3/12/2016
ADDRESS	Street		Number	
	Brent	Street	1232	
TYPE & NUMBER OF BLGS & STRUCTURES	Type		Number	
	Single Family House		1	
Current Use of Primary Building	Single Family	Historic Use of Primary Building	Single Family	
Style of Primary Bldg	Minimal Traditional			
Number of Stories	1	Width (bays)	3	
Foundation Material	Cinderblock	Depth (rooms)	3	
Year Built	1950	Wall Cladding Material	Brick	
Roof Shape	Side Gable	Roof Material	Composition Shingle	
Decorative Details/Unique Features	Green shutters on left front window. Front door flanked by a tree on either side. Brick planter along the front right side of the house. Front gable on the front left side of the house with vinyl siding.			
Evidence of Integrity Location/Materials	Original brick siding.			
Additions/Alterations to Primary Building	New windows and roof.			
Condition of Primary Building	Good		code	G

Observable Threats	None			
Compatibility with Adjacent Land Uses	Good			
Potential NR Eligibility	Contributing		code	C
Other Comments / Salient Details	Chimney on the right side of the house. Brick stairs and path leading from sidewalk to the front door.			
Photo Views				
1 3/4 View	2 Front View	3	4

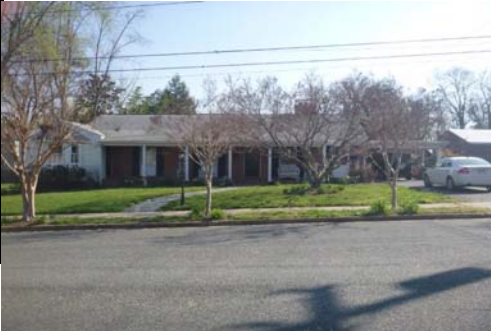
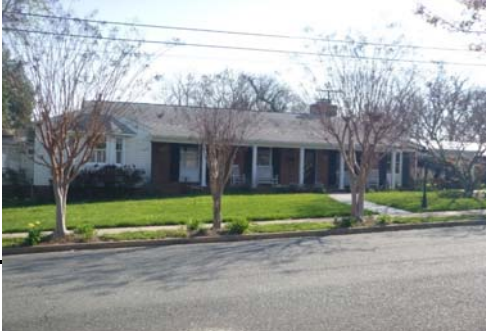
Name of Surveyors	Kimberly Packett		Survey Date	3/12/2016
ADDRESS	Street		Number	
	Augustine Avenue		1101	
TYPE & NUMBER OF BLGS & STRUCTURES	Type		Number	
	Single Family House		1	
Current Use of Primary Building	Single Family	Historic Use of Primary Building	Single Family	
Style of Primary Bldg	Ranch			
Number of Stories	1	Width (bays)	6	
Foundation Material	Cinderblock	Depth (rooms)	2	
Year Built	1965	Wall Cladding Material	Brick	
Roof Shape	Side gable	Roof Material	Composition shingle	
Decorative Details/Unique Features	Black shutters on front windows on original section of house. Addition on the left side of the house with vinyl siding and a bay window. Roof hangs over front porch supported by white beams. White paneling below front original windows.			
Evidence of Integrity Location/Materials	Original brick siding. Original windows on original section of the house.			
Additions/Alterations to Primary Building	Addition on the left side of the house with vinyl siding. New roof.

Condition of Primary Building	Good			code
				G
Observable Threats	None			
Compatibility with Adjacent Land Uses	Good			
Potential NR Eligibility	Contributing			code
				C
Other Comments / Salient Details	Cement driveway on right side of the house leading to attached carport. Stone path leading from sidewalk to brick steps leading to front porch. Small bushes and garden along front of house. Interior chimney on right side of the house. Lamp post in front lawn.			
Photo Views				
1 Front View	2 3/4 View	3	4

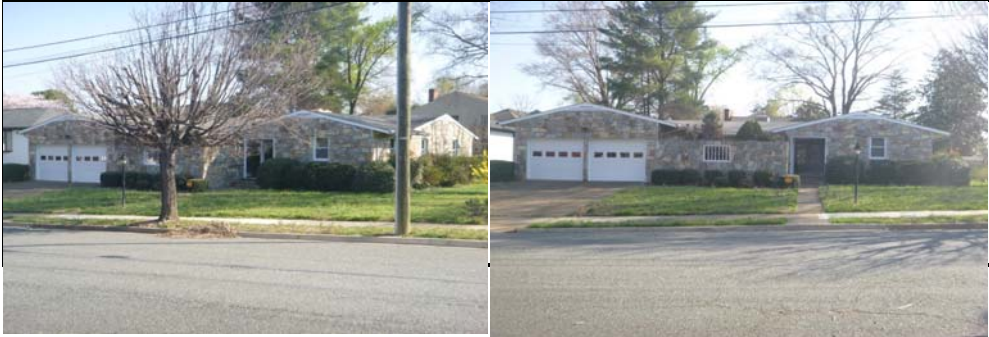
Name of Surveyors	Kimberly Packett		Survey Date	3/12/2016
ADDRESS	Street		Number	
	Augustine Avenue		1111	
TYPE & NUMBER OF BLGS & STRUCTURES	Type		Number	
	Single Family House		1	
Current Use of Primary Building	Single Family	Historic Use of Primary Building	Single Family	
Style of Primary Bldg	Ranch			
Number of Stories	1	Width (bays)	4	
Foundation Material	Cinderblock	Depth (rooms)	3	
Year Built	1974	Wall Cladding Material	Stone	
Roof Shape	Cross Gable	Roof Material	Composition shingle	
Decorative Details/Unique Features	Front gables on either end of the front of the house. Small courtyard to the left of the front door. Double green french doors.			
Evidence of Integrity Location/Materials	Original stone siding and windows.			
Additions/Alterations to Primary Building	New roof.			
Condition of Primary Building	Good		code	
			G	
Observable Threats	None			
Compatibility with Adjacent Land Uses	Good			
Potential NR Eligibility	Non-Contributing		code

N	
Other Comments / Salient Details	Cement driveway and stairs leading from sidewalk to front door. Lamp post on front lawn. Cement driveway on left side of the house leading to attached garage. Bushes along the front and the right of the house.			
Photo Views				
1 3/4 View	2 Front View	3	4

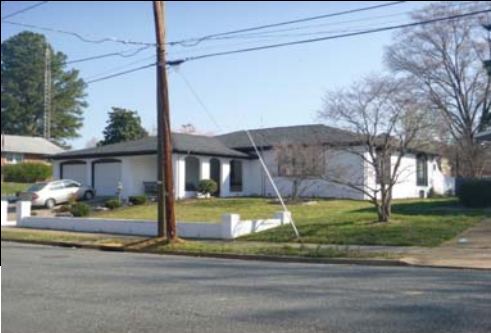
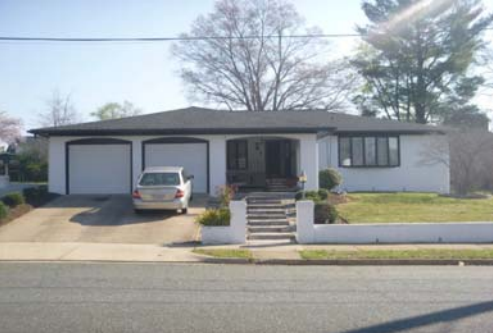
Name of Surveyors	Kimberly Packett		Survey Date	3/12/2016
ADDRESS	Street		Number	
	Augustine Avenue		1201	
TYPE & NUMBER OF BLGS & STRUCTURES	Type		Number	
	Single Family House		1	
Current Use of Primary Building	Single Family	Historic Use of Primary Building	Single Family	
Style of Primary Bldg	Neo-Mediterranean			
Number of Stories	1	Width (bays)	4	
Foundation Material	Cinderblock	Depth (rooms)	2	
Year Built	1974	Wall Cladding Material	Brick	
Roof Shape	Hip	Roof Material	Composition shingle	
Decorative Details/Unique Features	Roof extends over the front porch with brick wall archway on the right side of the porch. Sidelight on the right side of the front door.			
Evidence of Integrity Location/Materials	Original brick siding and windows.			
Additions/Alterations to Primary Building	New roof.			
Condition of Primary Building	Good	code		
		G		
Observable Threats	None			
Compatibility with Adjacent Land Uses	Fair, style doesn't fit in neighborhood.

Potential NR Eligibility	Non-Contributing	code		
		N		
Other Comments / Salient Details	Painted white brick wall along the front of the property. Cement driveway on the left side of the house leading to attached garage. Stone steps and path leading from sidewalk to front door. Lamp post in front yard.			
Photo Views				
1 3/4 View	2 Front View	3	4

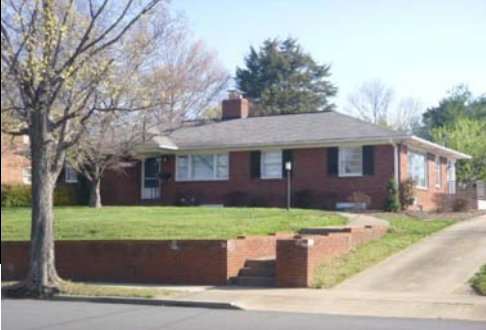
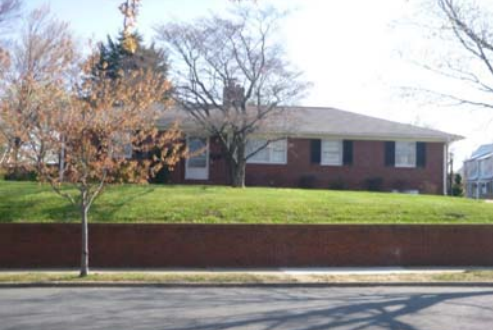
Name of Surveyors	Kimberly Packett		Survey Date	3/12/2016
ADDRESS	Street	Number		
	Stafford Avenue	1101		
TYPE & NUMBER OF BLGS & STRUCTURES	Type	Number		
	Single Family House	1		
Current Use of Primary Building	Single Family	Historic Use of Primary Building	Single Family	
Style of Primary Bldg	Ranch			
Number of Stories	1	Width (bays)	5	
Foundation Material	Cinderblock	Depth (rooms)	3	
Year Built	1958	Wall Cladding Material	Brick	
Roof Shape	Hip	Roof Material	Composition Shingle	
Decorative Details/Unique Features	Black shutters on front windows.			
Evidence of Integrity Location/Materials	Original brick siding and windows.			
Additions/Alterations to Primary Building	New roof.			
Condition of Primary Building	Good	code		
		G		
Observable Threats	None			
Compatibility with Adjacent Land Uses	Good			
Potential NR Eligibility	Contributing	code		
		C		
Other Comments / Salient Details	Brick retaining wall along front of the property and stairs leading to path. Cement driveway on the right side of the house. Cement stairs and path leading from sidewalk to front door. Lamp post in front yard. Central chimney. Cement stairs with iron railing leading to sidedoor. Small bushes along front of house.

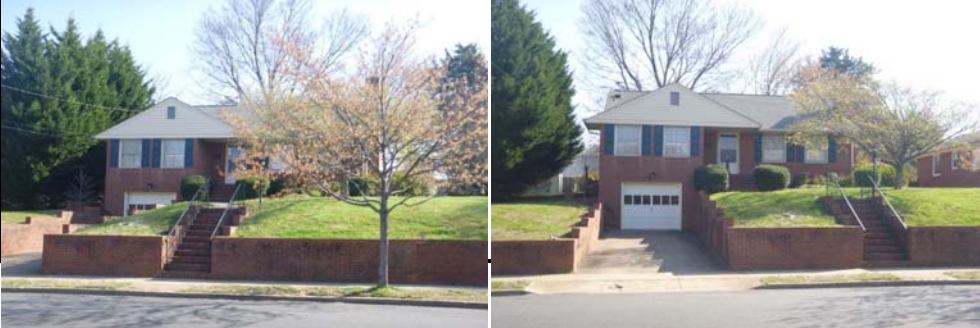
Name of Surveyors	Kimberly Packett		Survey Date	3/12/2016
ADDRESS	Street		Number	
	Stafford Avenue		1109	
TYPE & NUMBER OF BLGS & STRUCTURES	Type		Number	
	Single Family House		1	
Current Use of Primary Building	Single Family	Historic Use of Primary Building	Single Family	
Style of Primary Bldg	Minimal Traditional			
Number of Stories	1 1/2	Width (bays)	5	
Foundation Material	Cinderblock	Depth (rooms)	2	
Year Built	1962	Wall Cladding Material	Brick	
Roof Shape	Side Gable	Roof Material	Composition shingle	
Decorative Details/Unique Features	Blue shutters on front windows. Front gable on left front side of the house. Front gable hangs over front door.			
Evidence of Integrity Location/Materials	Original brick siding.			
Additions/Alterations to Primary Building	New roof and windows.			
Condition of Primary Building	Good			code G
Observable Threats	None			
Compatibility with Adjacent Land Uses	Good			
Potential NR Eligibility	Contributing			code C

Other Comments / Salient Details	Brick retaining wall along front of property and on either side of driveway. Cement driveway on left side of the house leading to basement attached garage. Brick stairs and path with iron railing leading from sidewalk to front door. Bushes along front of house. Chimney on right end of the house. Lamp post on front lawn.			
Photo Views				
1 3/4 View	2 Front View	3	4

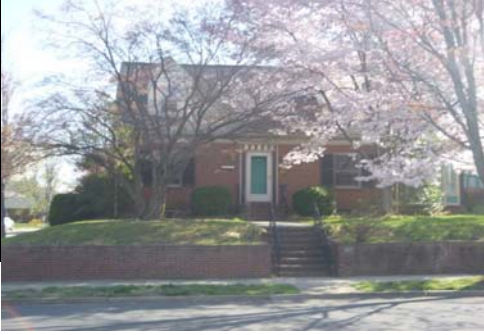
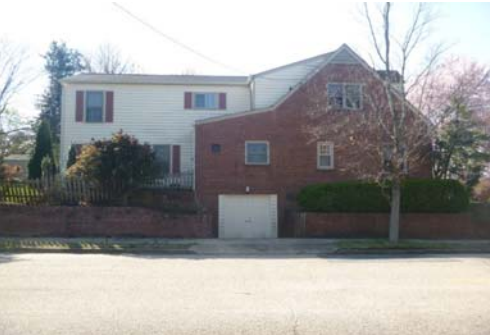
Name of Surveyors	Kimberly Packett		Survey Date	3/12/2016
ADDRESS	Street		Number	
	Stafford	Avenue	1117	
TYPE & NUMBER OF BLGS & STRUCTURES	Type		Number	
	Single Family House		1	
Current Use of Primary Building	Single Family	Historic Use of Primary Building	Single Family	
Style of Primary Blg	Cape Cod			
Number of Stories	2	Width (bays)	3	
Foundation Material	Concrete	Depth (rooms)	5	
Year Built	1954	Wall Cladding Material	Brick	
Roof Shape	Side Gable	Roof Material	Composition shingle	
Decorative Details/Unique Features	Tan and red striped awning above front door. Blue shutters on front first story windows. Red shutters on side windows on addition. Two front gable dormers on the front of the house. Attached basement garage. Large addition on rear of house with front gable roof and vinyl siding.			
Evidence of Integrity Location/Materials	Original brick siding and windows on original section of house.

Additions/Alterations to Primary Building	Large addition on rear of the house with vinyl siding. New roof.			
Condition of Primary Building	Good			code
				G
Observable Threats	None			
Compatibility with Adjacent Land Uses	Good			
Potential NR Eligibility	Contributing			code
				C
Other Comments / Salient Details	Brick retaining wall along front and side of property. Cement driveway on left side of the house leading to attached basement garage. Wood picket fence around the backyard. Bushes and garden along front and side of house. Brick stairs and path with iron railing leading from sidewalk to front door. Sun room on right side of the house.			
Photo Views				
1 Front View	2 Side View	3	4

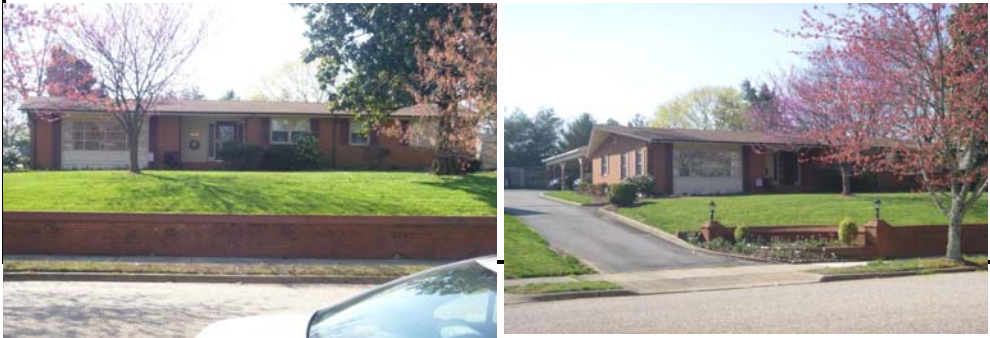
Name of Surveyors	Kimberly Packett		Survey Date	3/12/2016
ADDRESS	Street		Number	
	Royston	Street	1316	
TYPE & NUMBER OF BLGS & STRUCTURES	Type		Number	
	Single Family House		1	
Current Use of Primary Building	Single Family	Historic Use of Primary Building	Single Family	
Style of Primary Bldg	Ranch			
Number of Stories	1	Width (bays)	5	
Foundation Material	Cinderblock	Depth (rooms)	3	
Year Built	1963	Wall Cladding Material	Brick	
Roof Shape	Side Gable	Roof Material	Composition Shingle	
Decorative Details/Unique Features	Sidelights on either side of the front door. Red shutters on front windows. Tan paneling below window on front left side. Tan siding around front door. Carport attached to rear of house.			
Evidence of Integrity Location/Materials	Original brick siding and windows.			
Additions/Alterations to Primary Building	New roof.			
Condition of Primary Building	Good		code	G
Observable Threats	None

Compatibility with Adjacent Land Uses	Good			
Potential NR Eligibility	Contributing		code	C
Other Comments / Salient Details	Brick retaining wall along front of the property. Paved driveway on left side of the house leading to attached carport on rear of the house. Paved path leading from driveway to brick stairs and front porch. Wood privacy fence along back of backyard. Garden at foot of driveway and along front of house.			
Photo Views				
1 Front View	2 3/4 View	3	4

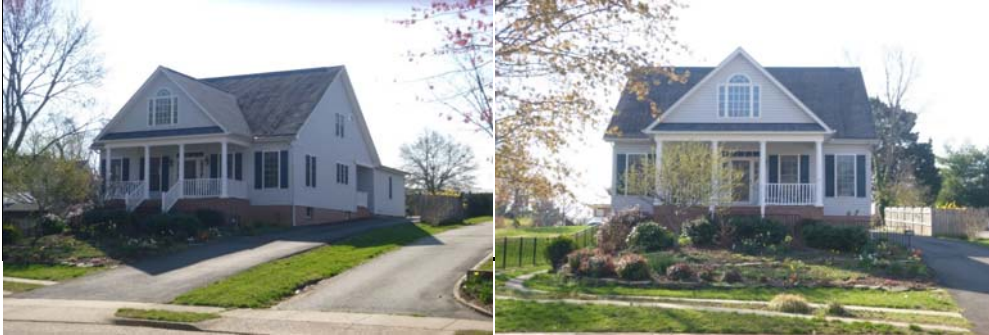
Name of Surveyors	Kimberly Packett		Survey Date	3/12/2016
ADDRESS	Street		Number	
	Royston	Street	1312	
TYPE & NUMBER OF BLGS & STRUCTURES	Type		Number	
	Single Family House		1	
Current Use of Primary Building	Single Family	Historic Use of Primary Building	Single Family	
Style of Primary Bldg	Craftsman			
Number of Stories	1 1/2	Width (bays)	5	
Foundation Material	Brick	Depth (rooms)	4	
Year Built	2002	Wall Cladding Material	Vinyl siding	
Roof Shape	Side Gable	Roof Material	Composition shingle	
Decorative Details/Unique Features	Blue shutters on front windows. Transom and sidelights around front door. Front gable hangs over front porch with white column supports. Palladian window on front gable.			
Evidence of Integrity Location/Materials	All original materials.			
Additions/Alterations to Primary Building	None.			
Condition of Primary Building	Excellent		code	E
Observable Threats	None			
Compatibility with Adjacent Land Uses	Fair, newer construction and landscape makes it stand out in the neighborhood.

Potential NR Eligibility	Non-Contributing		code	N
Other Comments / Salient Details	Paved driveway on right side of the house. Cement path that leads from driveway to back of house. Brick path and stairs that lead from driveway to brick front porch with white railings and columns. Black iron fence on left side of property. Wood privacy fence on right side of property. Large garden in front of house.			
Photo Views				
1 3/4 View	2 Front View	3	4

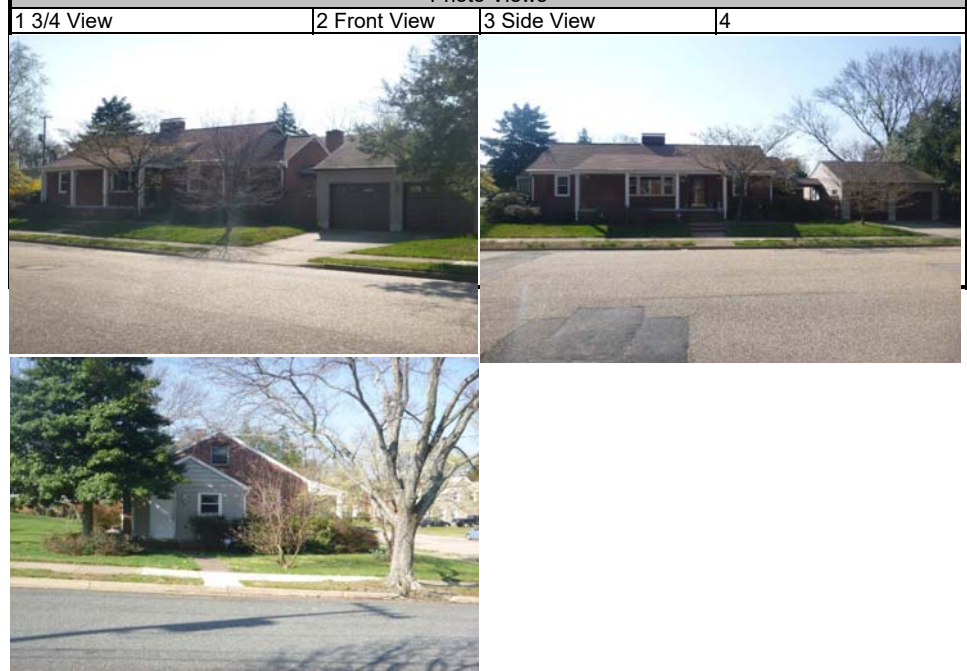
Name of Surveyors	Kimberly Packett		Survey Date	3/12/2016
ADDRESS	Street		Number	
	Royston	Street	1300	
TYPE & NUMBER OF BLGS & STRUCTURES	Type		Number	
	Single Family House		1	
	Shed		1	
Current Use of Primary Building	Single Family	Historic Use of Primary Building	Single Family	
Style of Primary Bldg	Minimal Traditional			
Number of Stories	1	Width (bays)	4	
Foundation Material	Cinderblock	Depth (rooms)	3	
Year Built	1958	Wall Cladding Material	Brick	
Roof Shape	Side gable	Roof Material	Composition shingle	
Decorative Details/Unique Features	Roof hangs over front porch supported by white beams. White surround around windows. Attached double garage on the right side of the property with vinyl siding. Addition on left side of house with side door and vinyl siding.			
Evidence of Integrity Location/Materials	Original brick siding and windows.			
Additions/Alterations to Primary Building	Attached garage is an addition. New roof.

Condition of Primary Building	Good			code G
Observable Threats	None			
Compatibility with Adjacent Land Uses	Good			
Potential NR Eligibility	Contributing			code C
Other Comments / Salient Details	Central chimney. Cement driveway on right side of the property that leads to attached double garage. Cement path and stairs leading from sidewalk to brick front porch. Chimney on rear of house. Garage is attached to main house by covered walkway. Shed in back left side of backyard. Cement path leading to left side door.

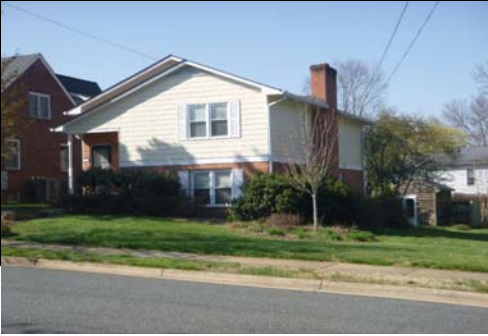
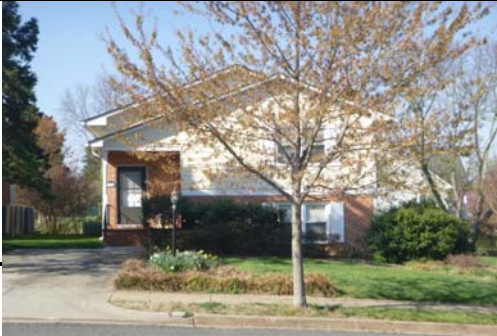
Name of Surveyors	Kimberly Packett		Survey Date	3/12/2016
ADDRESS	Street		Number	
	Augustine Avenue		1104	
TYPE & NUMBER OF BLGS & STRUCTURES	Type		Number	
	Single Family House		1	
	Shed		1	
Current Use of Primary Building	Single Family	Historic Use of Primary Building	Single Family	
Style of Primary Bldg	Craftsman			
Number of Stories	1 1/2	Width (bays)	3	
Foundation Material	Cinderblock	Depth (rooms)	3	
Year Built	1971	Wall Cladding Material	Brick	
Roof Shape	Front Gable	Roof Material	Composition shingle	
Decorative Details/Unique Features	Double front gable roof. White shutters on front windows. Roof hangs over front door landing supported by white column. Brick siding on first and middle floor. hardboard siding on second story.			
Evidence of Integrity Location/Materials	Original brick siding and windows.			
Additions/Alterations to Primary Building	New roof and hardboard siding.			
Condition of Primary Building	Good	code

G		
Observable Threats	None			
Compatibility with Adjacent Land Uses	Good			
Potential NR Eligibility	Non-Contributing	code		
		N		
Other Comments / Salient Details	Chimney on right end of the house. Bushes along front and right side of the house. Cement driveway on left side of the house. Brick stairs with iron railing leading from driveway to front door. Lamp post in front yard.			
Photo Views				
1 3/4 View	2 Front View	3	4

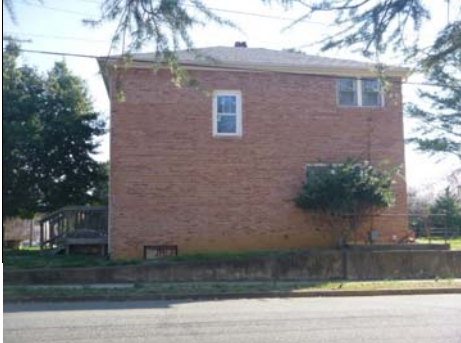
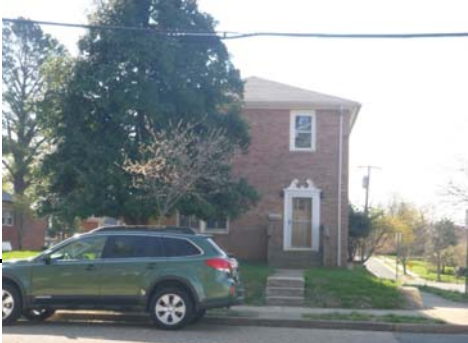
Name of Surveyors	Kimberly Packett		Survey Date	3/12/2016
ADDRESS	Street		Number	
	Brent	Street	1238	
TYPE & NUMBER OF BLGS & STRUCTURES	Type		Number	
	Single Family House		1	
Current Use of Primary Building	Single Family	Historic Use of Primary Building	Single Family	
Style of Primary Bldg	American Foursquare			
Number of Stories	2	Width (bays)	2	
Foundation Material	Concrete	Depth (rooms)	2	
Year Built	1917	Wall Cladding Material	Brick	
Roof Shape	Hip	Roof Material	Composition shingle	
Decorative Details/Unique Features	White pilasters on either side of front door with a white broken pediment above it.			
Evidence of Integrity Location/Materials	Original brick siding.			
Additions/Alterations to Primary Building	New windows and roof.			
Condition of Primary Building	Fair		code	F
Observable Threats	None			
Compatibility with Adjacent Land Uses	Good			
Potential NR Eligibility	Non-Contributing		code	N
Other Comments / Salient Details	Cement retaining wall along right side of property. Cement steps and path leading from sidewalk to wood steps and landing with wood railing in front of front door. Central chimney. Stairs leading to basement entrance on the back right side of the house.

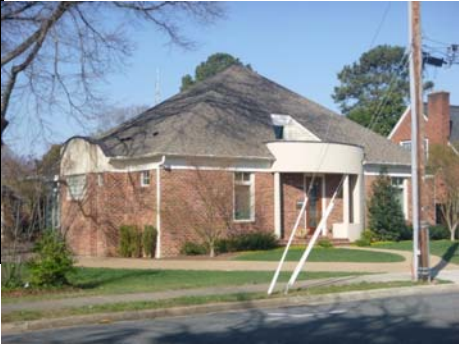
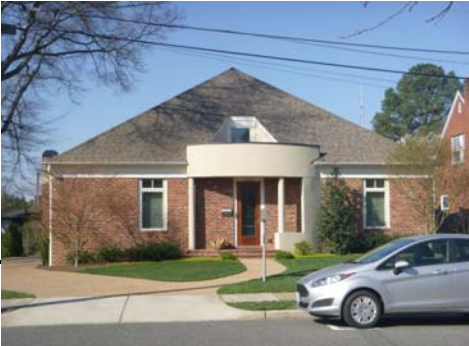
Name of Surveyors	Kimberly Packett		Survey Date	3/12/2016
ADDRESS	Street		Number	
	Colony	Road	1206	
TYPE & NUMBER OF BLGS & STRUCTURES	Type		Number	
	Single Family House		1	
Current Use of Primary Building	Single Family	Historic Use of Primary Building	Single Family	
Style of Primary Bldg	Postmodern			
Number of Stories	1	Width (bays)	3	
Foundation Material	Cinderblock	Depth (rooms)	3	
Year Built	2009	Wall Cladding Material	Brick	
Roof Shape	Hip	Roof Material	Composition shingle	
Decorative Details/Unique Features	Cement circular portico above front porch. Window on front second story behind top of circular portico. Semi-circular cement wall on left side of building with cubed window.			
Evidence of Integrity Location/Materials	All original materials.			
Additions/Alterations to Primary Building	None.			
Condition of Primary Building	Good			code G
Observable Threats	None			
Compatibility with Adjacent Land Uses	Good

Potential NR Eligibility	Non-Contributing			code N
Other Comments / Salient Details	Cement driveway along the left side of the house. Cement path and brick stairs leading from driveway/sidewalk to the front door. Small bushes and trees along front of house. Lamp post in front yard.			
Photo Views				
1 3/4 View	2 Front View	3	4

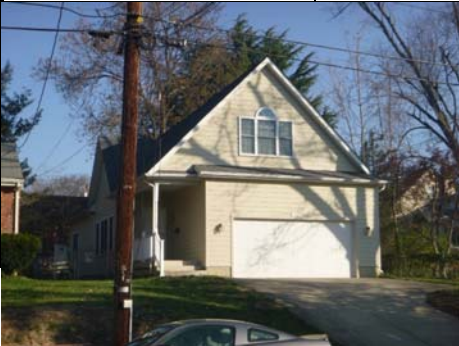
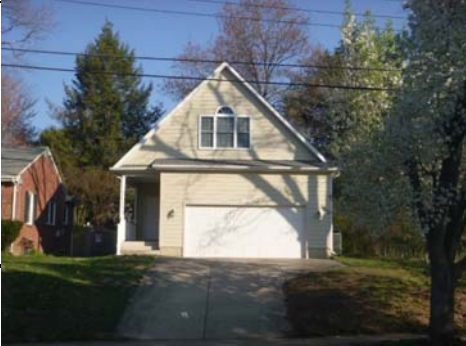
Name of Surveyors	Kimberly Packett		Survey Date	3/12/2016
ADDRESS	Street		Number	
	Dandridge	Street	1407	
TYPE & NUMBER OF BLGS & STRUCTURES	Type		Number	
	Single Family House		1	
Current Use of Primary Building	Single Family	Historic Use of Primary Building	Single Family	
Style of Primary Bldg	Postmodern			
Number of Stories	1 1/2	Width (bays)	2	
Foundation Material	Concrete	Depth (rooms)	3	
Year Built	2008	Wall Cladding Material	Vinyl Siding	
Roof Shape	Cross Gable	Roof Material	Composition shingle	
Decorative Details/Unique Features	Palladian window on front gable. Roof hangs over porch to the right of the attached garage where the front door is located.			
Evidence of Integrity Location/Materials	All original materials			
Additions/Alterations to Primary Building	None			
Condition of Primary Building	Excellent		code	E
Observable Threats	Poor, does not match surrounding styles.			
Compatibility with Adjacent Land Uses	Good

Potential NR Eligibility	Non-Contributing		code	N
Other Comments / Salient Details	Cement driveway leading to attached garage in the front of the house. Cement stairs with white railing leading from driveway to porch. Chainlink fence around backyard.			
Photo Views				
1 3/4 View	2 Front View	3	4
